Inspection Photos

Loc: 320988

Operator: **DOVER ATWOOD CORPORATION**

Inspection Date: 10/31/2023

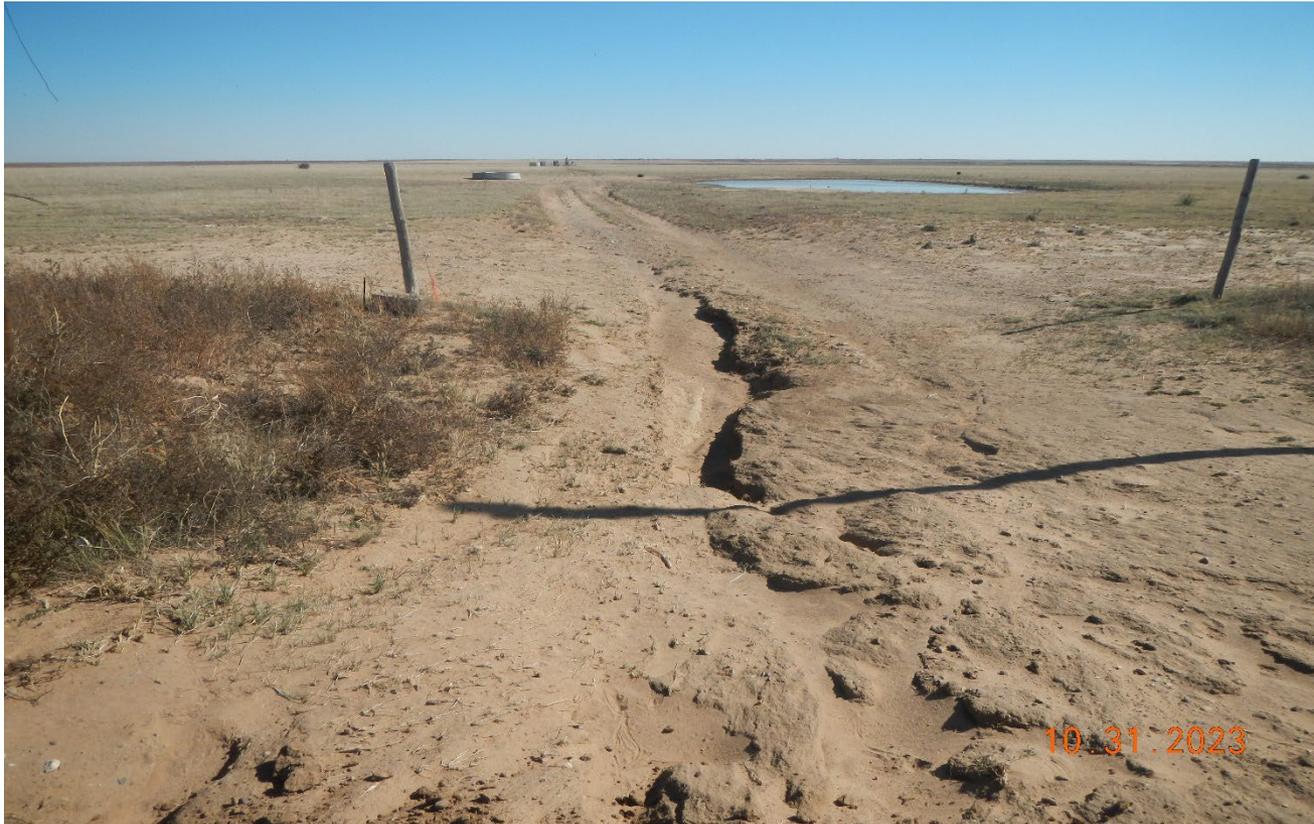
Photo 1. Facing east at the access road. There is erosion along the road that needs to be repaired and stabilized..

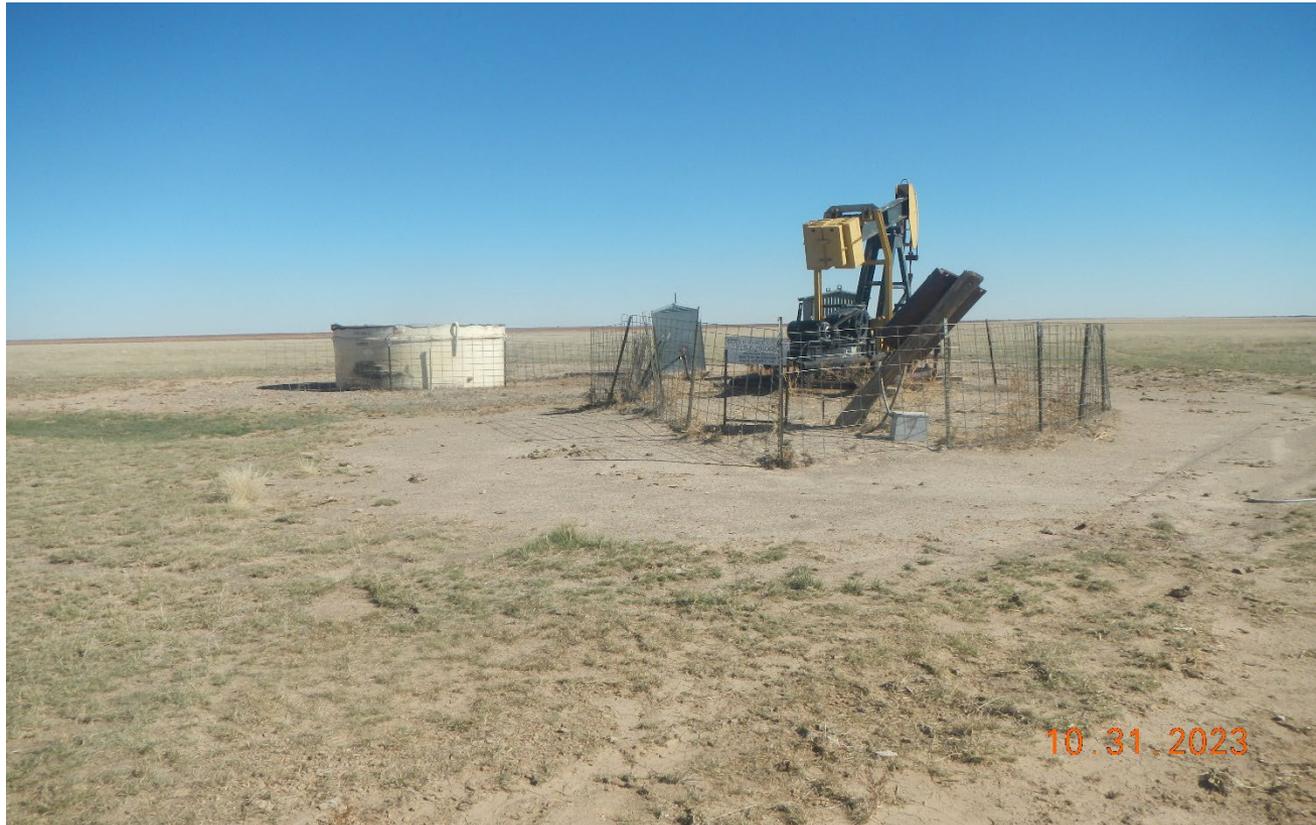
Photo 2. Facing northeast toward the wellsite.

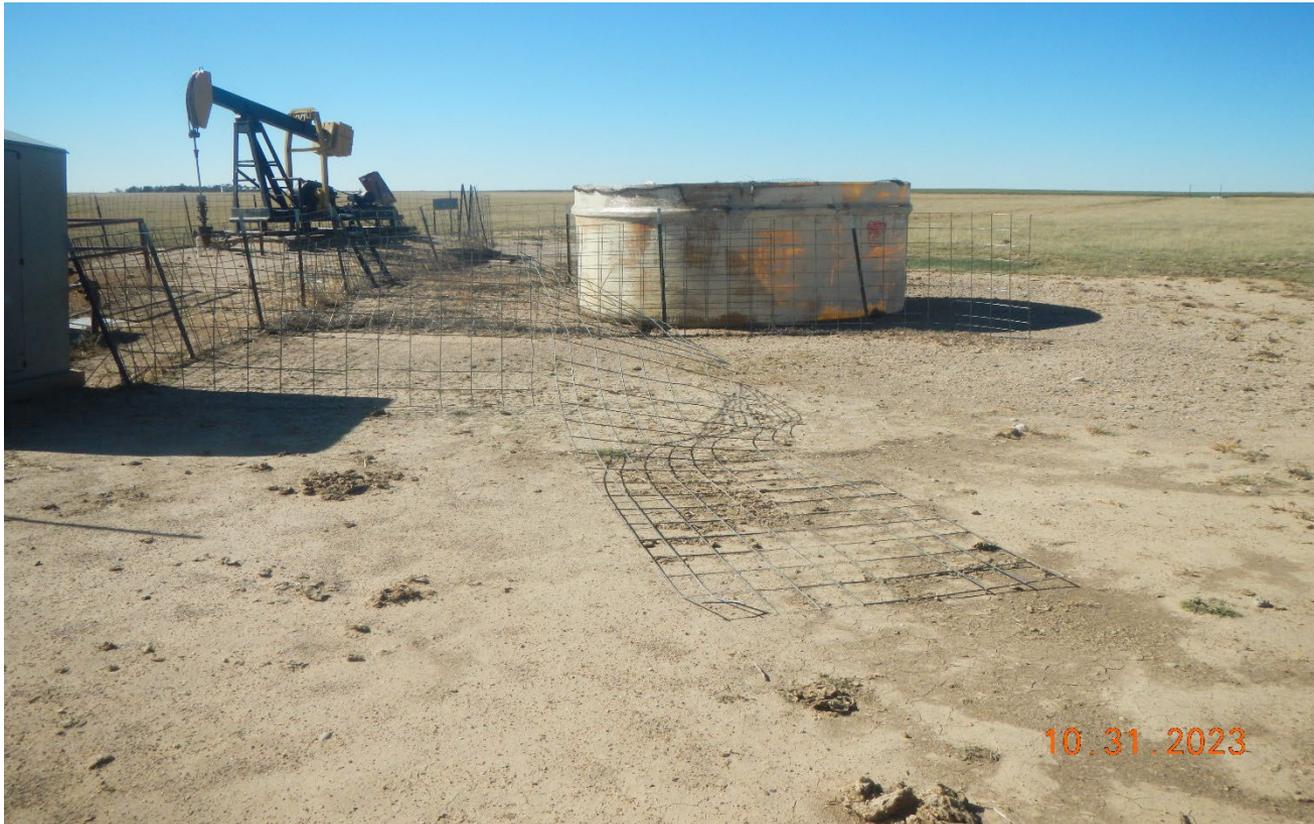
Photo 3. There is no secondary containment around the open top tank. The fence around the equipment is in disrepair and the cattle panel is laying on the ground.

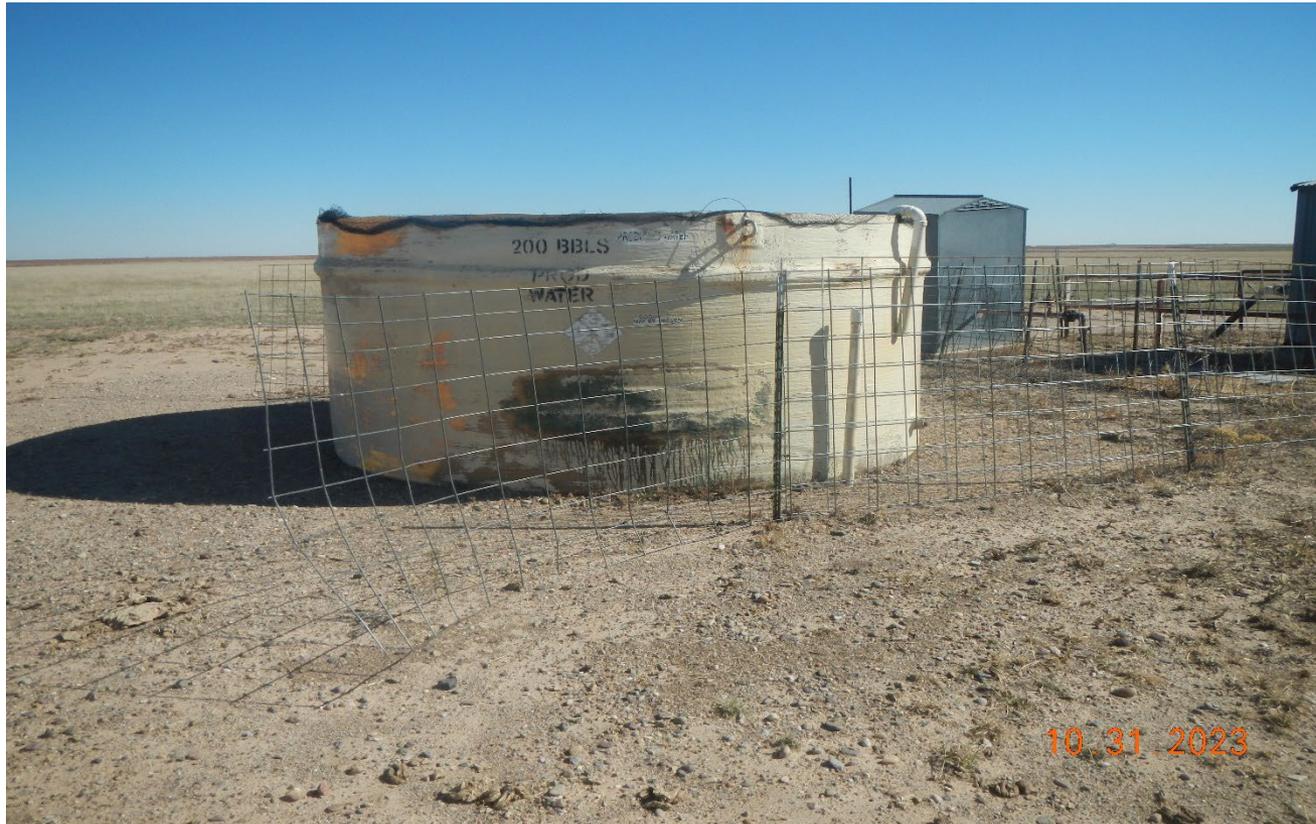
Photo 4. There is no secondary containment around the open top tank. The fence around the equipment is in disrepair.

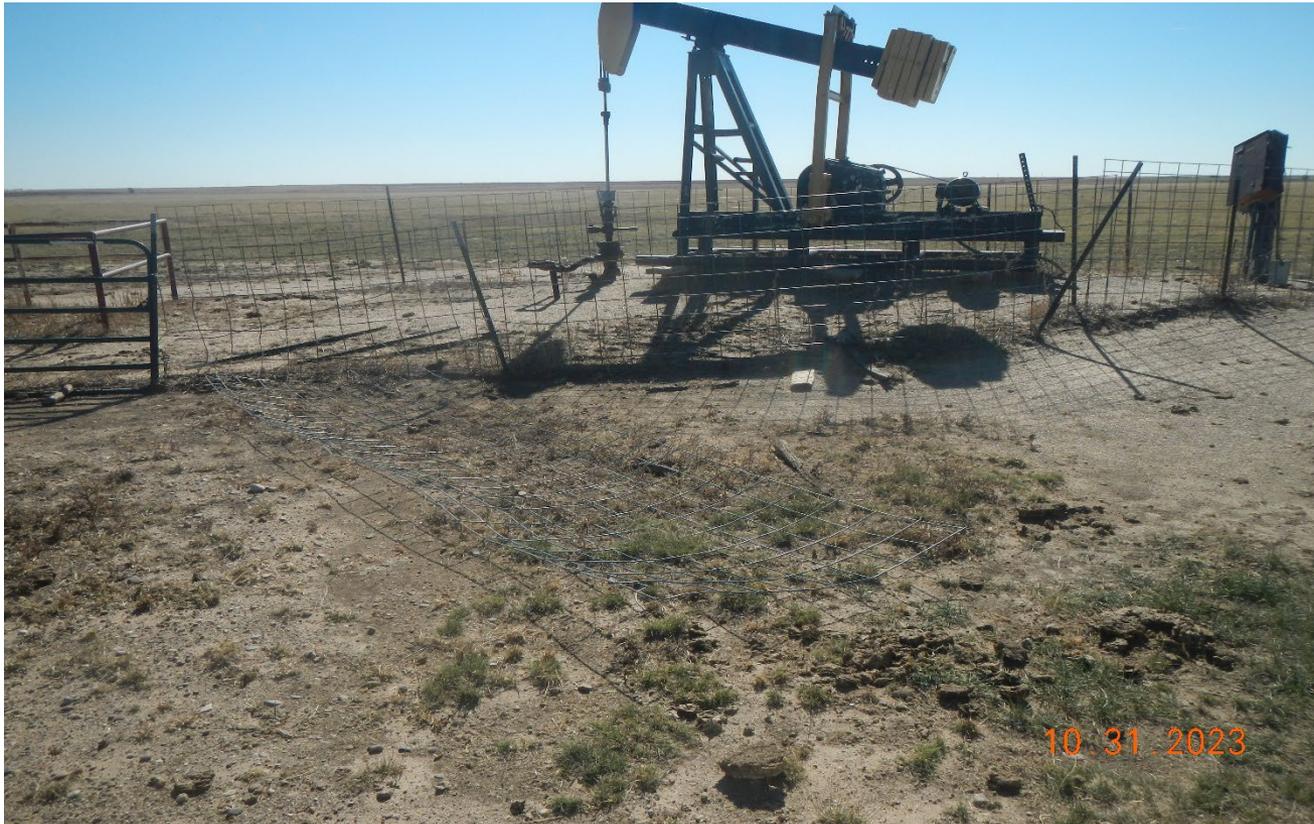
Photo 5. Facing toward the pumpjack. The fence around the equipment is in disrepair and the cattle panel is laying on the ground.
