# Inspection Photos

Loc: 429852

Operator: **DOVER ATWOOD CORPORATION**

Inspection Date: 10/31/2023

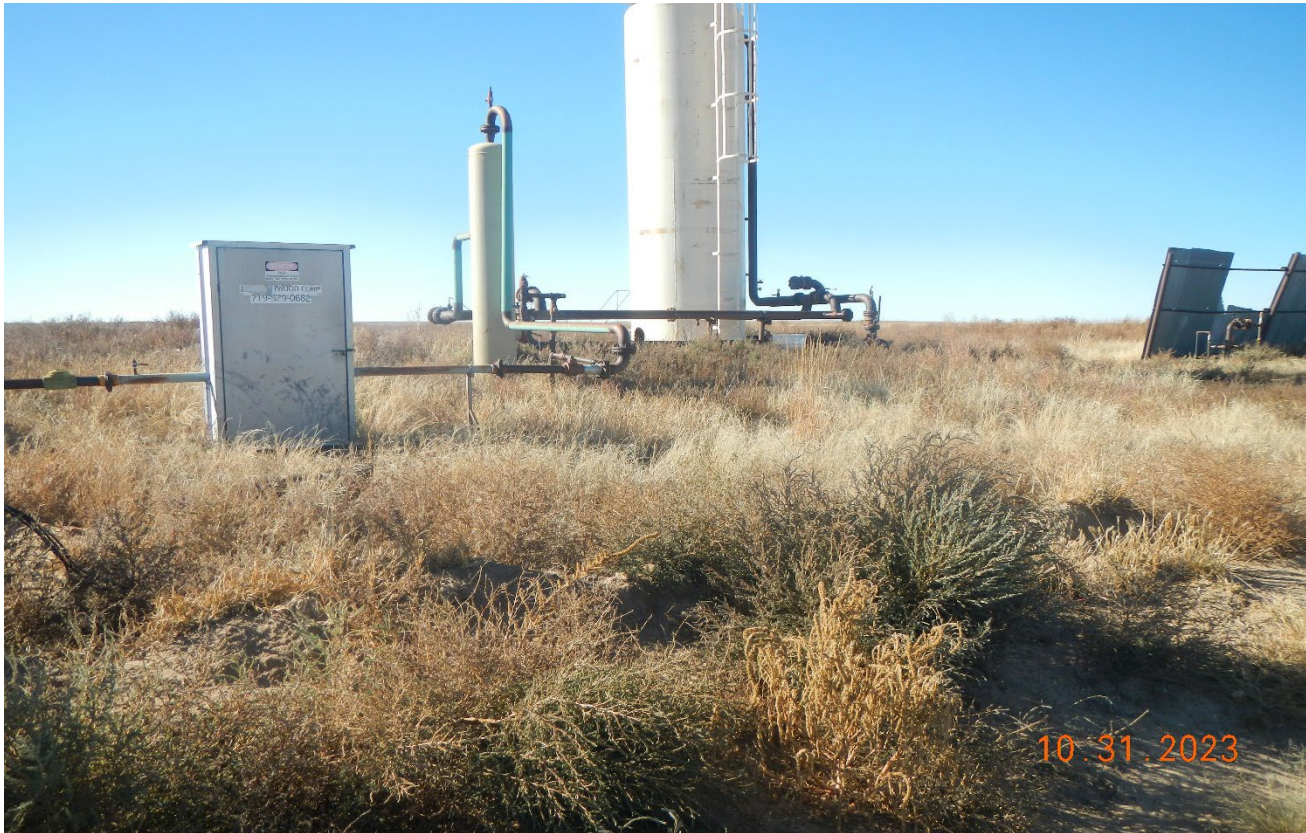
**Photo 1.** Facing west toward the Walsh/Bishop Gas Compressor. There is weeds and dry vegetation around the equipment which is a fire hazard.

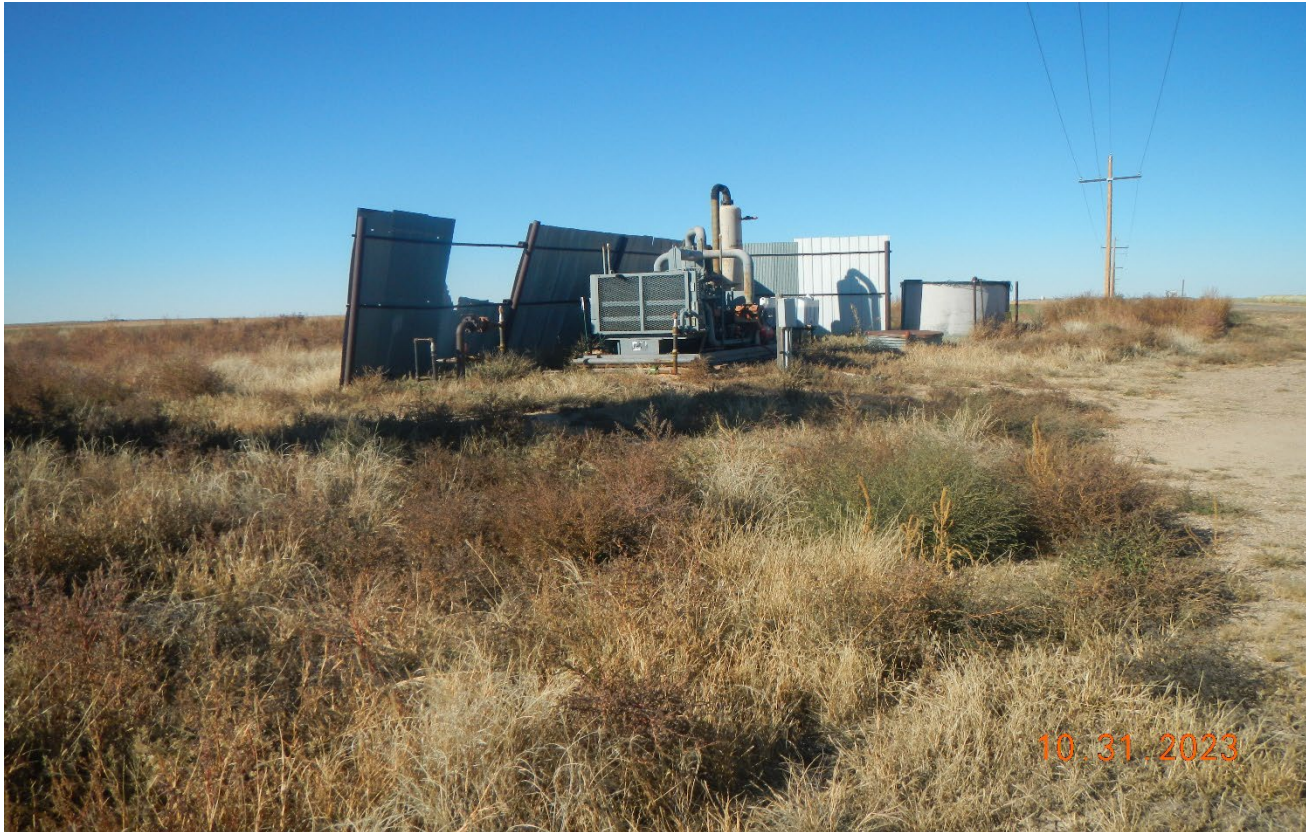
**Photo 2.** Facing northwest toward the Walsh/Bishop Gas Compressor. There is weeds and dry vegetation around the equipment which is a fire hazard.

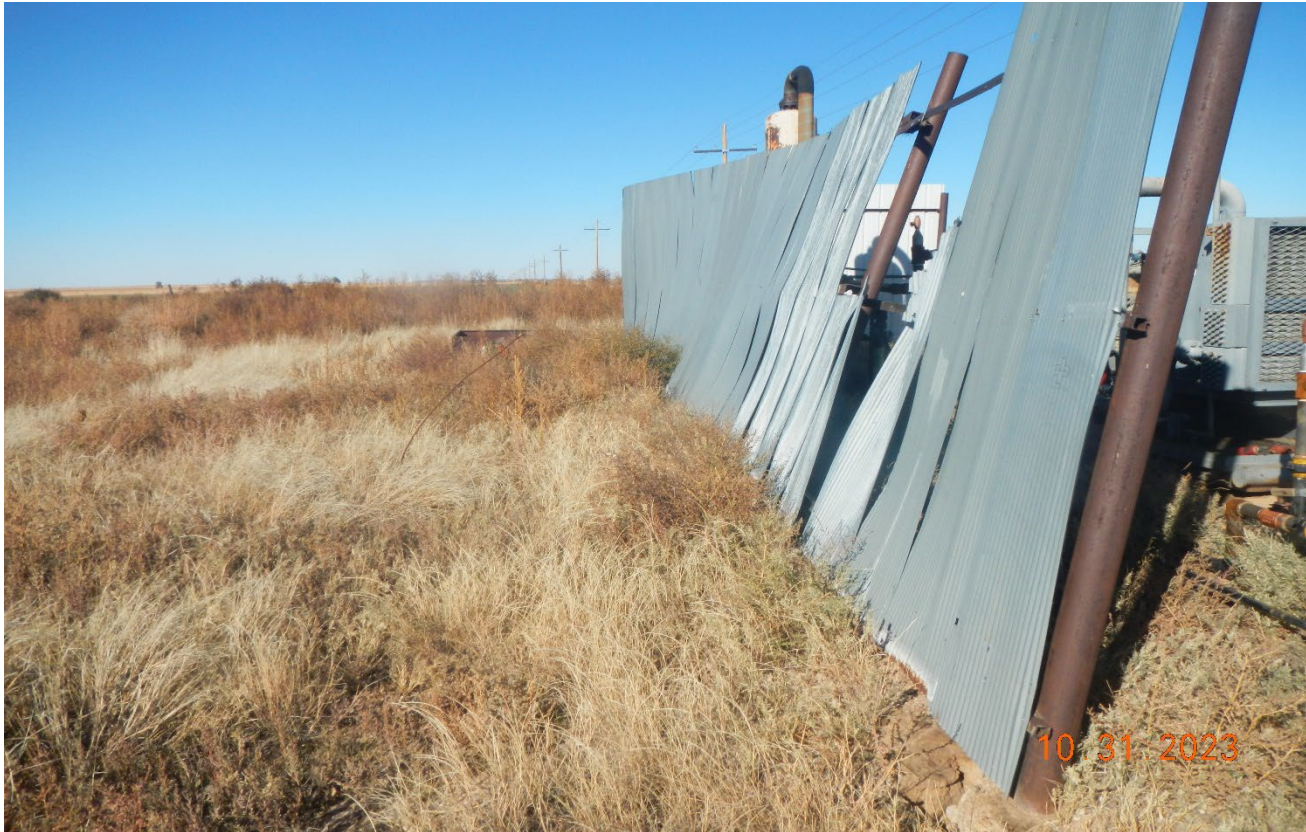
**Photo 3.** The wall behind the compressor engine is leaning over about to fall down.

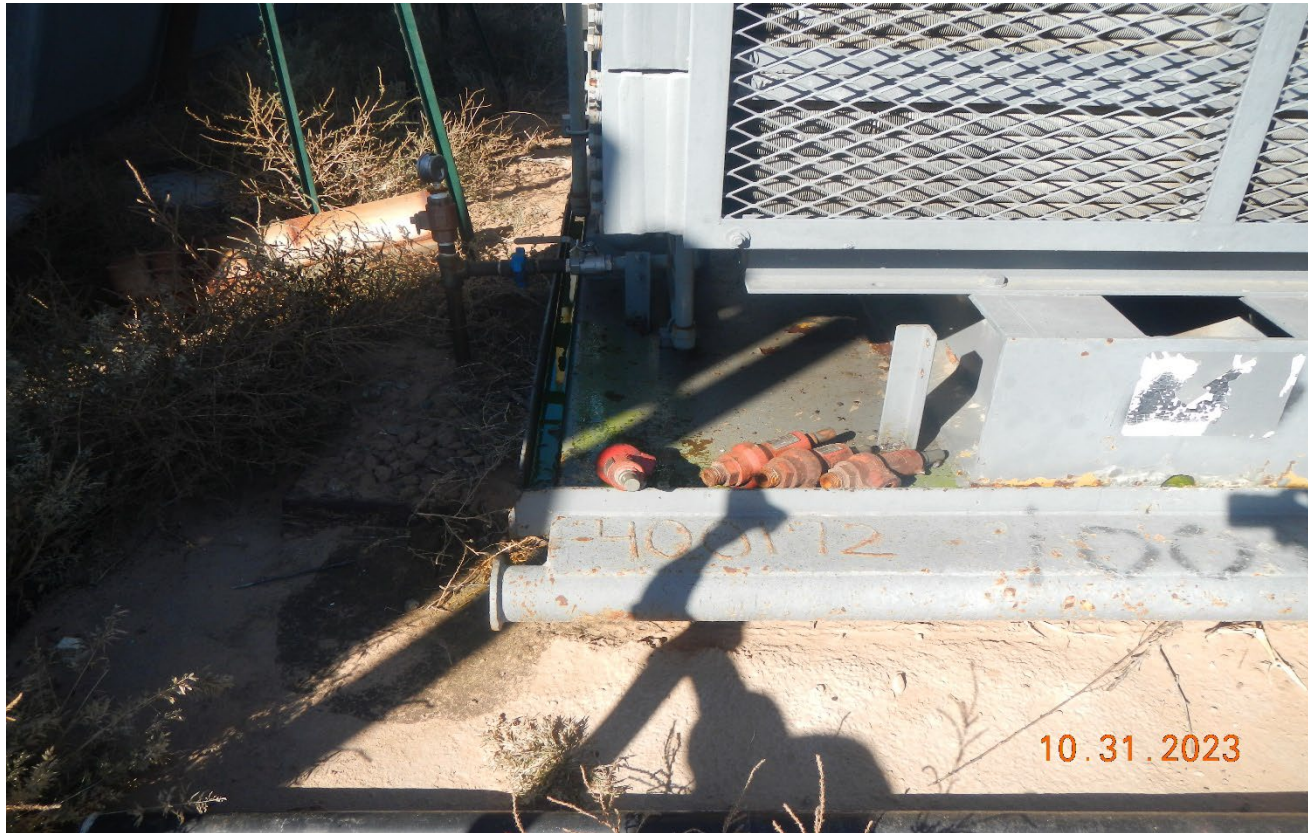
**Photo 4.** There is green liquid glycol I the engine skid that must be cleaned up.

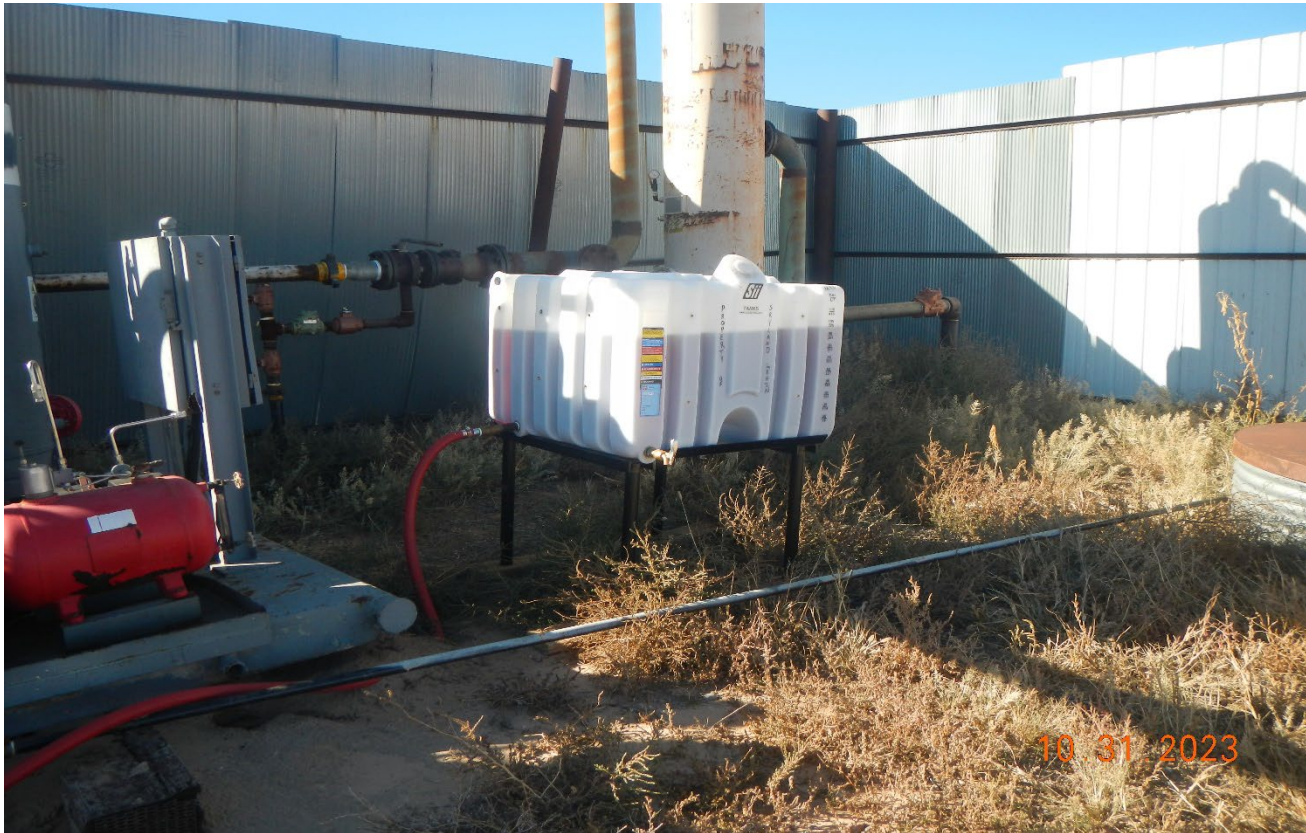
**Photo 5.** There is no secondary containment at the chemical tote.

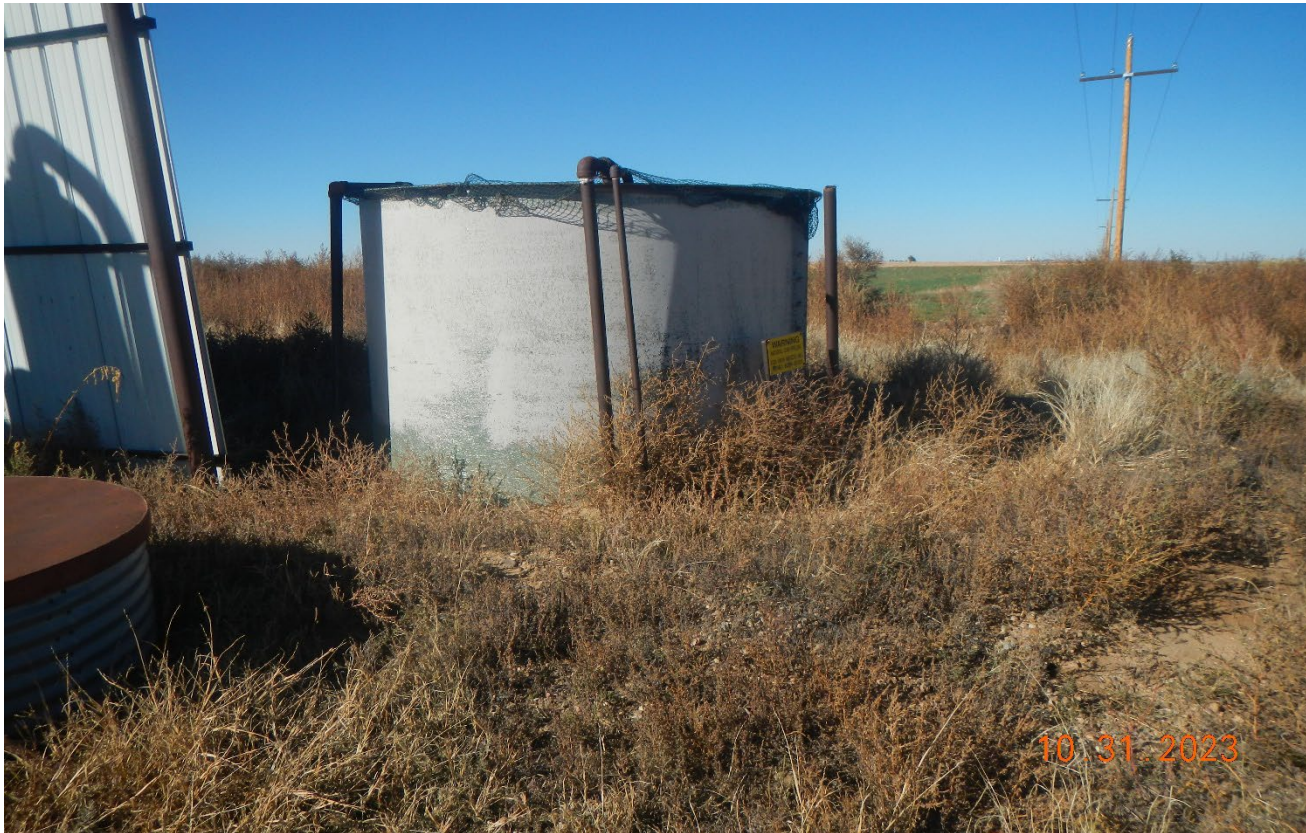
**Photo 6.** There are weeds around the open top tank and insufficient secondary containment.

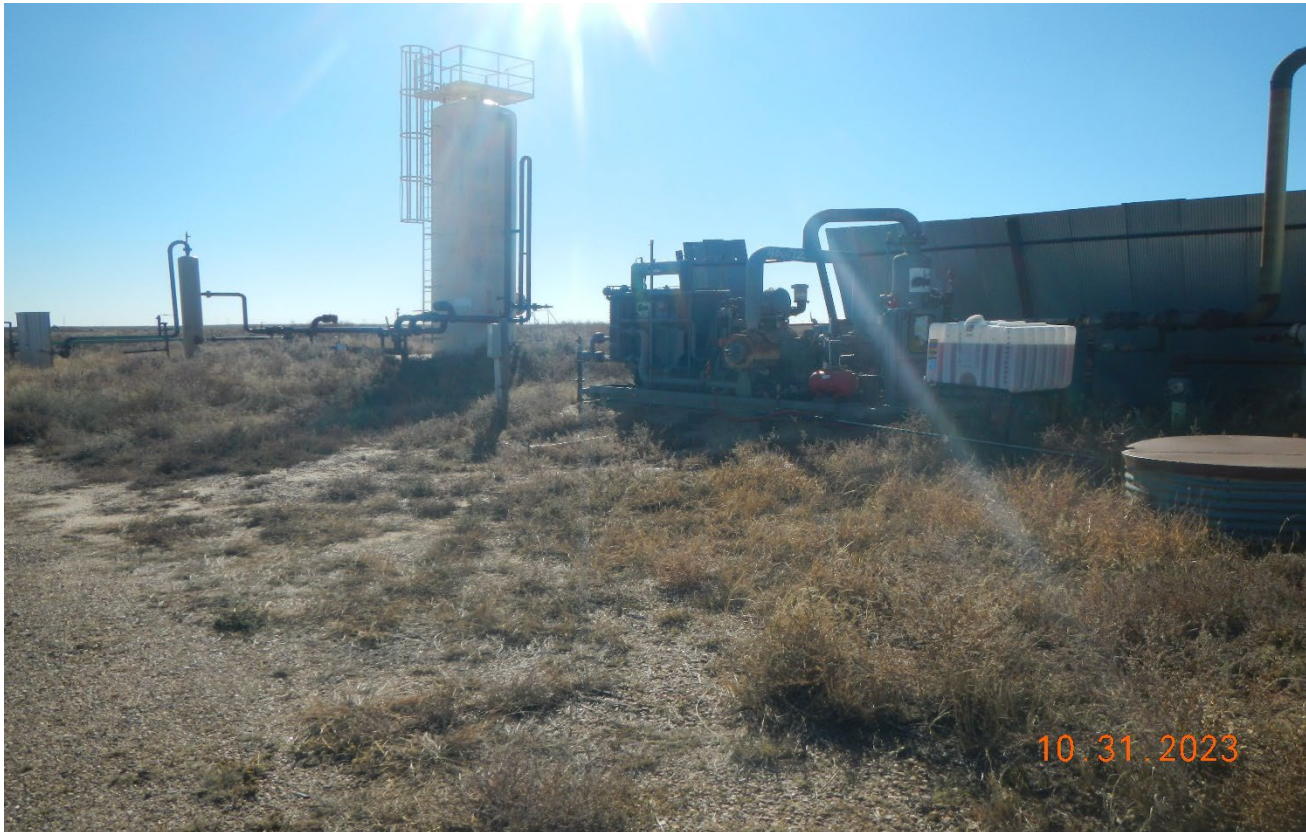
**Photo 7.** Facing southwest at the location which is located off a busy County Road.

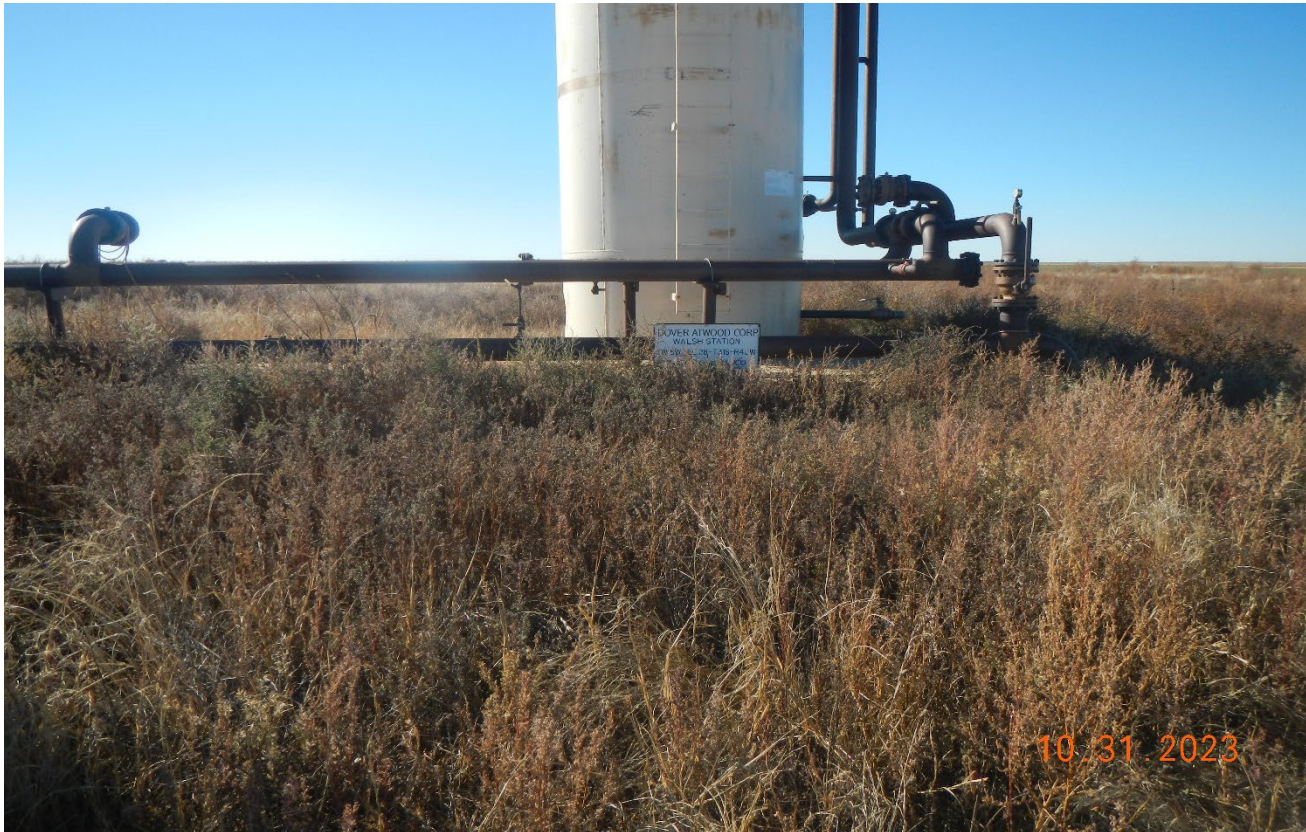
**Photo 8.** Facing toward the separator. There is no secondary containment and the location sign is obscured by weed cover.
