Inspection Photos

Loc: 320973

Operator: **DOVER ATWOOD CORPORATION**

Inspection Date: 10/31/2023

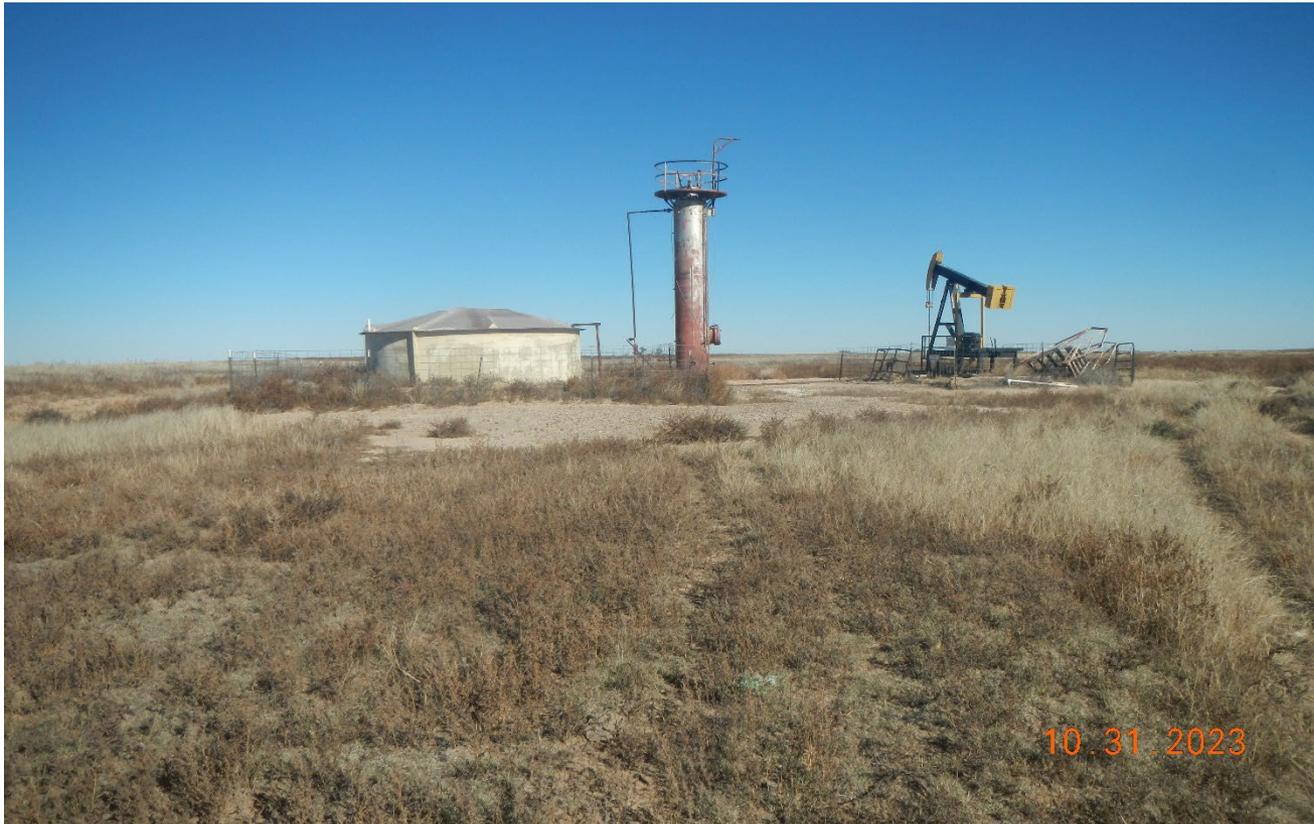
Photo 1. Facing northwest toward the wellsite.

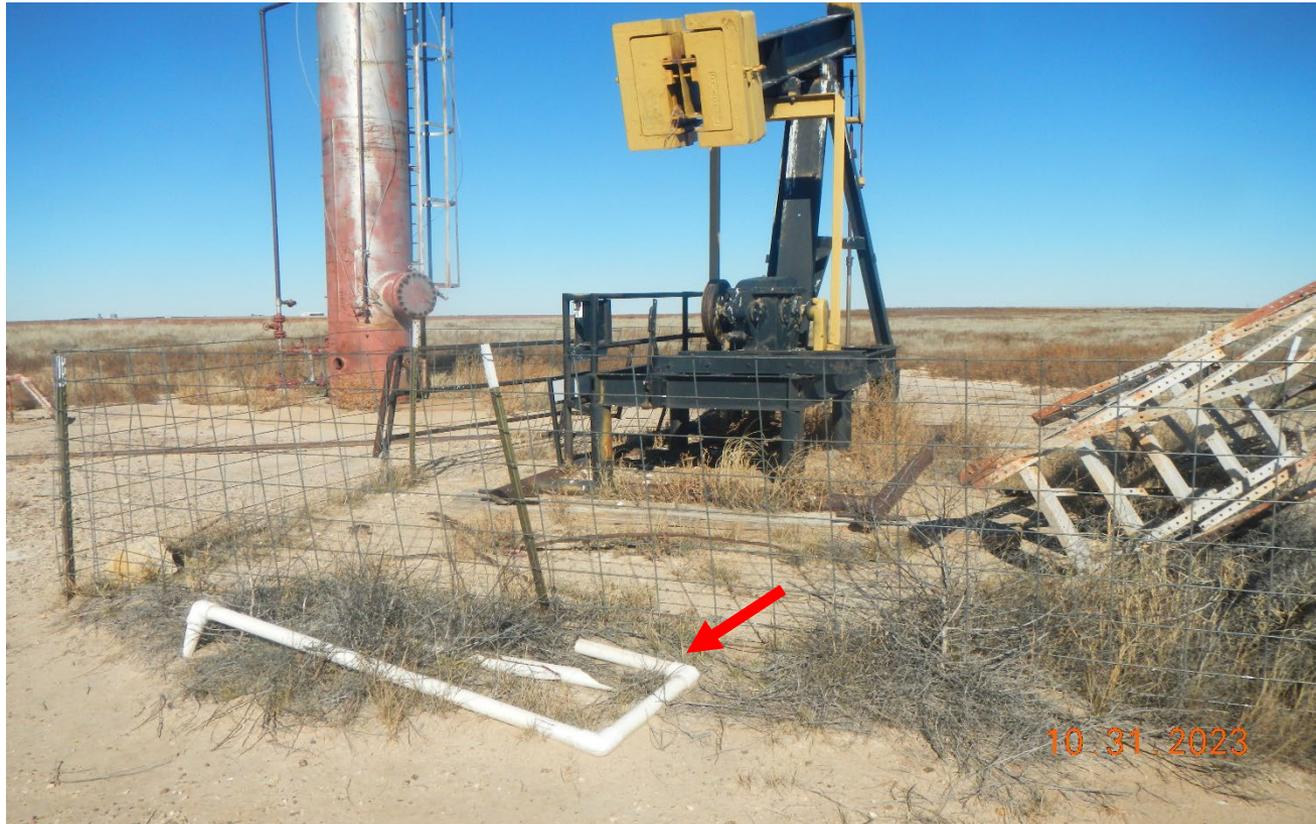
Photo 2. There is a broken pipe at red arrow and weeds around the equipment.

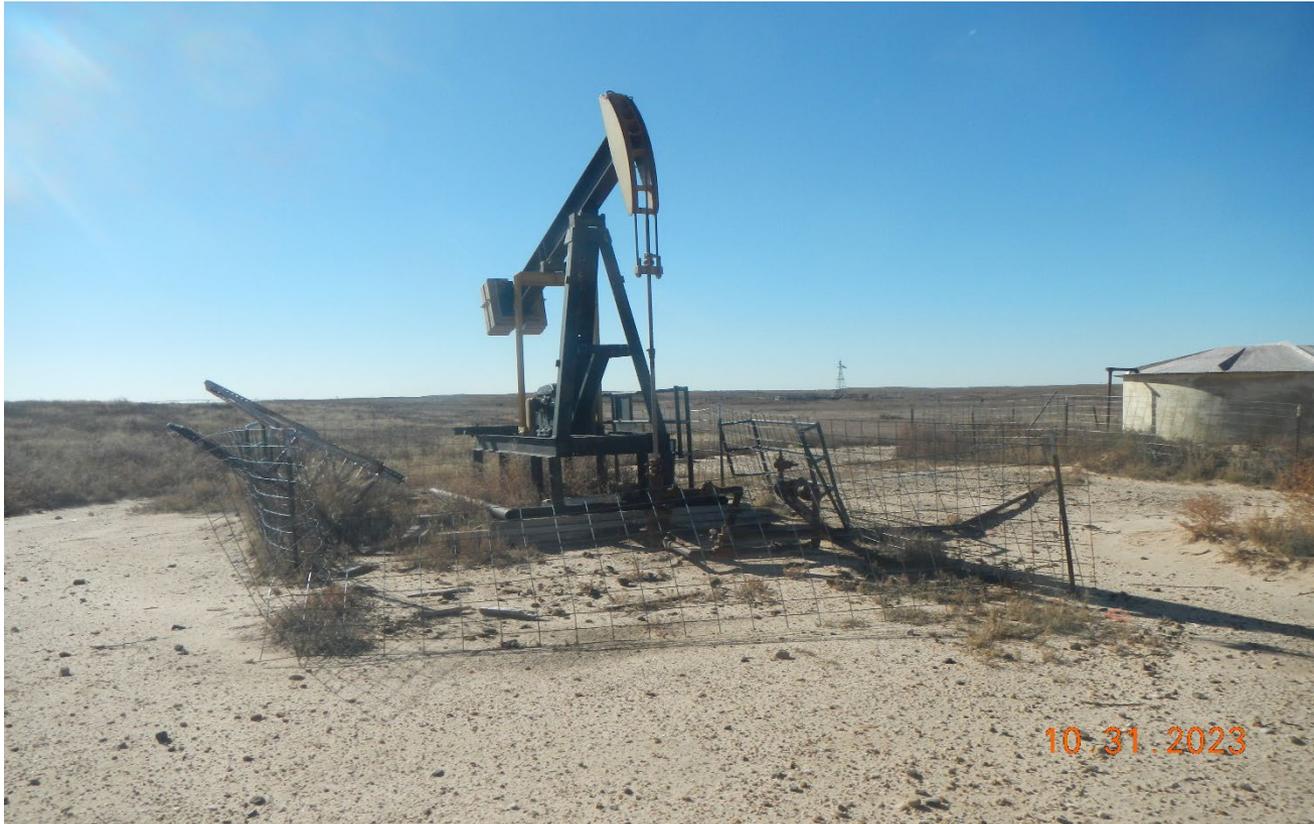
Photo 3. The fence around the pumpjack is in disrepair.

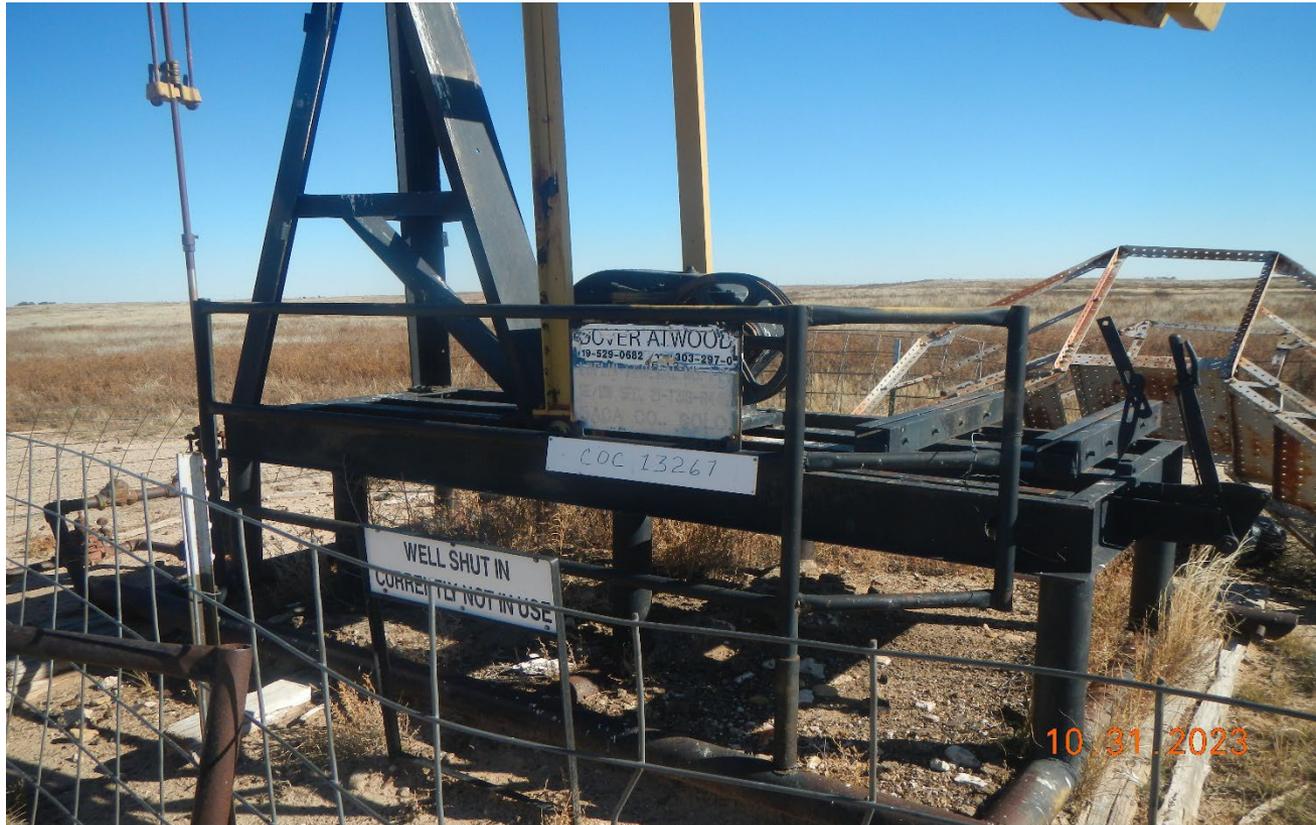
Photo 4. The sign posted at the well is faded and does not meet the requirements.

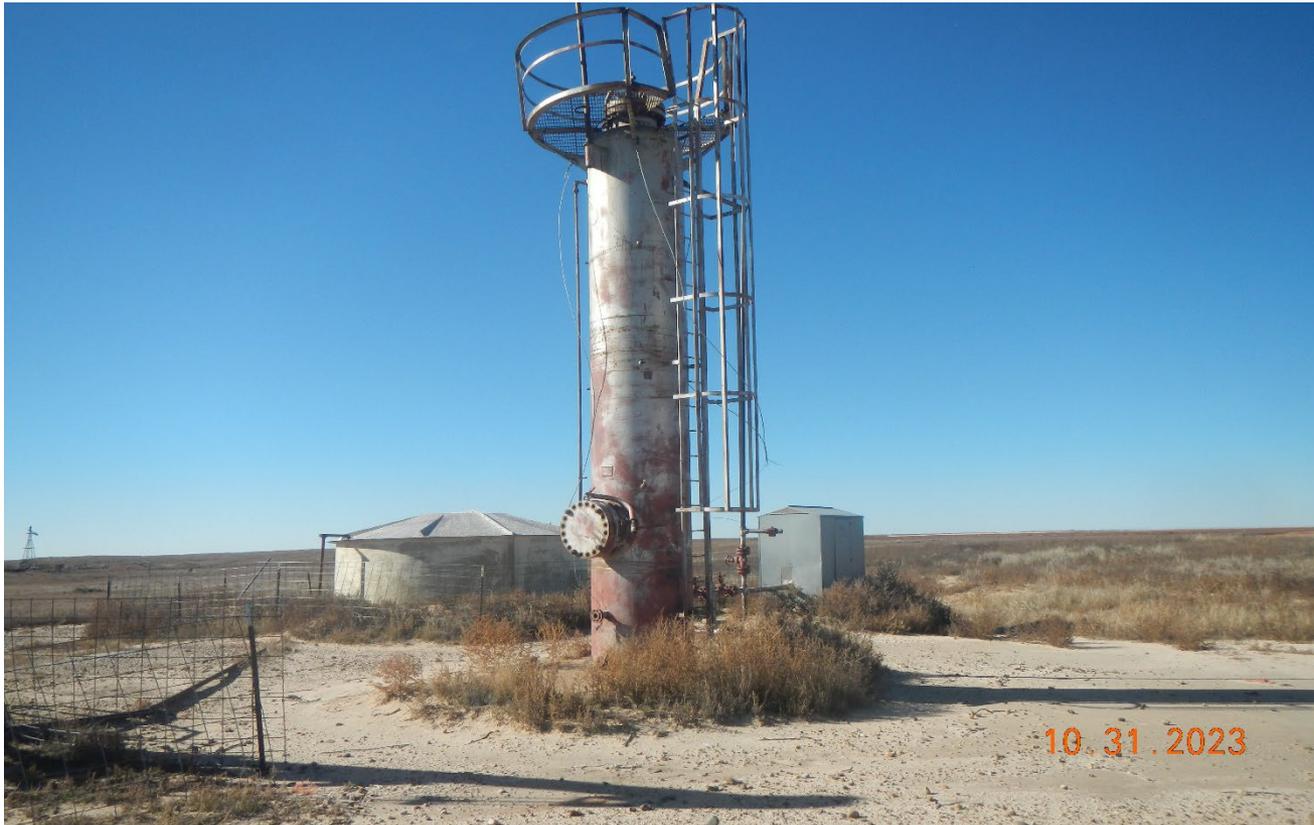
Photo 5. Facing toward the separator. There is no containment around the separator.

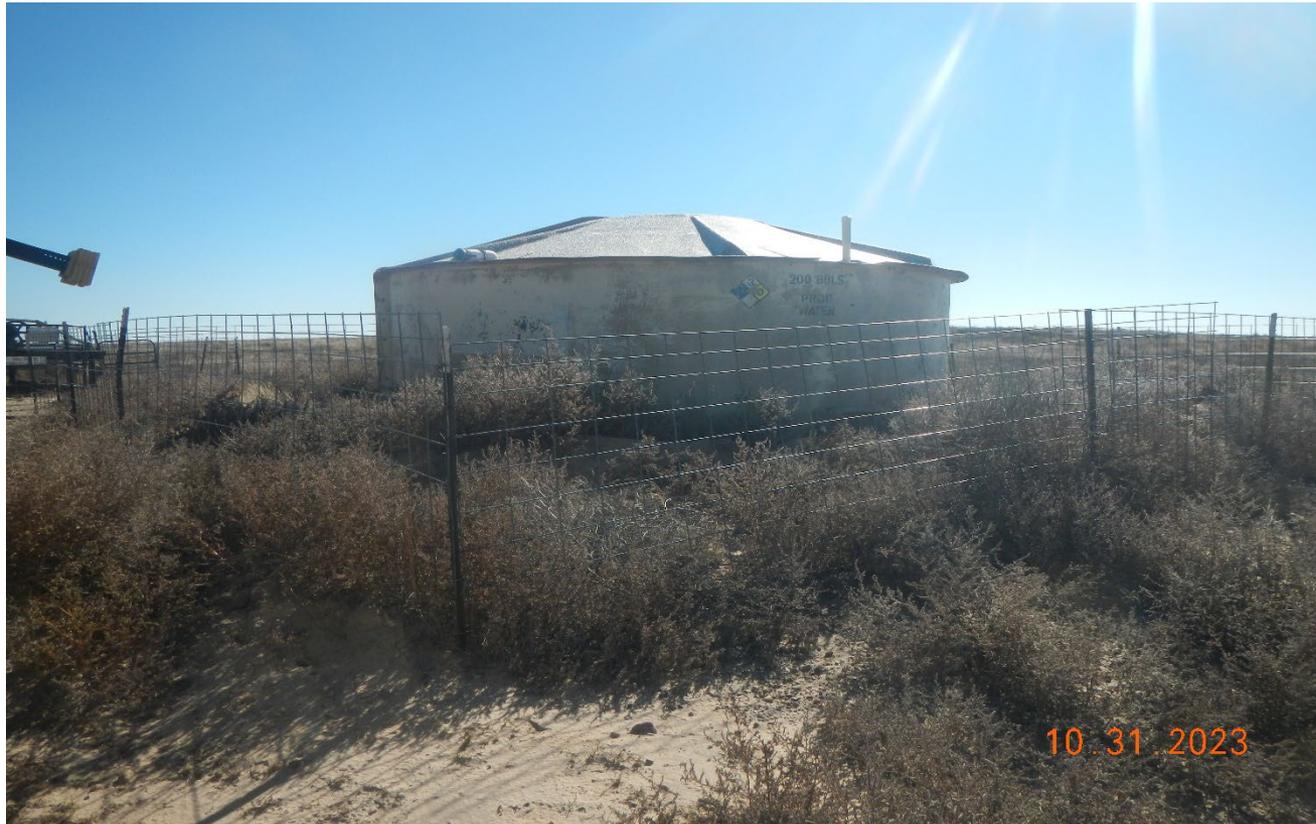
Photo 5. Facing toward the tank. There are weeds around the tank that are a fire hazard. Secondary containment is insufficient. And the labeling is faded.
