Inspection Photos

Location Name: CAERUS PICEANCE LLC SCARBER RO2 Pad

Location #: 334669

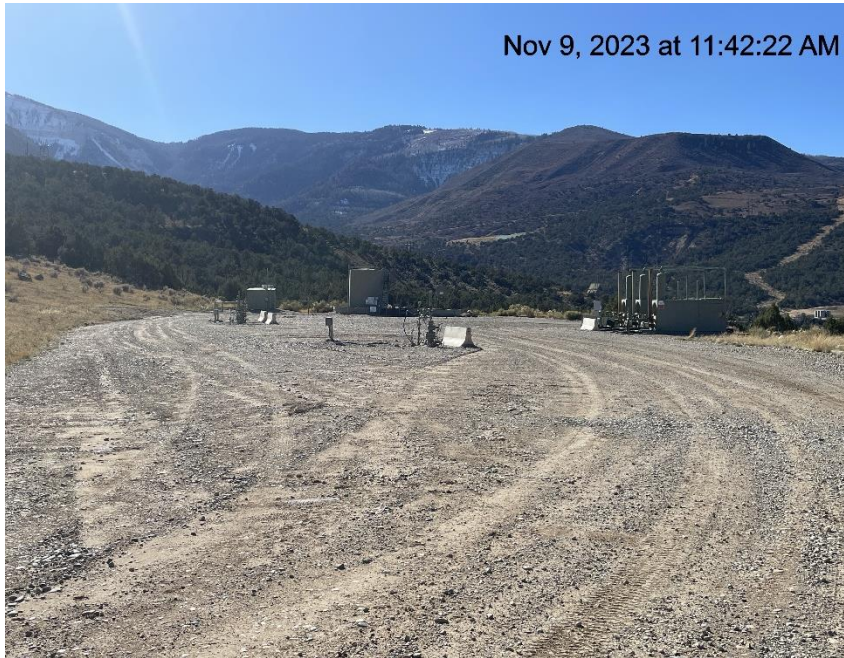
Photo # 6202 From entrance to location

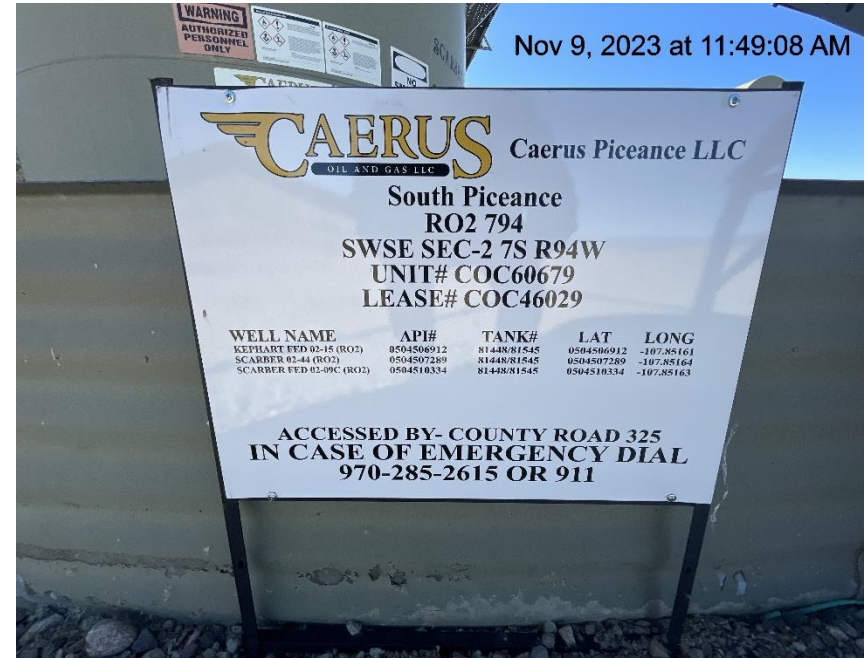
Photo # 6203 Location

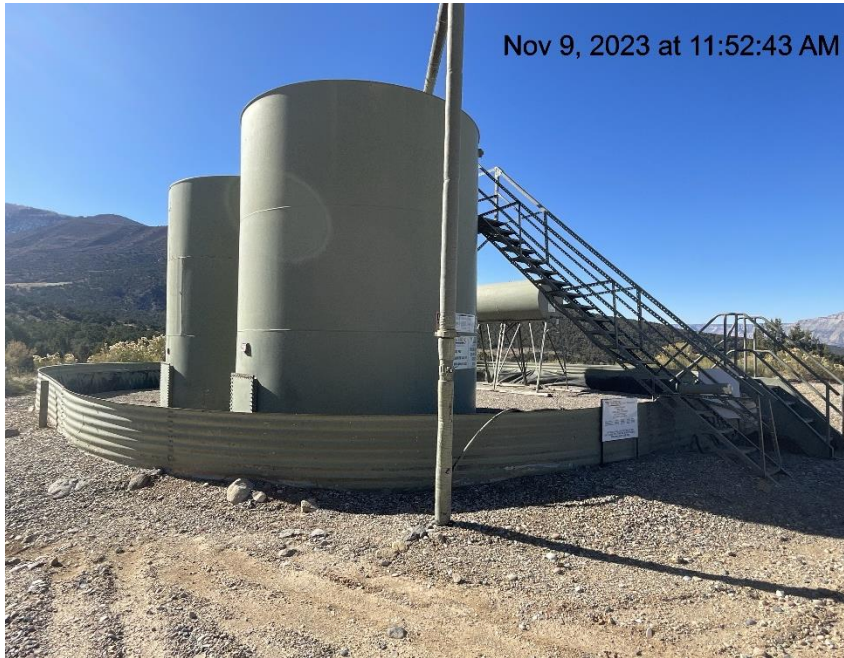
Photo # 6204 Location

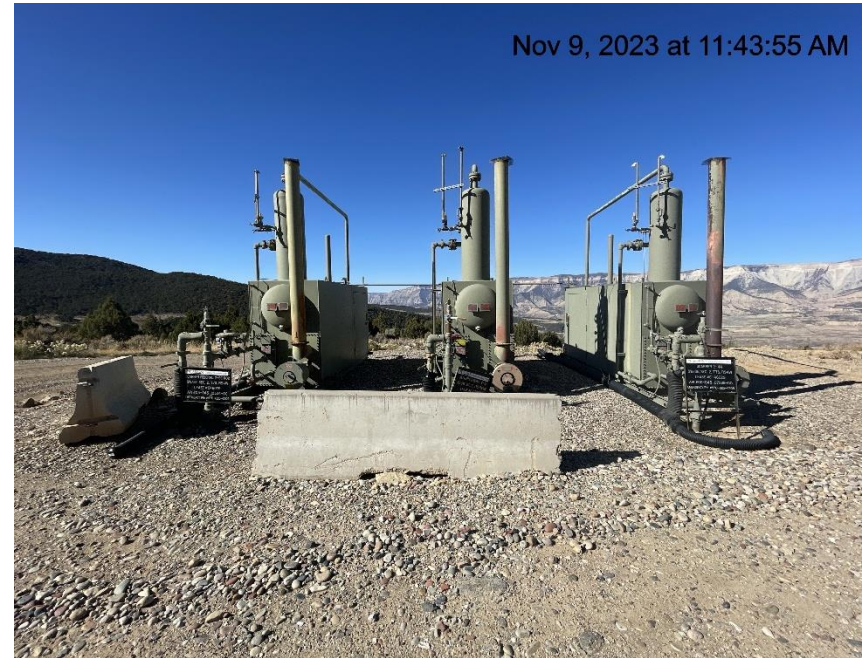
Photo # 6205 Location

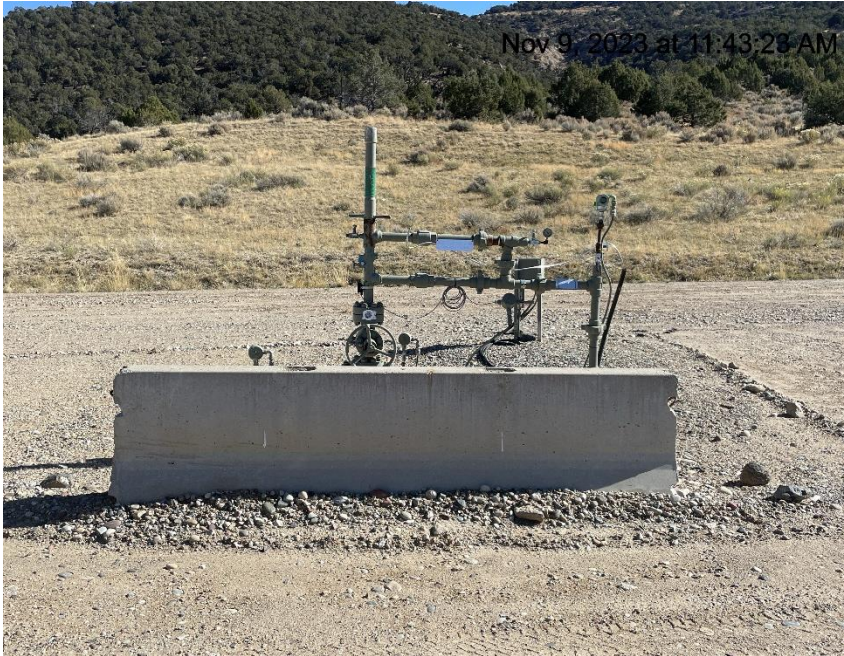
Photo # 6206 Location

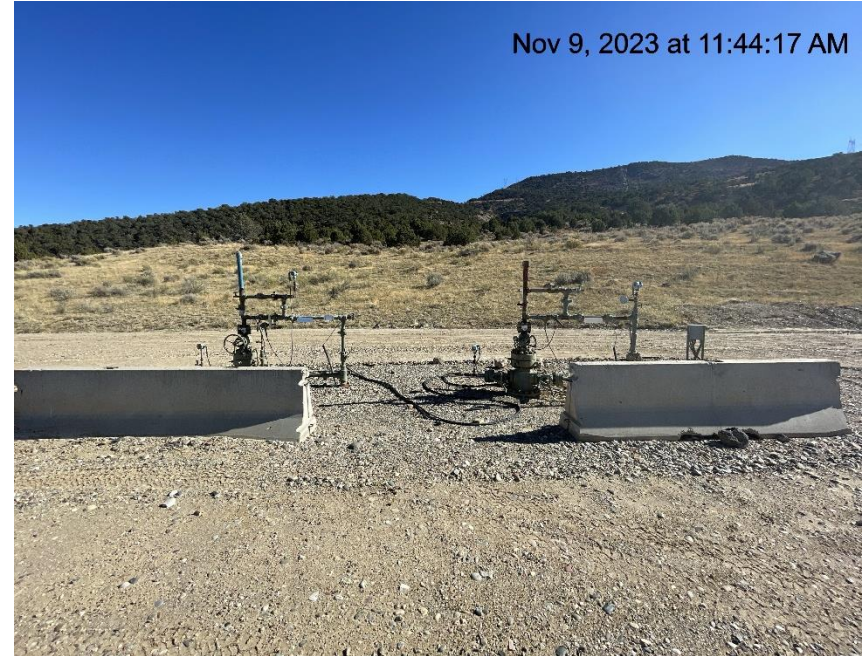
Photo # 6207 Location

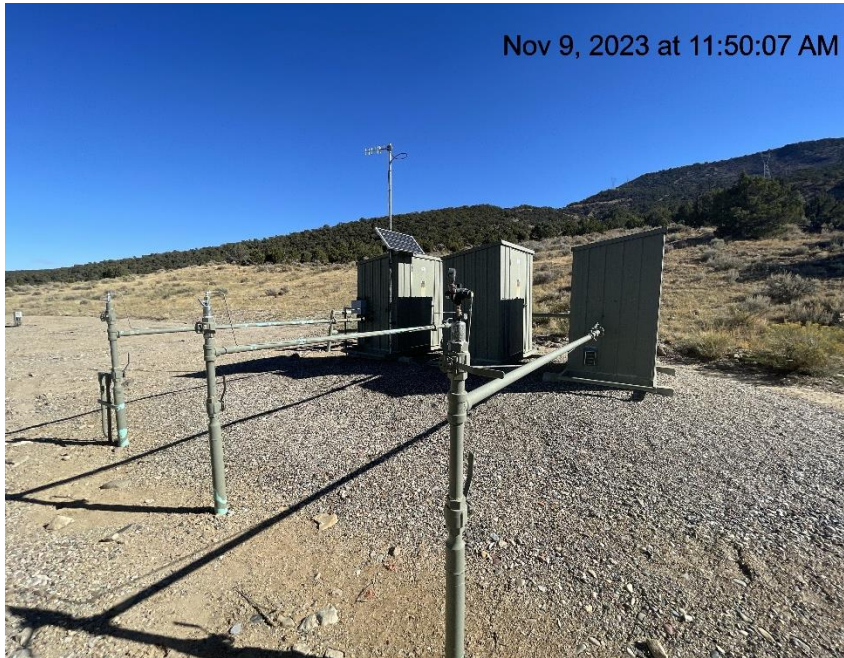
Photo # 6208 Location

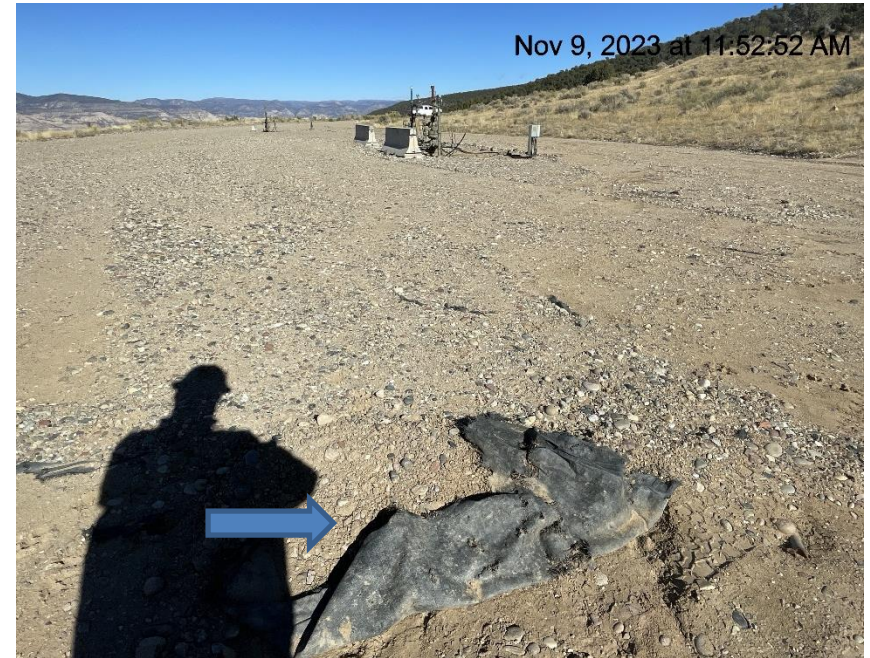
Photo # 6209 Debris
