Inspection Photos

API: 043-06219

Operator: AUSCO PETROLEUM INC

Inspection Date: 11/8/2023

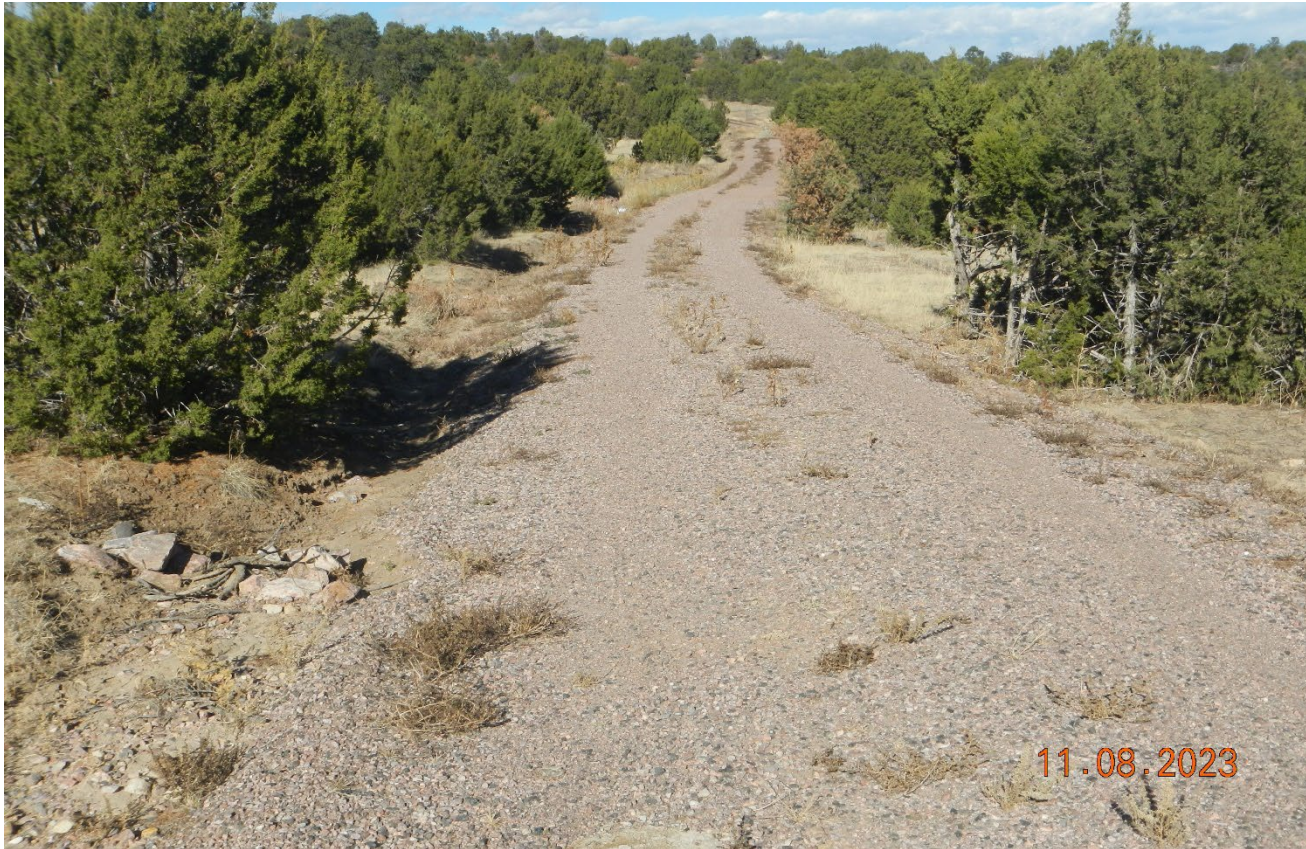
Photo 1. Facing northwest along the access road. There are some check dams where stormwater is going around the check dam. BMP maintenance is needed.

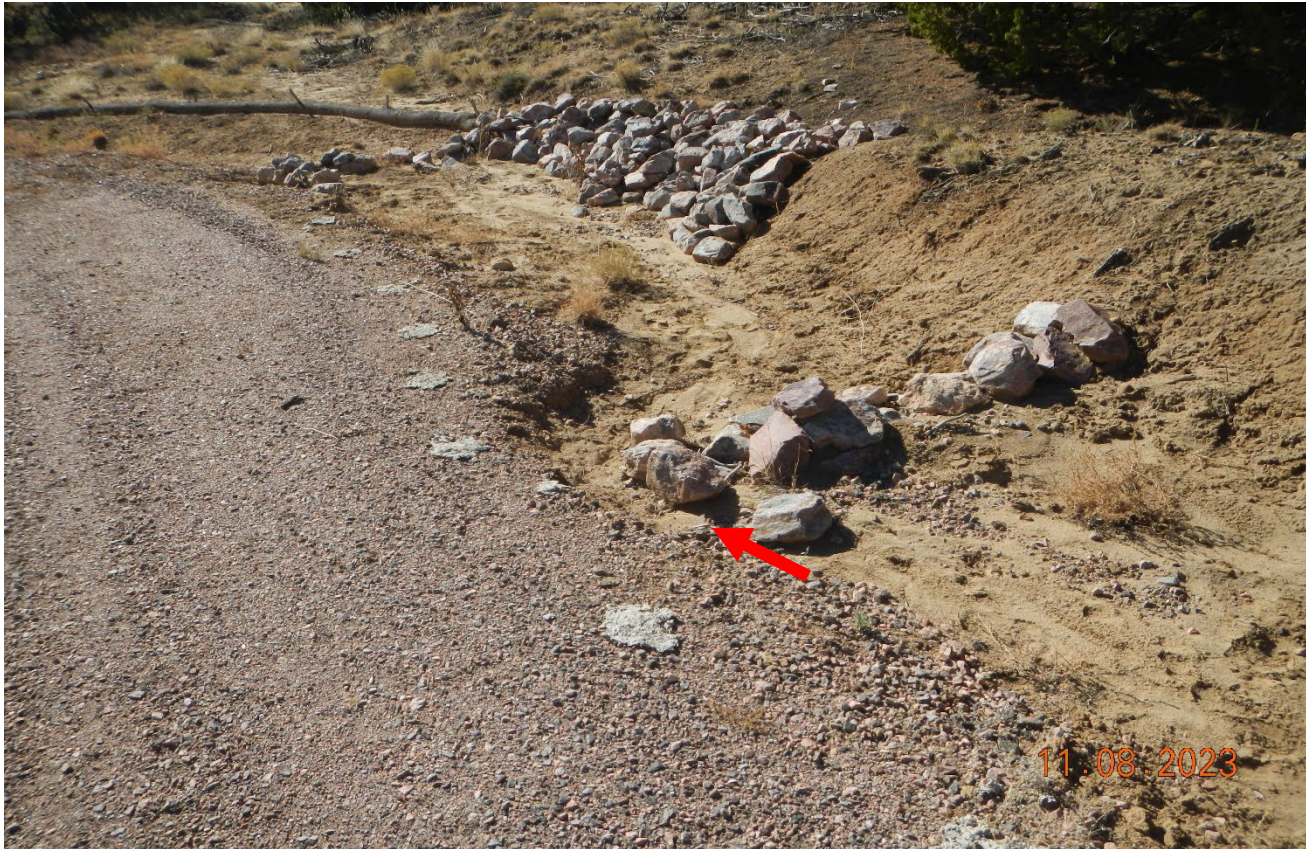
Photo 2. There are several check dams that are in need of maintenance. Red arrow points to where stormwater is eroding around the check dam.

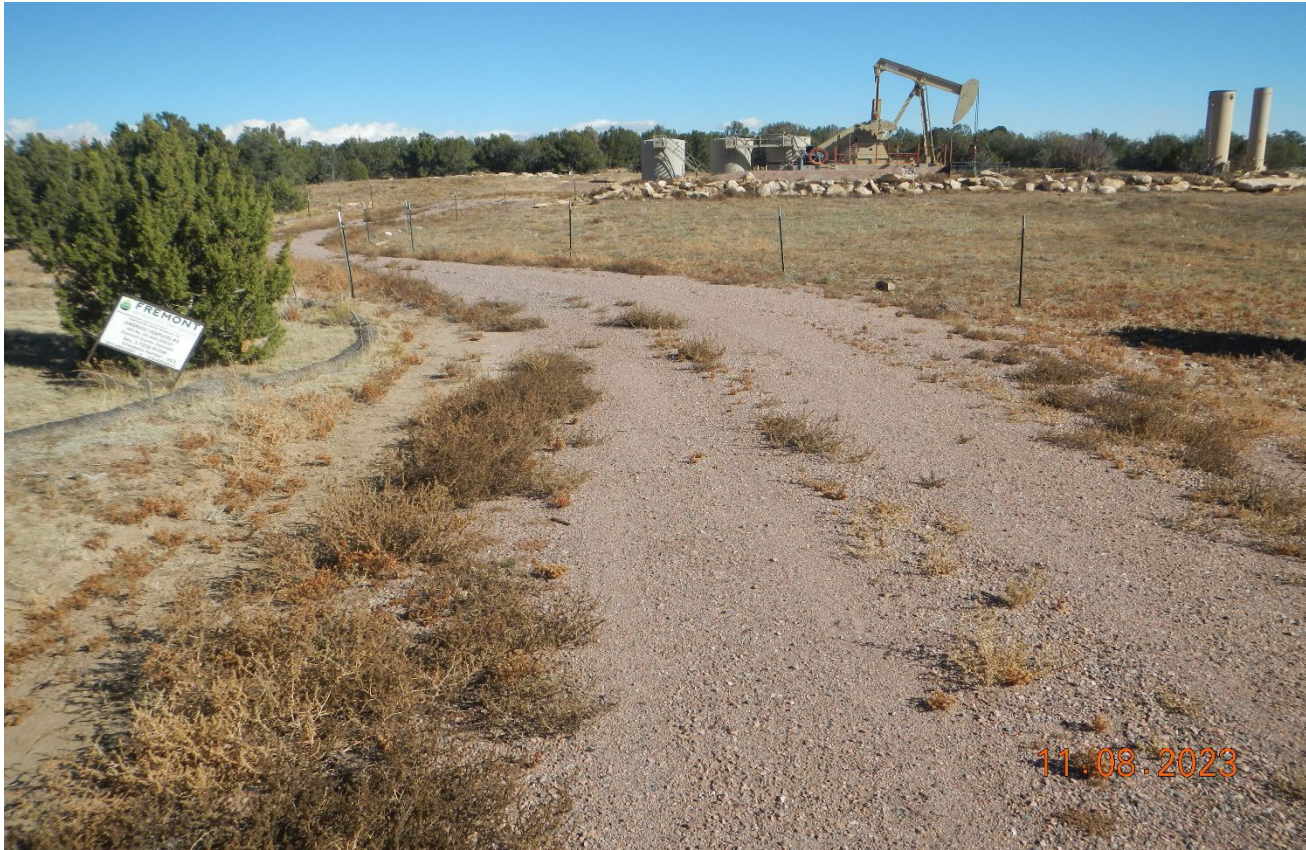
Photo 3. Facing north toward the location.

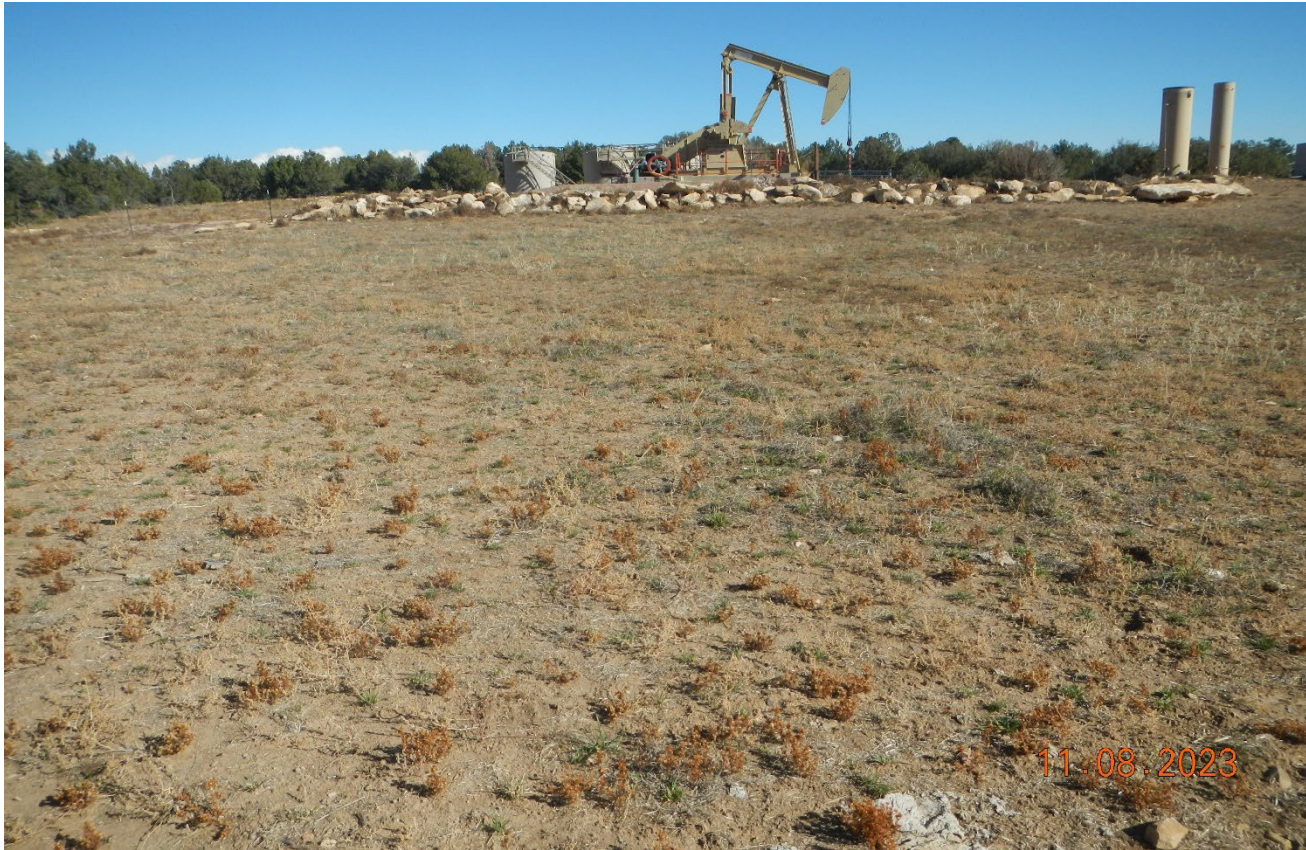
Photo 4. There is desirable vegetation beginning to establish in the reclamation area.

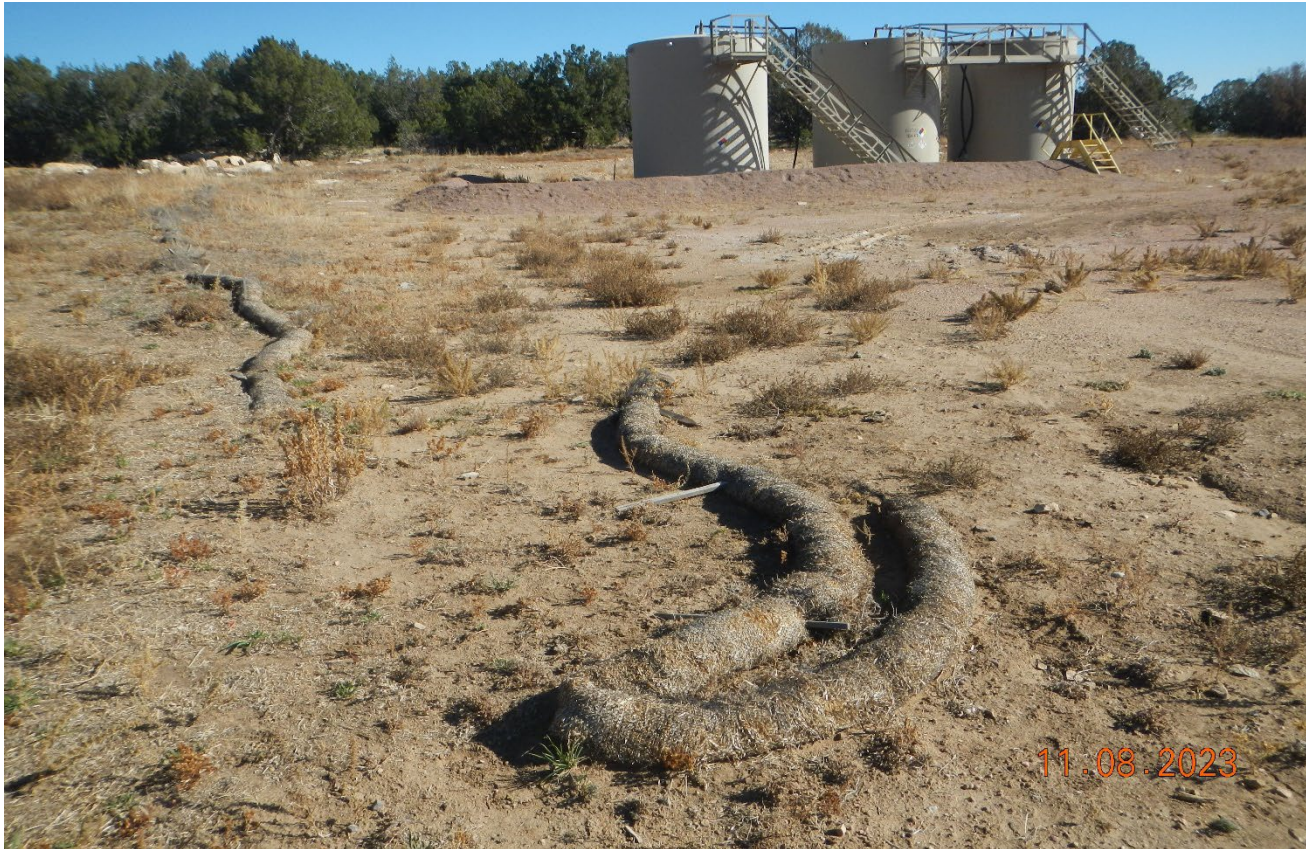
Photo 5. Facing north toward the location. There are displaced wattles that need to be repaired. Previous corrective action was not completed.

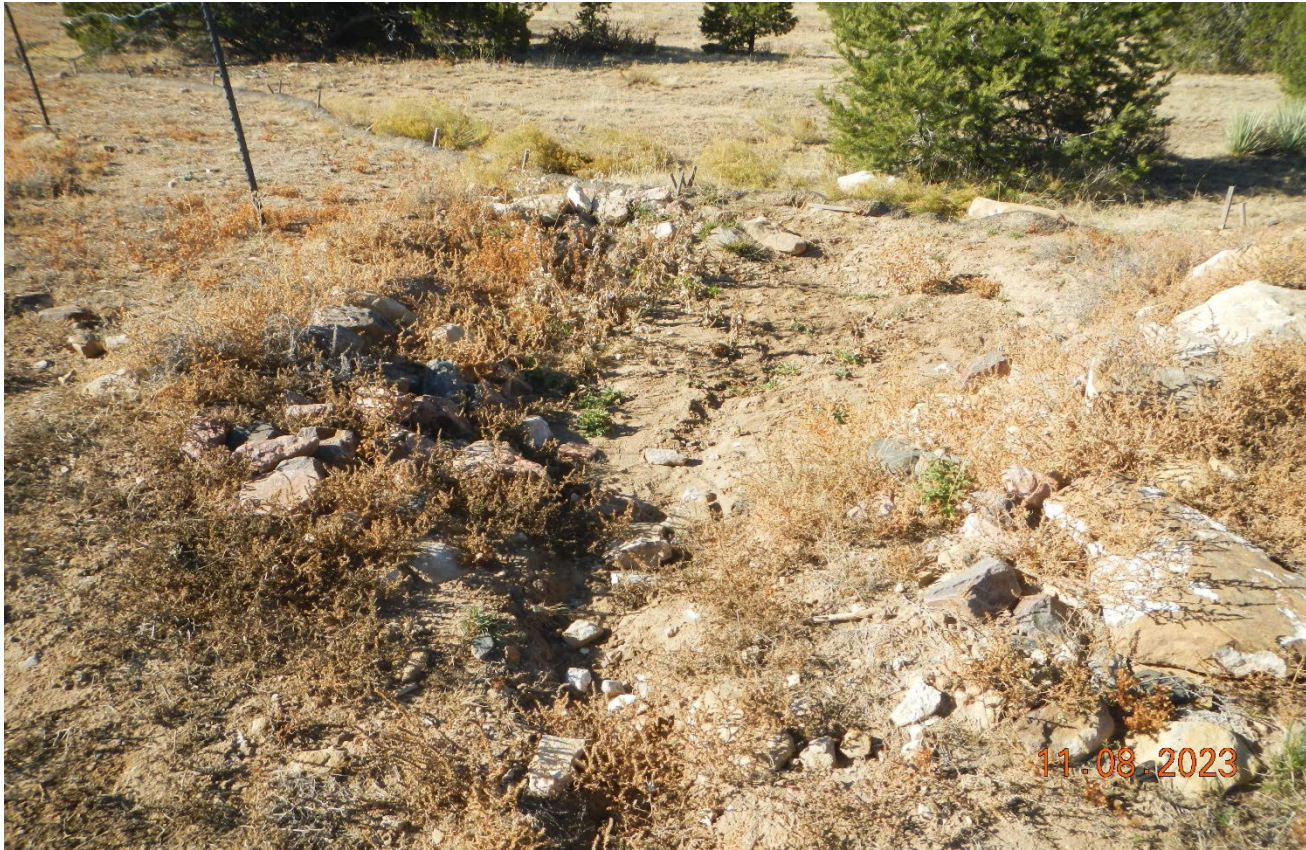
Photo 6. The sediment trap at the west side of the location is filled in with sediment.
