Inspection Photos

API: 043-06231

Operator: AUSCO PETROLEUM INC

Inspection Date: 11/8/2023

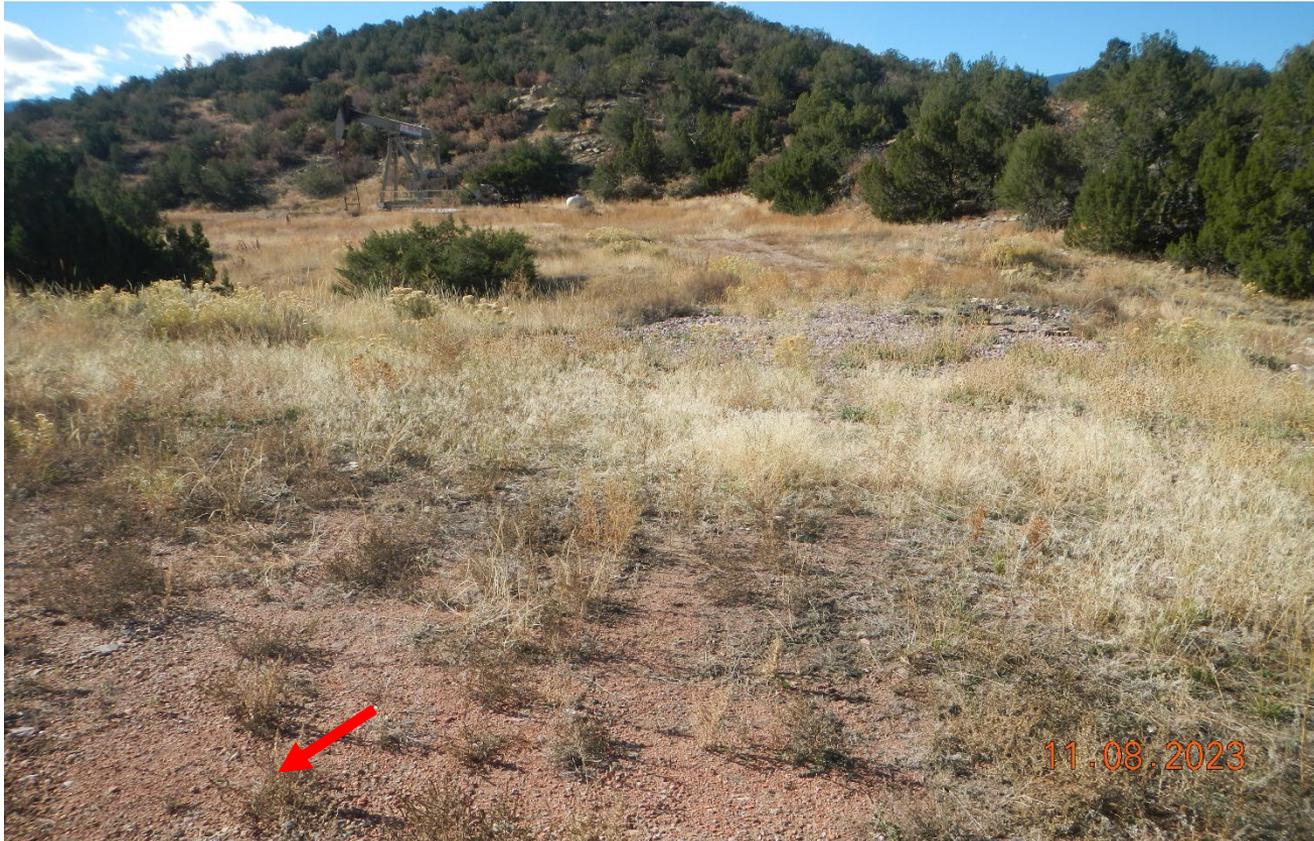
Photo 1. Facing southwest along the access road to the wellsite. There are noxious weeds along the road that need to be controlled. Red arrow points to List B – Halogeton.

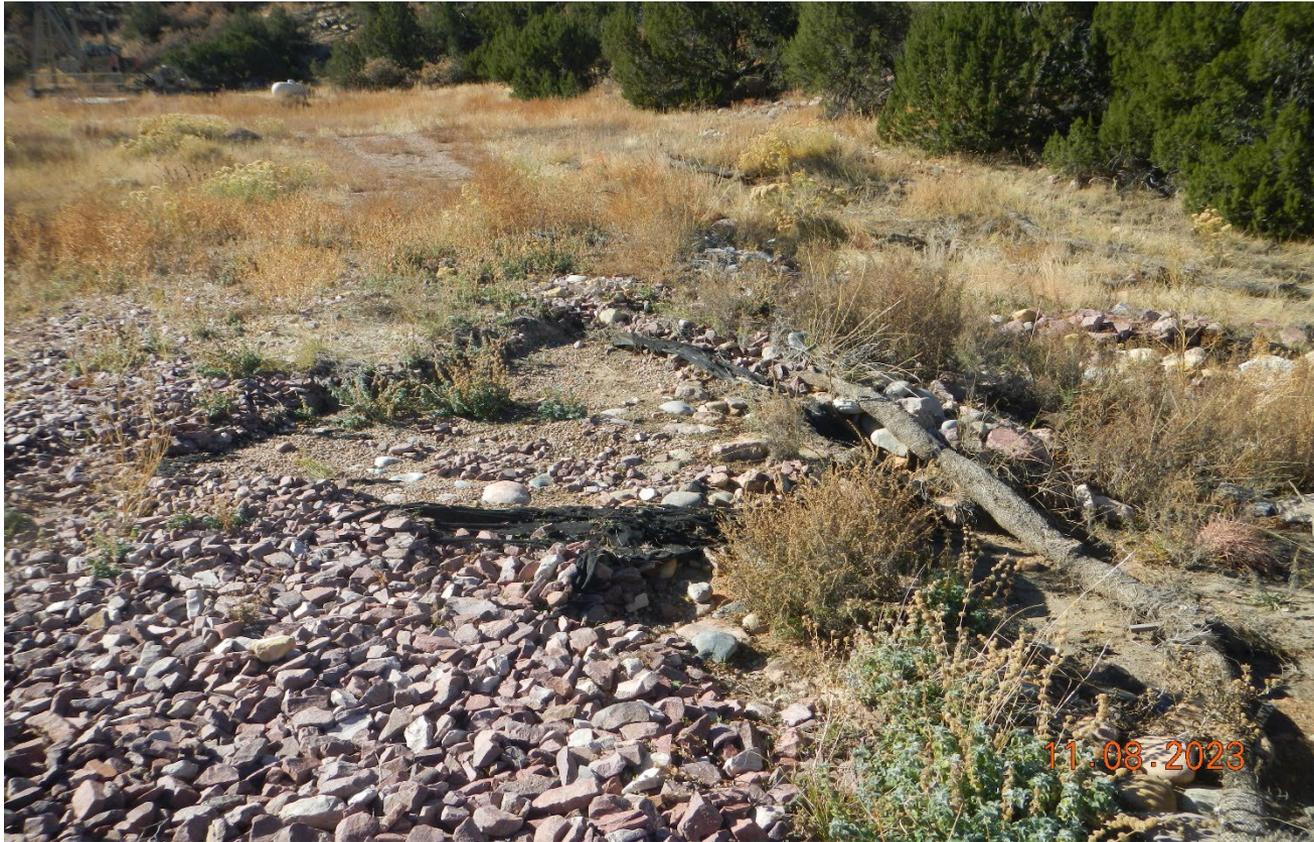
Photo 2. Facing toward the drainage crossing which has been washed out and has not been repaired. Previous corrective action was not completed.

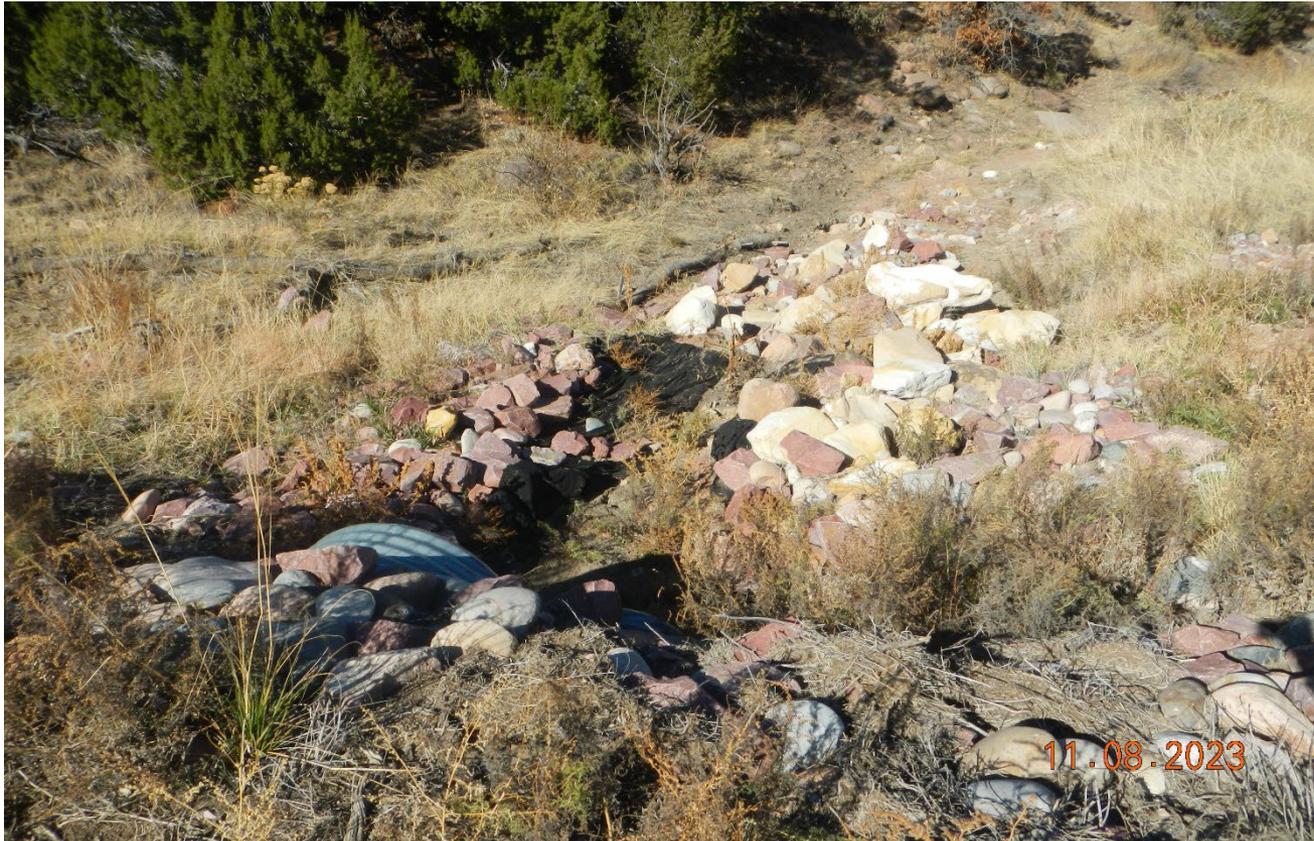
Photo 3. View of culvert outlet shows displaced rock. Outlet protection will need to be reinstalled. Previous corrective action was not completed.

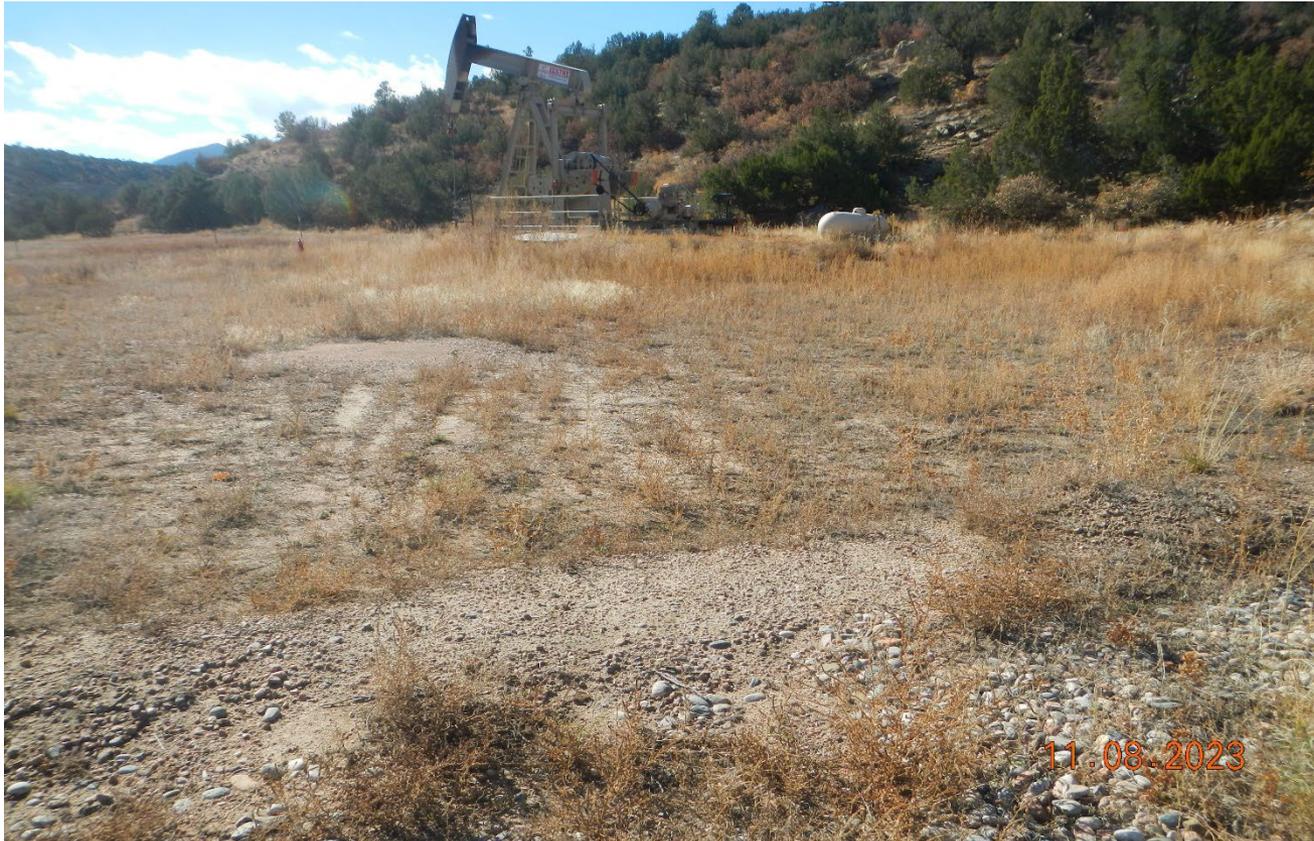
Photo 4. Facing southwest toward the wellsite. There are undesirable weeds around the equipment that need to be controlled.

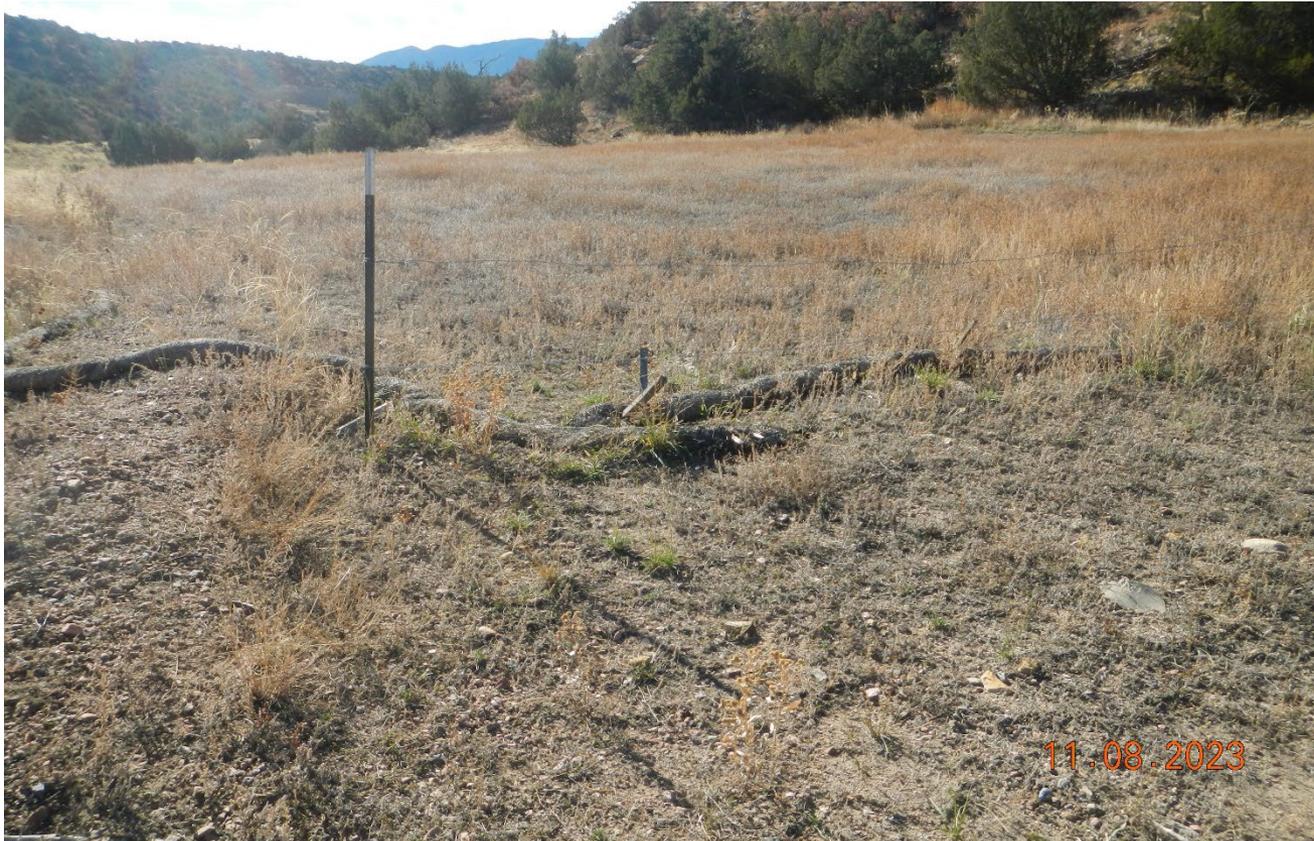
Photo 5. Facing southwest toward the interim reclamation area. There is mostly undesirable weeds growing throughout this area and the straw wattle is displaced. Previous corrective action was not completed.

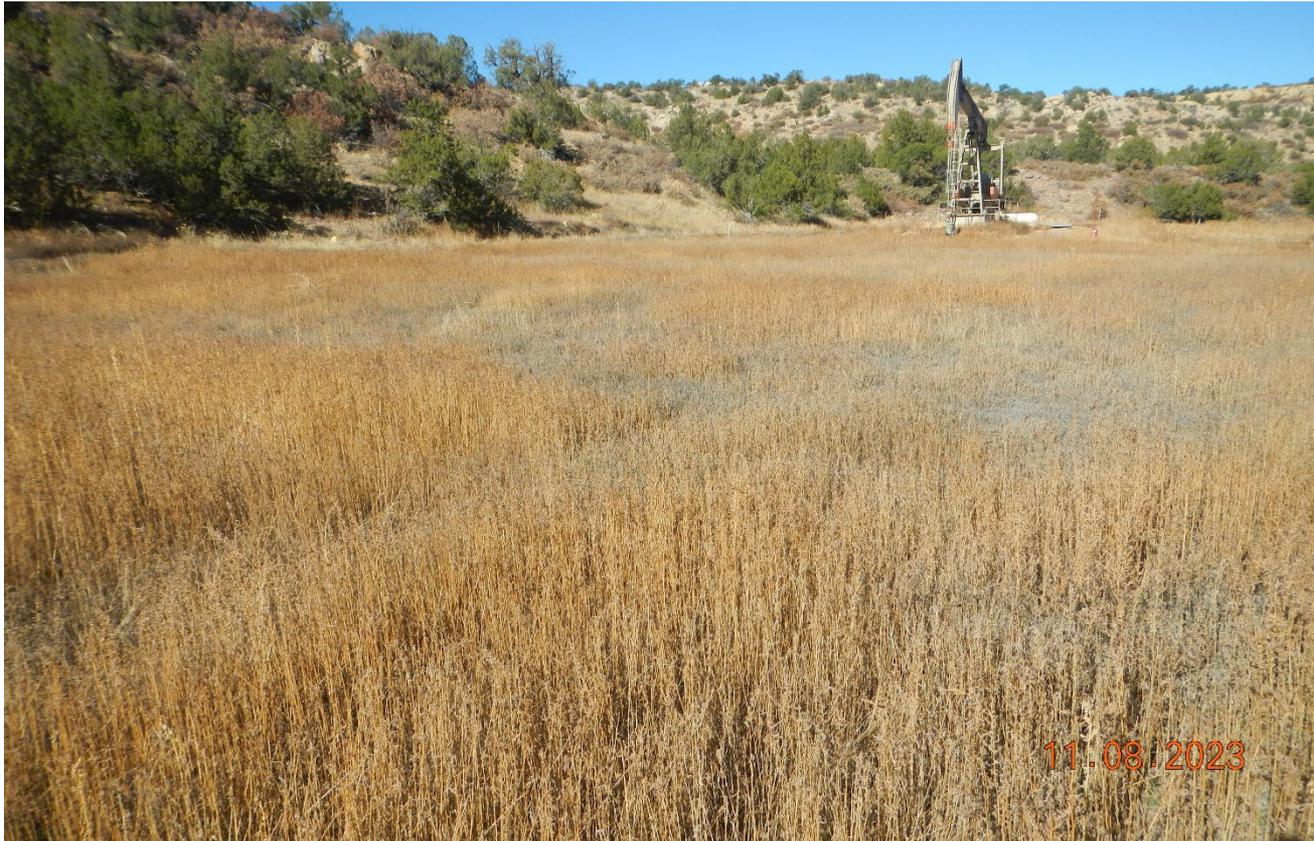
Photo 6. Facing northwest toward the interim reclamation area. There is entirely undesirable weeds growing throughout this area. This area will need weed control and reseeding. Previous corrective action was not completed.
