Inspection Photos

Location Name: MUSTANG RESOURCES LLC CLOUGH FEDERAL 14-24A-6S-94W

Location ID: 311543

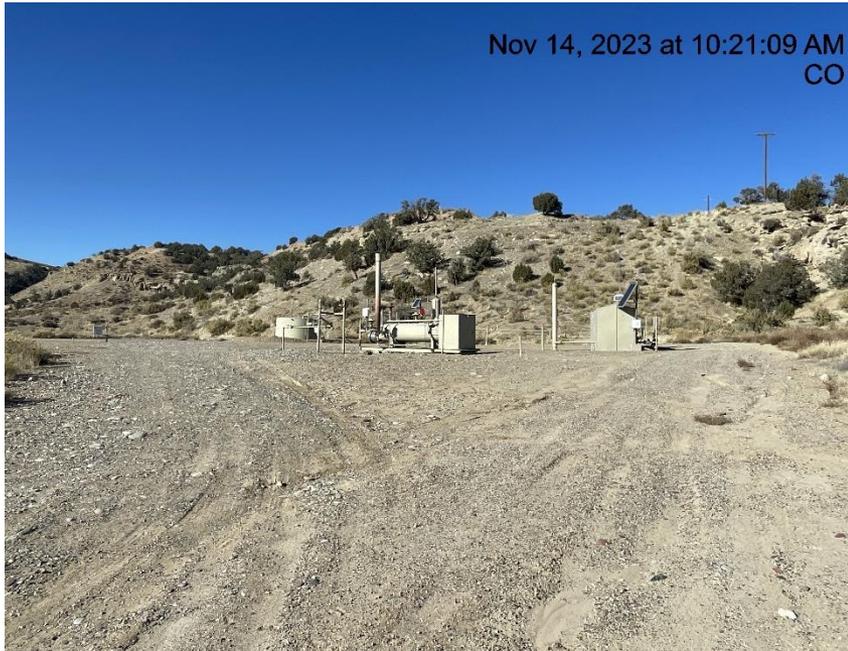
Photo # 6471 From entrance to location

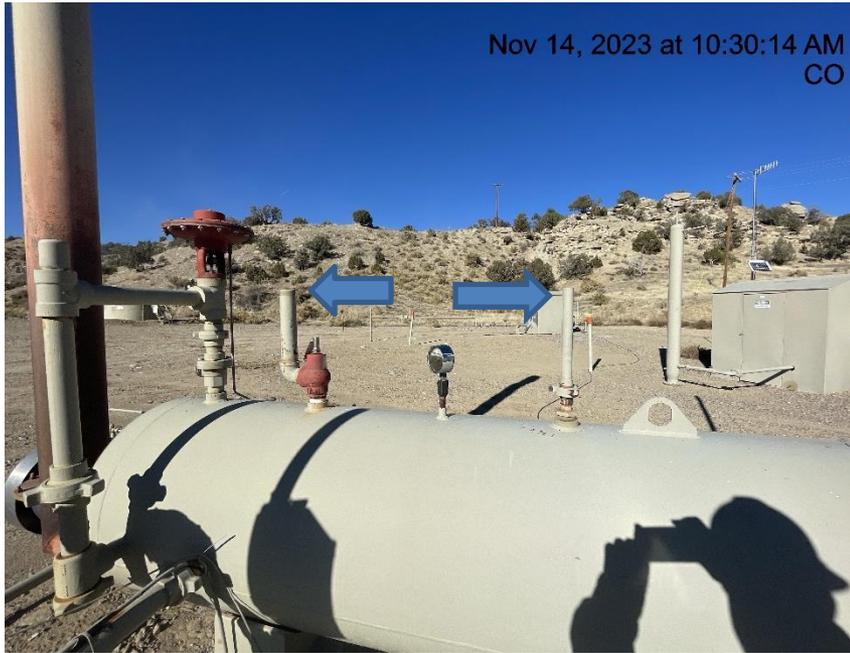
Photo # 6482 PRV & rupture disc vent lines lack caps

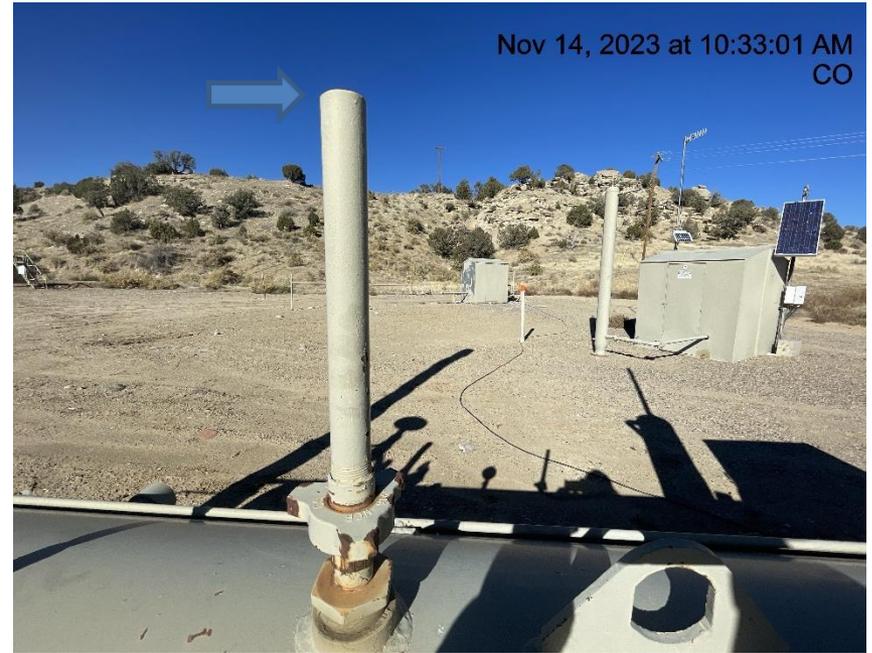
Photo # 6483 Rupture disc vent line lacks cap

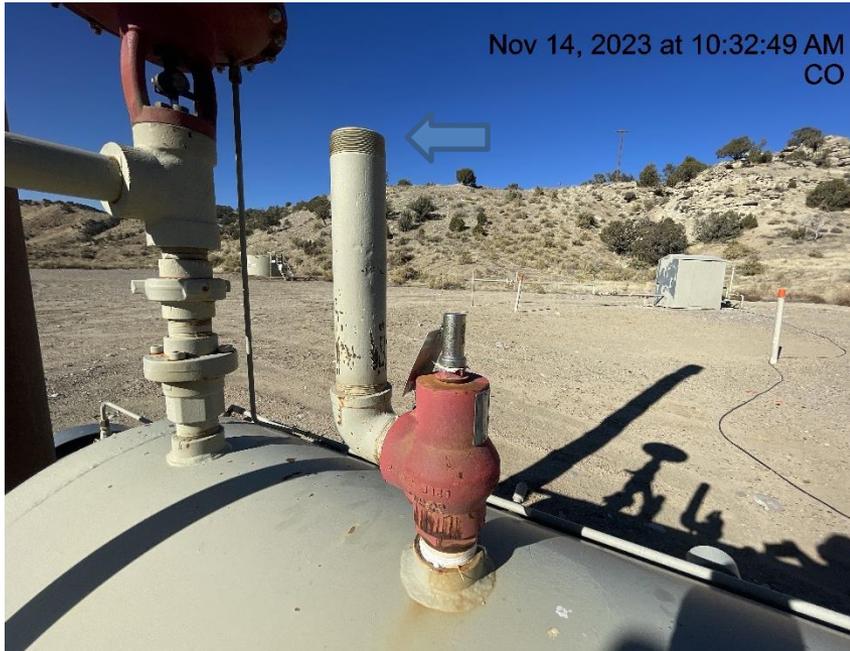
Photo # 6484 PRV vent line lacks cap

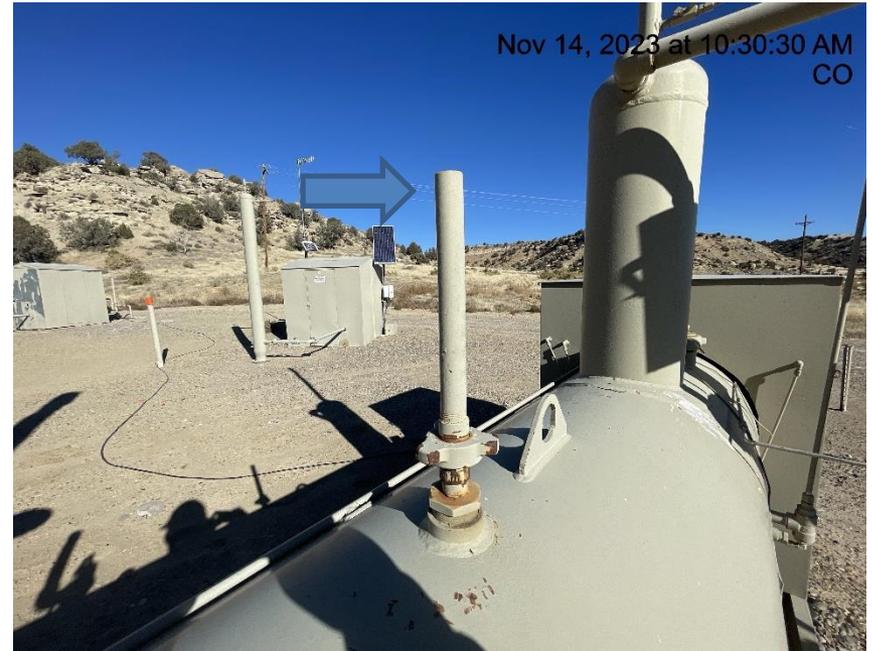
Photo # 6485 Observed distortion coming off rupture disc vent line/rupture disc leaking gas

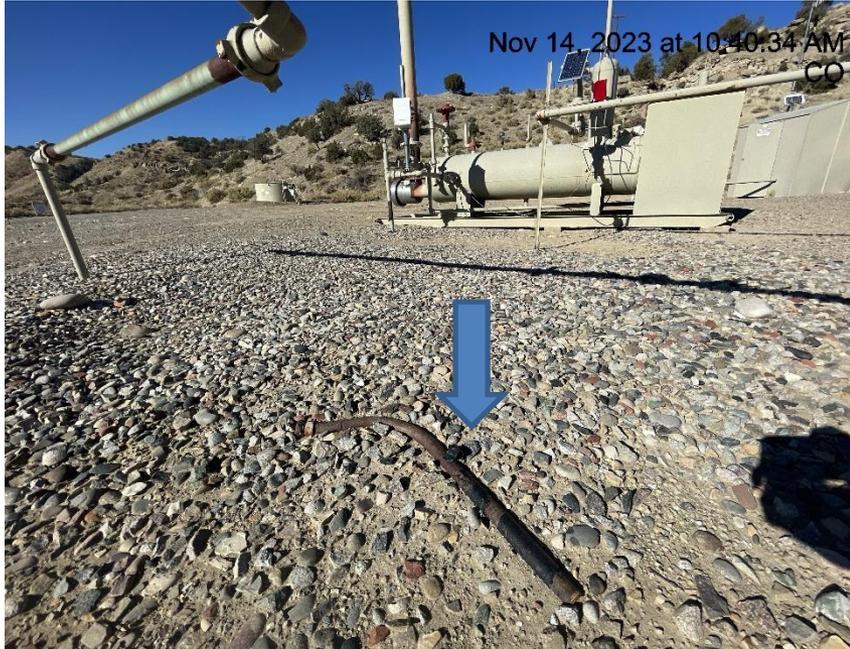
Photo # 6488 Debris
