Storm Water Management and Erosion control
Location Name: TEP ROCKY MOUNTAIN LLC CLOUGH 20 Pad
Location ID: 335068

Section/Township/Range: 15 6S94W

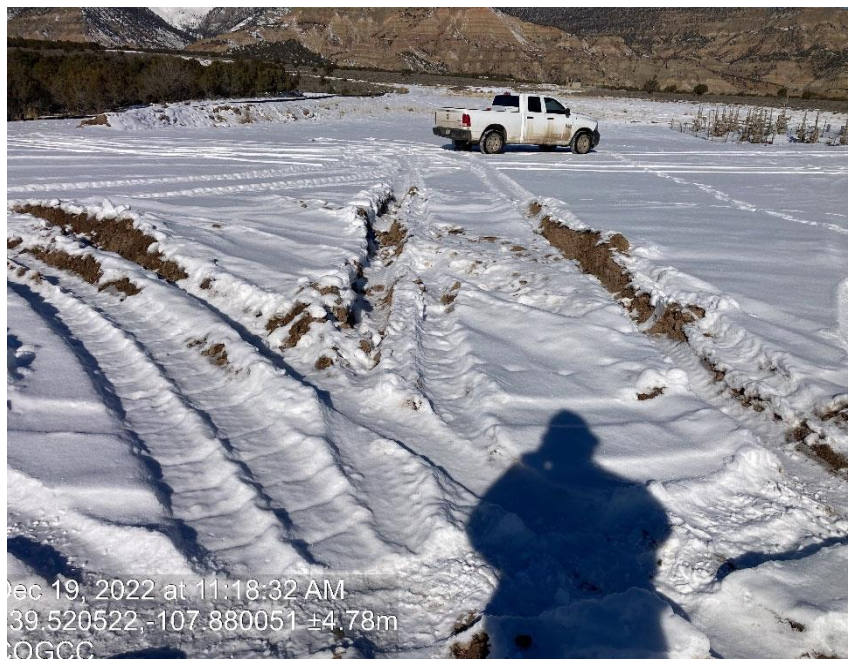
**Photo From inspection 707800037 conducted on
12/19/2022 Lack of stabilization/compaction**

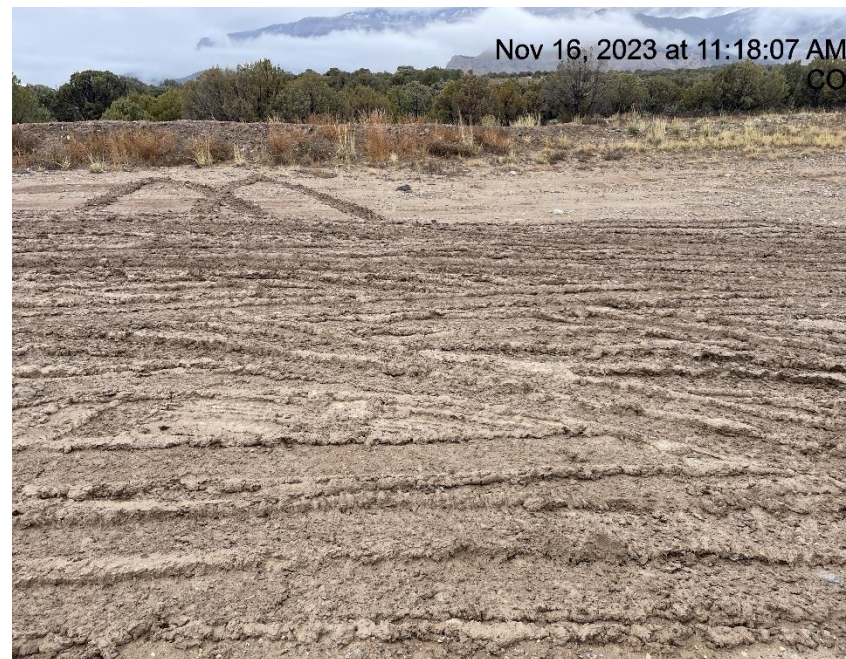
Photo # 6840 Lack of stabilization/compaction

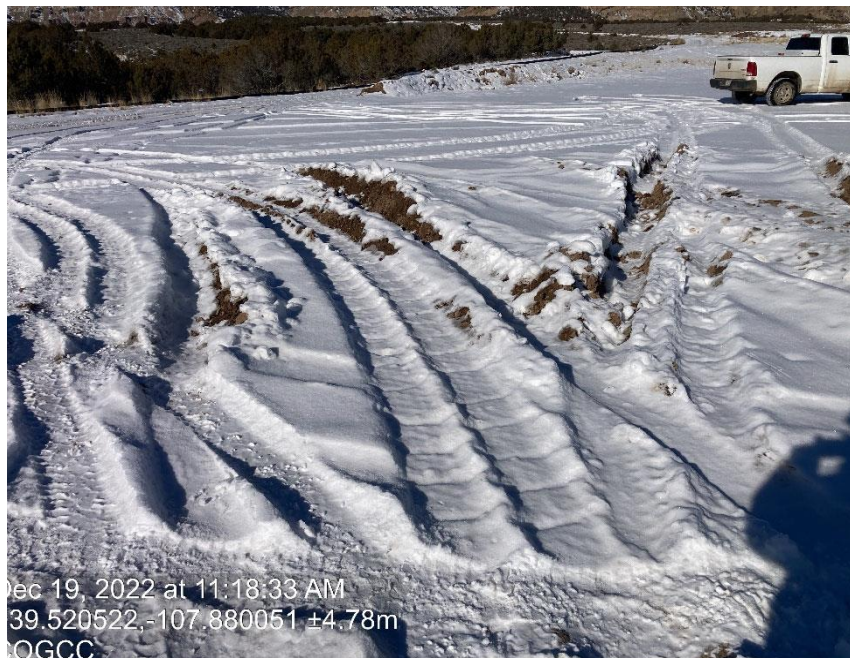
**Photo From inspection 707800037 conducted on
12/19/2022 Lack of stabilization/compaction**

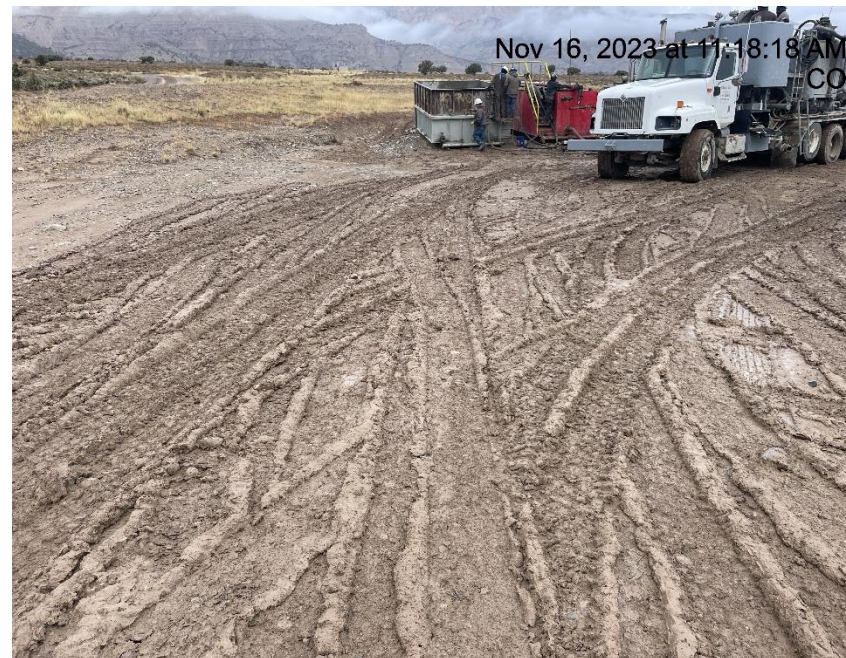
Photo # 6841 Lack of stabilization/compaction

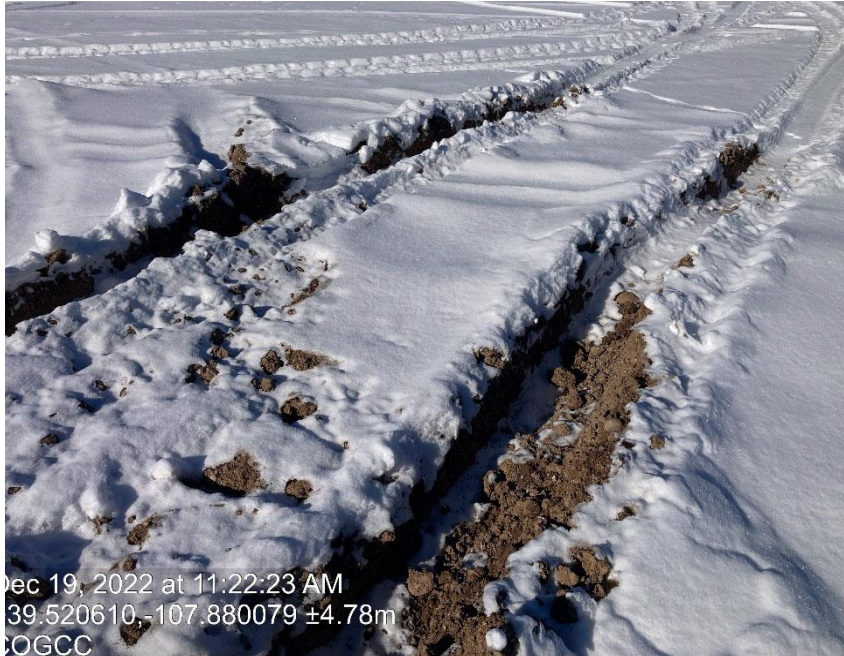
**Photo From inspection 707800037 conducted on
12/19/2022 Lack of stabilization/compaction**

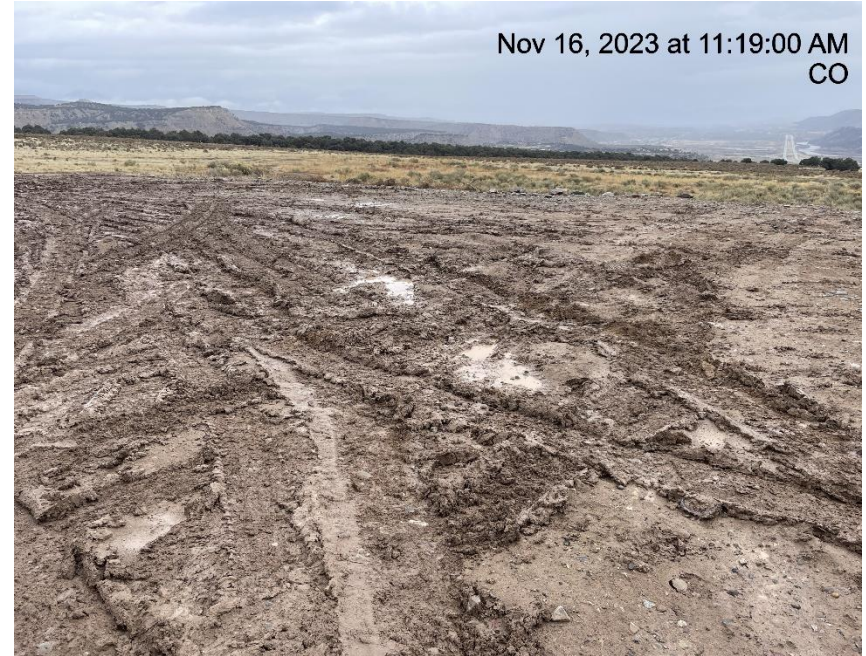
Photo # 6842 Lack of stabilization/compaction

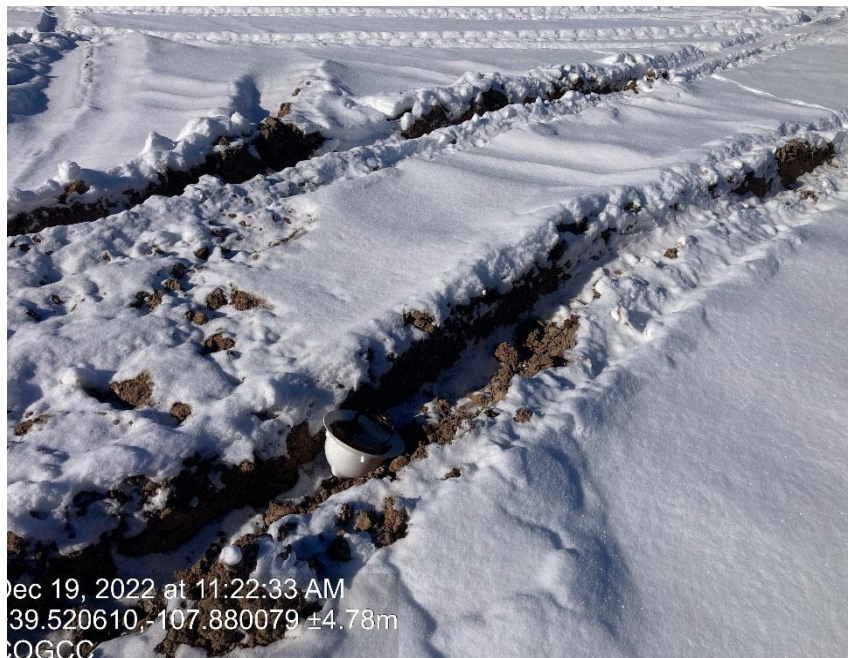
Photo From inspection 707800037 conducted on 12/19/2022 Lack of stabilization/compaction

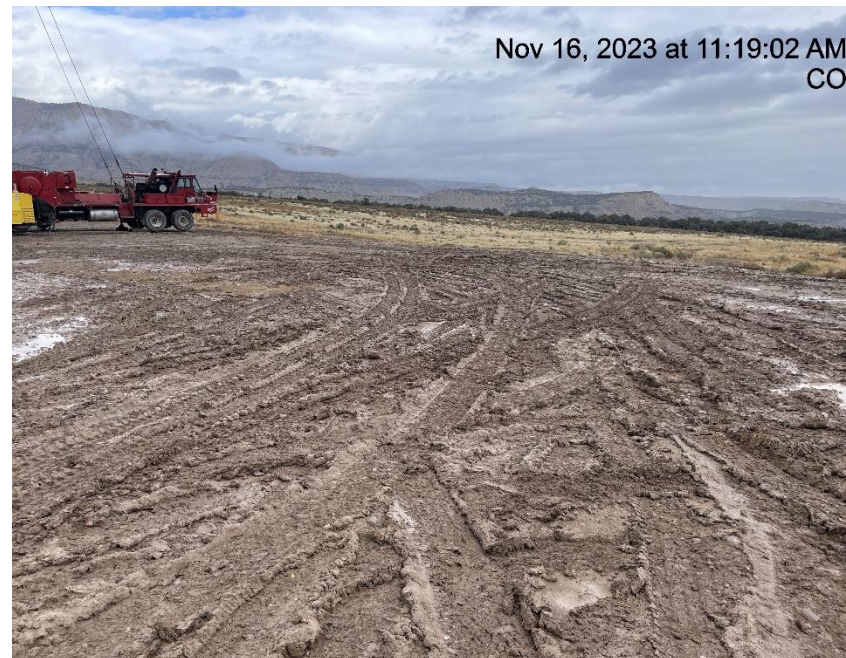
Photo # 6843 Lack of stabilization/compaction
