**Inspection Photos**  
**Location Name: Henderson #1**  
**Location ID: 331730**

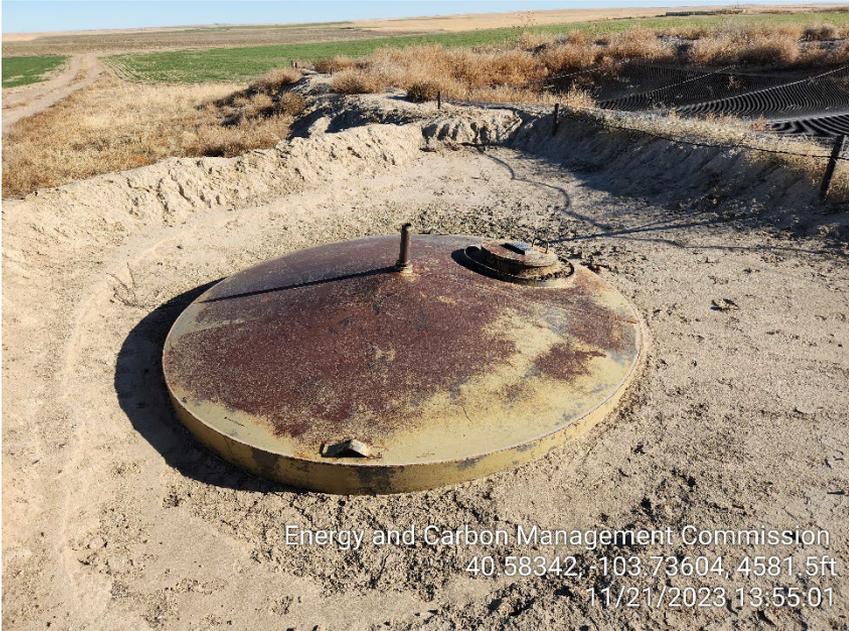
**Photo 1 – Skim Tank – NFPA Label missing**

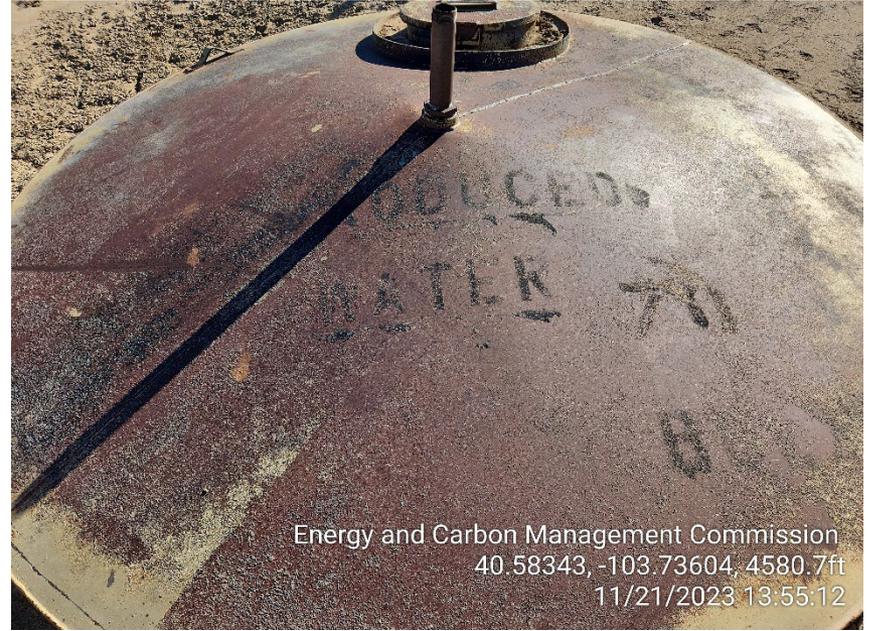
**Photo 2 – Skim Tank – NFPA Label missing**

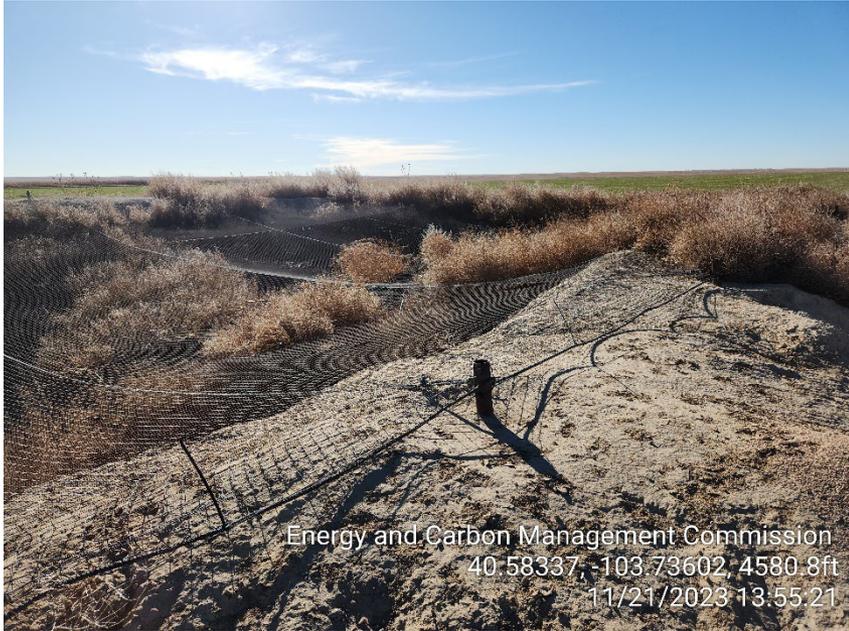
**Photo 3 – Pit Area – Looking West**

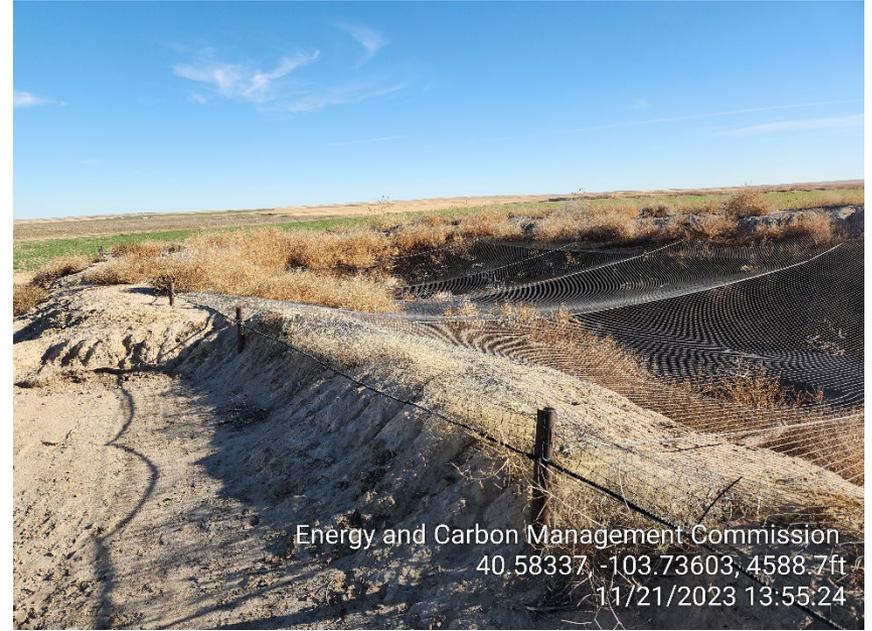
**Photo 4 – Pit Area – Looking East**

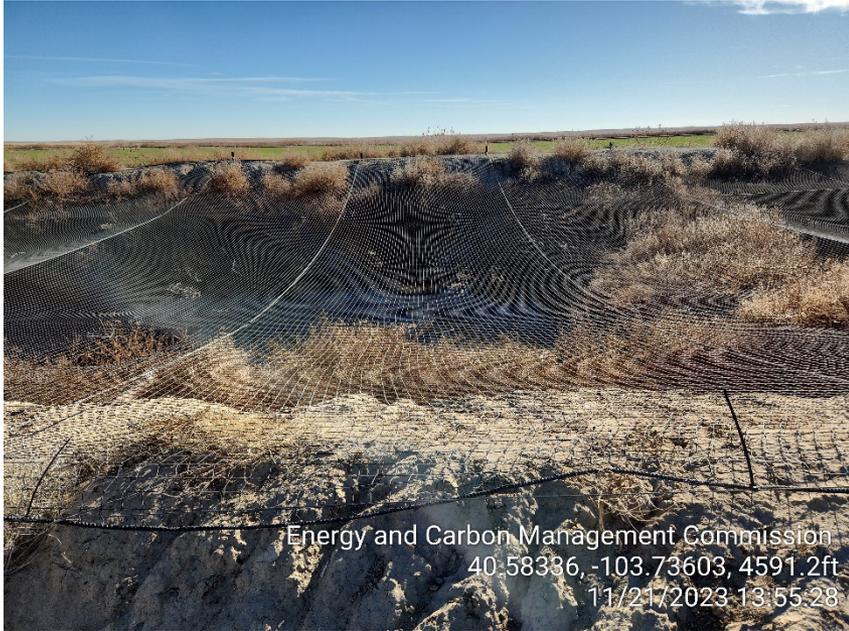
**Photo 5 – Pit Area – Looking South**

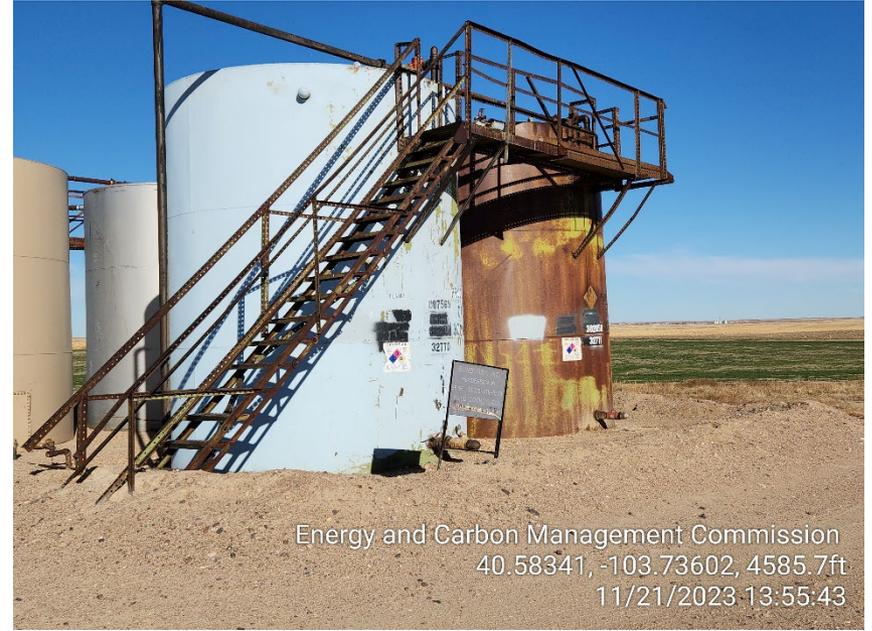
**Photo 6 – South Crude Oil Tanks**

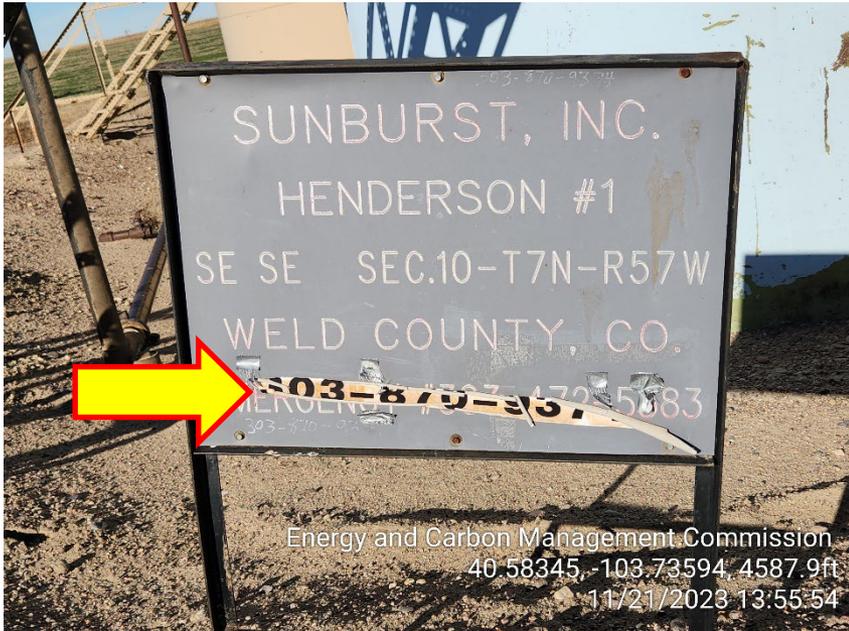
Photo 7 – Tank Battery Sign – 24-Hour Emergency Phone Number no longer visible

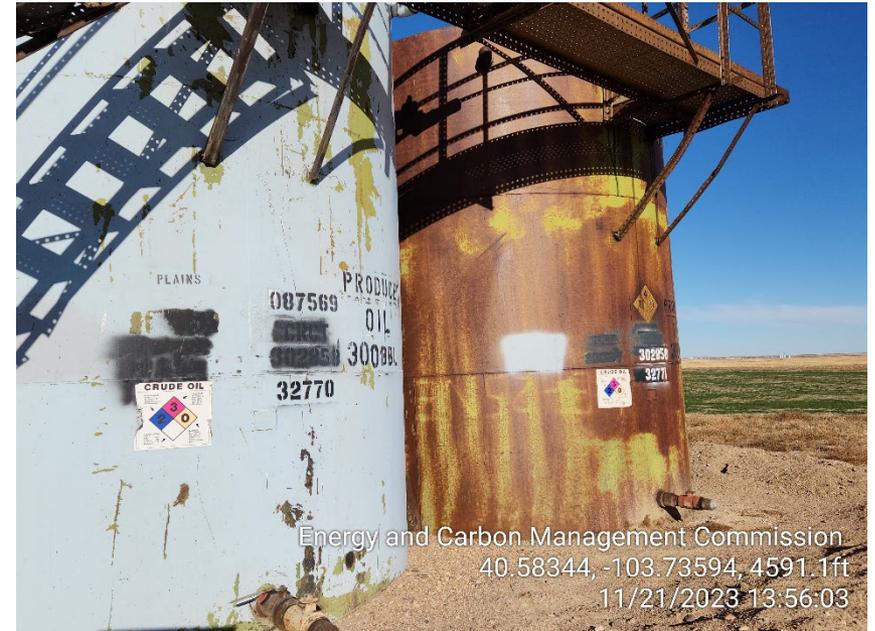
Photo 8 – South Crude Oil Tanks

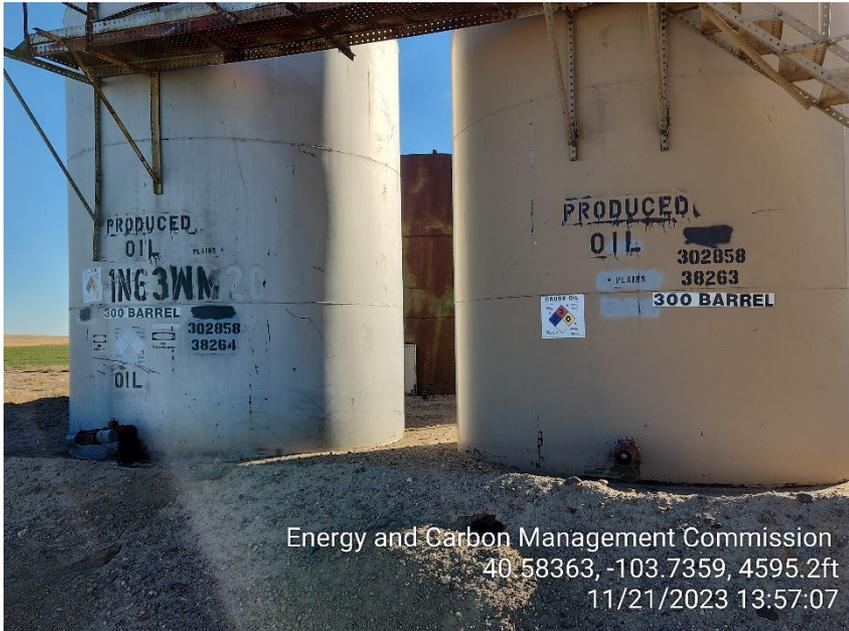
Photo 9 – North Crude Oil tanks

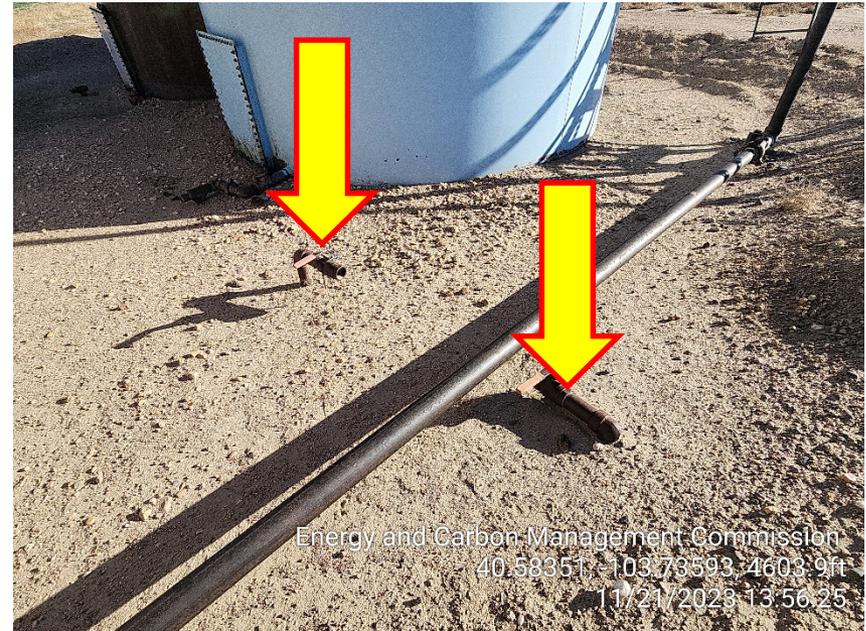
Photo 10 – Risers not marked with OOSLAT

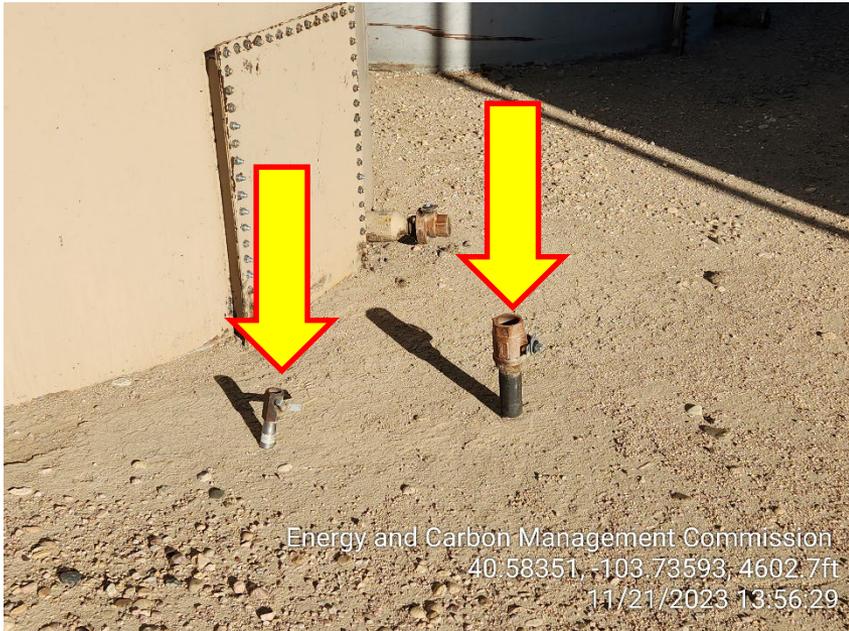
**Photo 11 – Risers not marked with OOSLAT**

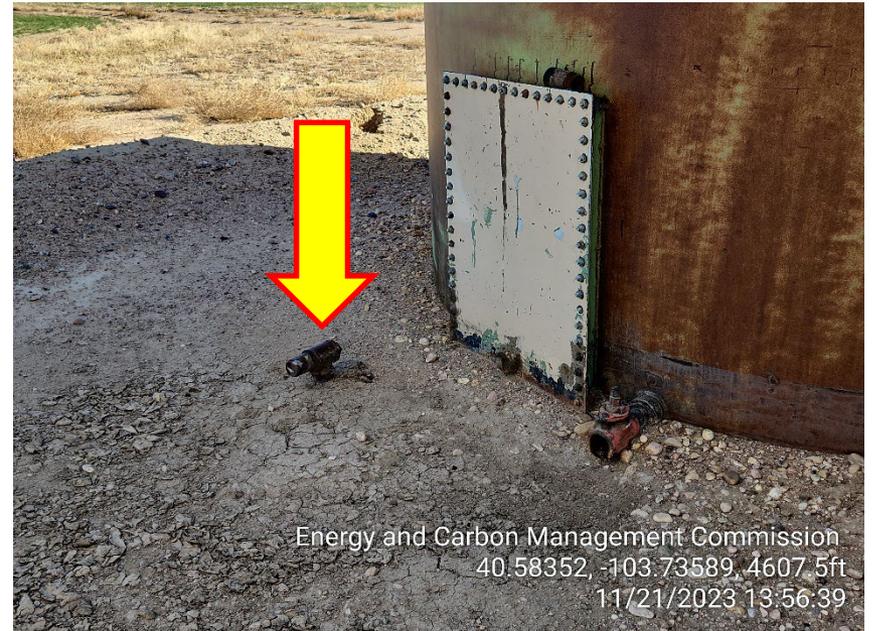
**Photo 12 – Risers not marked with OOSLAT**

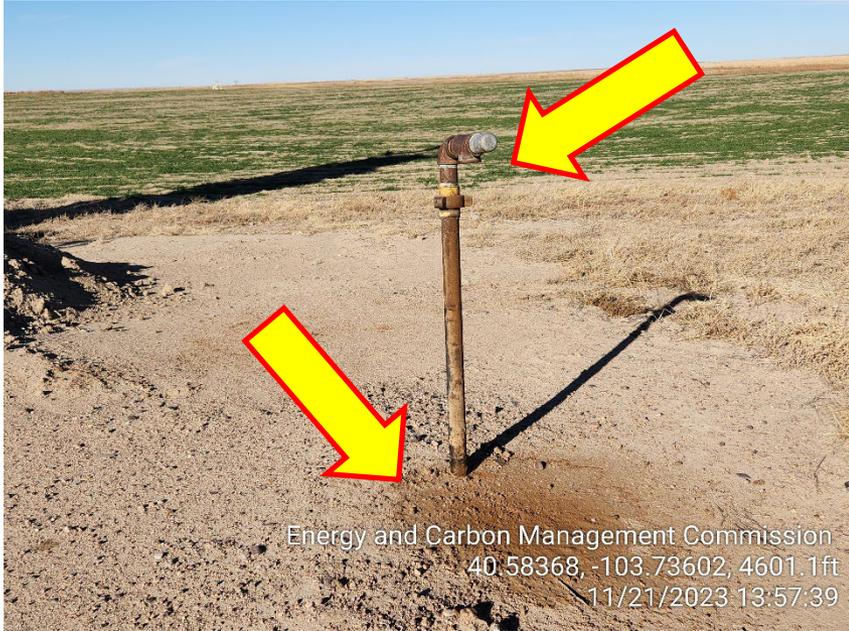
**Photo 13 – Riser East of Heater Treater not marked with OOSLAT and Stained Soil**

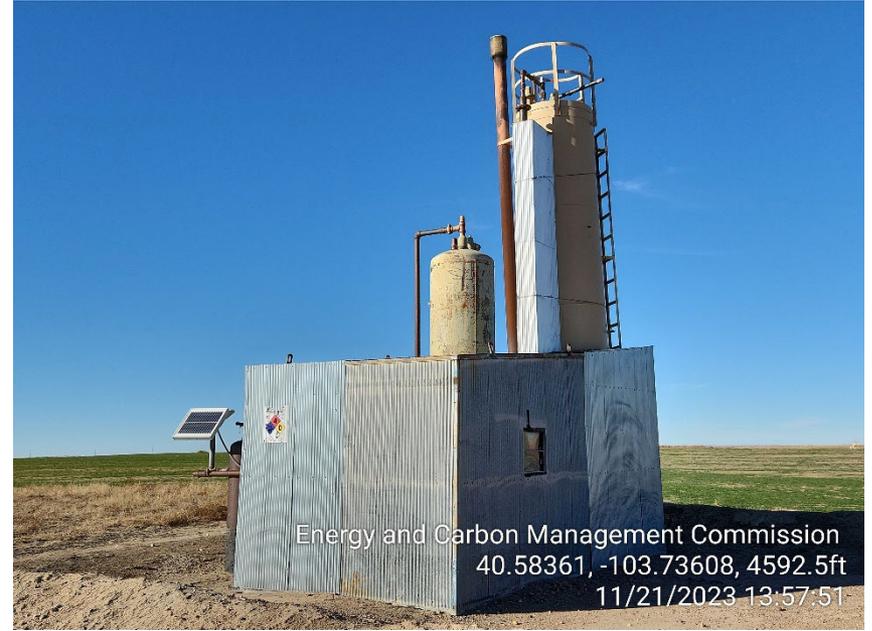
**Photo 14 – Heater Treater**

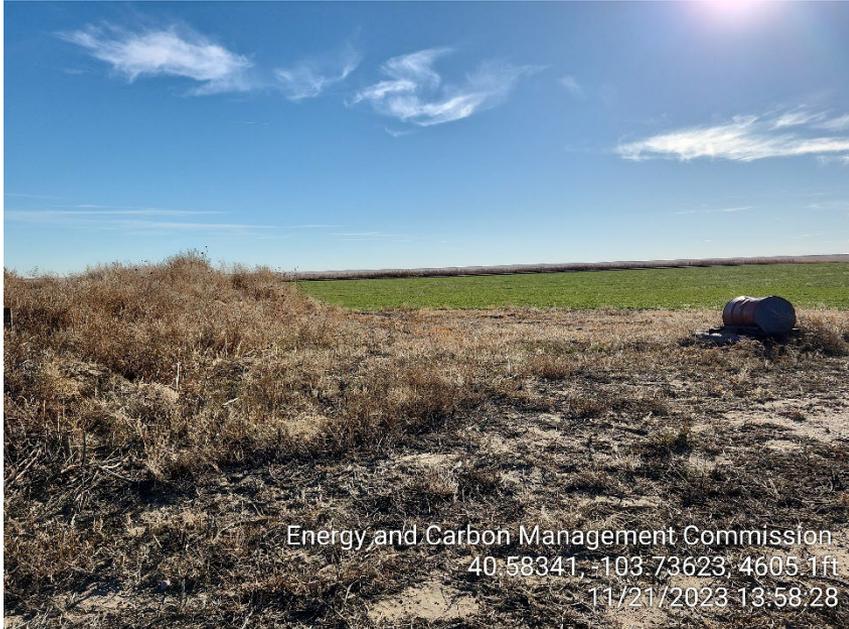
**Photo 15 – Unused Heater Treater and Gas Meter House  
have been removed**

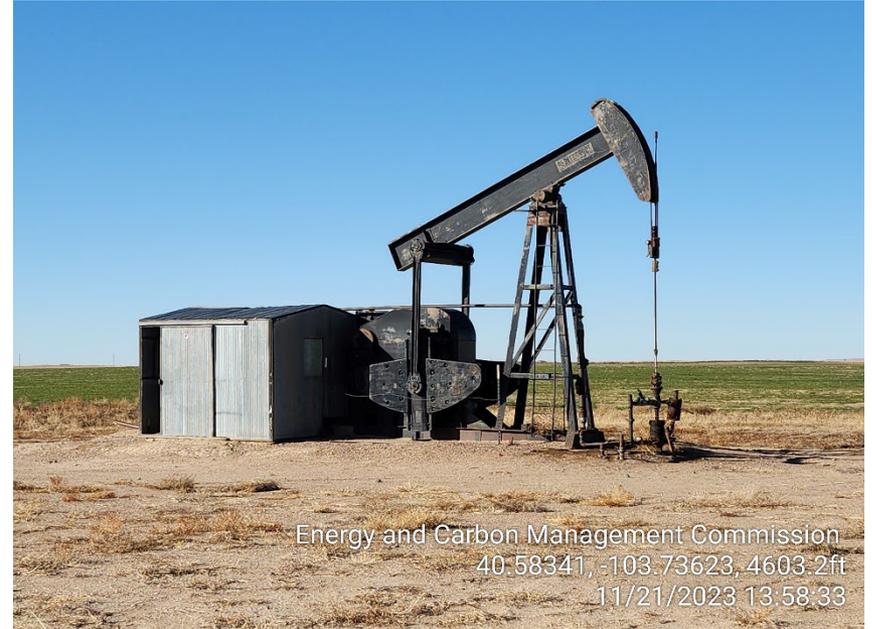
**Photo 16 – Pumping Unit**

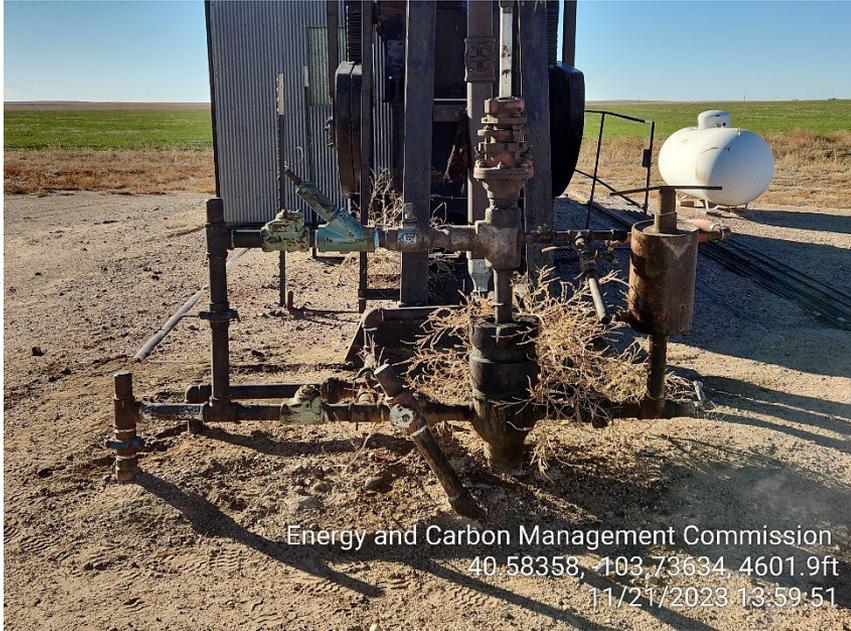
Photo 17 – Wellhead

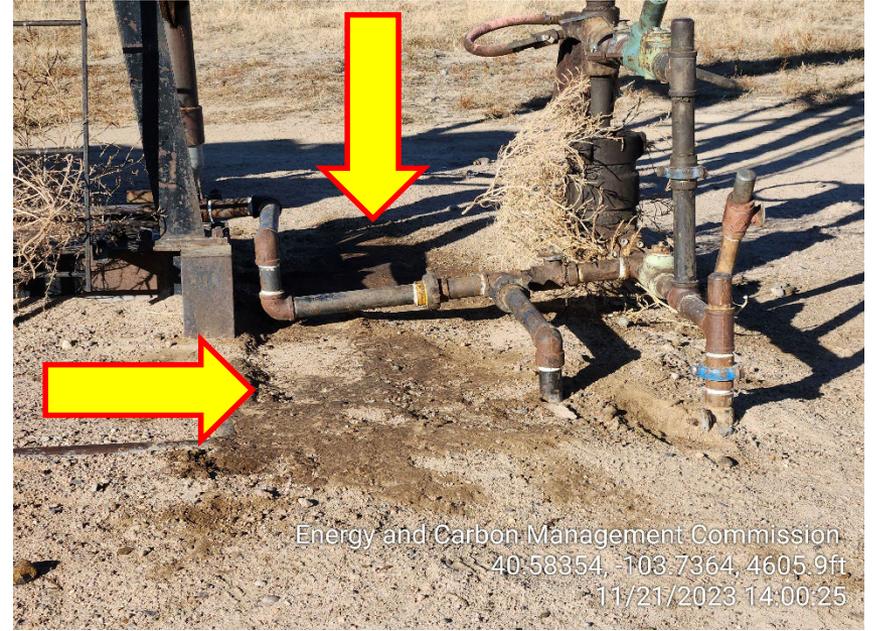
Photo 18 – Stained Soil at Wellhead
