Inspection Photos

Location Name: MUSTANG RESOURCES LLC RULISON FEDERAL 3-94-7S-94W Pad

Location ID: 322308

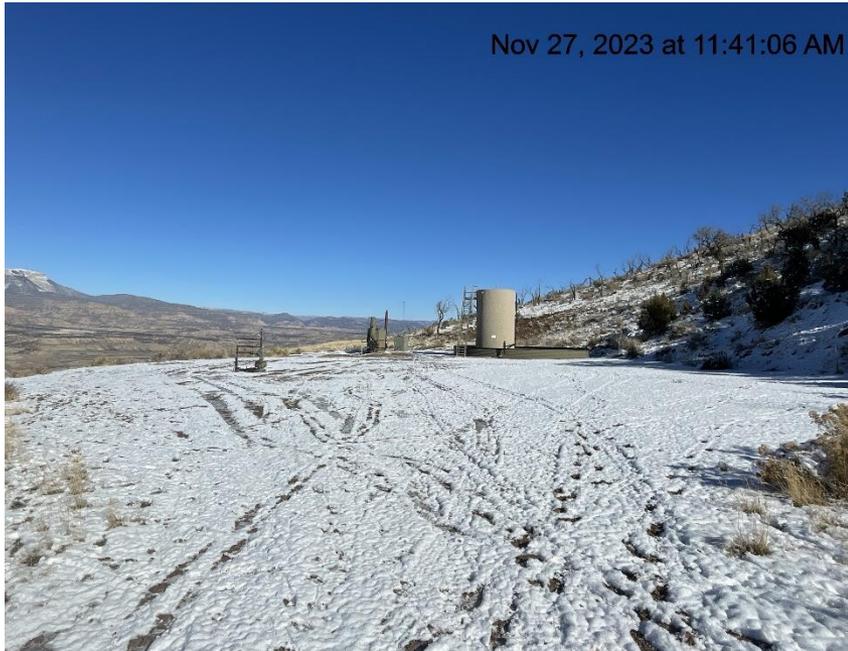
Photo # 7592 From entrance to location

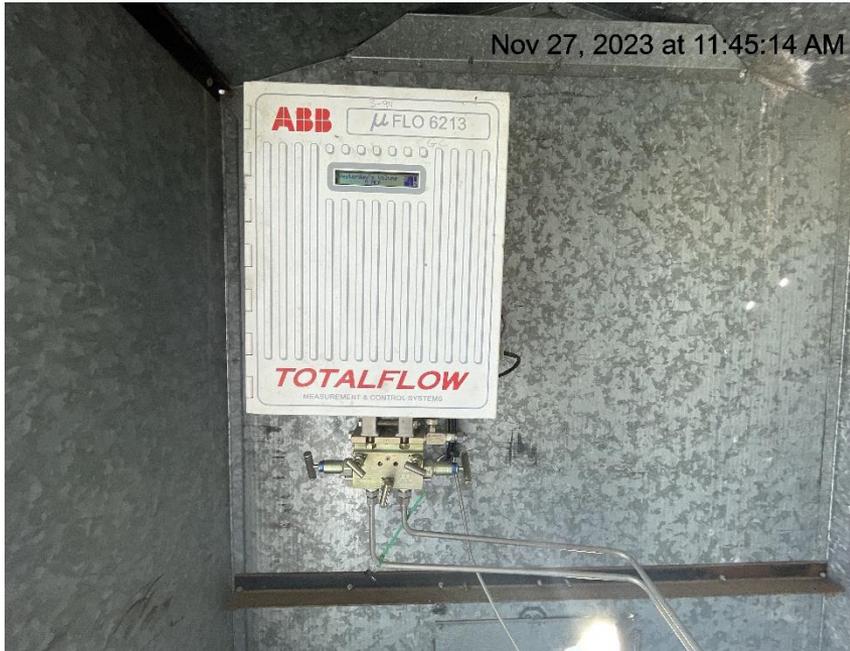
Photo # 7598 No cal card/meter calibration info not conspicuously posted

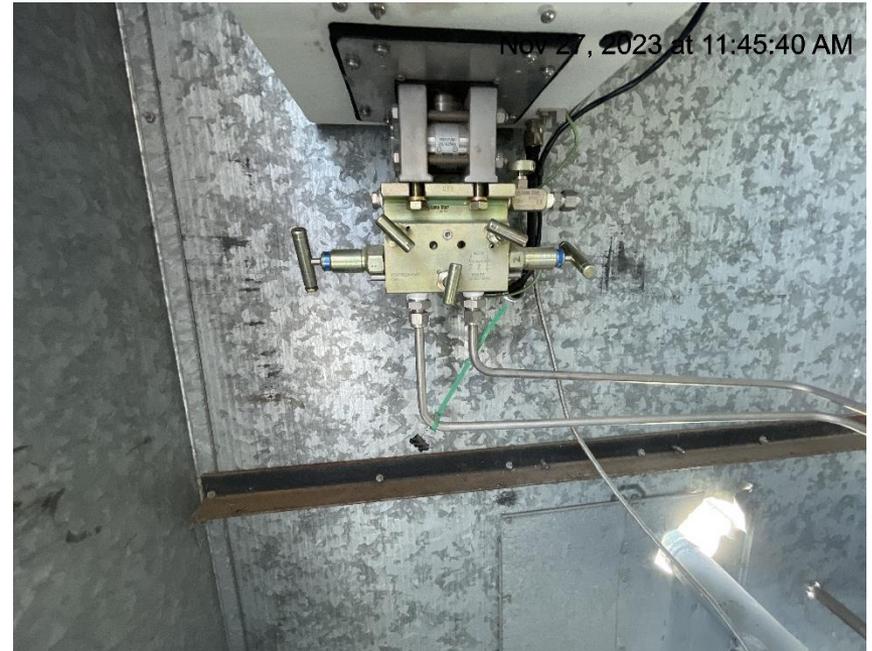
Photo # 7599 No cal card/meter calibration info not conspicuously posted

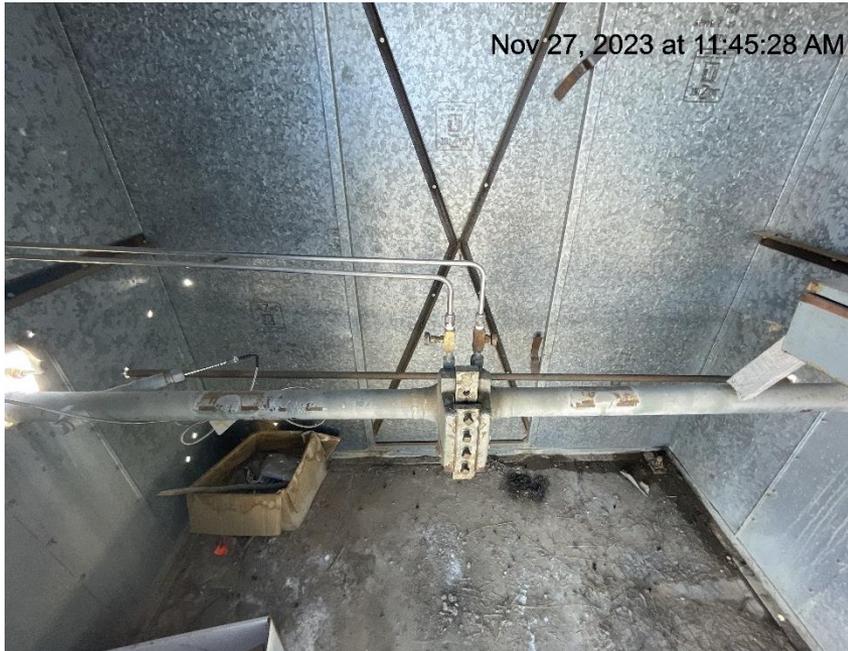
Photo # 7600 No cal card/meter calibration info not conspicuously posted

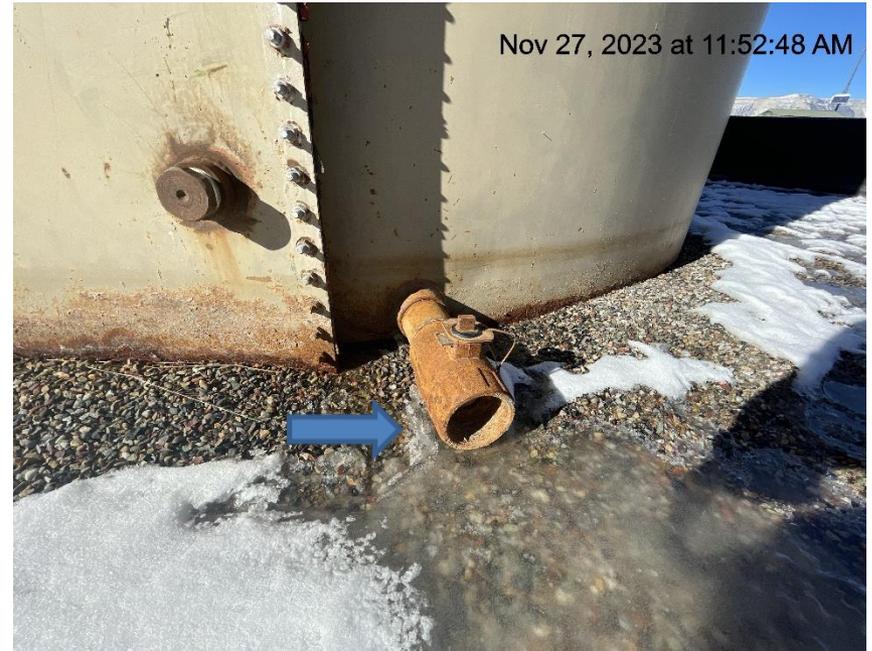
Photo # 7601 Open ended load line

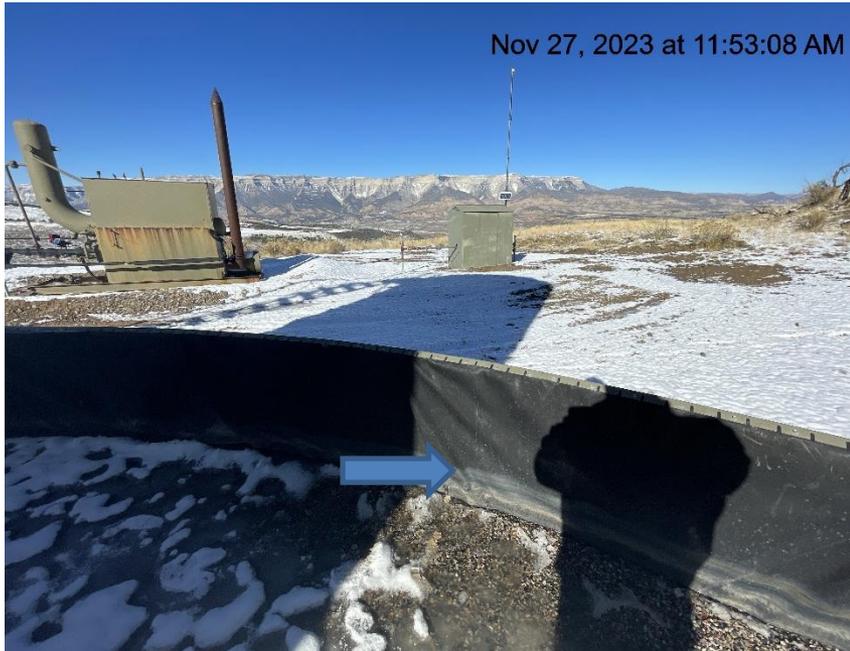
Photo # 7602 Hole in liner/liner needs maintenance

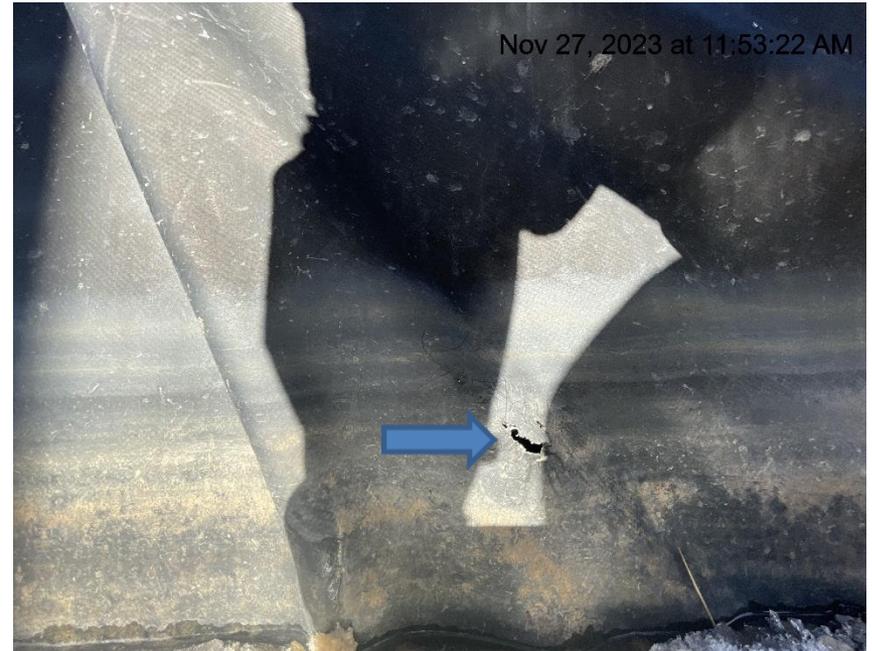
Photo # 7603 Hole in liner/liner needs maintenance

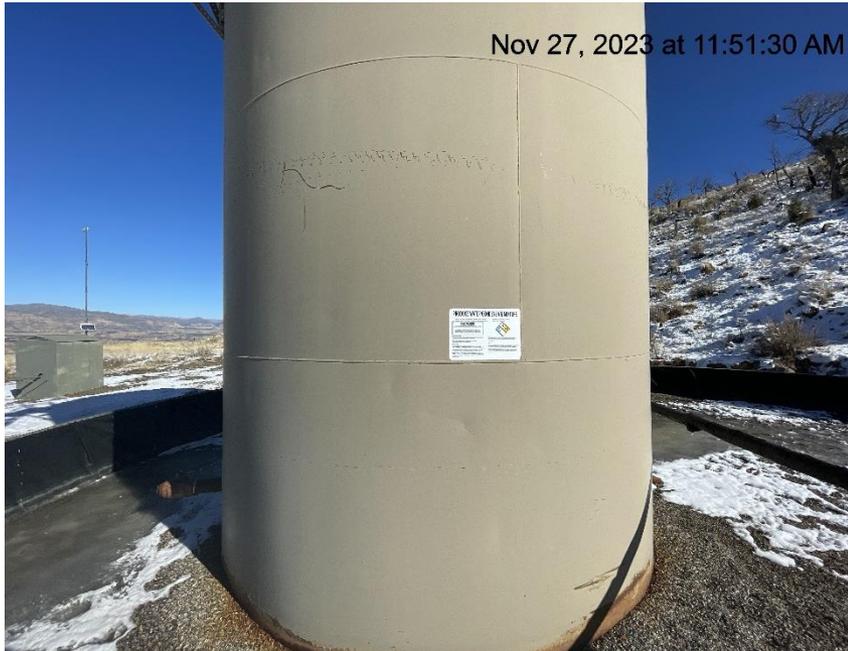
Photo # 7604 Production tank not properly labeled/missing required information

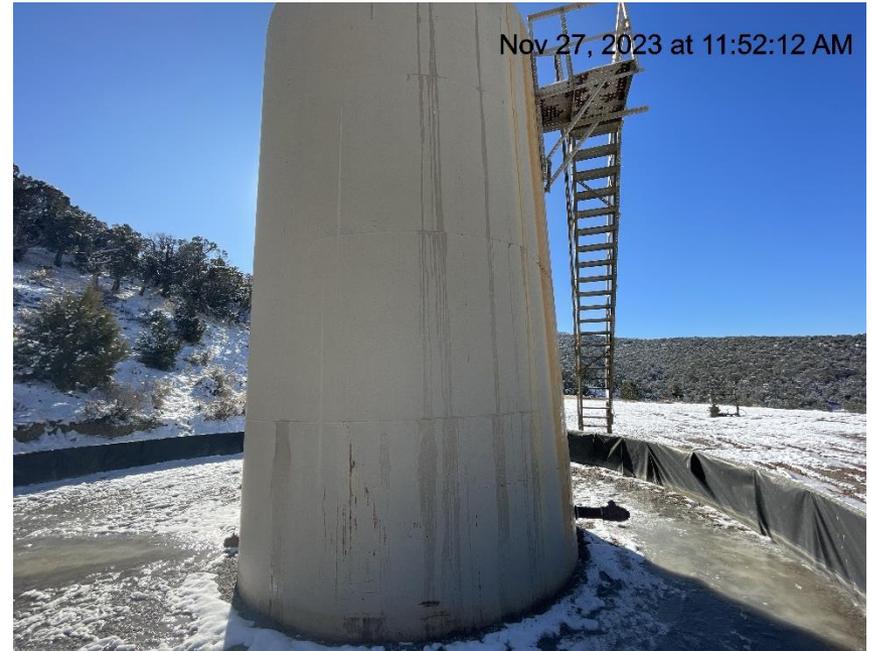
Photo # 7605 Production tank not properly labeled/missing required information

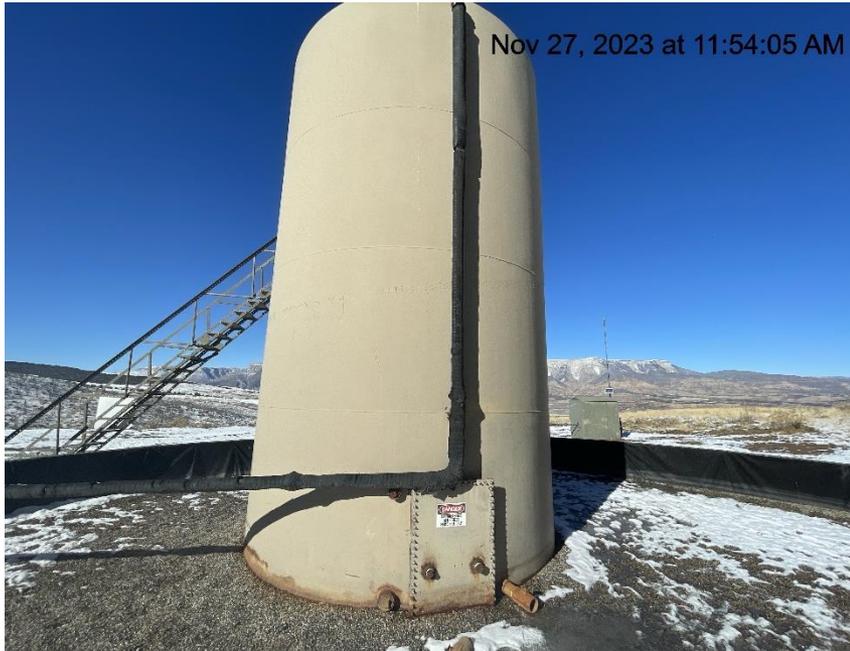
Photo # 7606 Production tank not properly labeled/missing required information

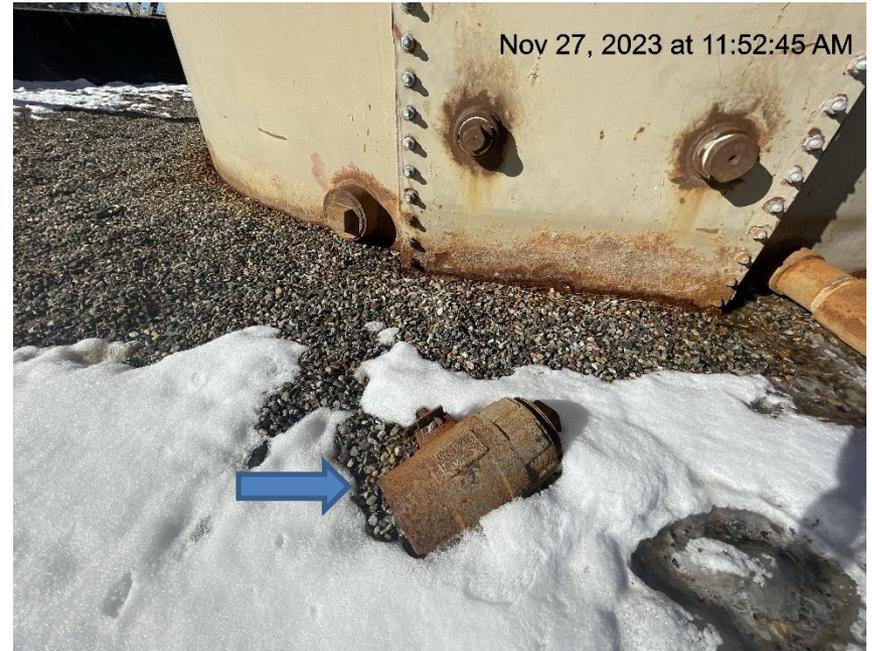
Photo # 7607 Debris
