Inspection Photos

API: 061-06403

Operator: STRACHAN EXPLORATION INC

Inspection Date: 11/29/2023

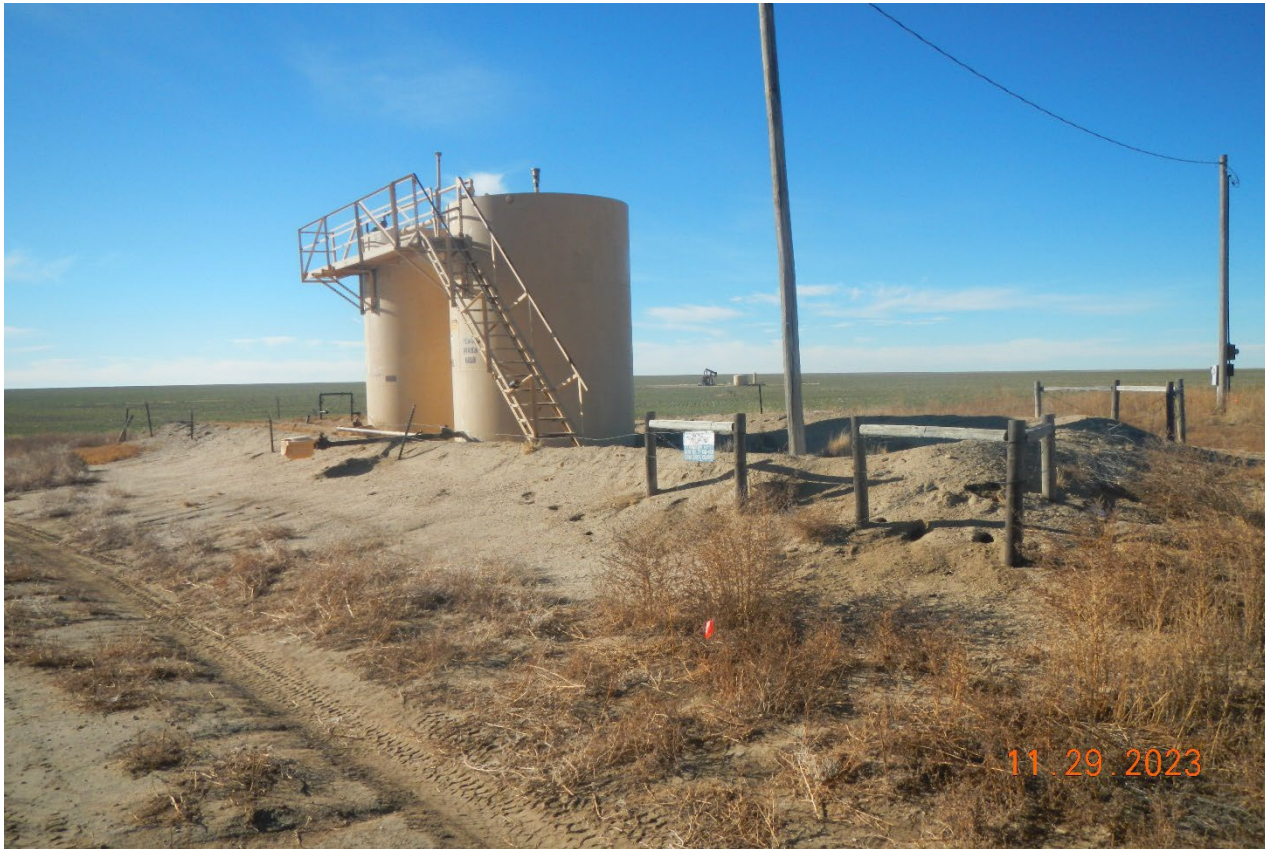
Photo 1. Facing toward the offsite tank battery location.

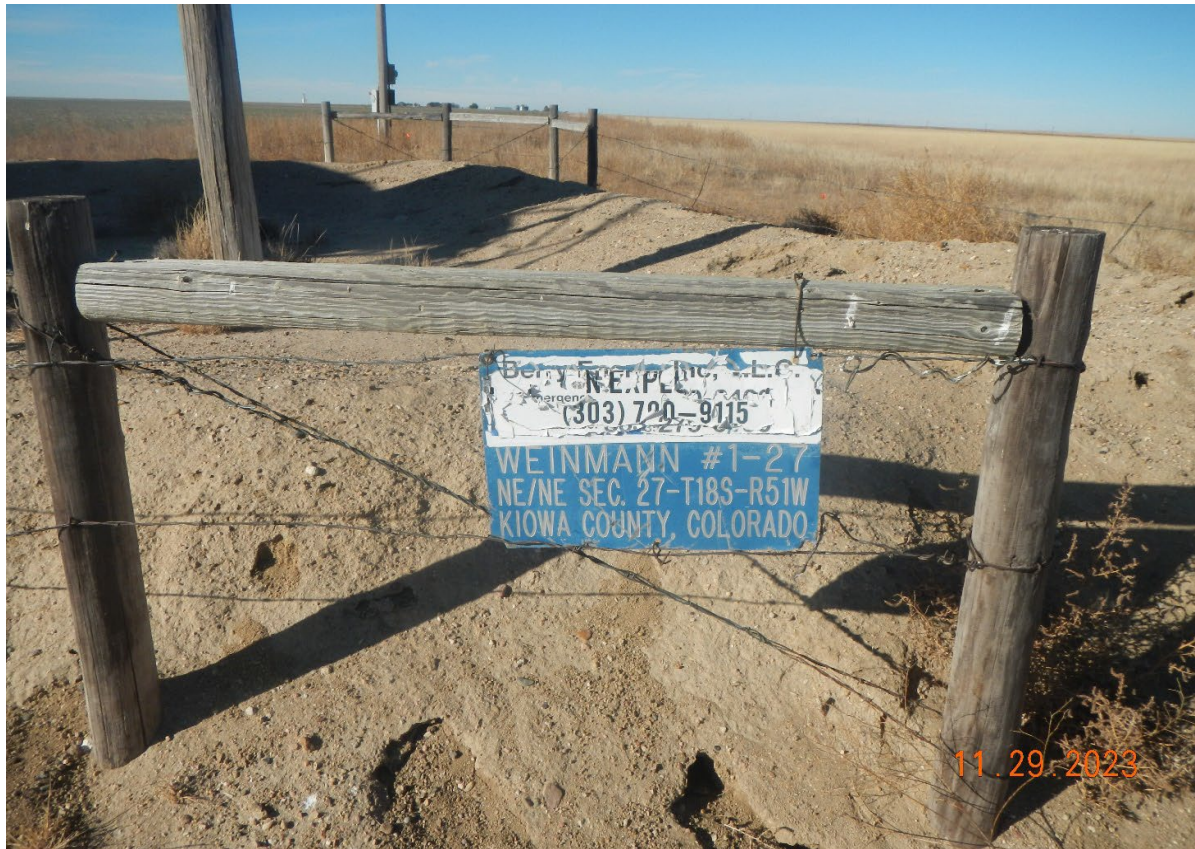
Photo 2. The sign is faded and does not meet the signage requirements of Rule 605.e. Previous corrective action was not completed.

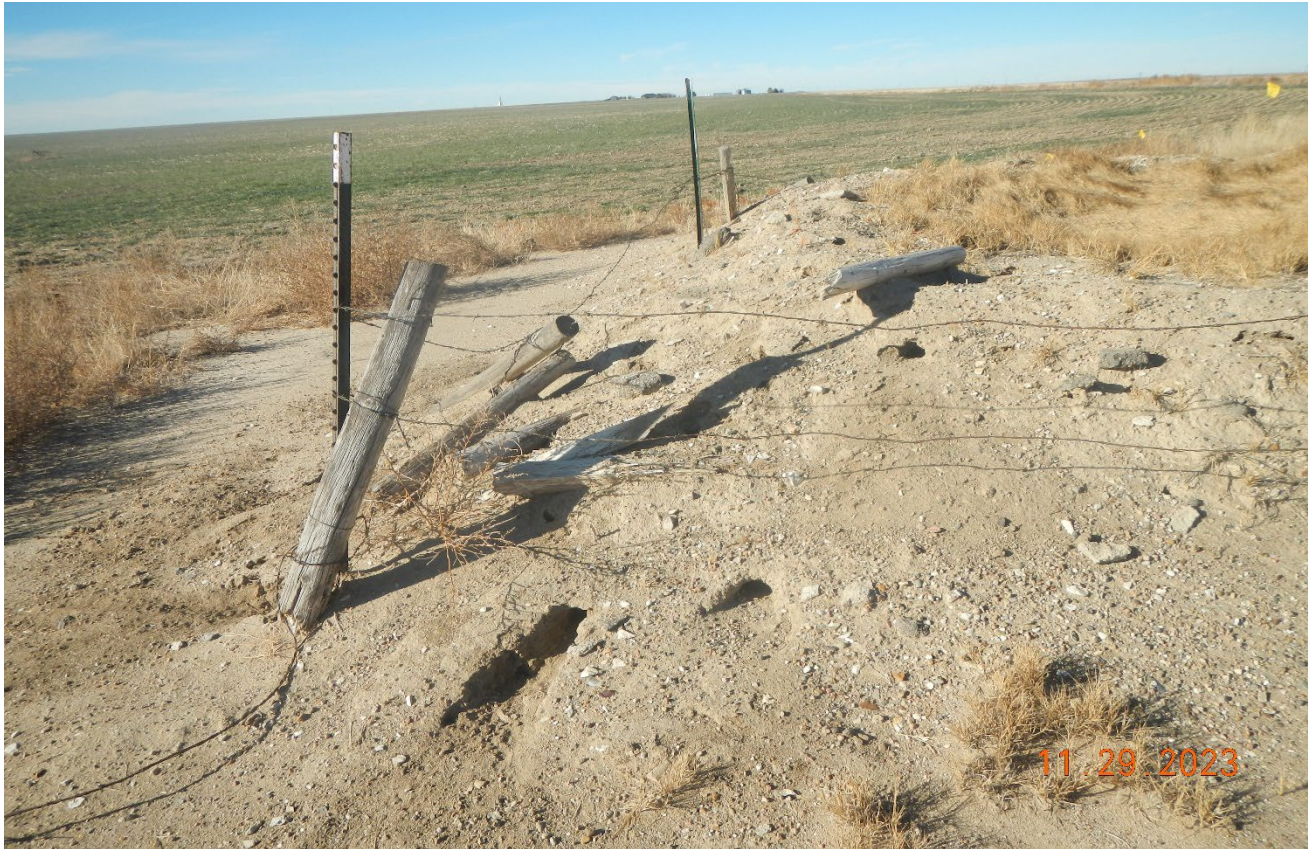
Photo 3. The fence around the tank battery is inadequate to prevent livestock entry and is not maintained. Previous corrective action was not completed.

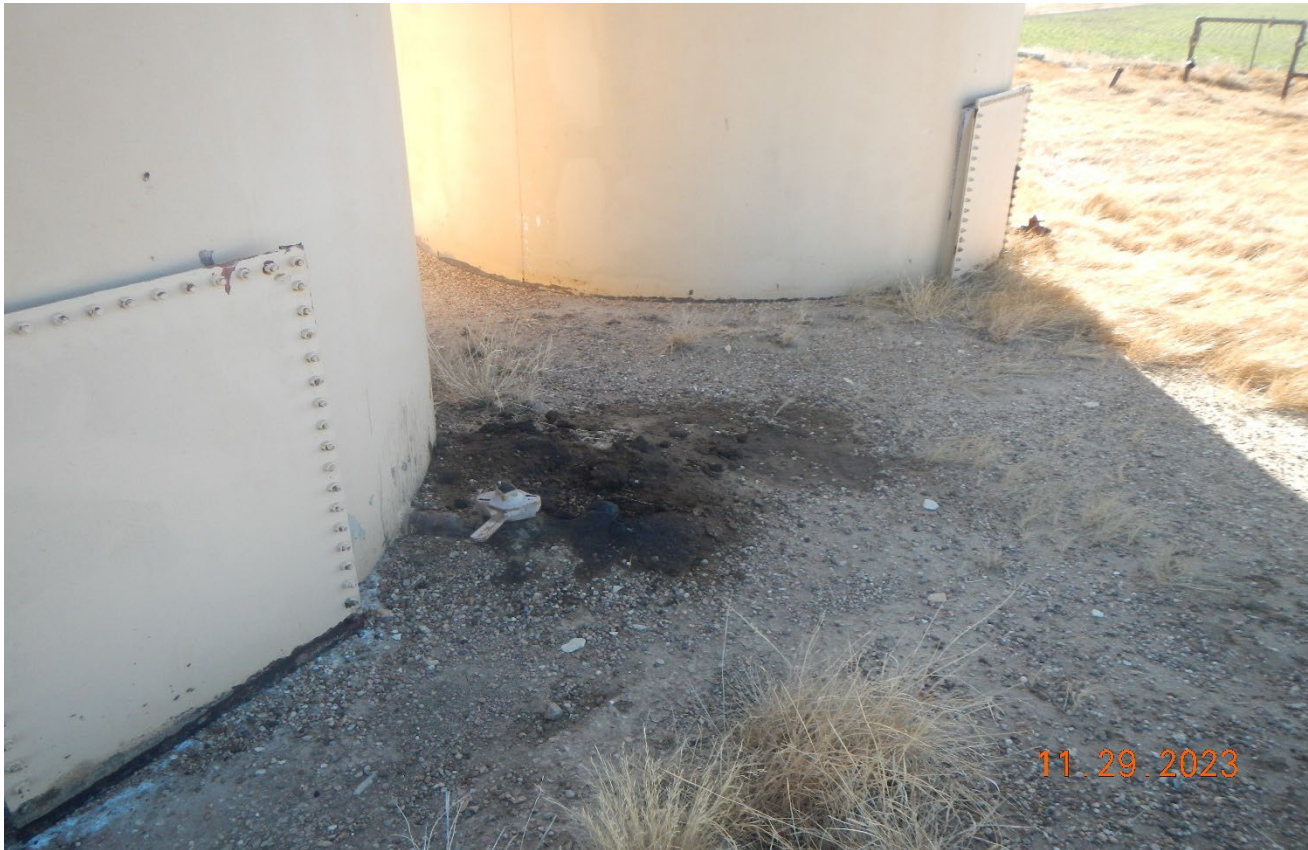
Photo 4. There is oil stained soil at the back side of the tank that needs to be cleaned up.

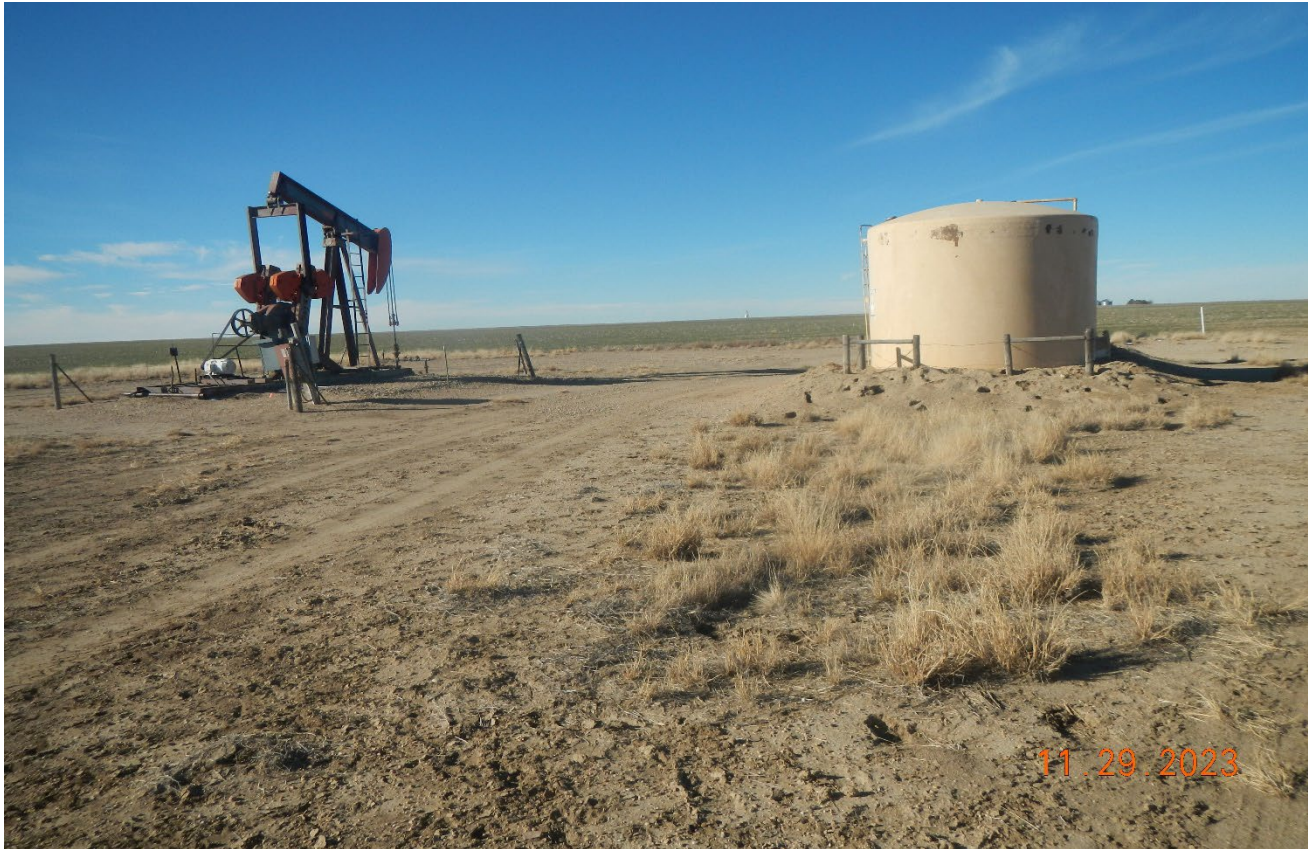
Photo 5. Facing southwest toward the wellsite..

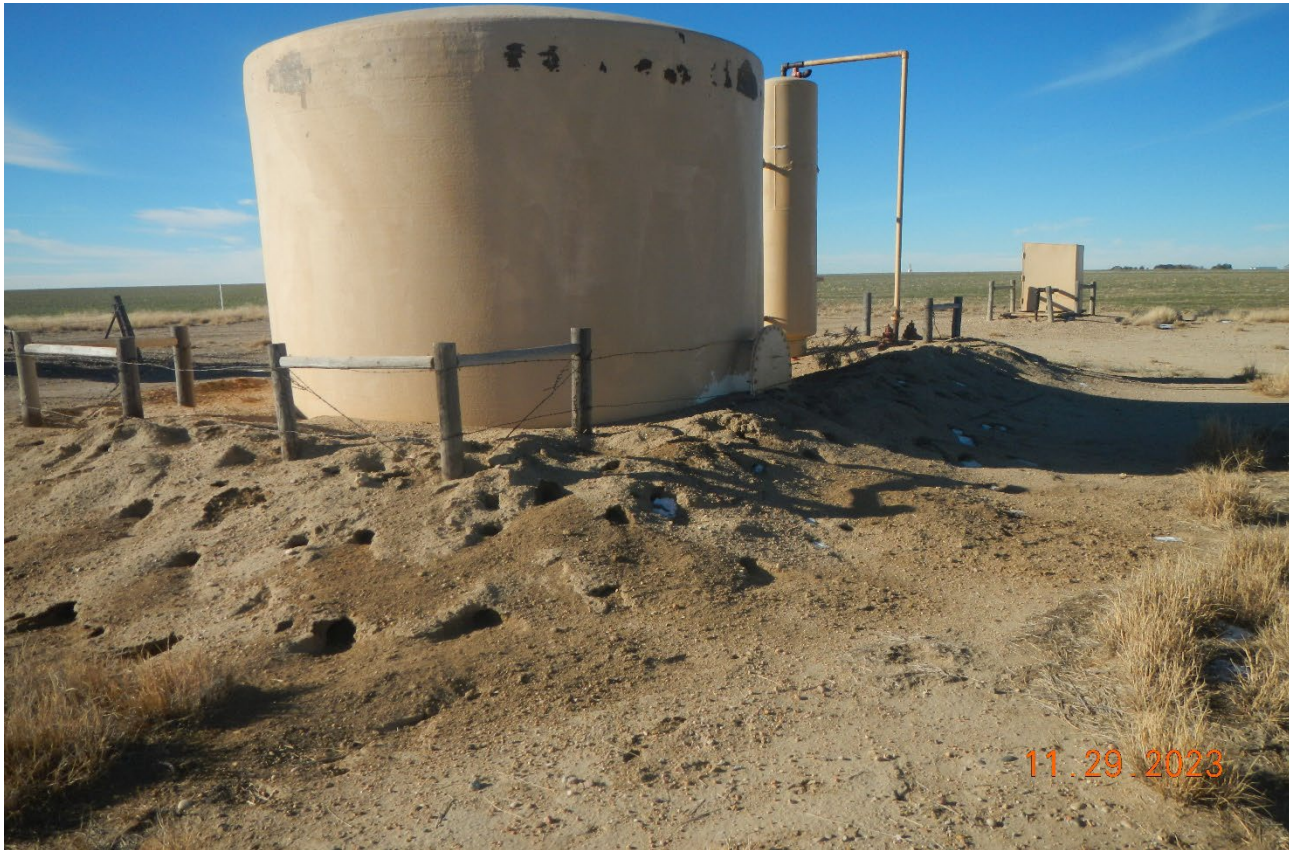
Photo 6. Facing toward the tank. The berm around the tank is inadequate to contain a spill. The fence around the tank is in disrepair. Previous corrective action was not completed.

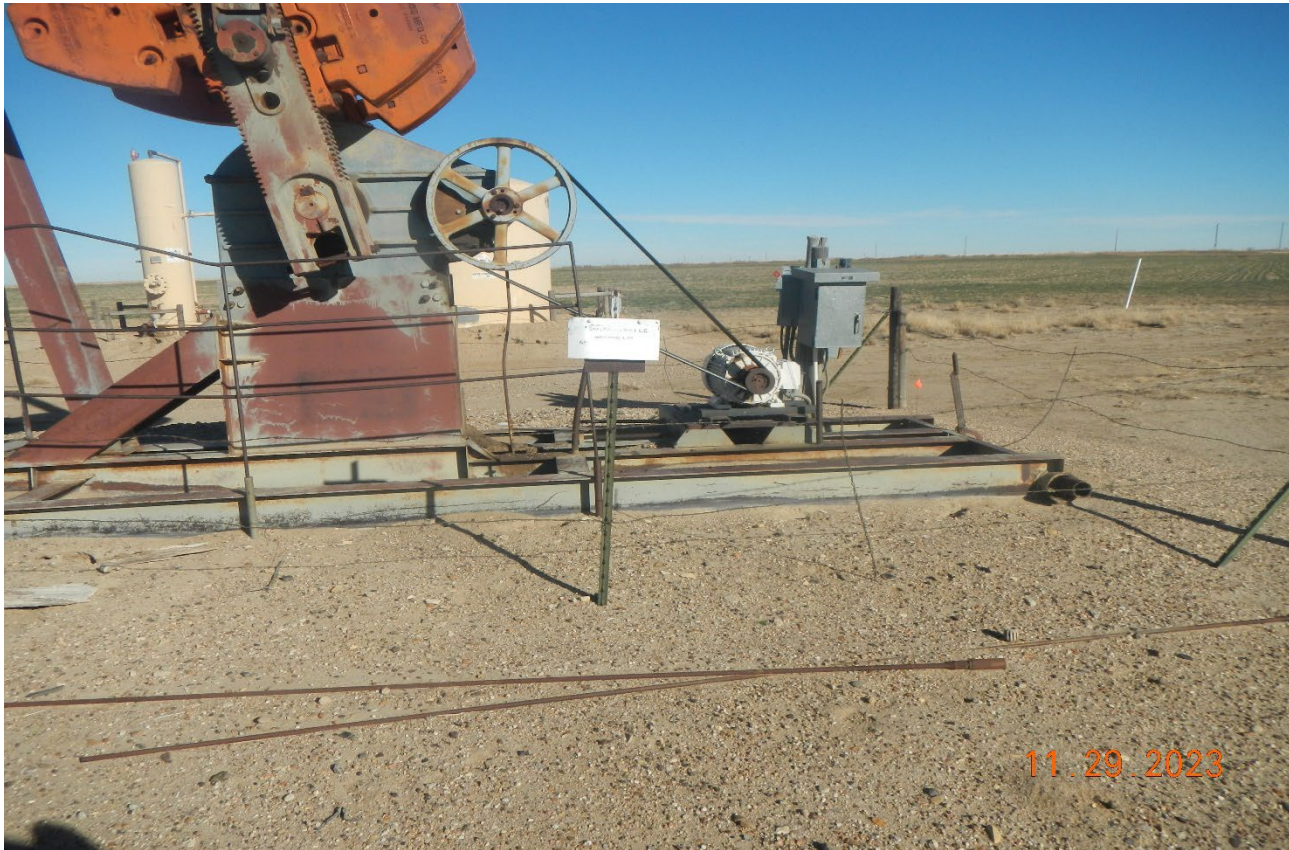
Photo 7. The well sign is faded and does not meet the signage requirements. Previous corrective action was not completed.
