# Inspection Photos

API: 061-06365

Operator: STRACHAN EXPLORATION INC

Inspection Date: 11/29/2023

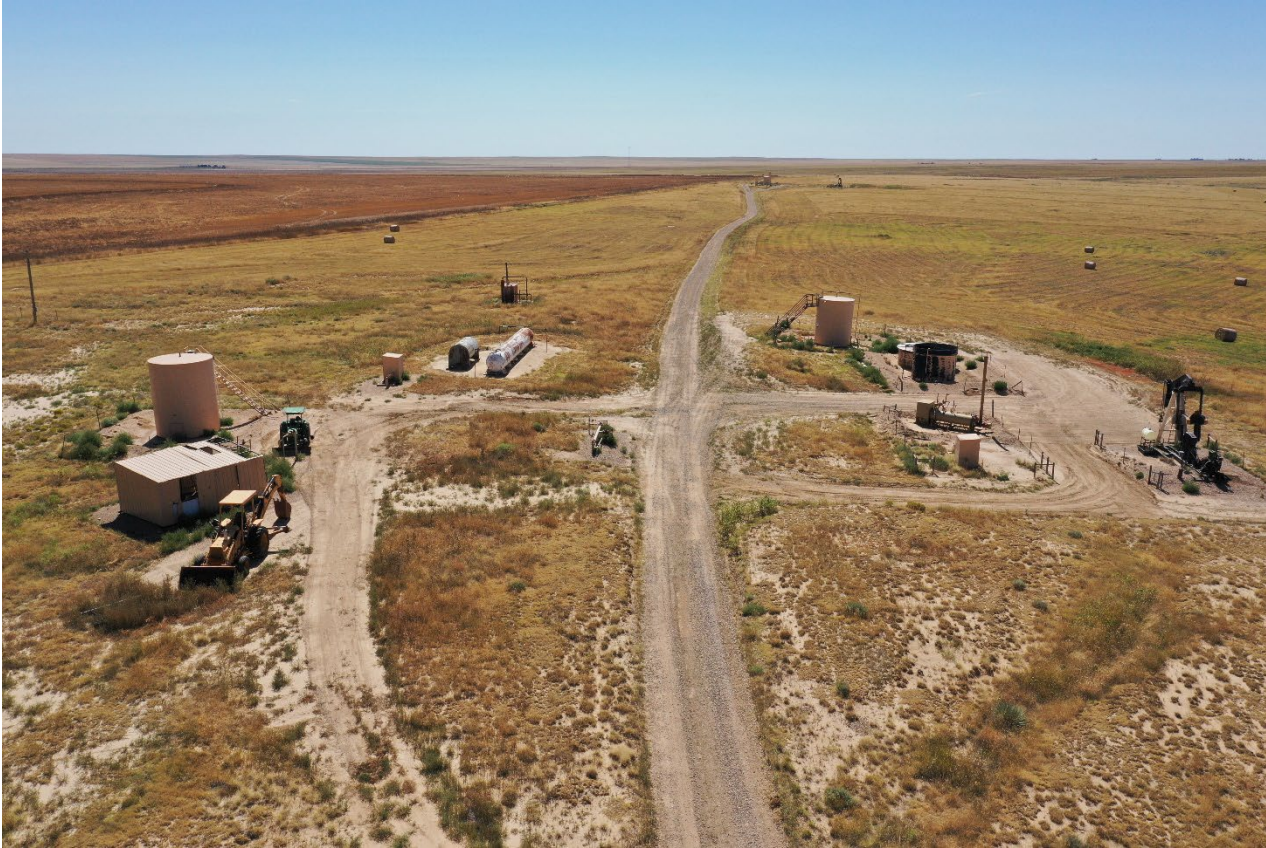
**Photo 1.** 8/24/23 Drone aerial photo facing east toward the location.

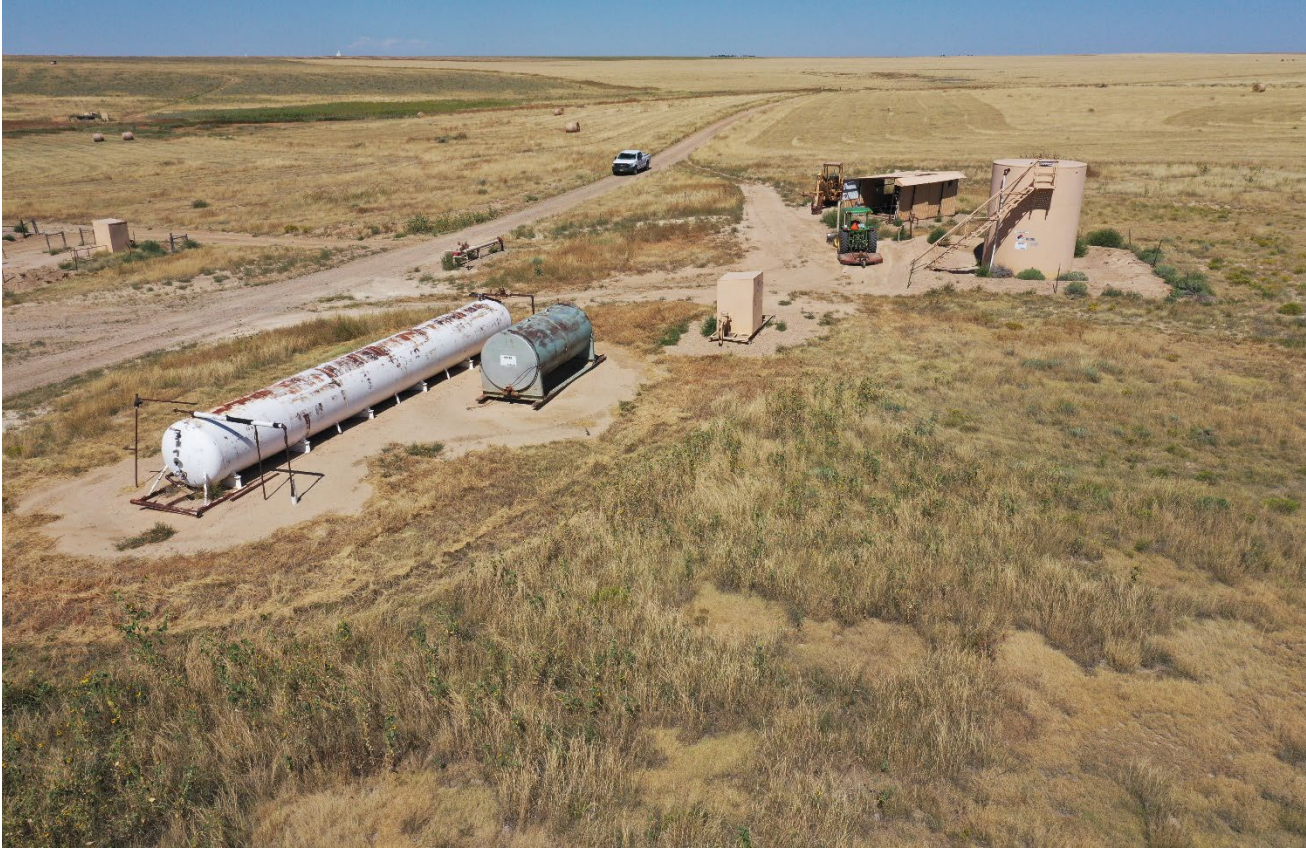
**Photo 2.** 8/24/23 Drone aerial photo facing west at the north side of the location

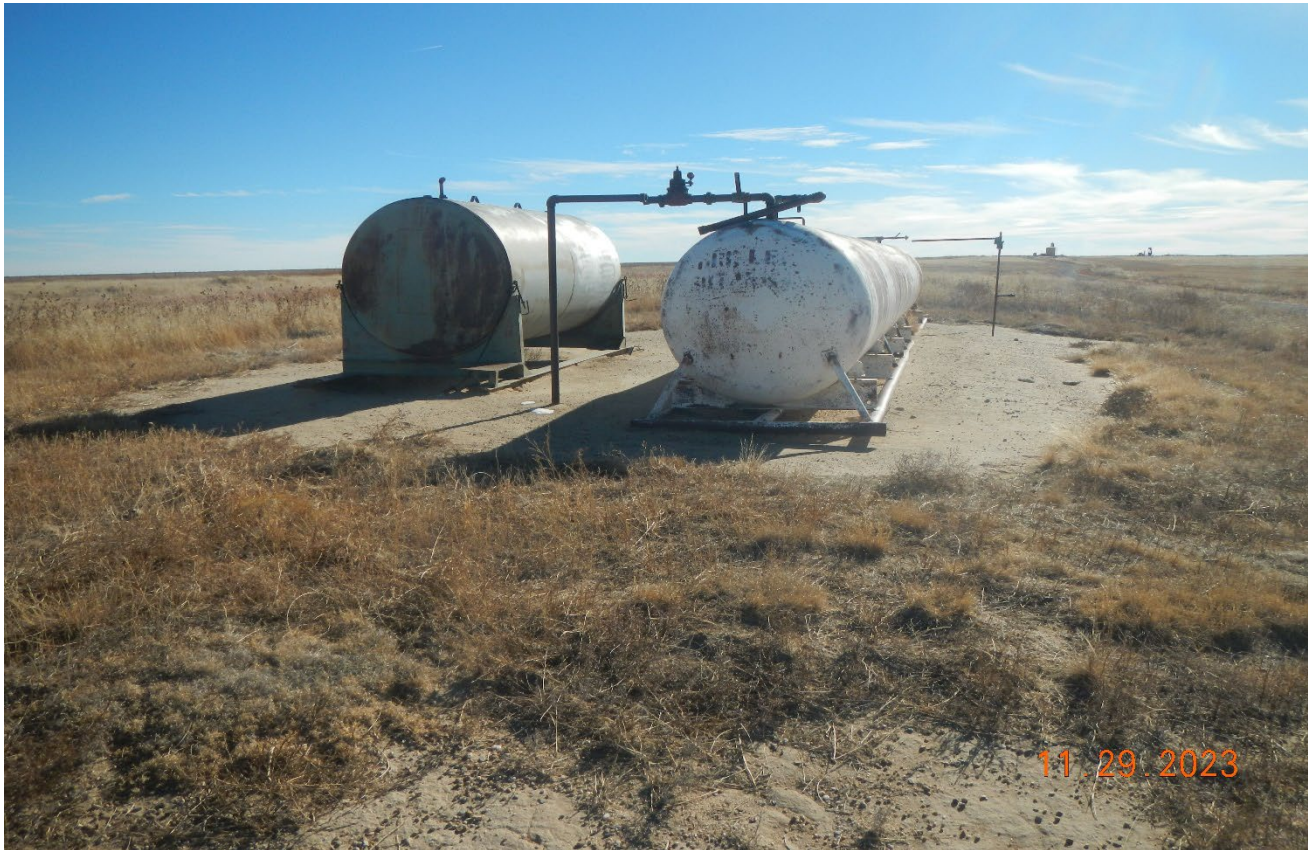
**Photo 3.** Facing southeast at the location. The two large volume tanks do not have proper labeling or secondary containment. If the tanks are unused then they need to be removed. Previous corrective action was not completed.

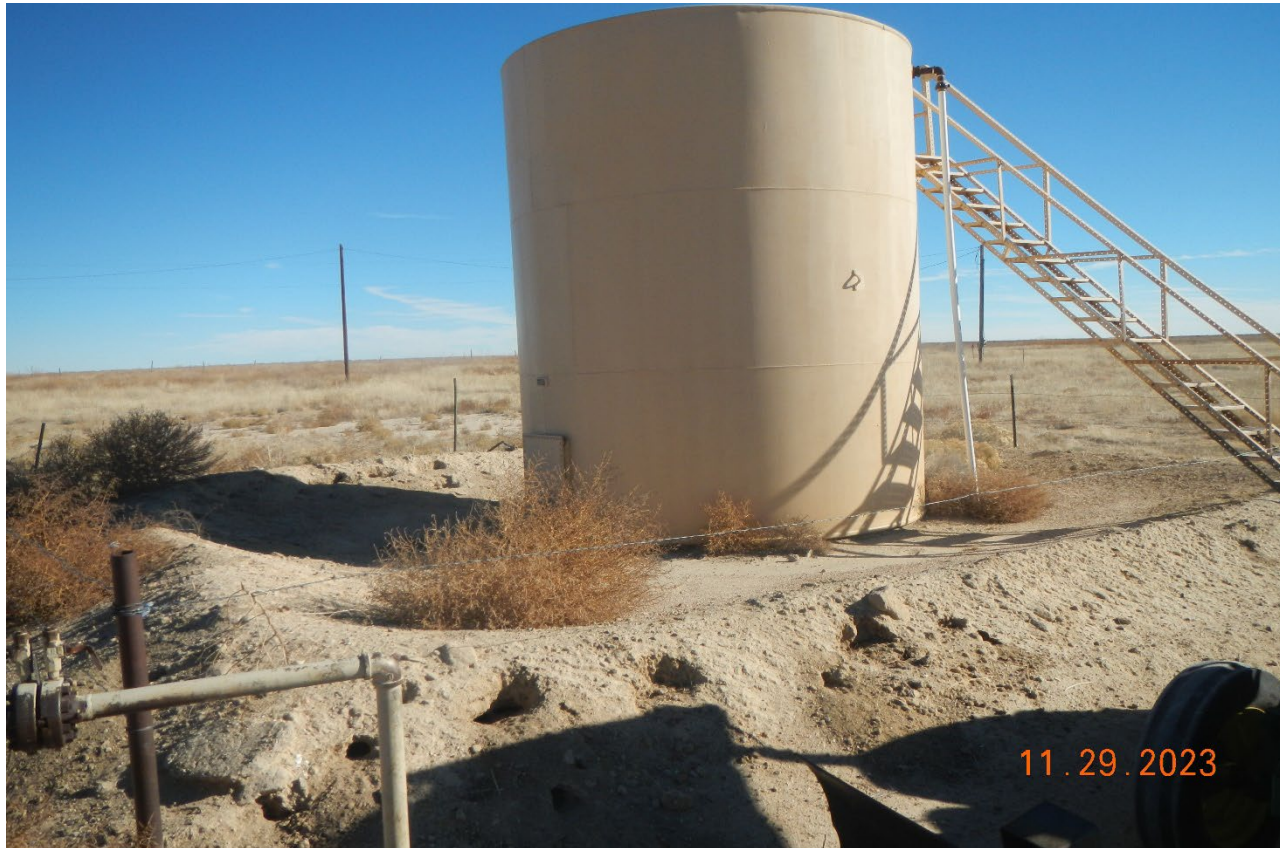
**Photo 4.** Facing at the north side of the location. The fence around the tank battery is inadequate to prevent livestock entry and is not maintained. Berm is insufficient to contain a spill (150% of tank capacity). Previous corrective action was not completed.

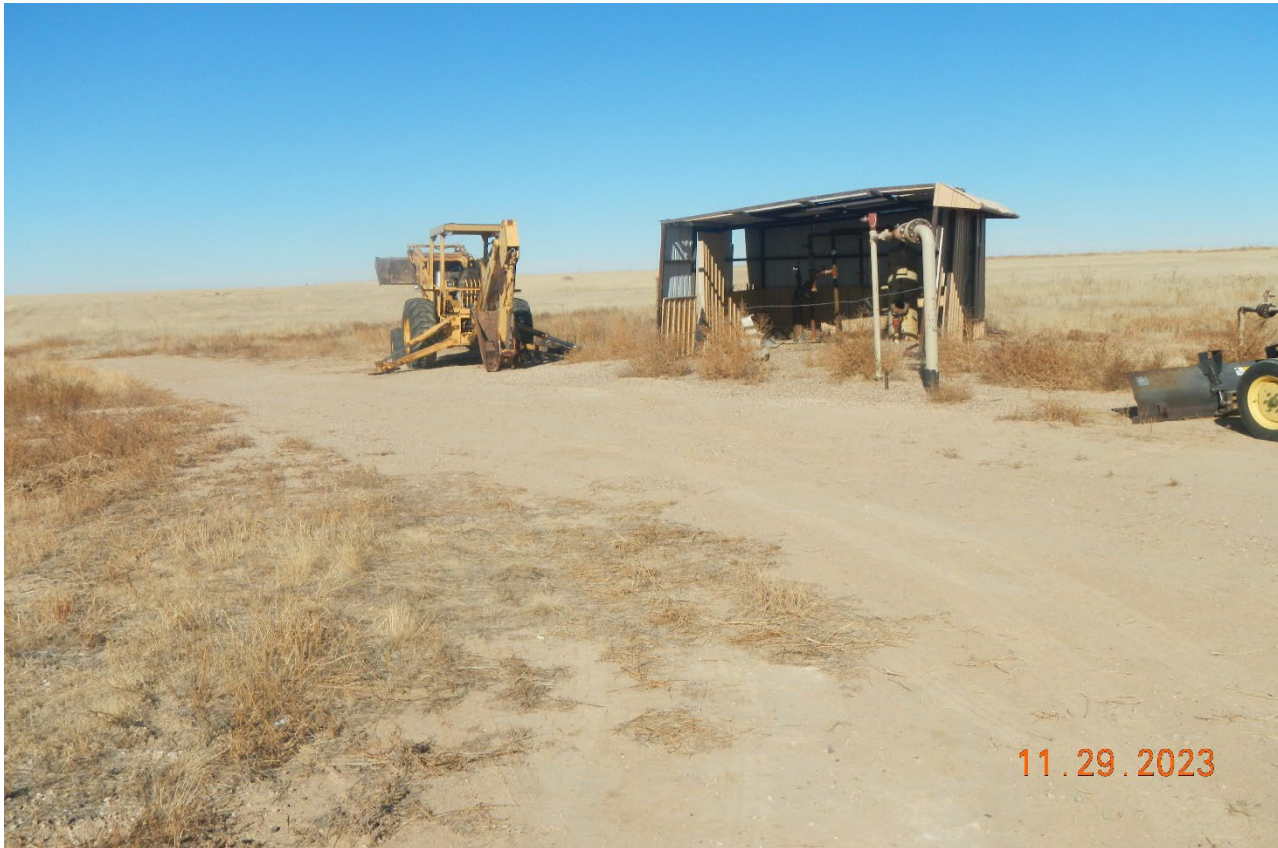
**Photo 5.** Facing northwest at the location.

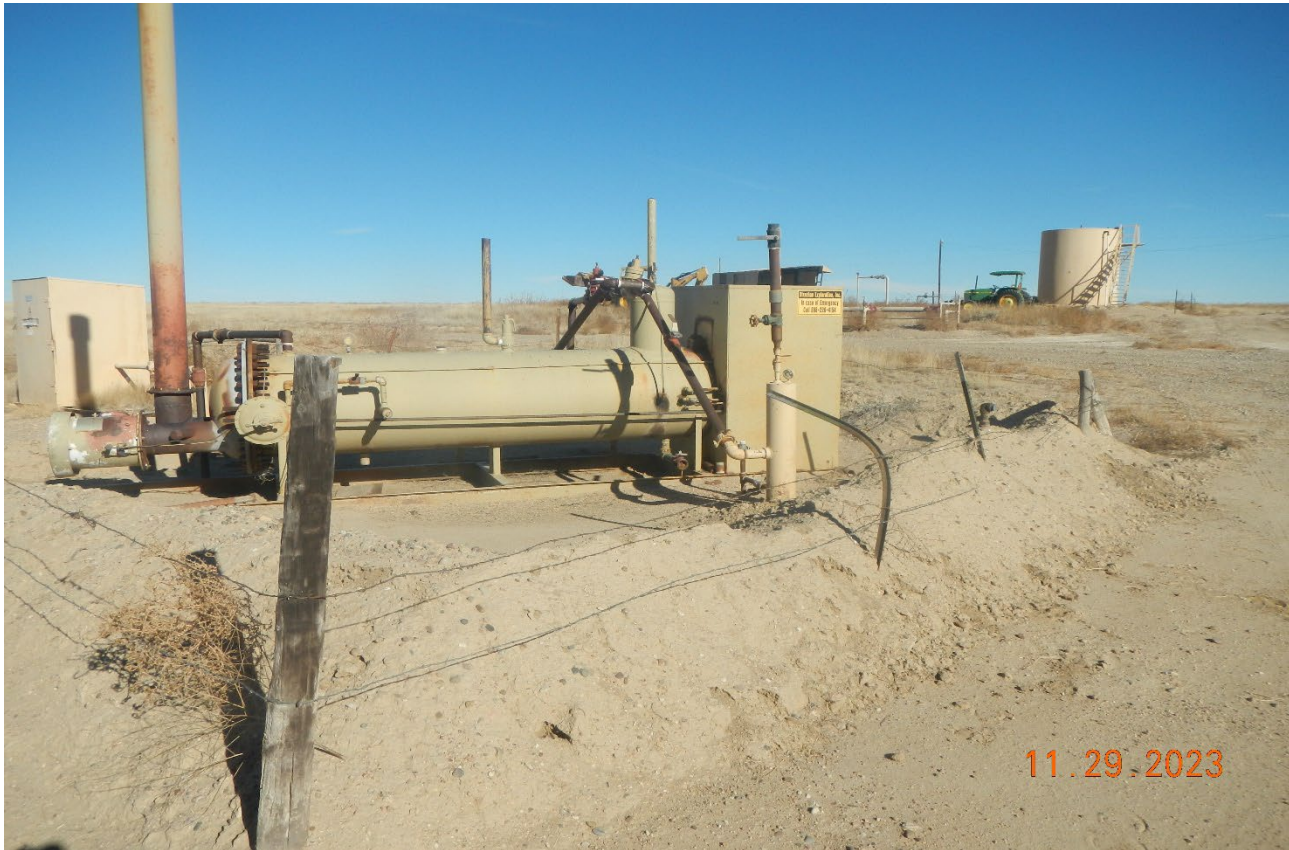
**Photo 6.** The northwest at the wellsite and production equipment. The fence around the equipment is inadequate to prevent livestock entry. Cattle track have previously been observed inside the 2 strand fence.

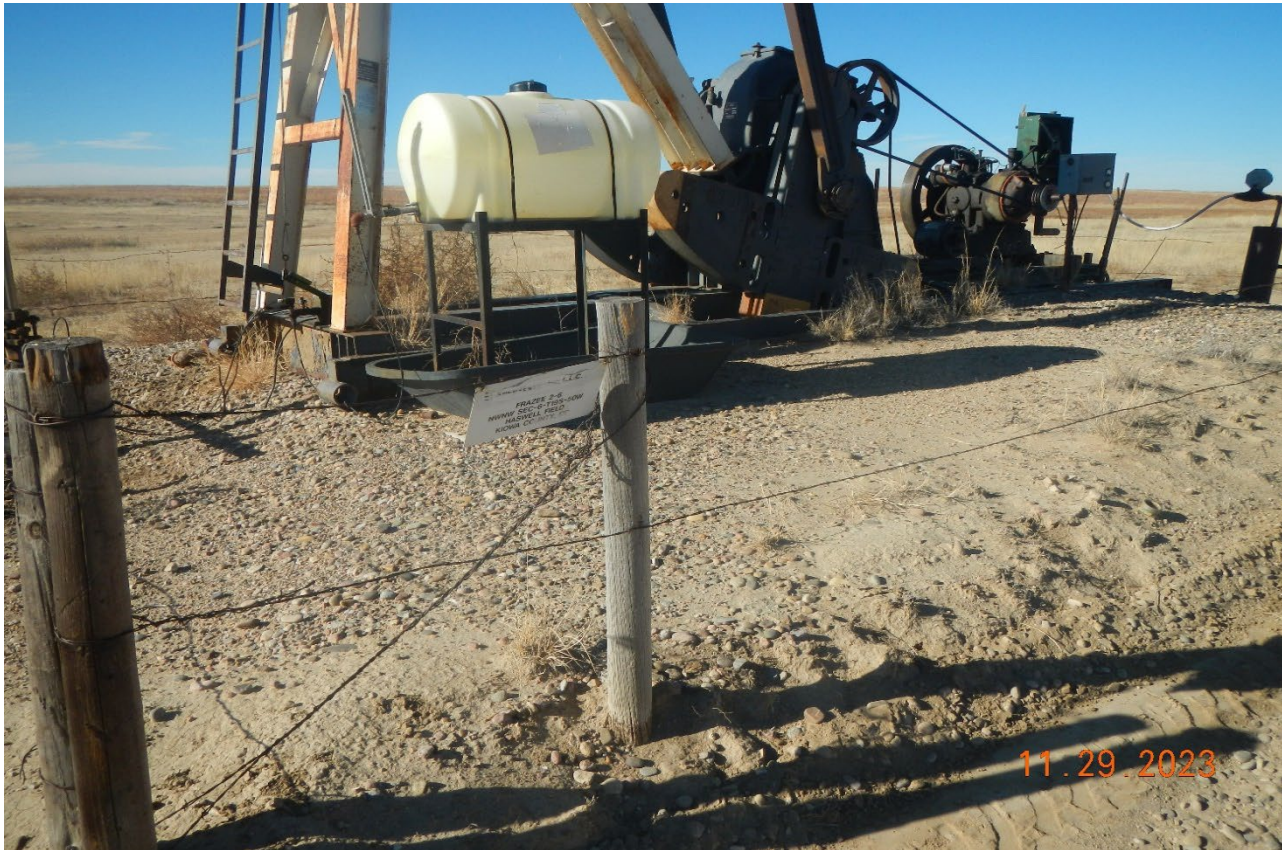
**Photo 7.** Facing toward the pumpjack. The well sign posted does not meet the signage requirements of the rules.

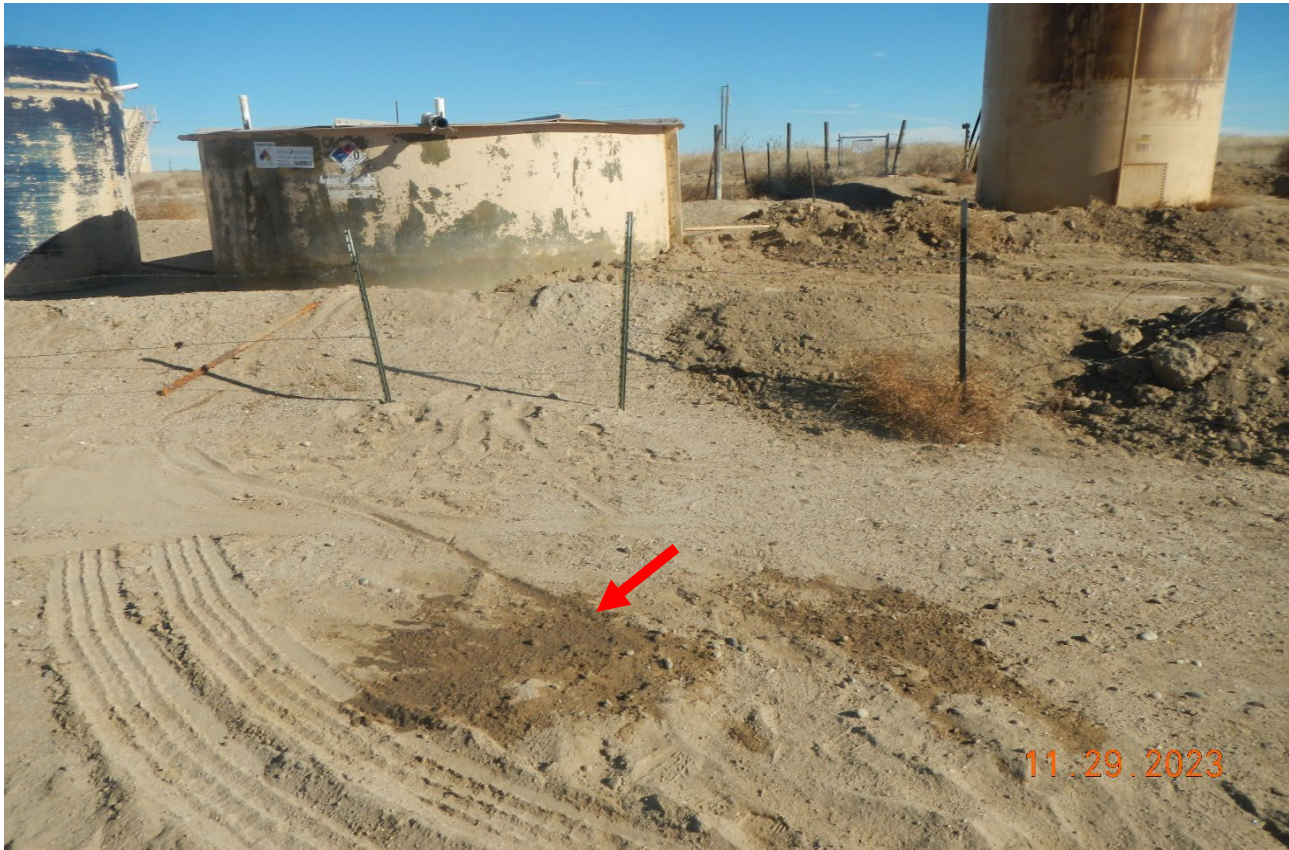
**Photo 8.** Facing toward the tanks at southeast side of the location. There is wet soils where the truck load out occurred and signs that the hose leak out water while disconnecting.

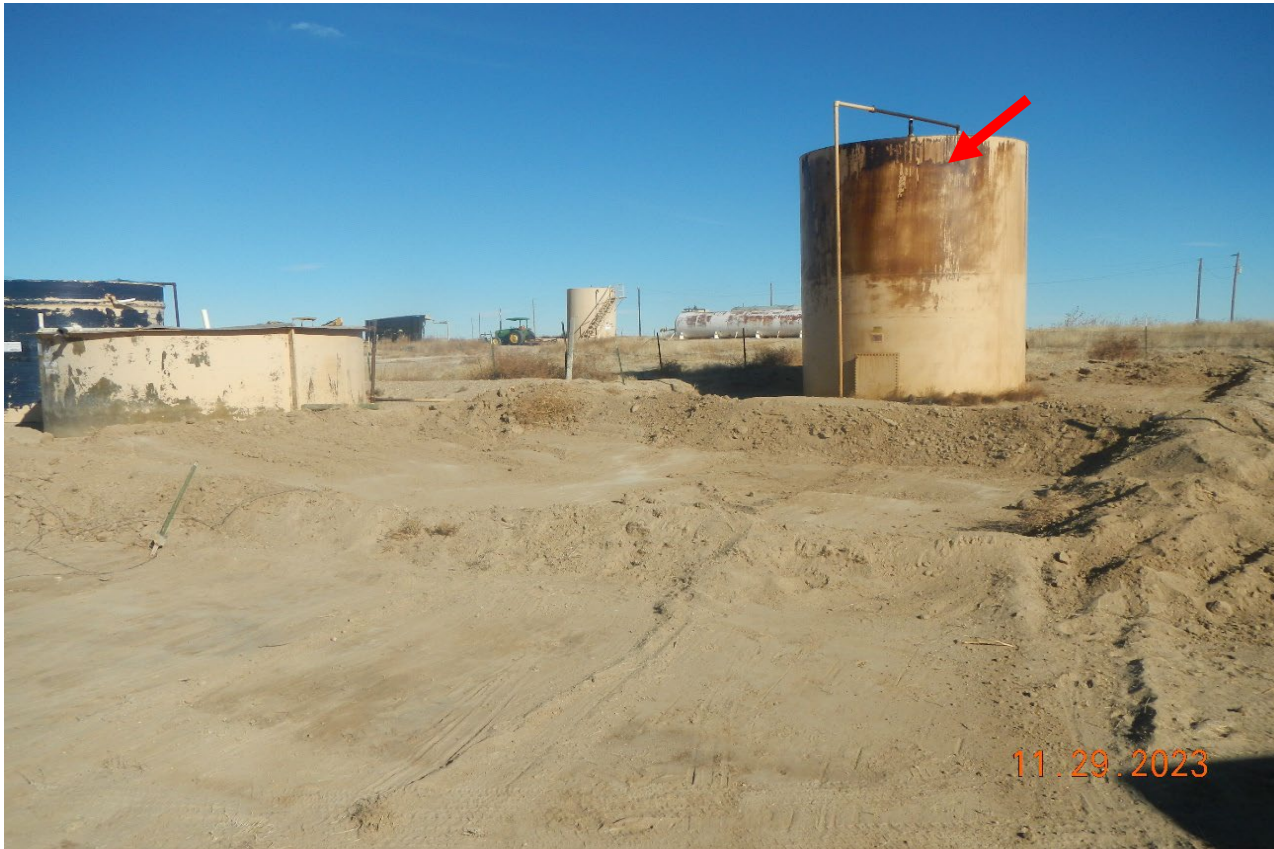
**Photo 9.** Facing northwest toward the tank battery. There was a recent spill that had occurred at the tank shown at red arrow. Soils have been pushed and secondary containment is not adequate. Loose soils are susceptible to erosion and all contaminated soils need to be cleaned up and removed.

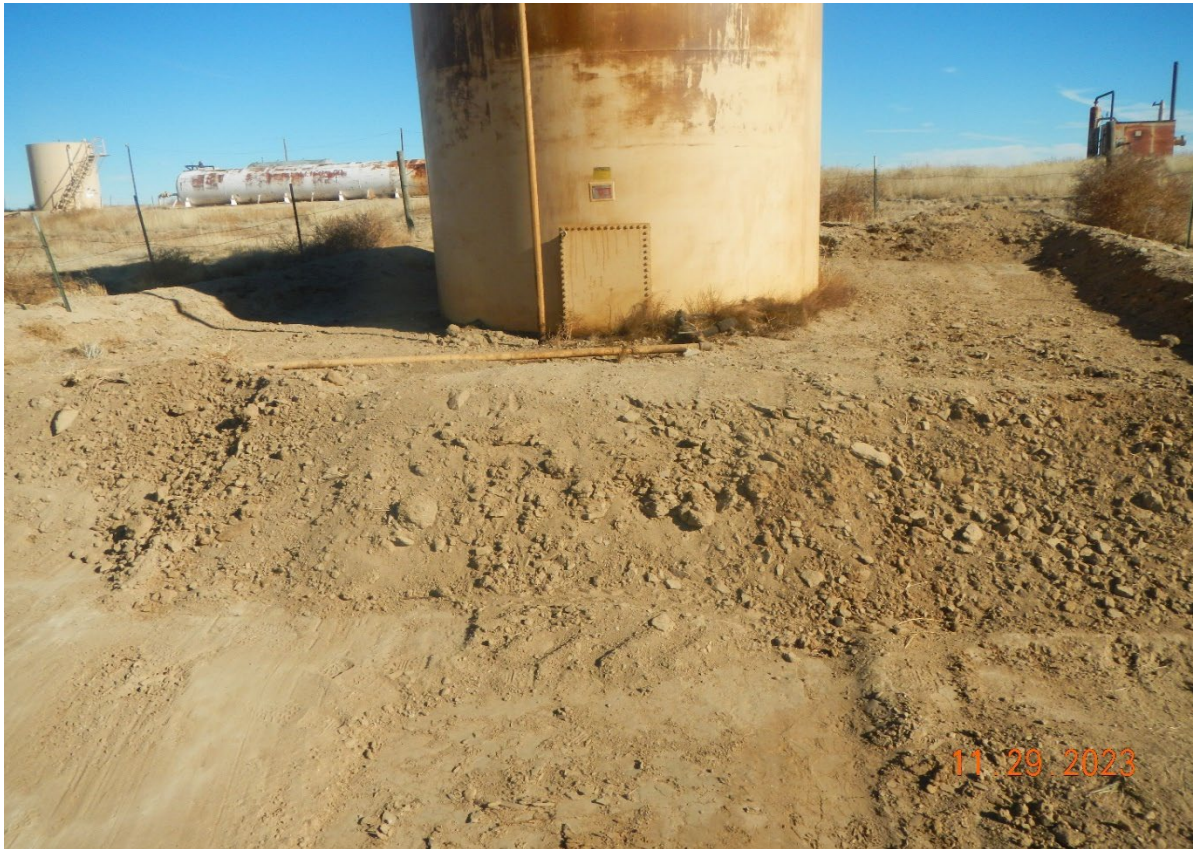
**Photo 10.** The berm pushed up is inadequate for secondary containment due to loose soils and inadequate size.

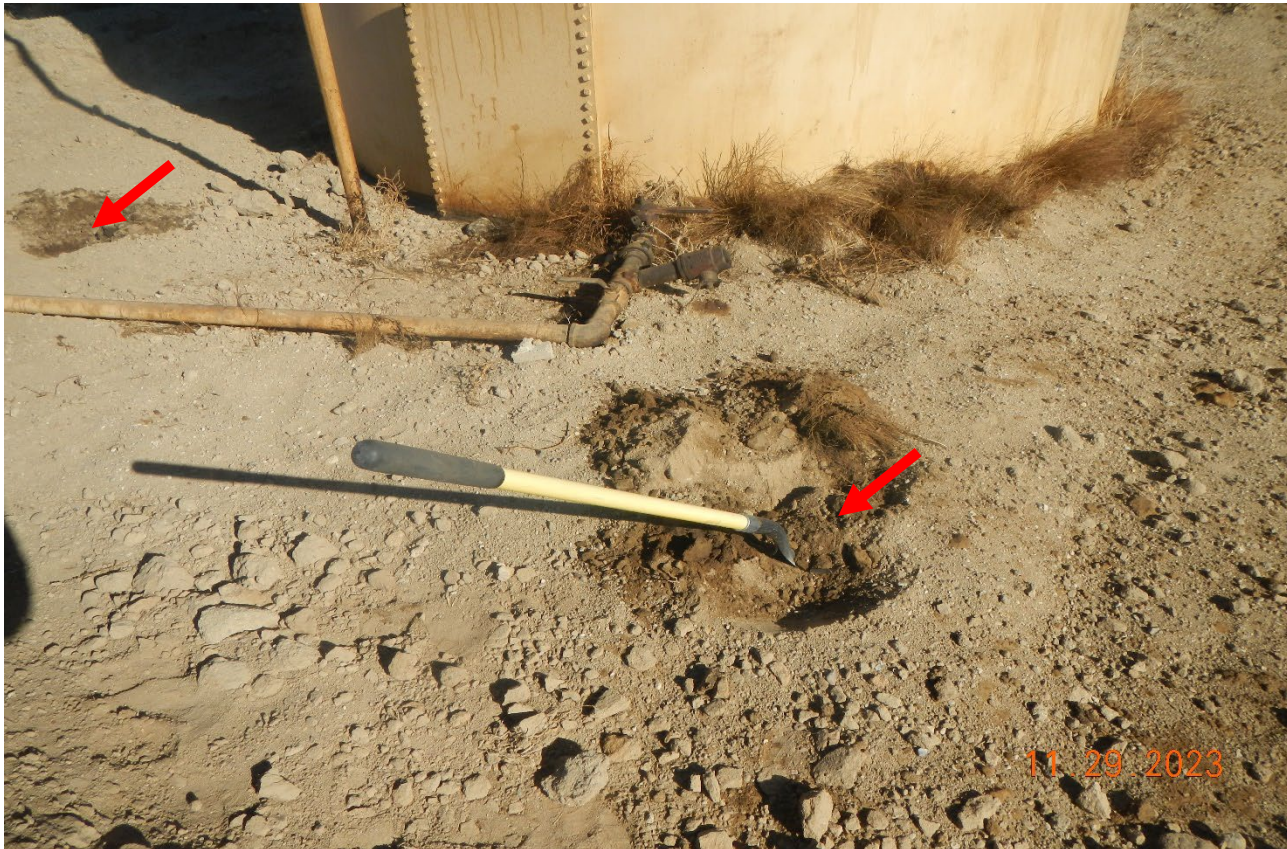
**Photo 11.** It appears dirt was pushed over the spill area which was not cleaned up. Shovel uncovered the fresh dirt placed over the oil stained soils show the stained oily soils at red arrow.

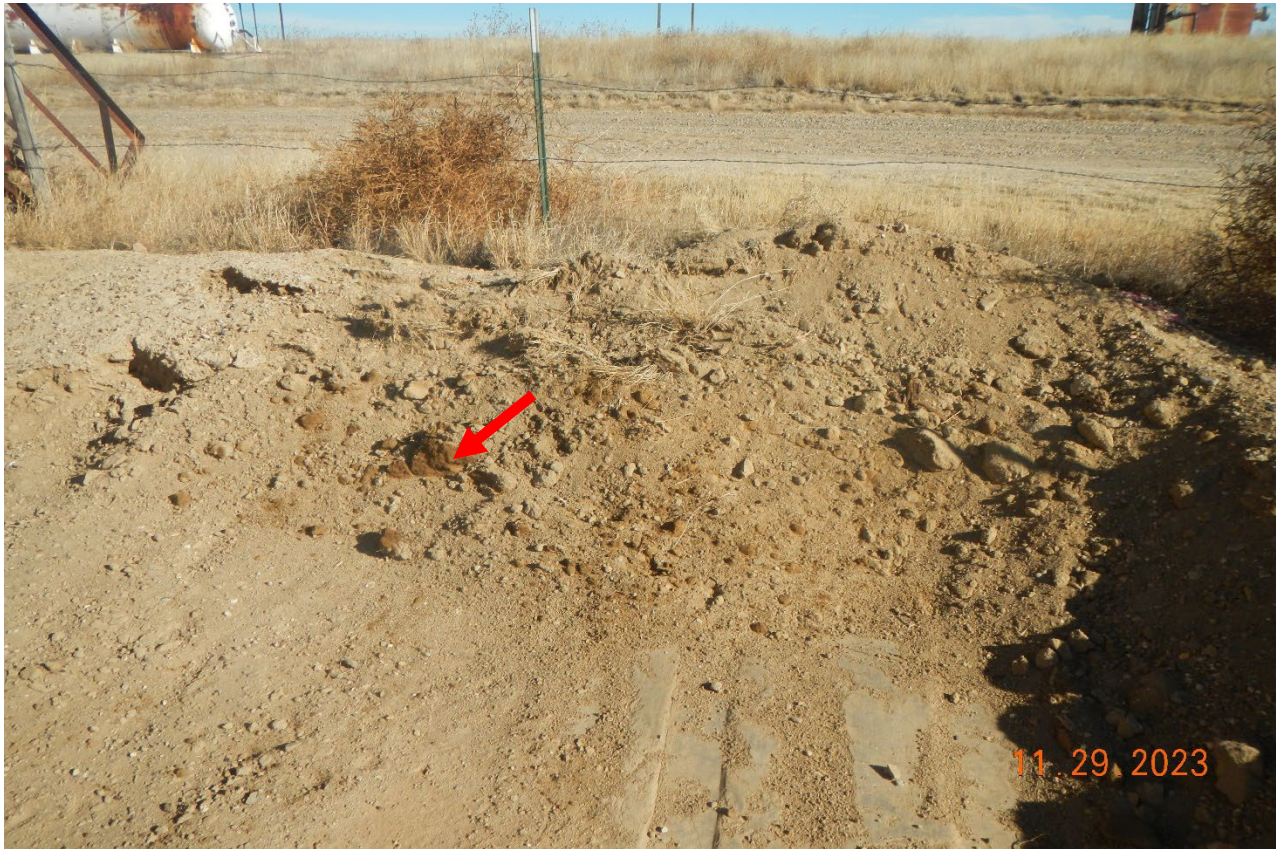
**Photo 12.** The loader had pushed up contaminated oil soils into the berm.

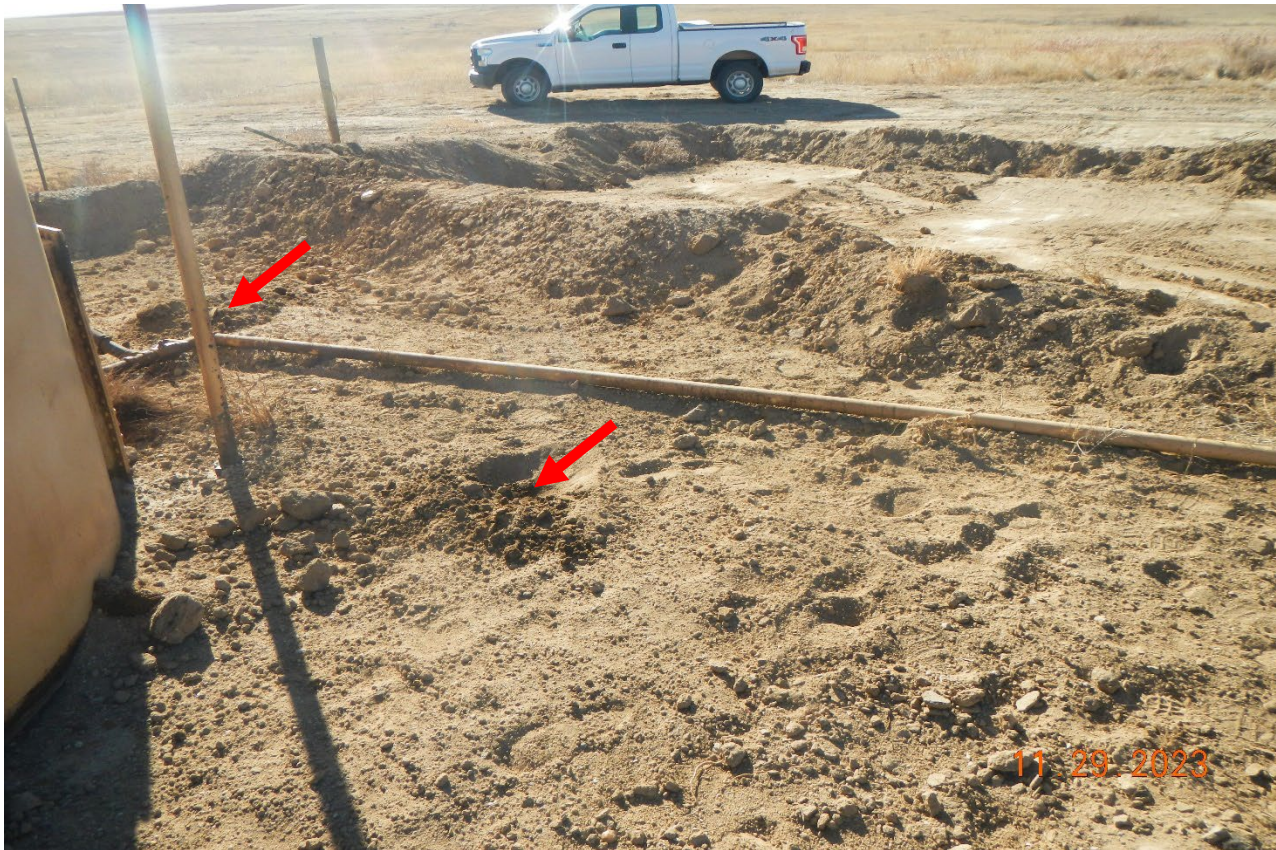
**Photo 13.** Facing back at the spill area where fresh dirt was spread over the spilled area of oil stained soils. Red arrows show the stained soils that uncovered the dirt laced over the spill area.
