Inspection Photos

API: 061-06394

Operator: STRACHAN EXPLORATION INC

Inspection Date: 11/29/2023

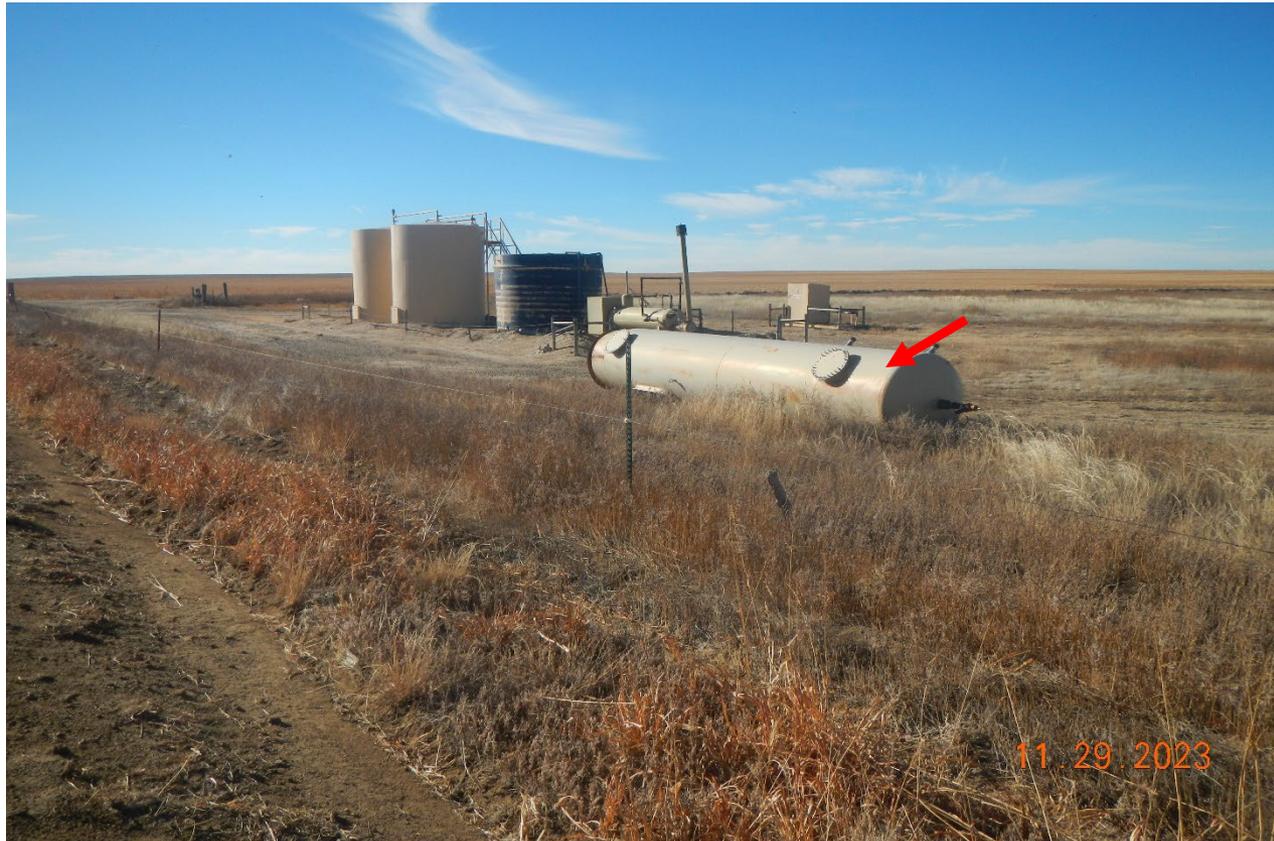
Photo 1. Facing toward the offsite tank battery location. This tank at red arrow is not in use and needs to be removed. Previous corrective action was not completed.

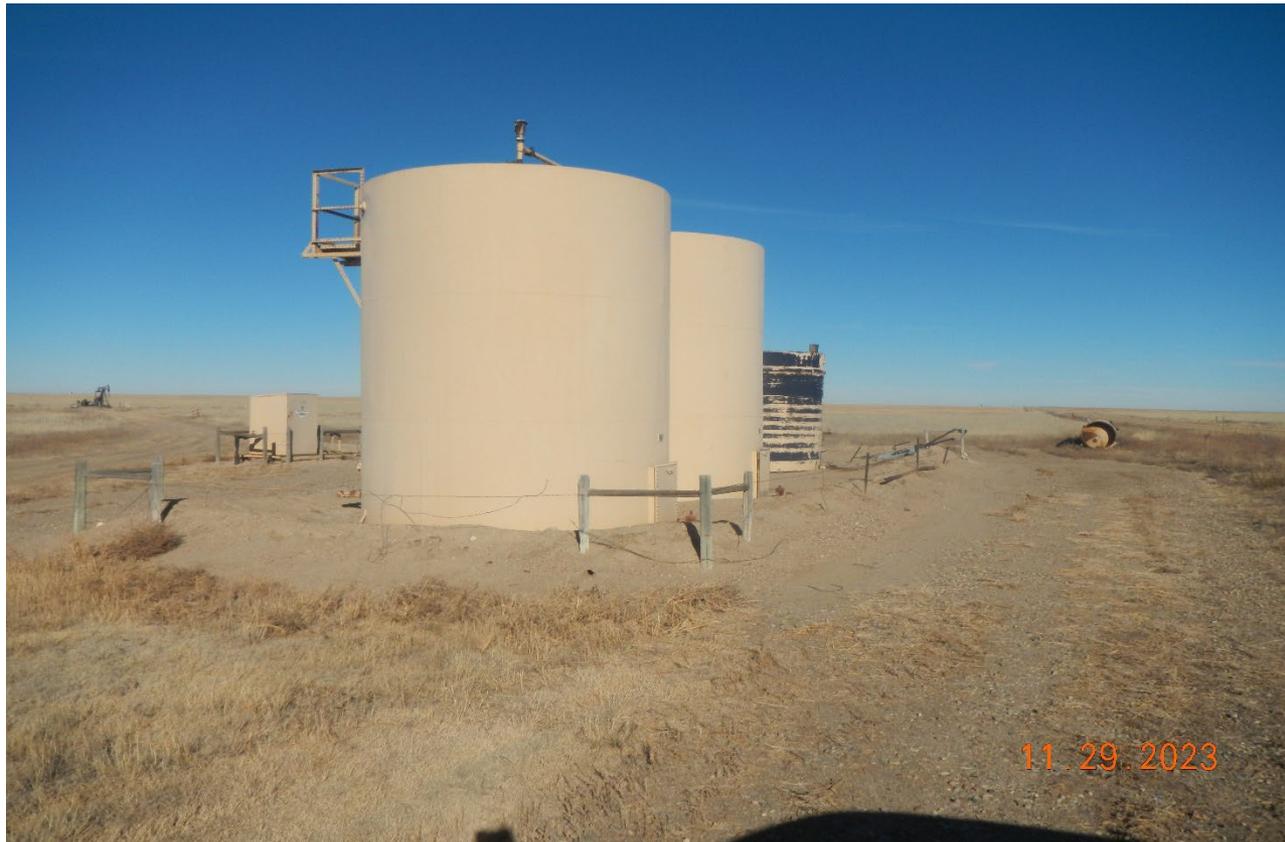
Photo 2. The fence around the tank is inadequate to prevent livestock entry and is not maintained. The berm around the tank is insufficient to contain a spill (150% of tank capacity) and has animal burrows the sides. Previous corrective action was not completed.

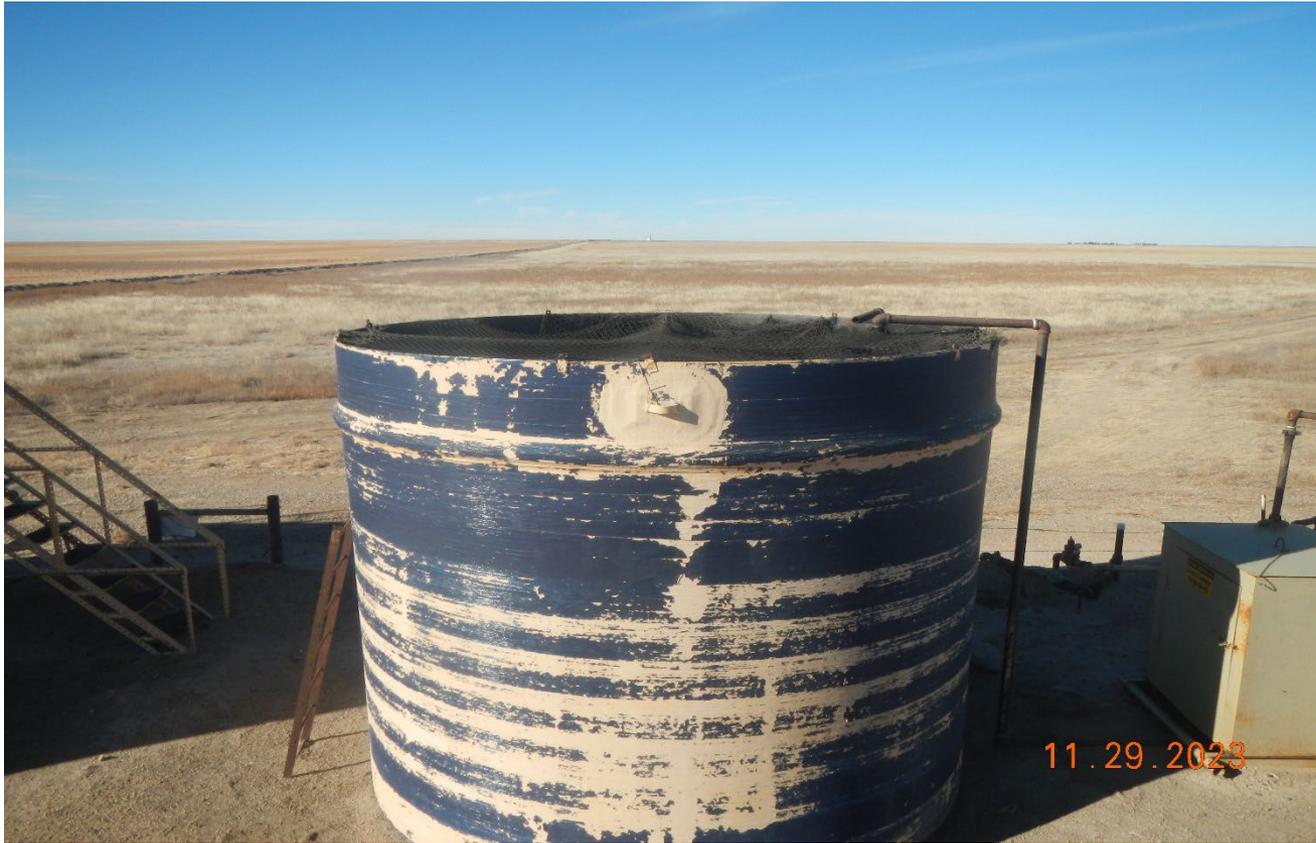
Photo 3. Netting was installed on the open top tank.

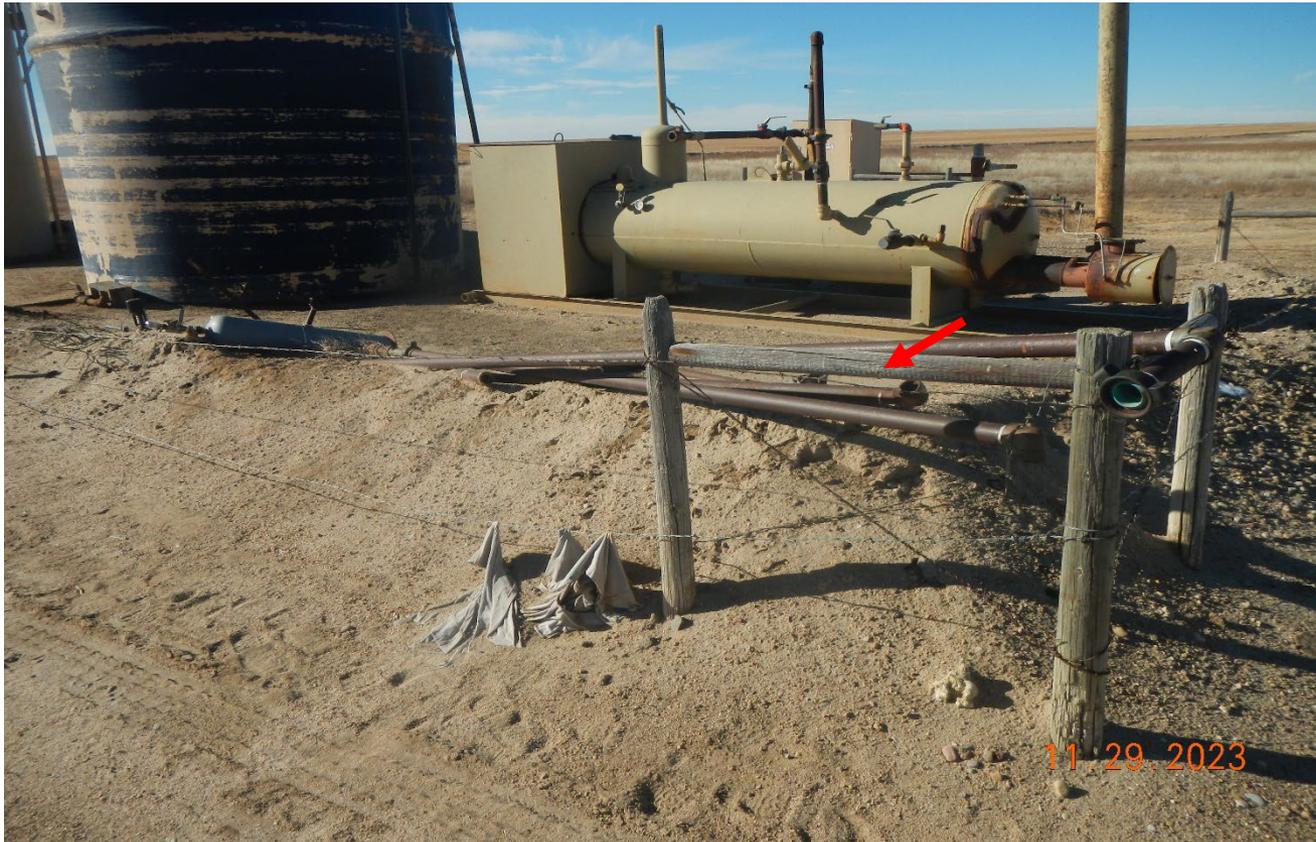
Photo 4. There is unused disconnected pipe that needs to be removed.

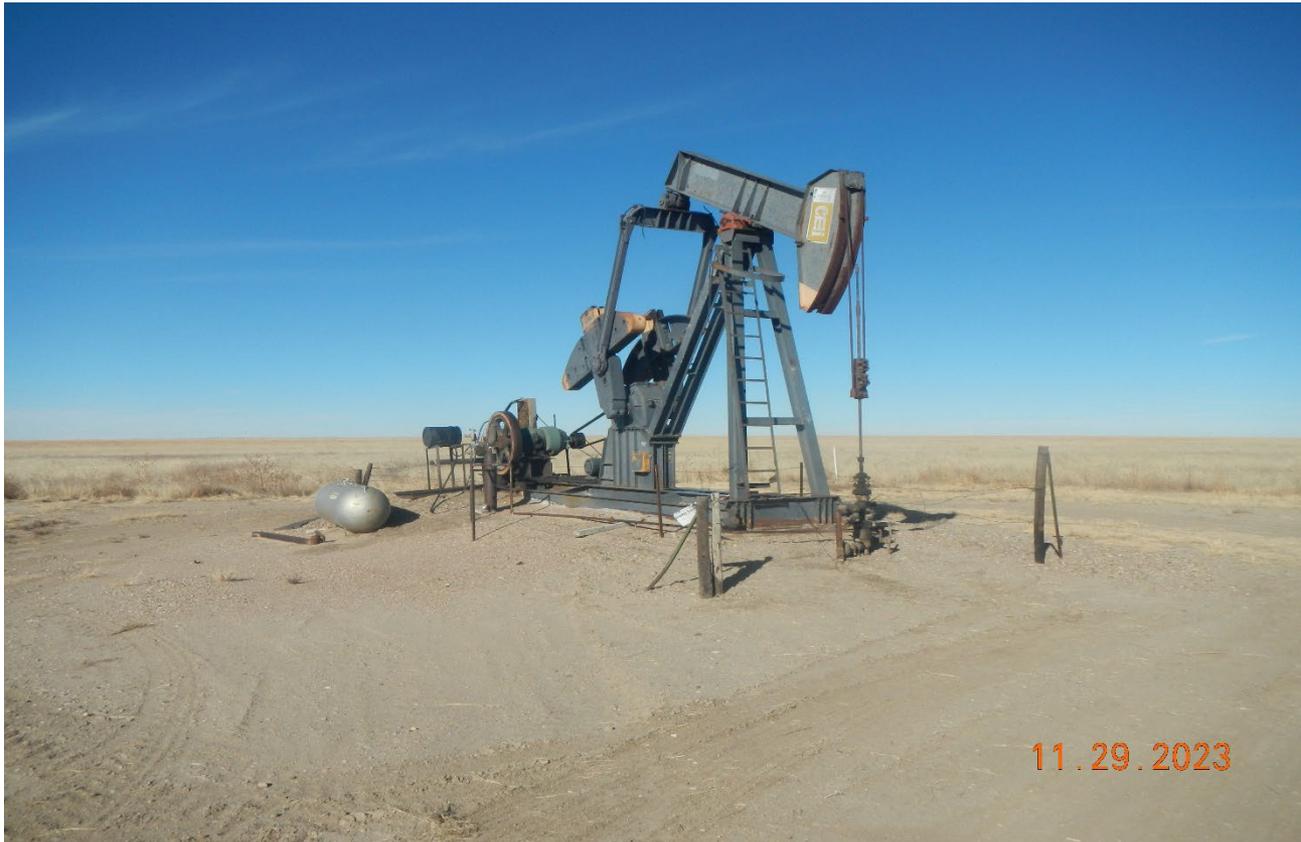
Photo 5. Facing northwest toward the wellsite.

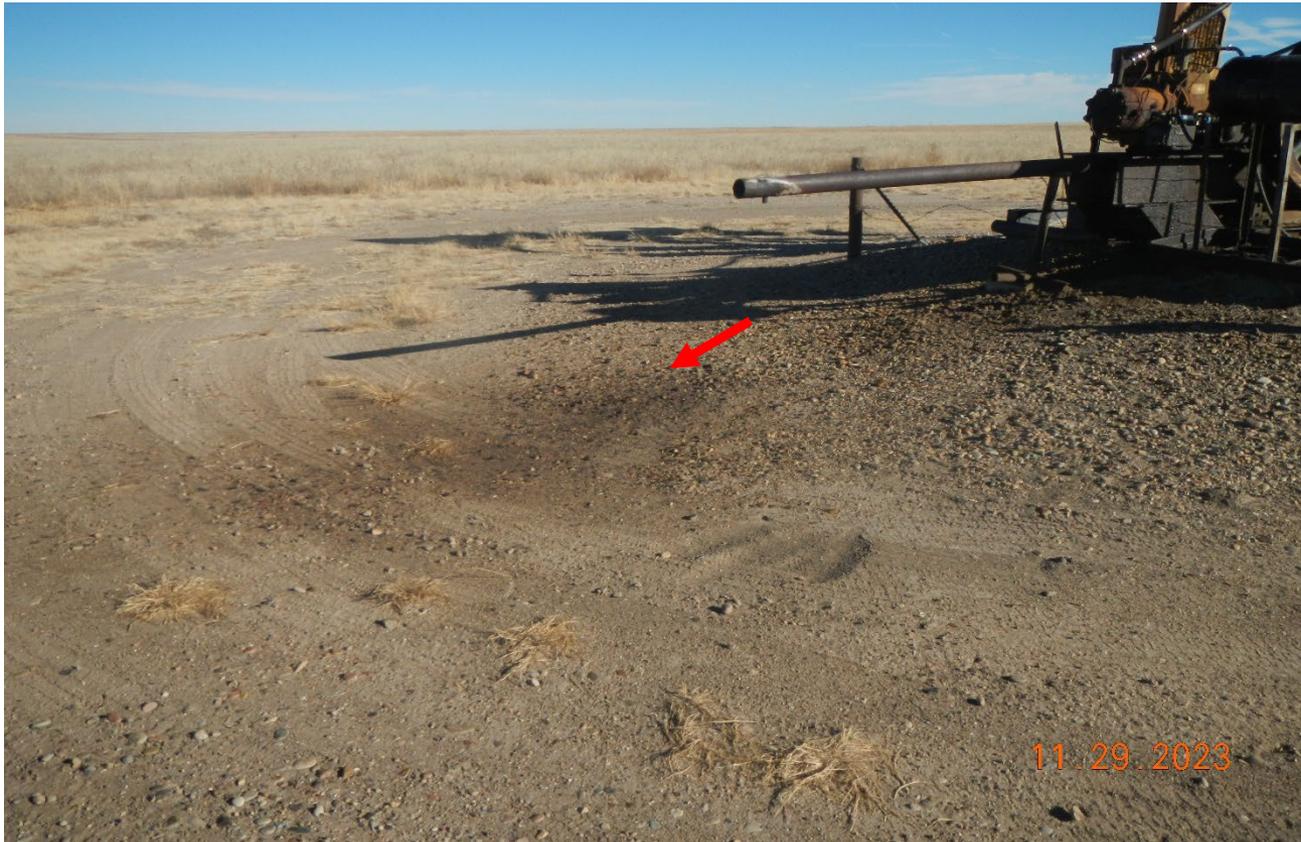
Photo 6. There is stained soils where exhaust is being blown on to the ground.

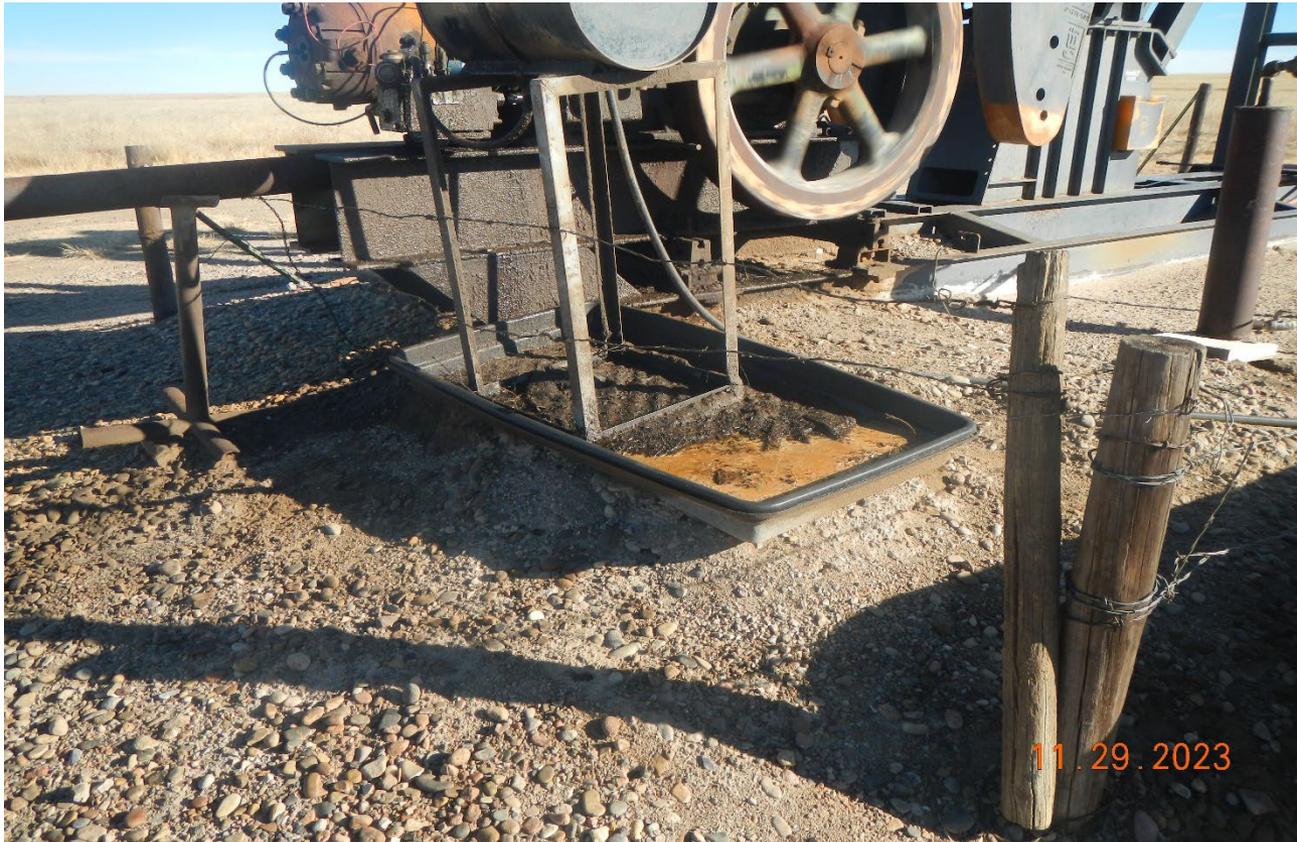
Photo 7. There is oily fluid in the containment next to the pump jack. Oily fluid has spilled onto the ground and needs to be cleaned up. Previous corrective action was not completed.
