Inspection Photos

API: 061-06271

Operator: SAMSON OIL COMPANY

Inspection Date: 11/29/2023

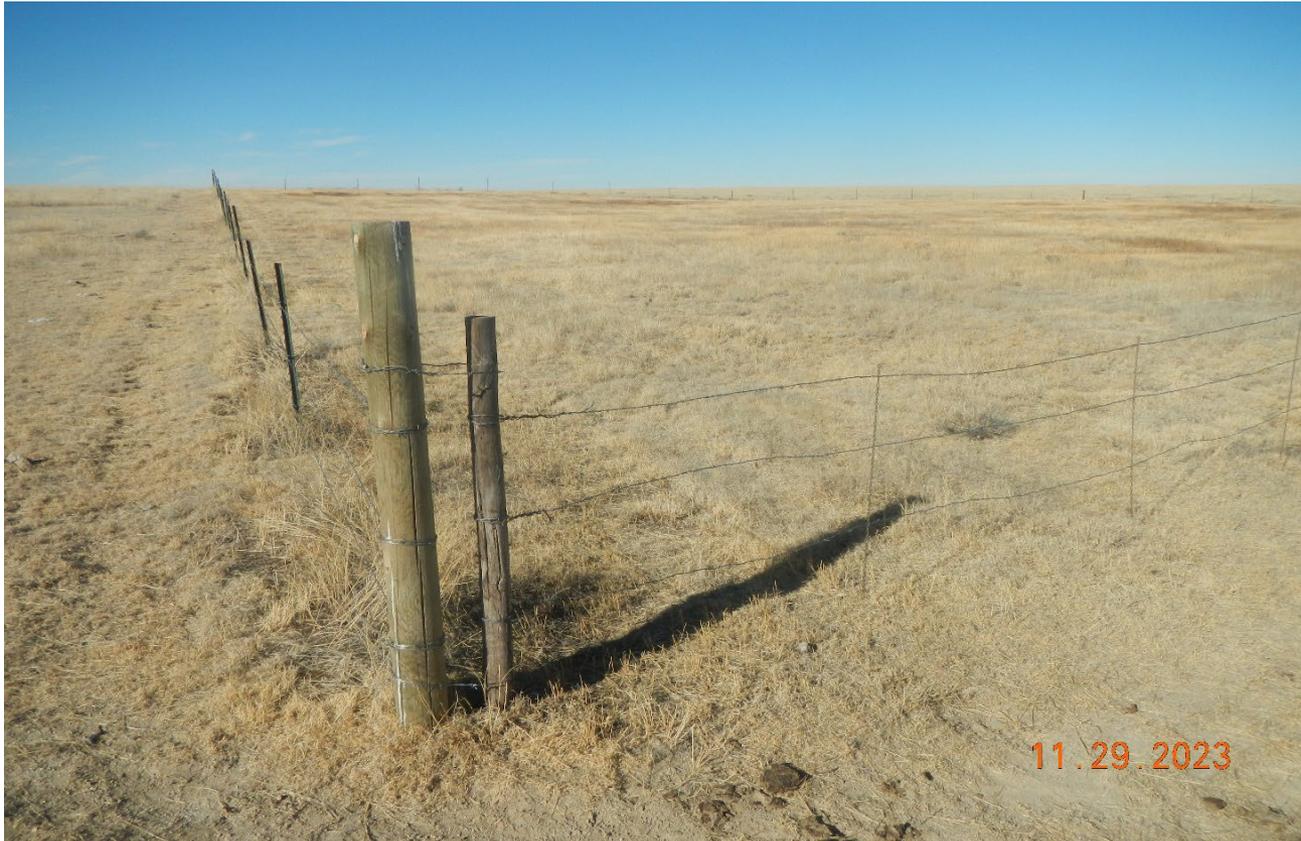
Photo 1. Facing west toward the fenced location. The location has been mowed.

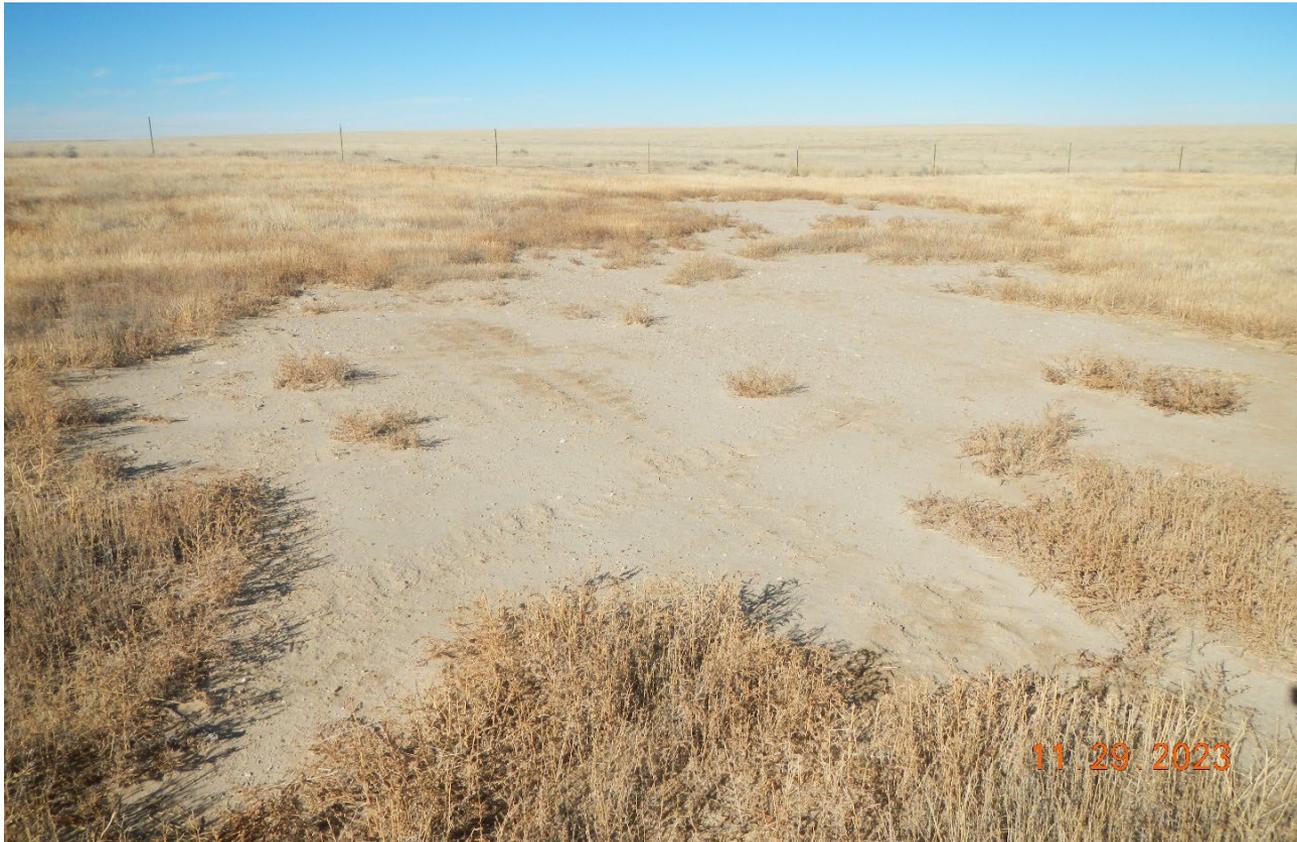
Photo 2. Center of the location facing northwest. This area has no vegetation growth which indicates impacted soils.

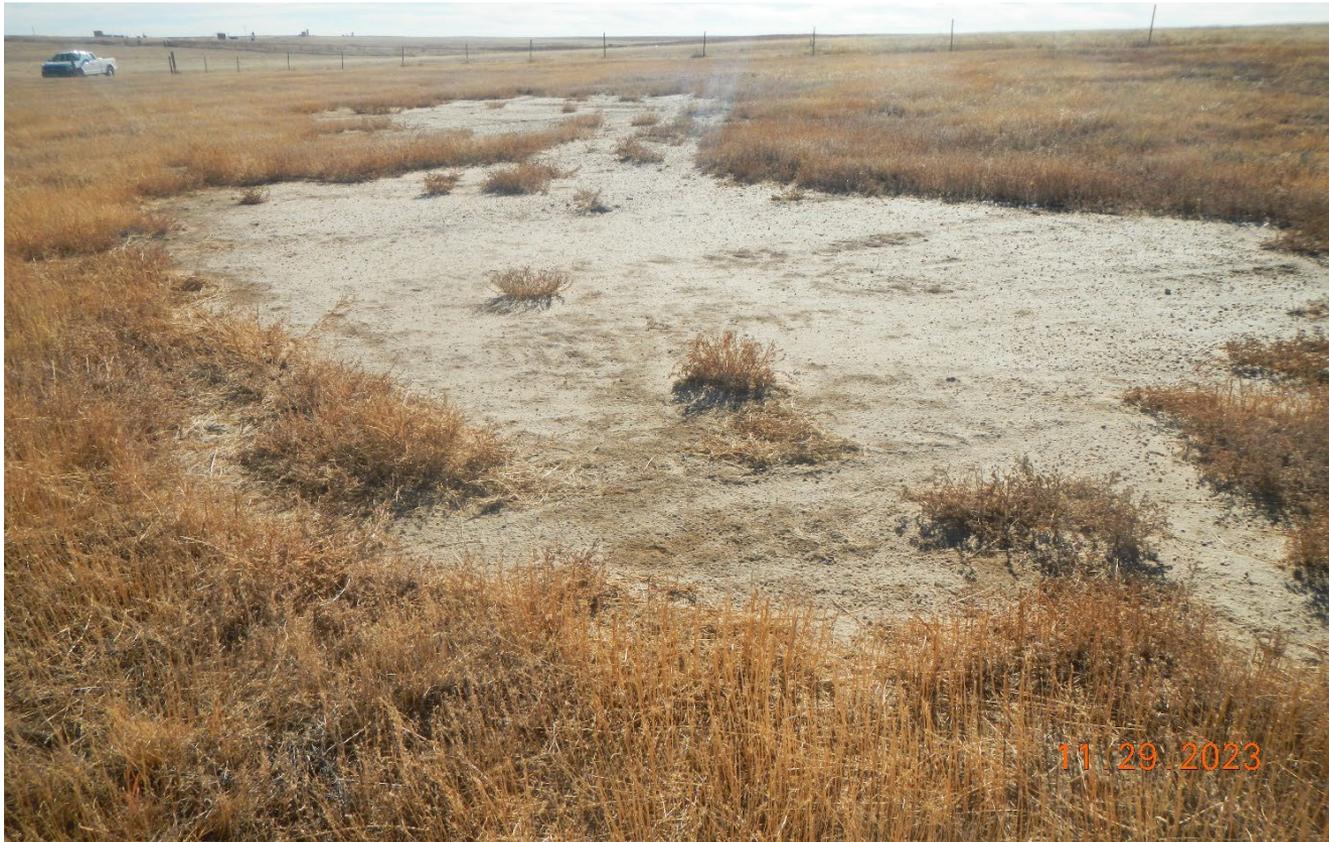
Photo 3. Facing southeast at the location. This area has no vegetation growth which indicates impacted soils.

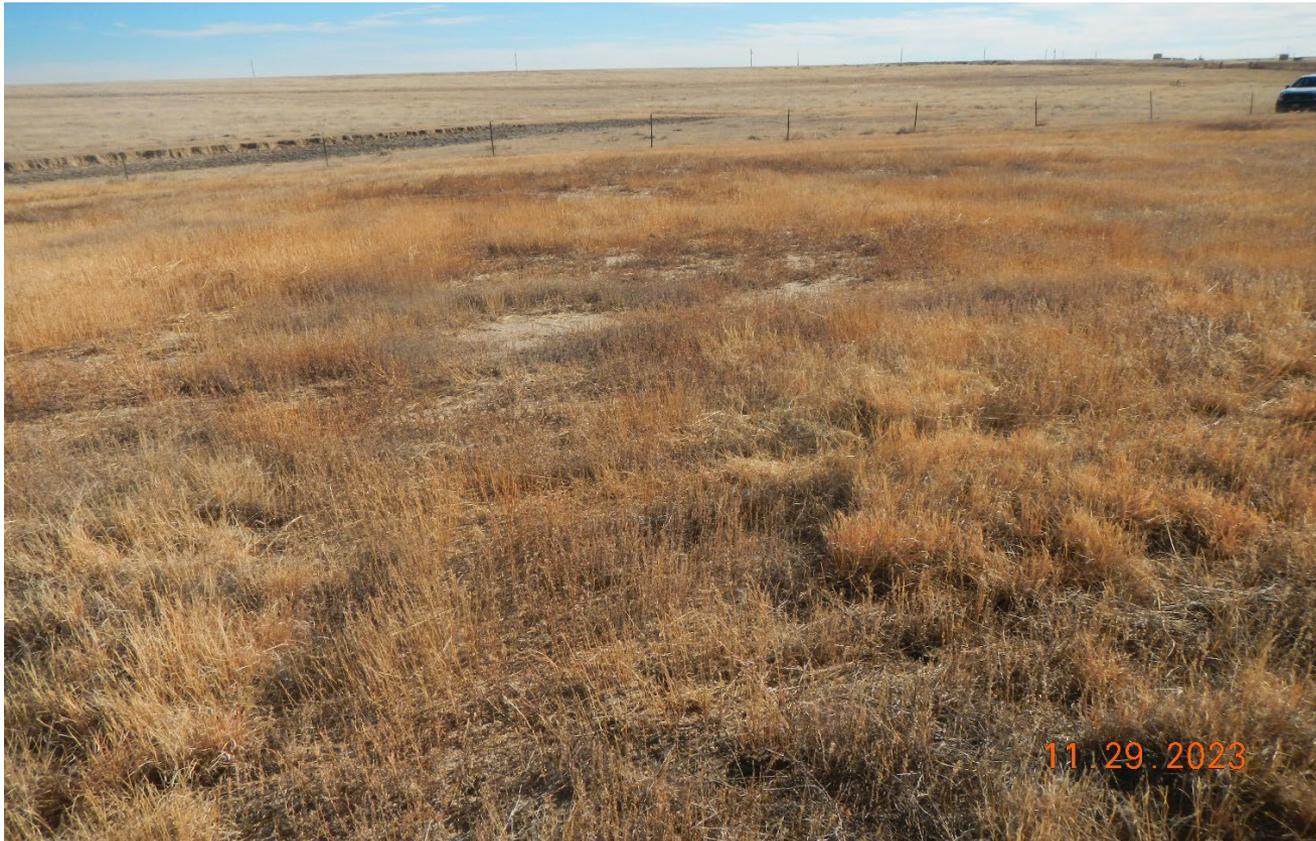
Photo 4. Center of the location facing east. There are undesirable weeds throughout most of the location. The vegetation has been mowed but further weed control will need to be conducted.

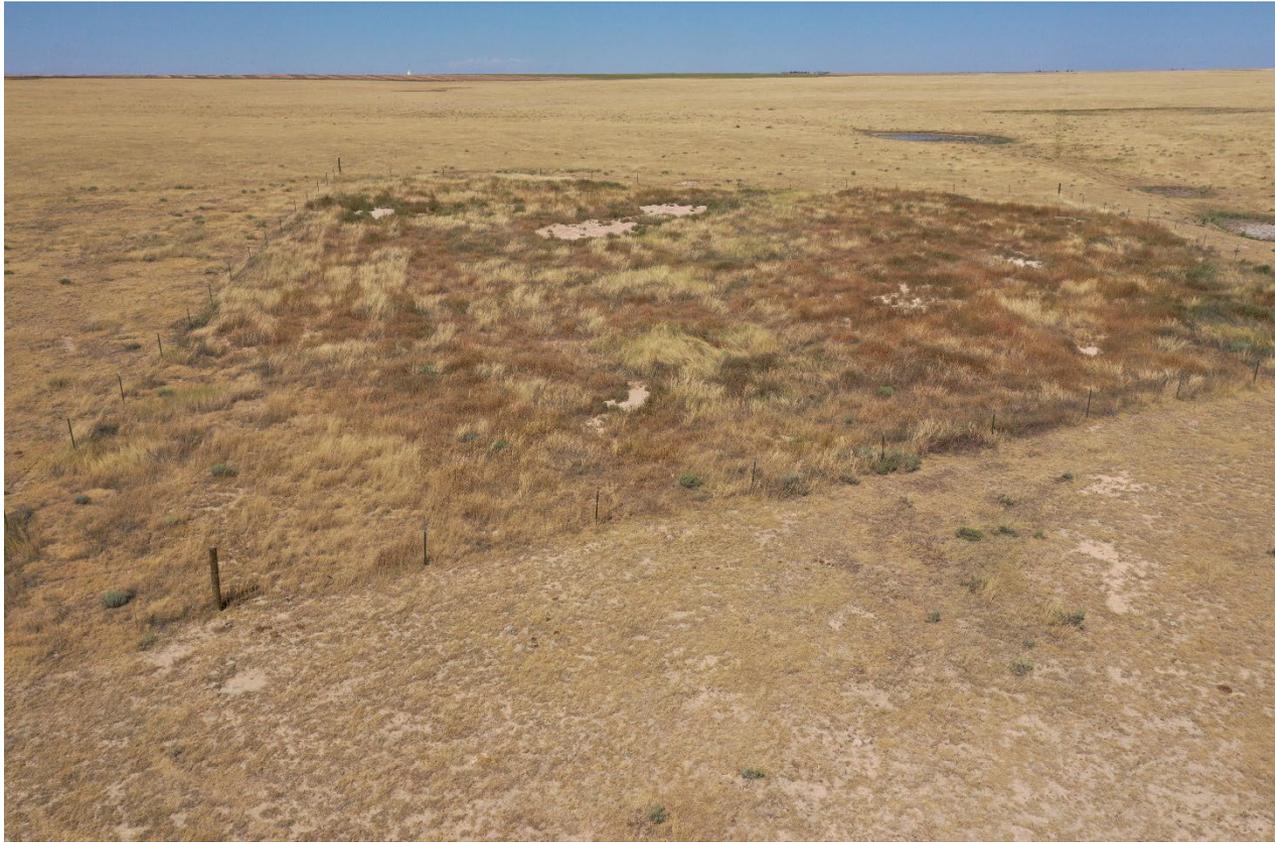
Photo 5. Drone aerial photo facing west toward the location. Taken 8/24/2023

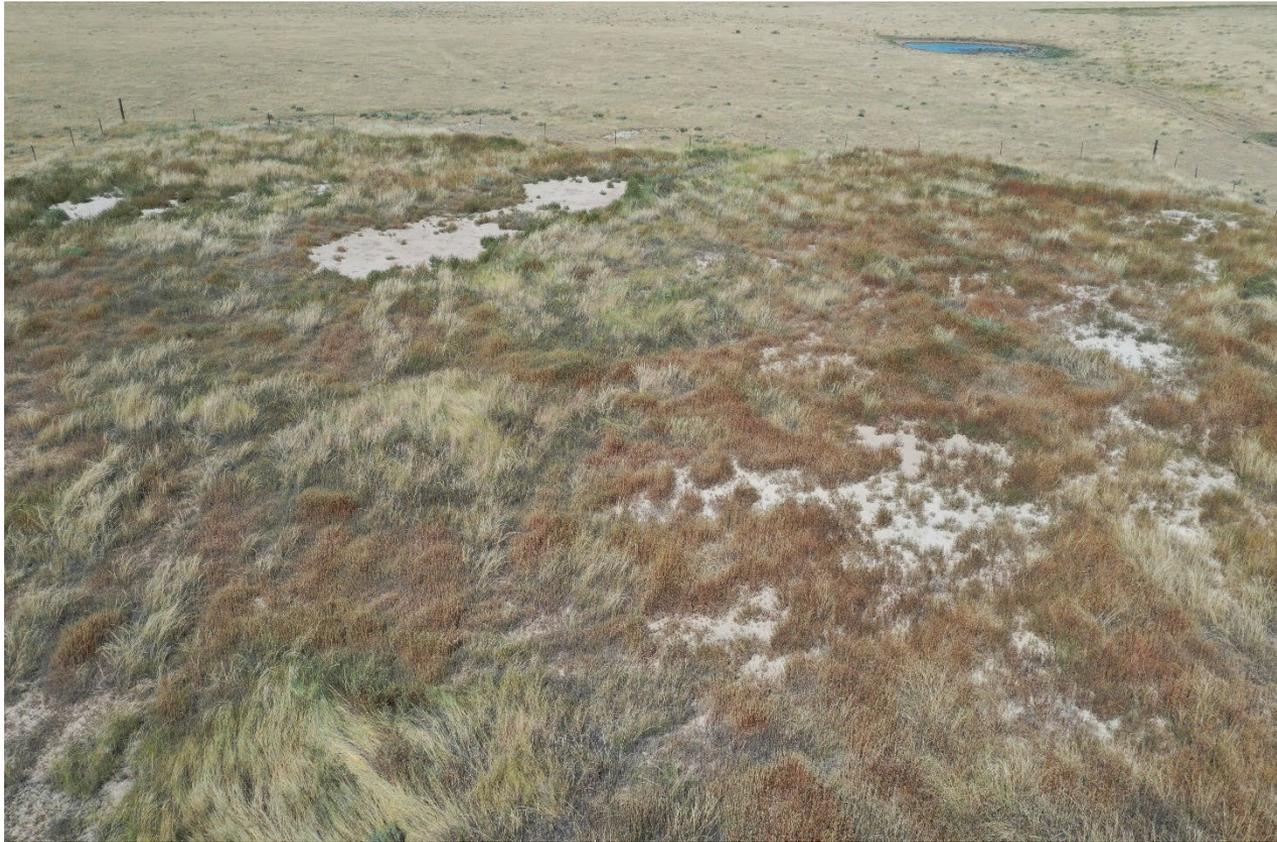
Photo 6. Drone aerial photo facing west down toward the location. The reddish brown vegetation is undesirable weeds (Kochia). The desirable vegetation has not re-established and there are bare areas with no vegetation.

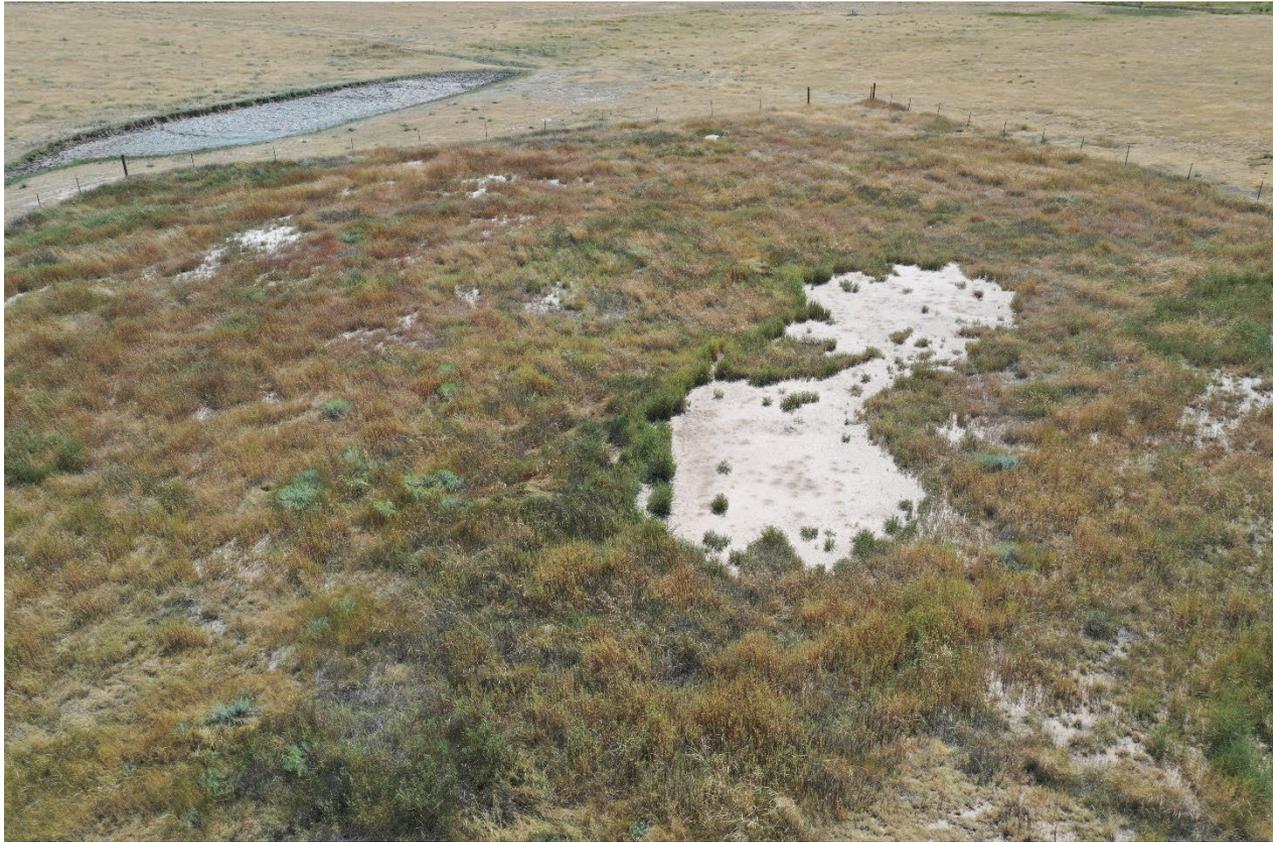
Photo 7. Drone aerial photo facing east down toward the location. The reddish brown vegetation is undesirable weeds (Kochia). The desirable vegetation has not re-established and there are bare areas with no vegetation. The bare area appears to be impacted soil from the wellsite. Taken 8/24/2023
