# Inspection Photos

API: 061-06366

Operator: SAMSON OIL COMPANY

Inspection Date: 8/24/2023

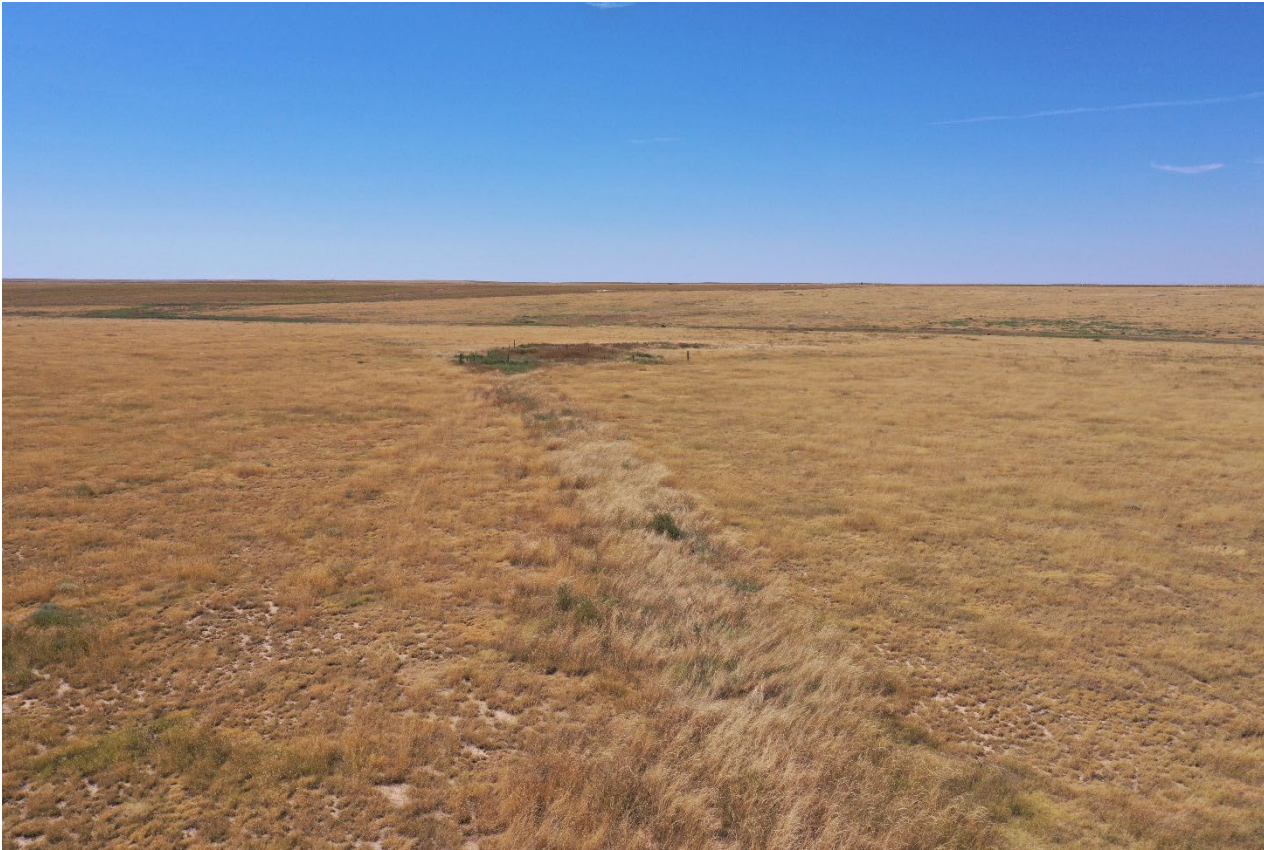
**Photo 1.** Drone aerial photo facing south toward the former access road and location. The perennial vegetation along the access road has re-established.

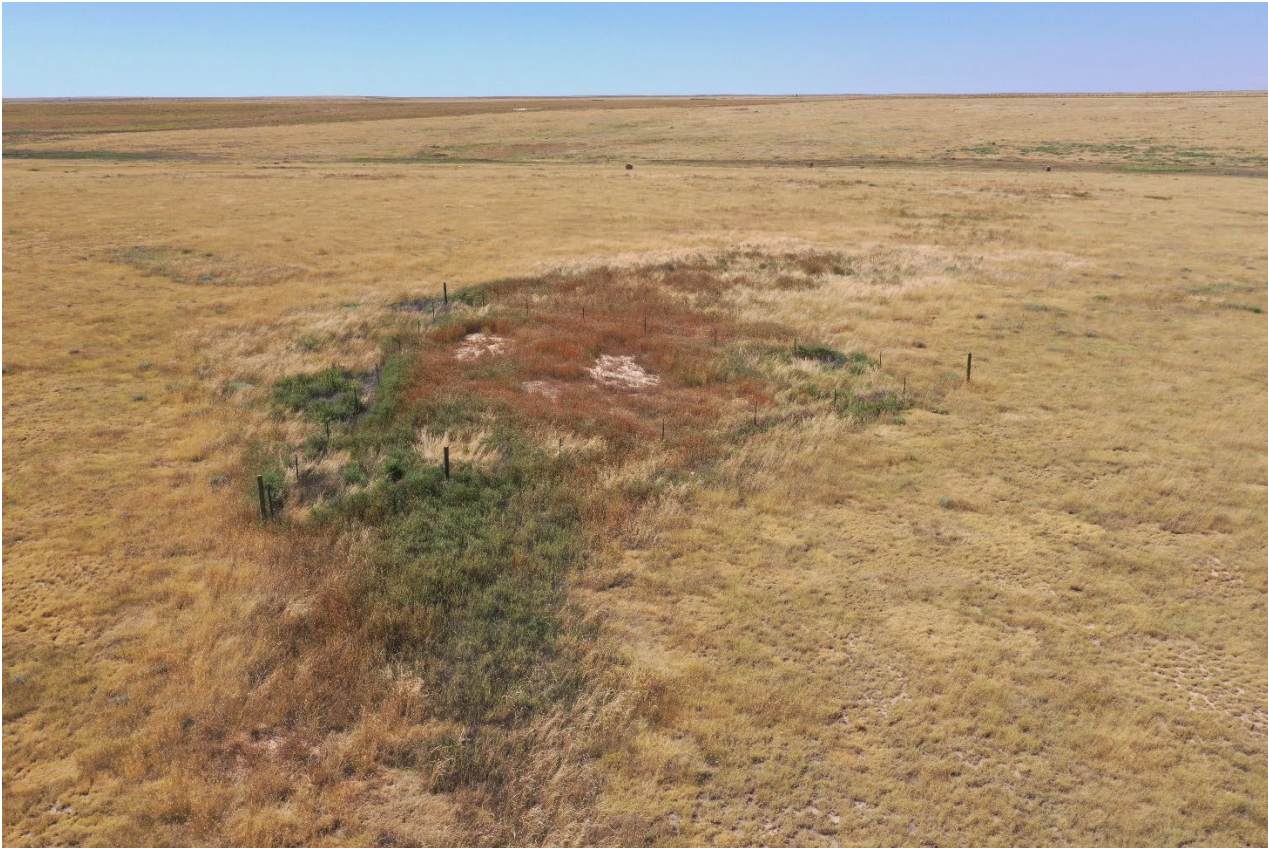
**Photo 2.** Drone aerial photo facing south toward the location. The green and reddish vegetation is undesirable weeds (Kochia) The desirable vegetation has not re-established.

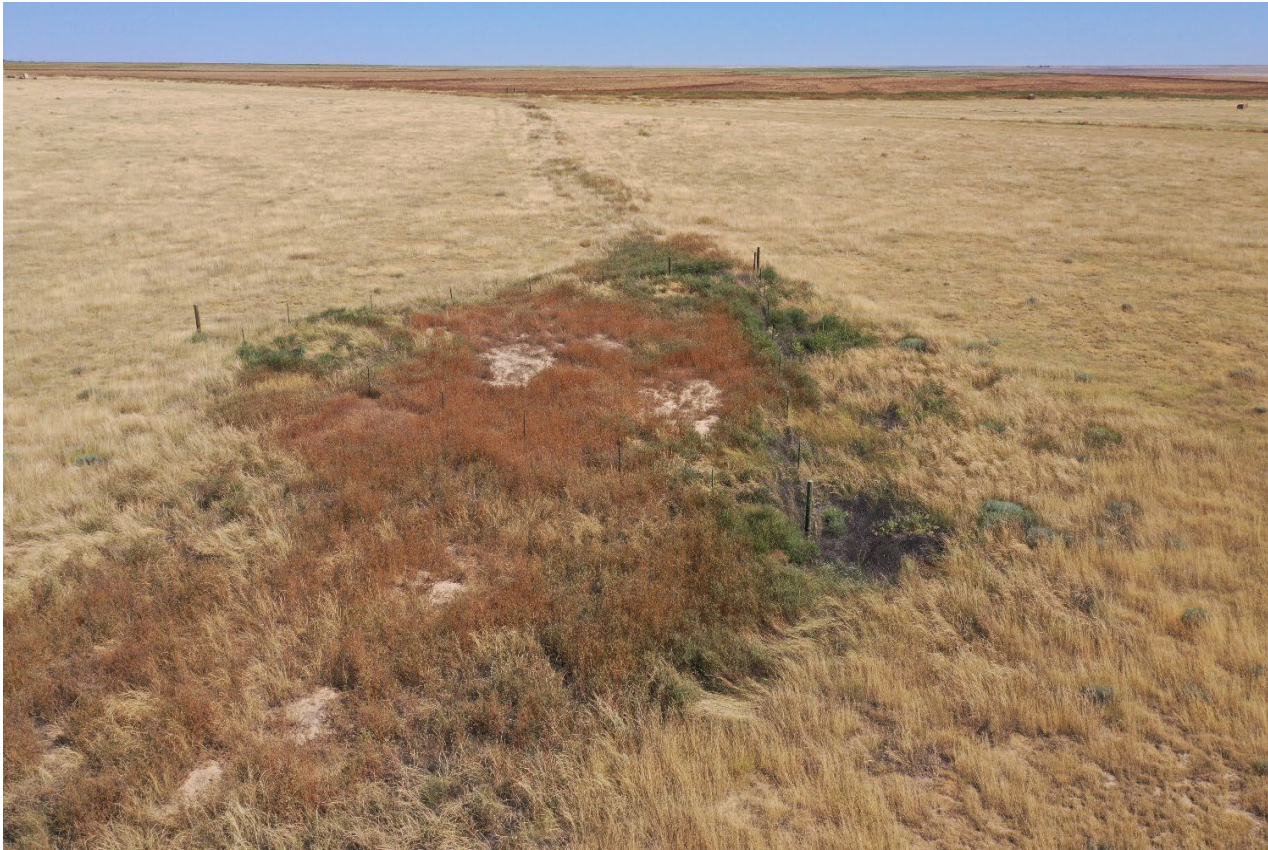
**Photo 3.** Drone aerial photo facing north toward the location. The green and reddish vegetation is undesirable weeds (Kochia) The desirable vegetation has not re-established.

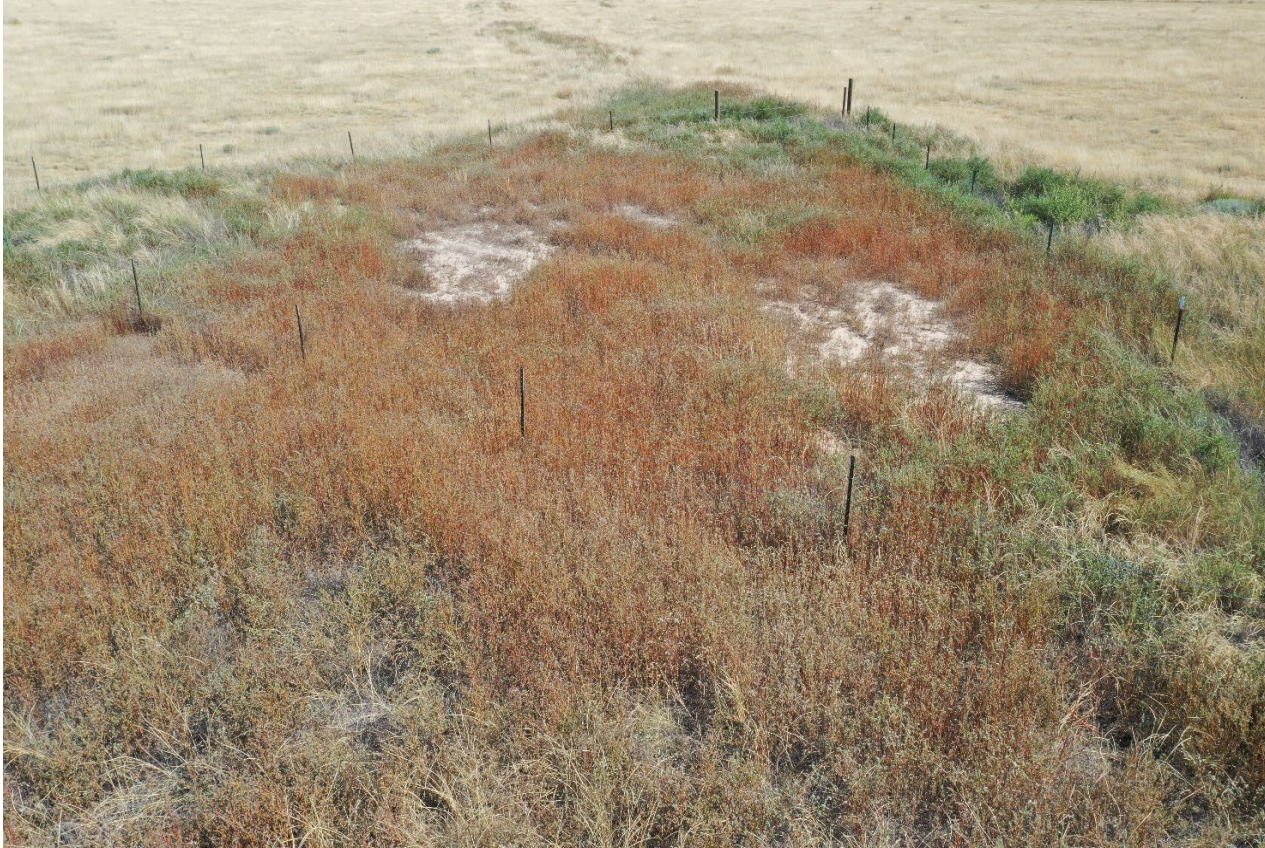
**Photo 4.** Closer view of the location and tall undesirable weeds (Kochia) which needs to be controlled. The fence installed does not completely surround the entire location.
