Inspection Photos
Location Name: UPRR_HABEL_1-35
Location ID: 319728

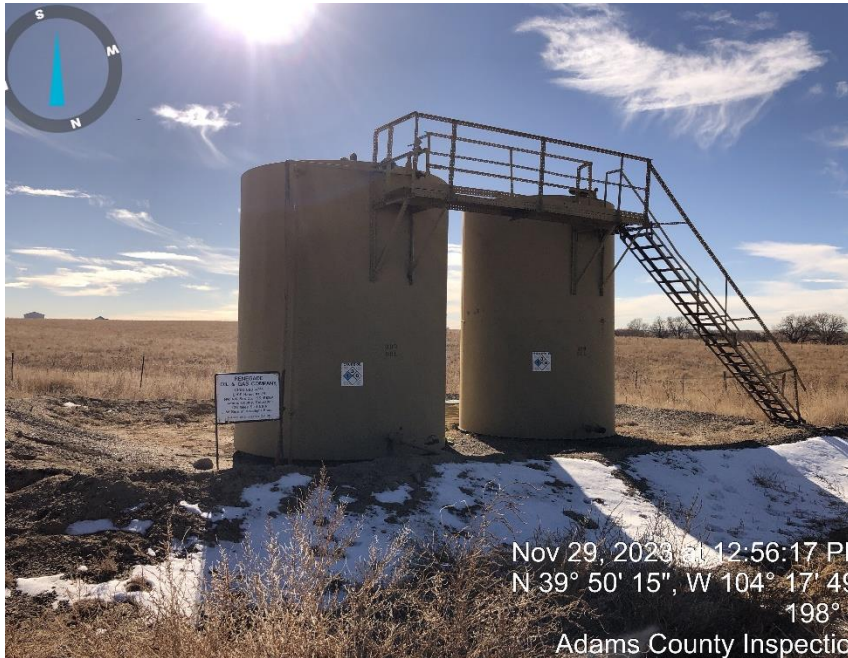
Photo #1 Tanks.

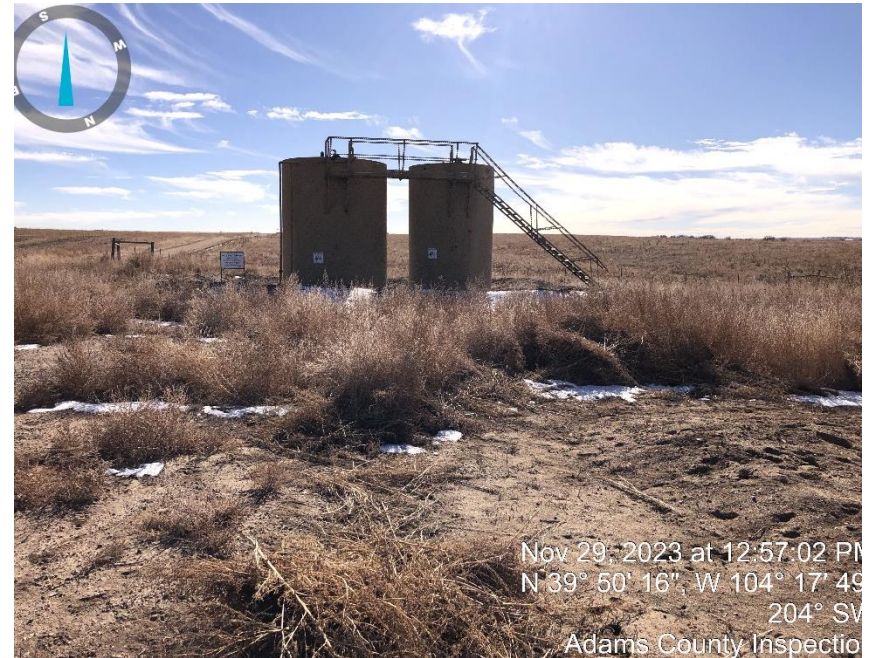
Photo #2 Weeds throughout location.

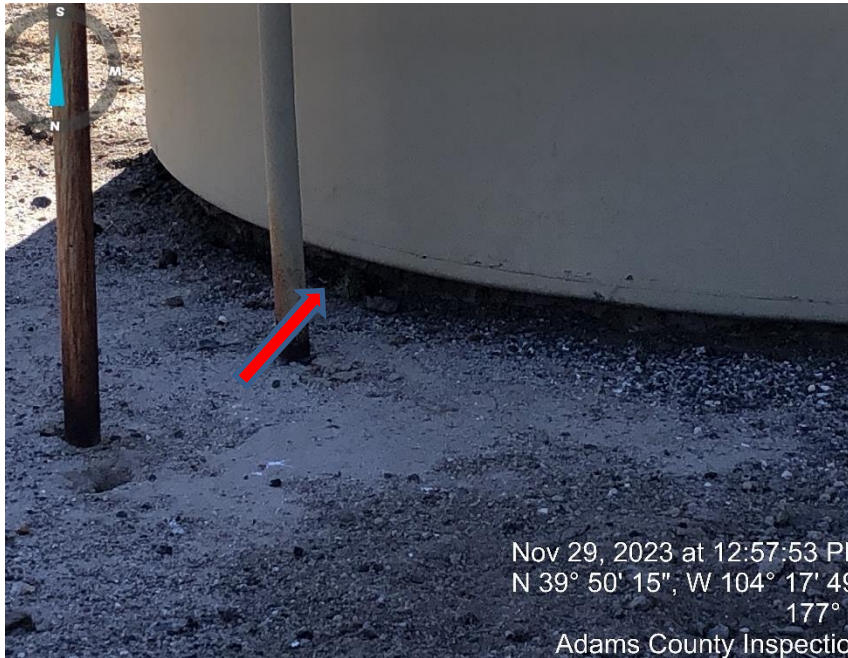
Photo #3 Berm eroded under crude tank.

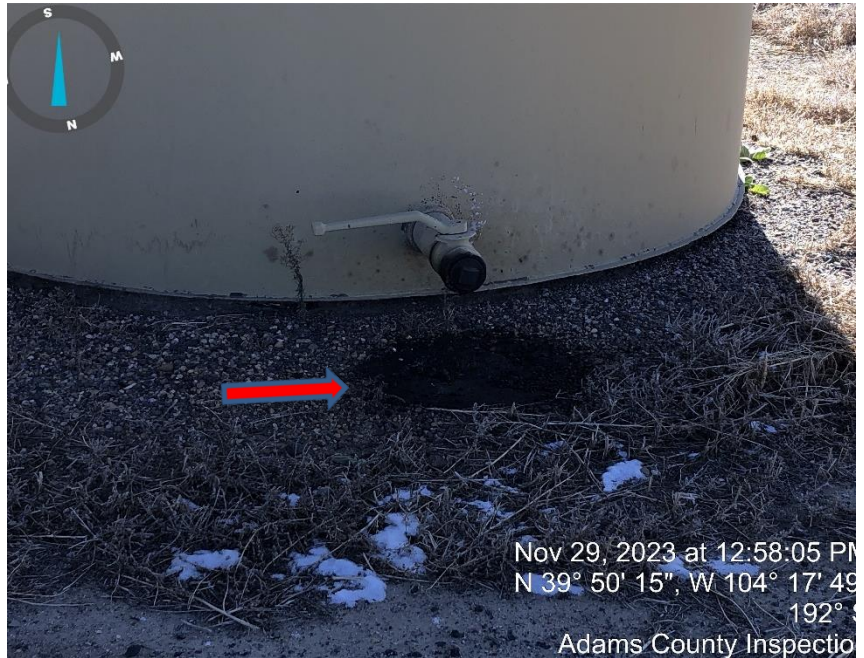
Photo #4 Stained soil.

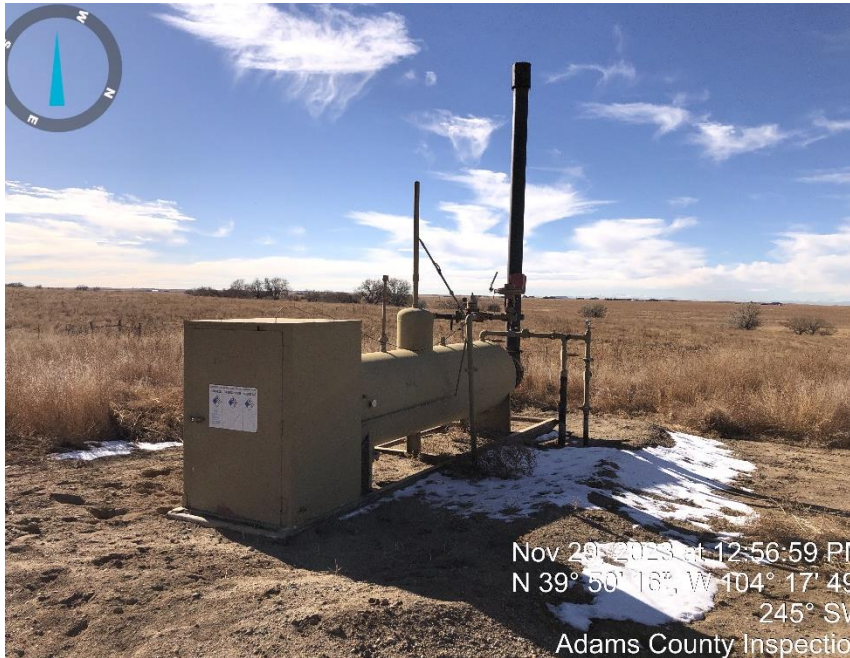
Photo #5 Separator.

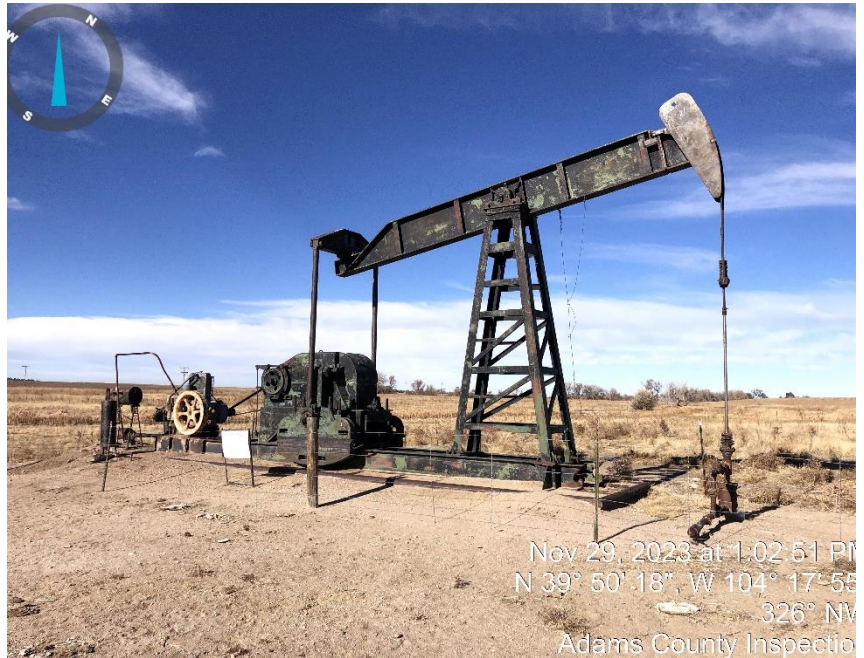
Photo #6 Pump jack.
