## Inspection Photos

Location Name: CAERUS PICEANCE LLC Battlement Mesa 36L-795 Pad

Location ID: 334180

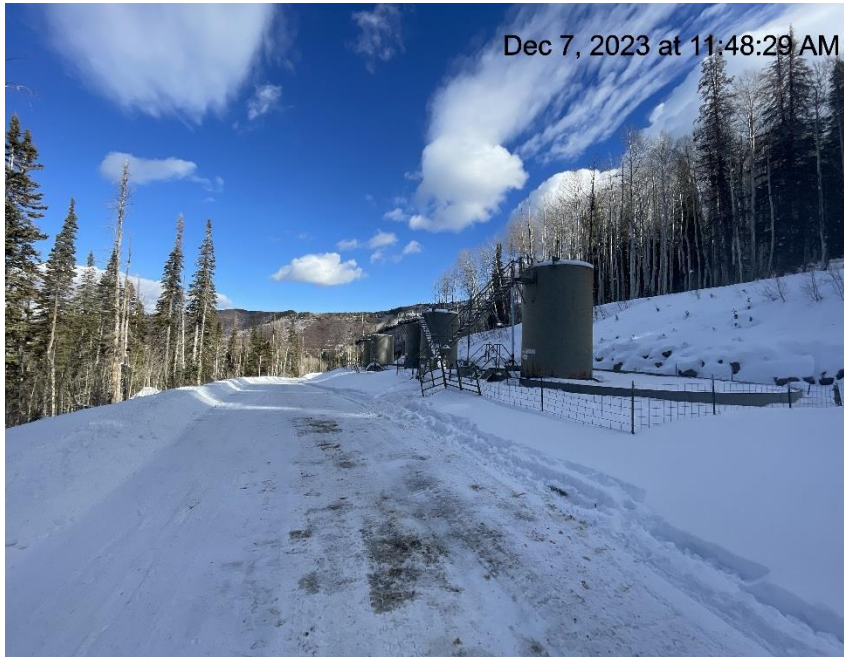
Photo # 8767 From entrance to location

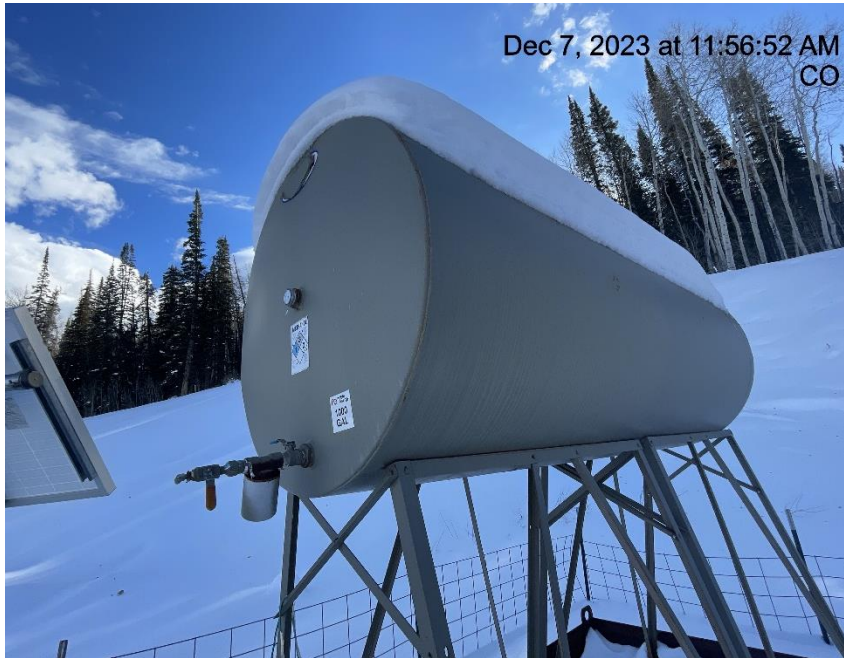
**Photo # 8777 Methanol tank improperly labeled/lacks required information/has inaccurate information**

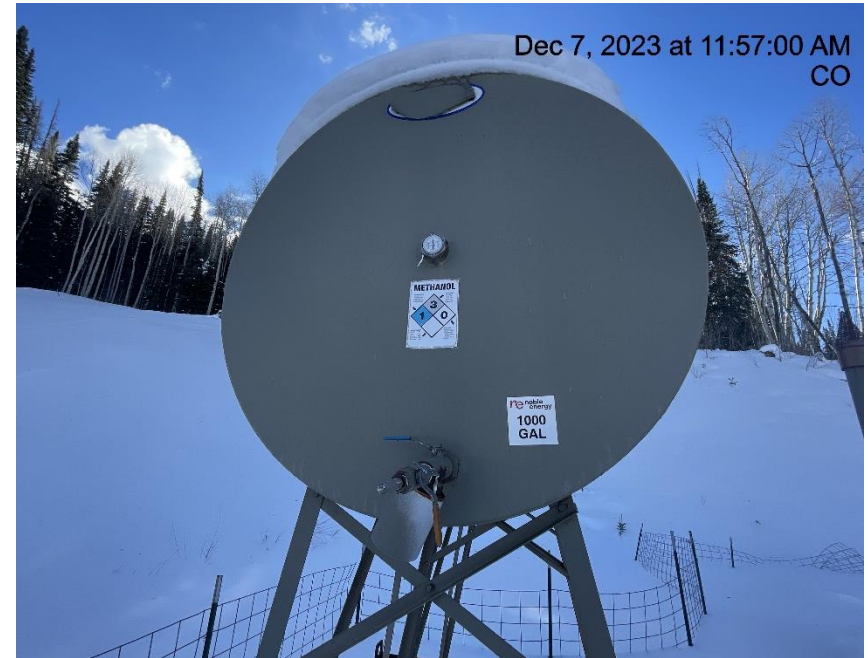
**Photo # 8778 Methanol tank improperly labeled/lacks required information/has inaccurate information**

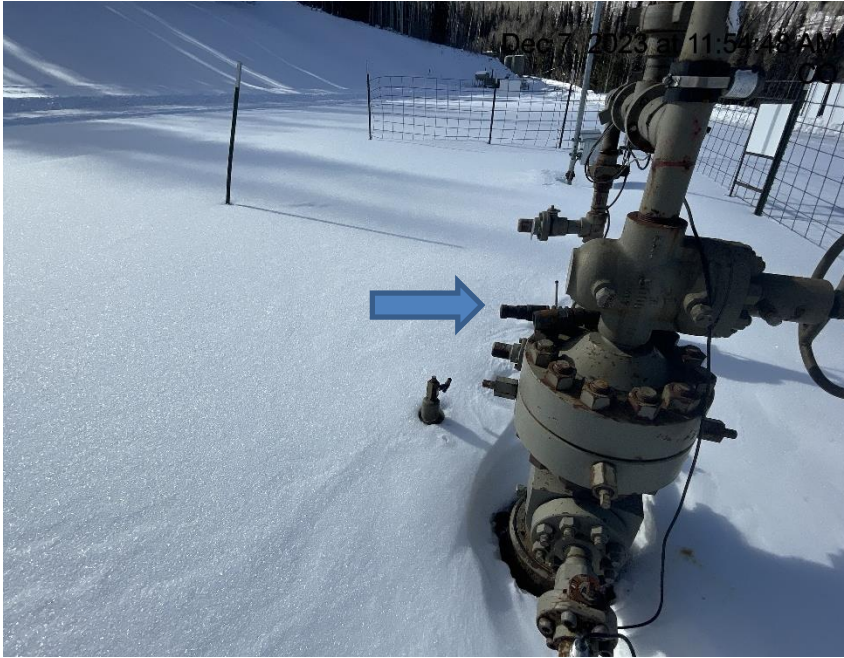
Photo # 8781 Debris

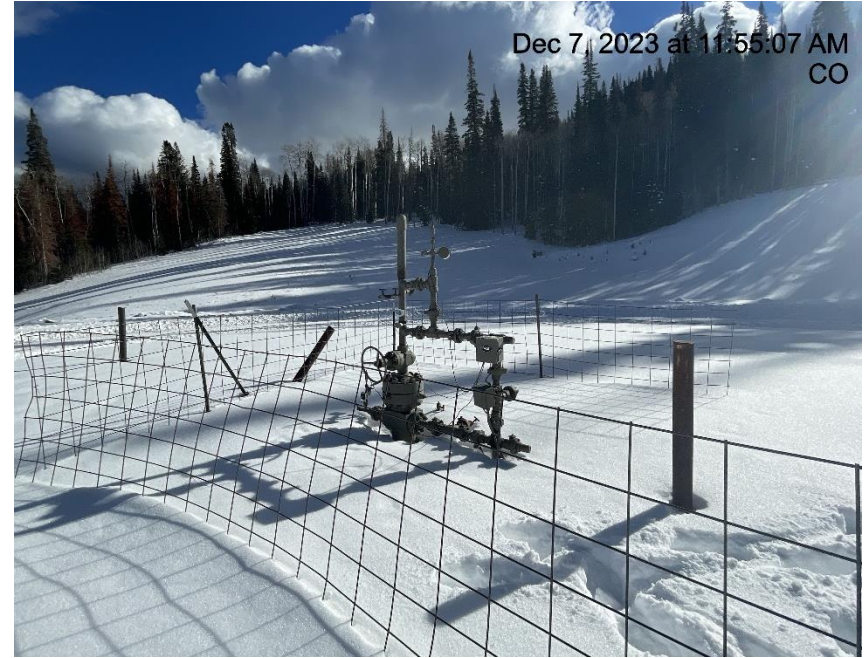
Photo # 8782 Wellhead lacks signage

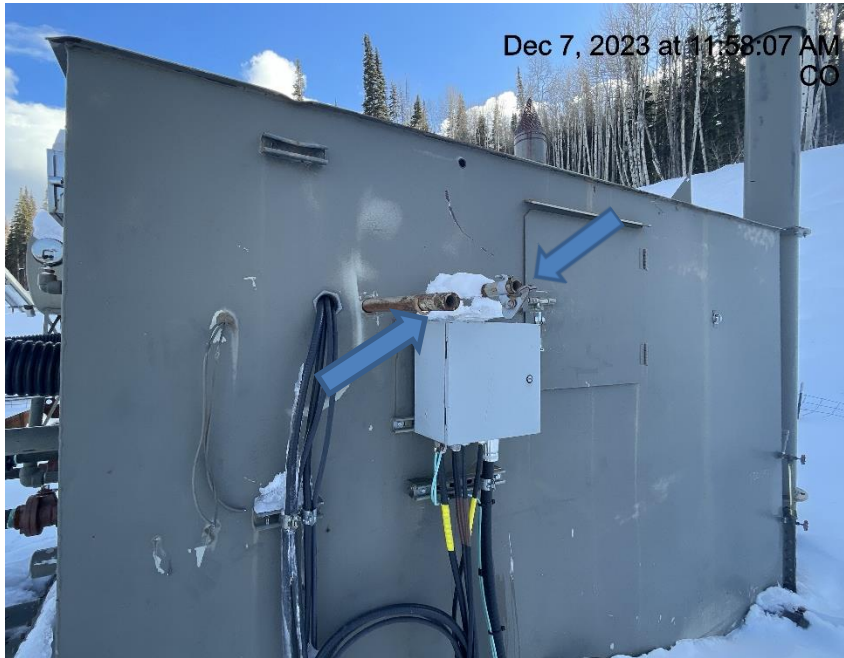
**Photo # 8783 PRV & rupture disc vent lines terminate in an unsafe manner**

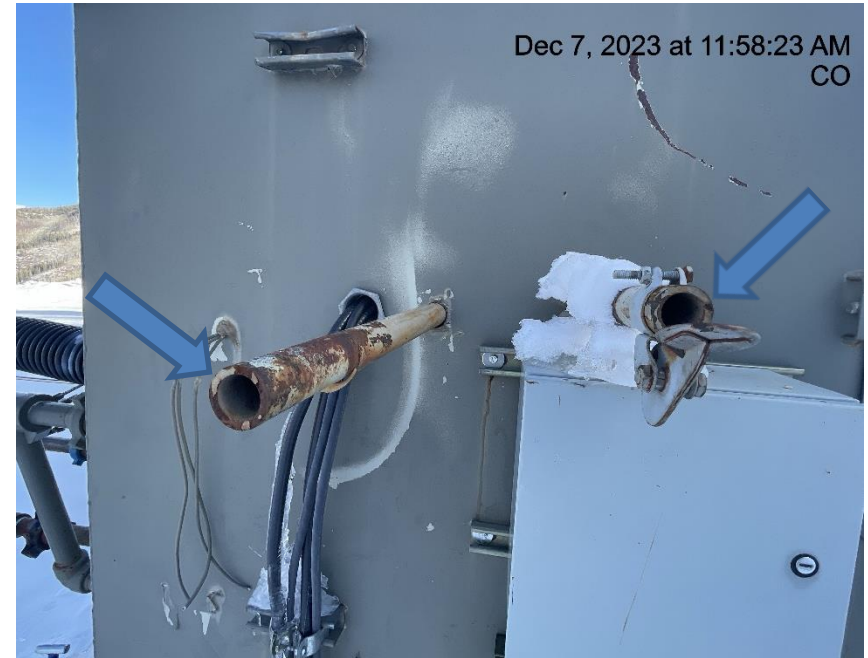
**Photo # 8784 PRV & rupture disc vent lines terminate in an unsafe manner**

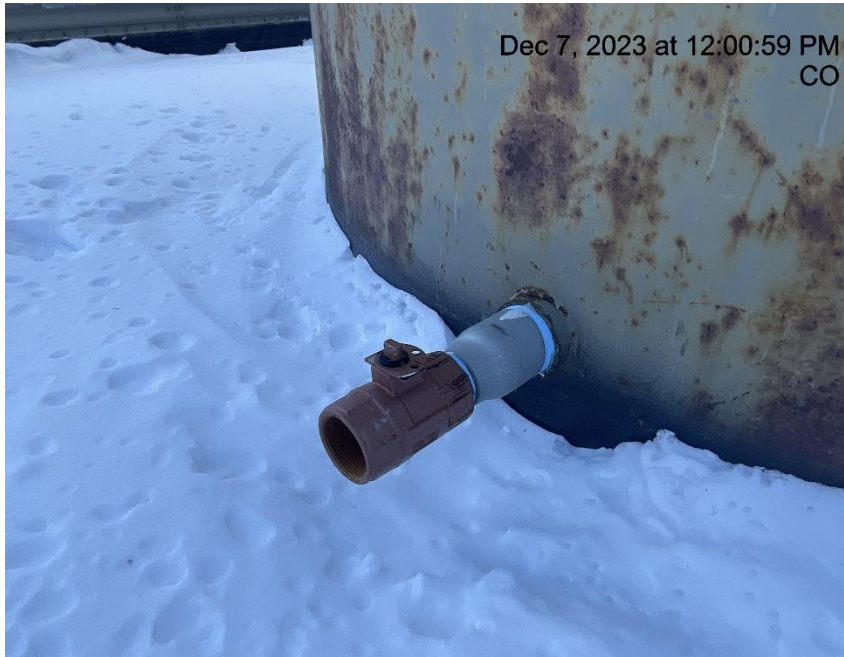
Photo # 8785 Open ended load line

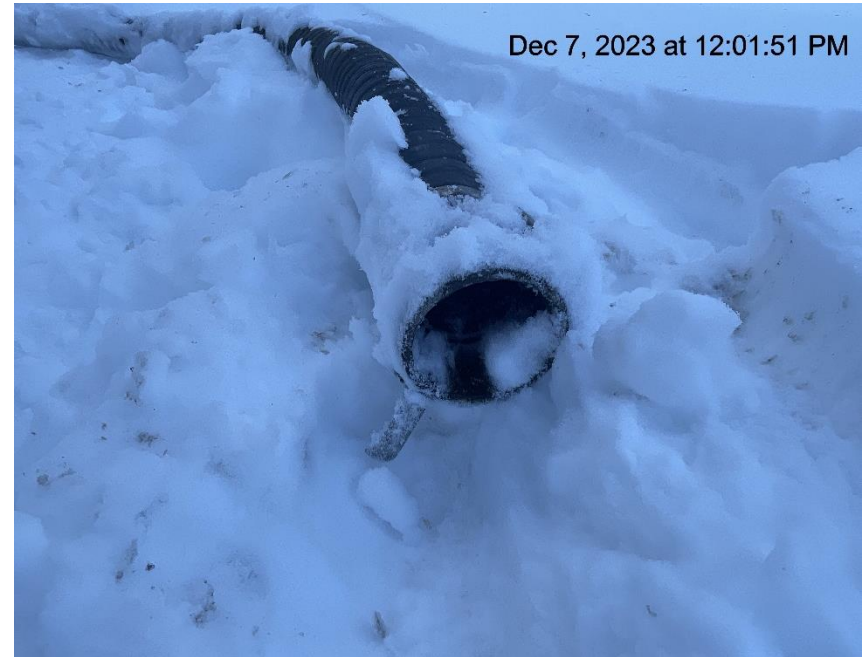
Photo # 8786 Open ended load line
