Storm Water Management and Erosion control
Location Name: TEP ROCKY MOUNTAIN LLC LEVERICH 31-09 Pad
Location ID: 334711

COLORADO
Energy & Carbon Management
Commission
Department of Natural Resources

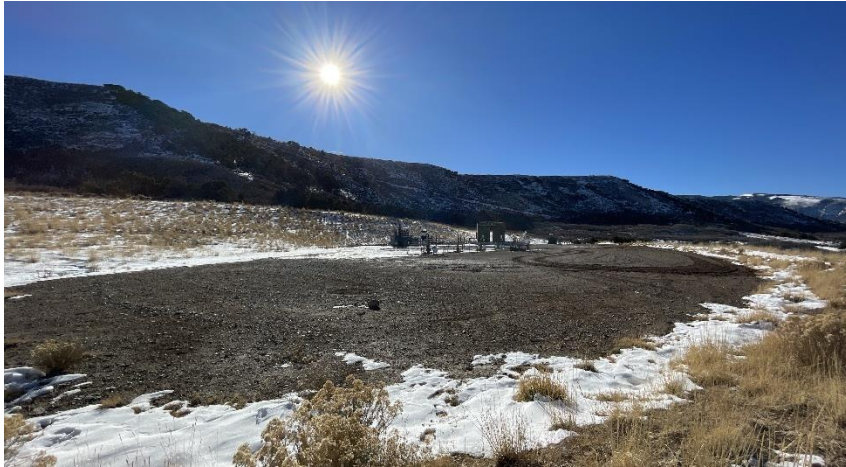
North West corner of location.

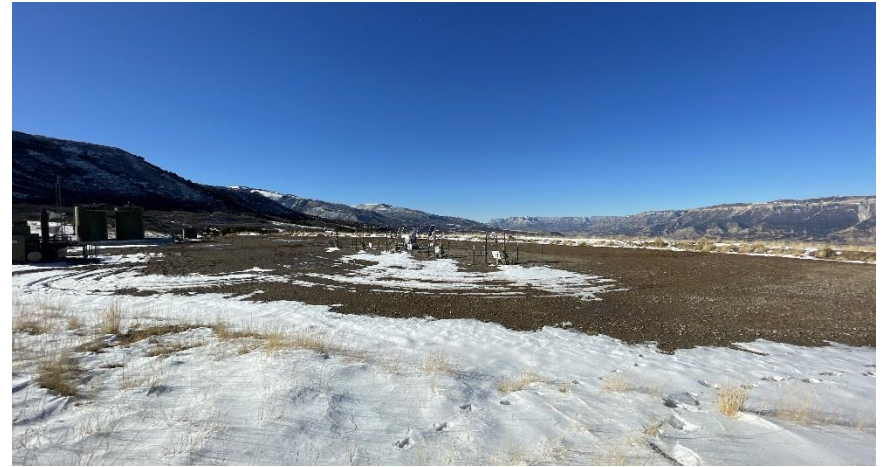
North East corner of location.

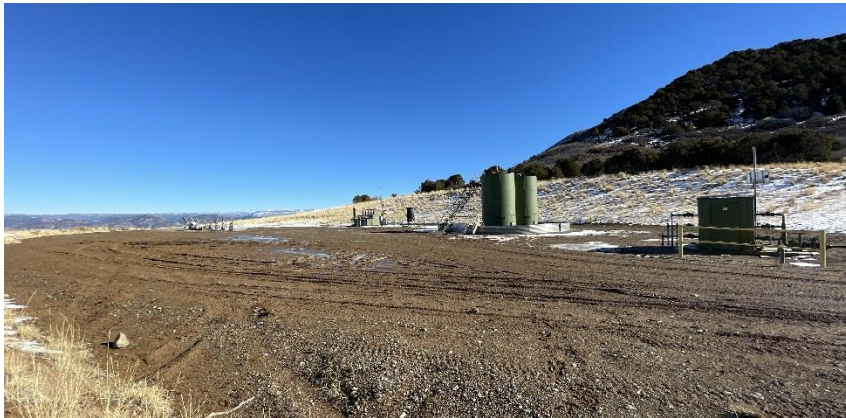
South West corner of location.

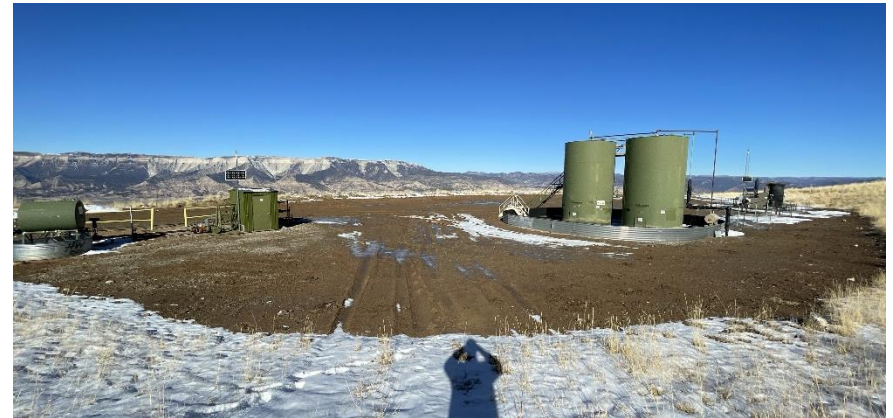
South East corner of location.

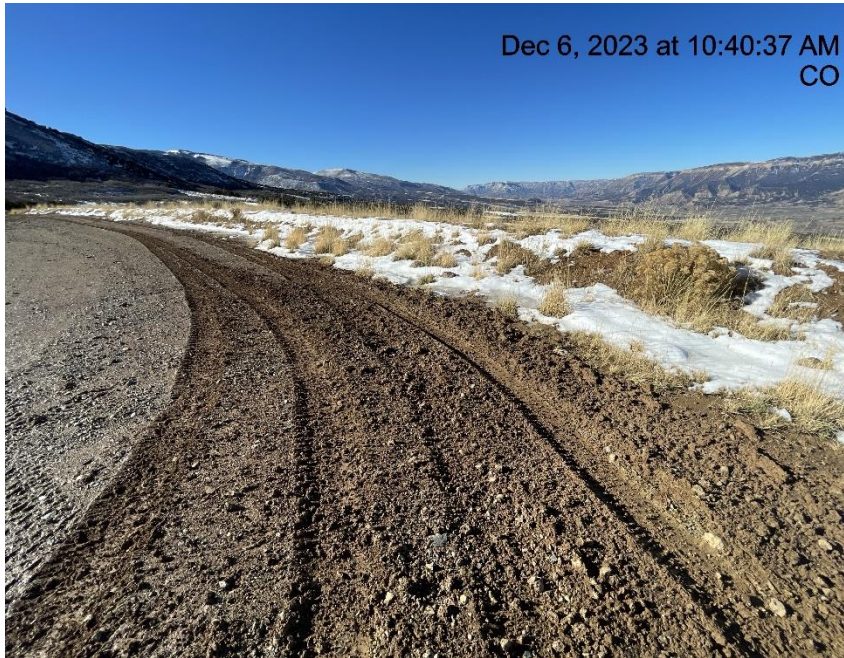
Photo # 8615 Lack of stabilization/compaction/insufficient BMP's

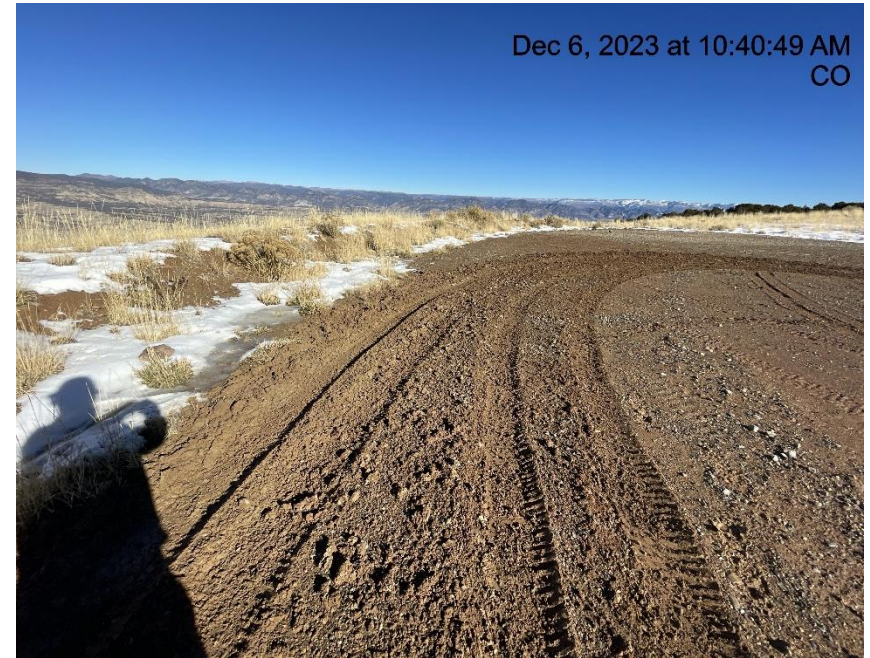
Photo # 8616 Lack of stabilization/compaction/insufficient BMP's

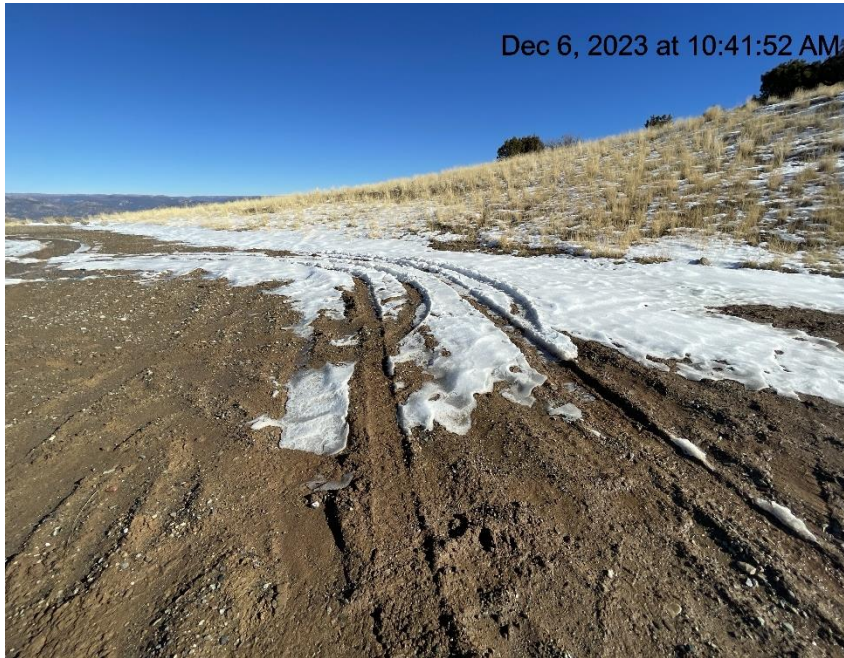
Photo # 8617 Lack of stabilization/compaction/insufficient BMP's

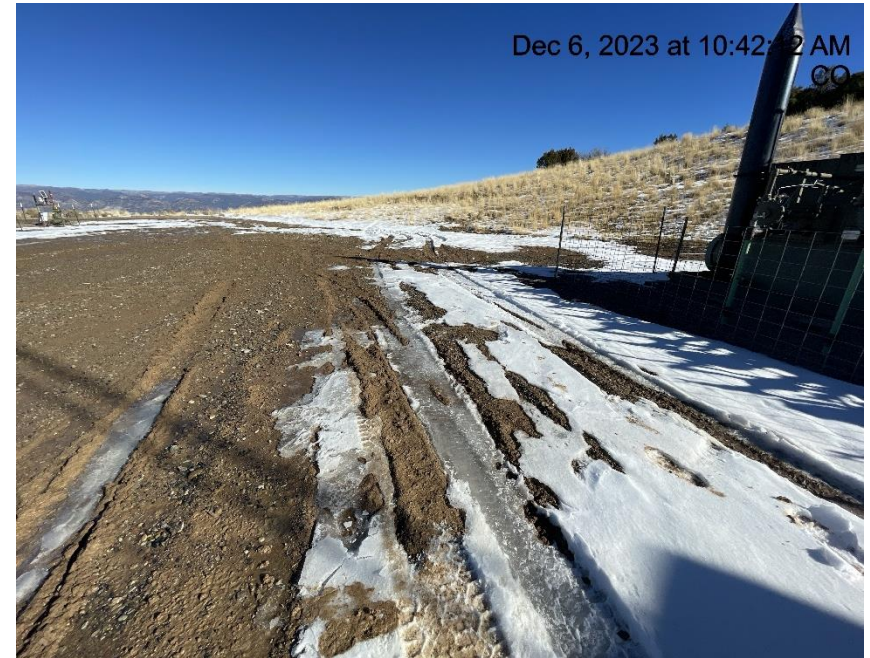
Photo # 8618 Lack of stabilization/compaction/insufficient BMP's

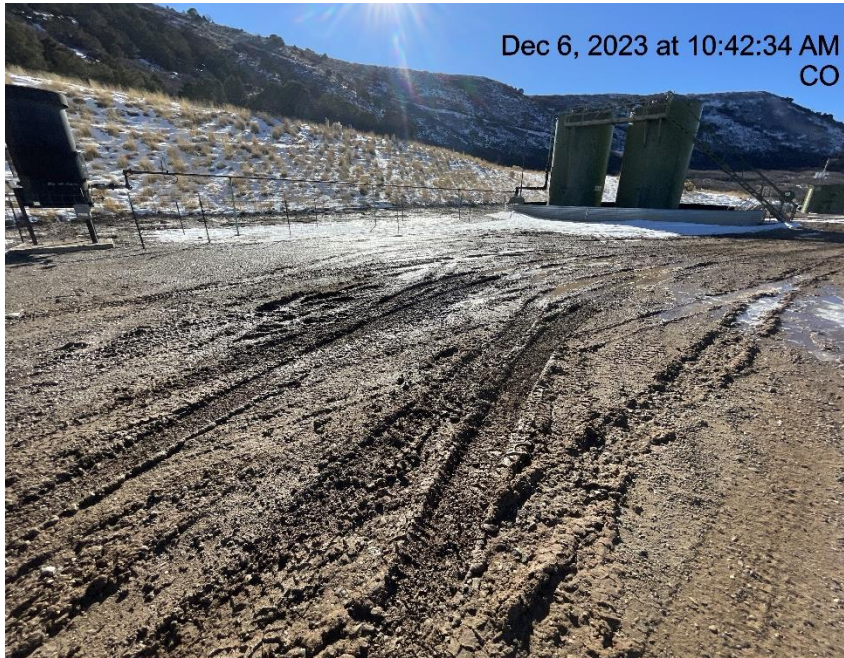
Photo # 8619 Lack of stabilization/compaction/insufficient BMP's

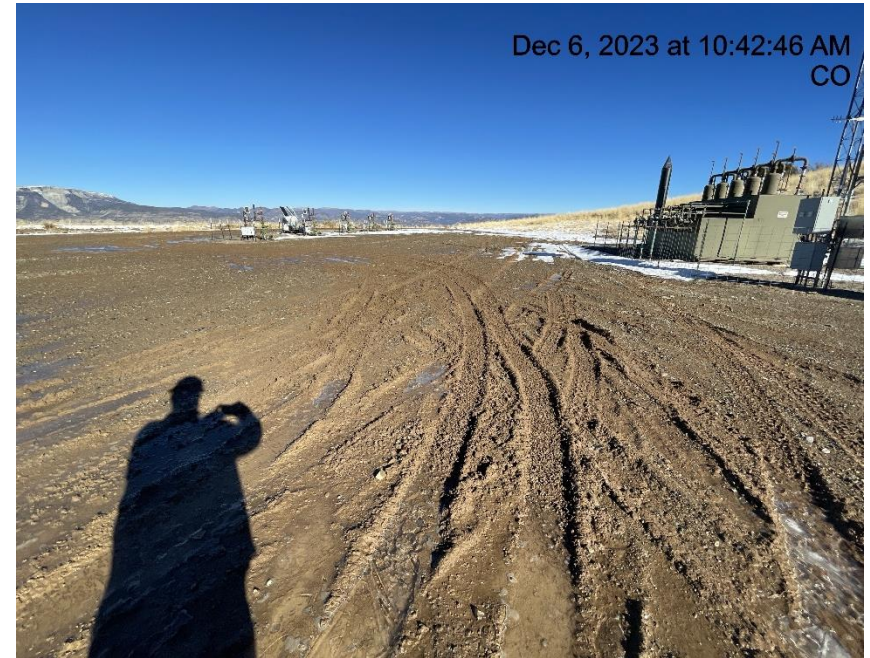
Photo # 8620 Lack of stabilization/compaction/insufficient BMP's

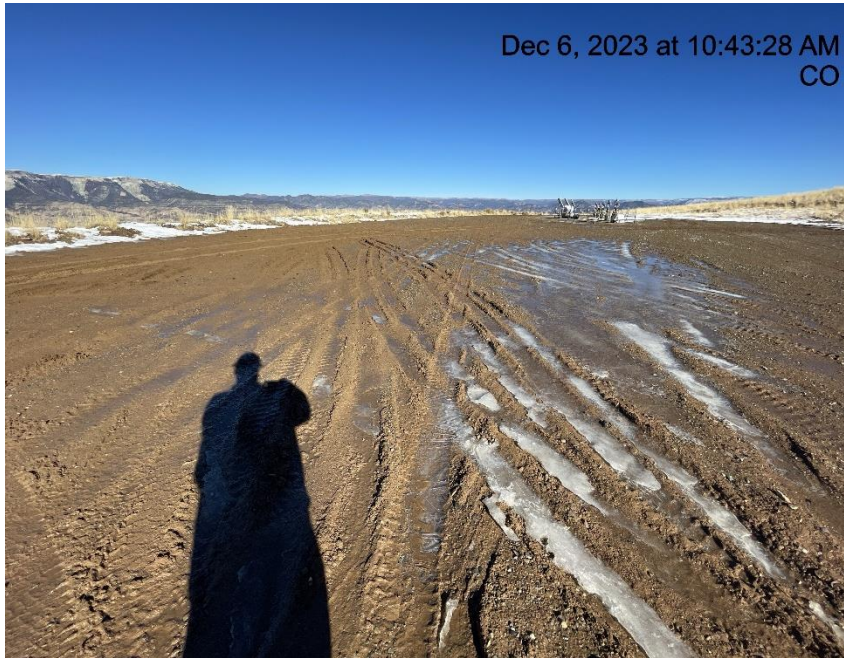
Photo # 8621 Lack of stabilization/compaction/insufficient BMP's

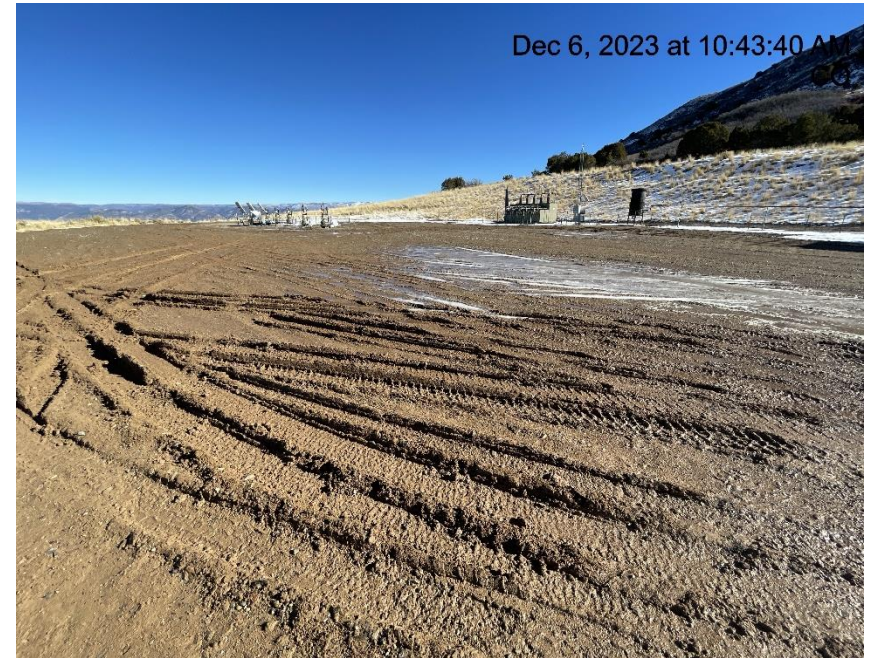
Photo # 8622 Lack of stabilization/compaction/insufficient BMP's

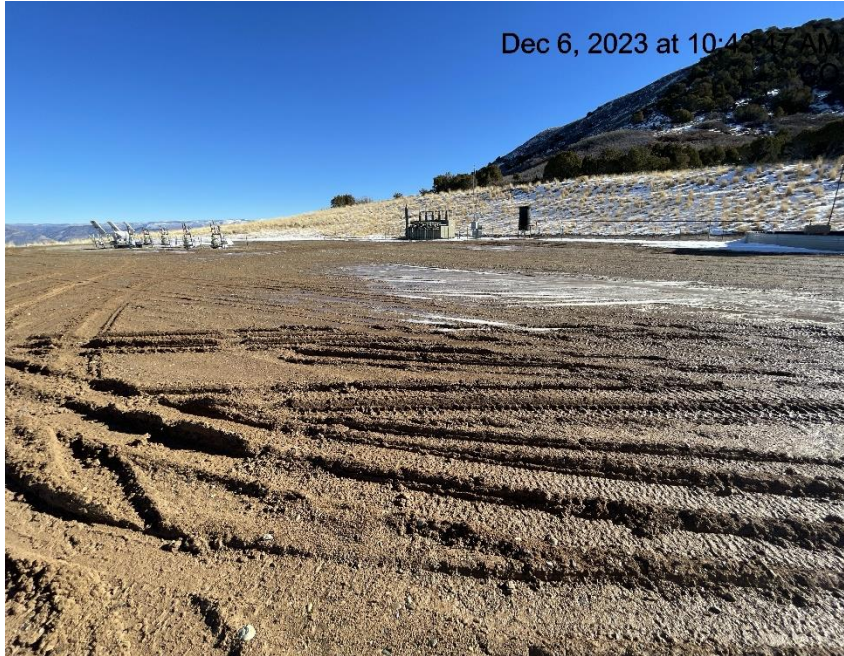
Photo # 8623 Lack of stabilization/compaction/insufficient BMP's

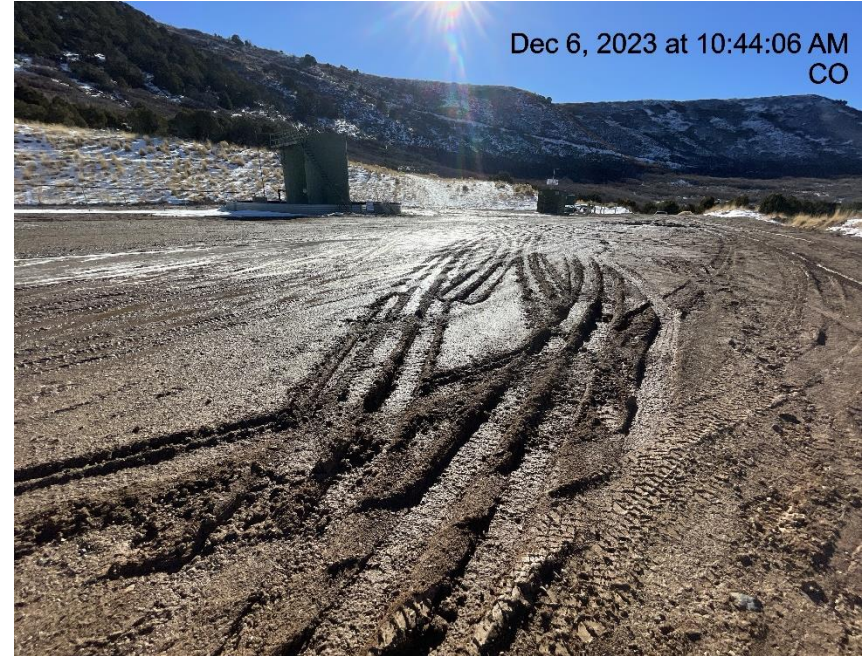
Photo # 8624 Lack of stabilization/compaction/insufficient BMP's

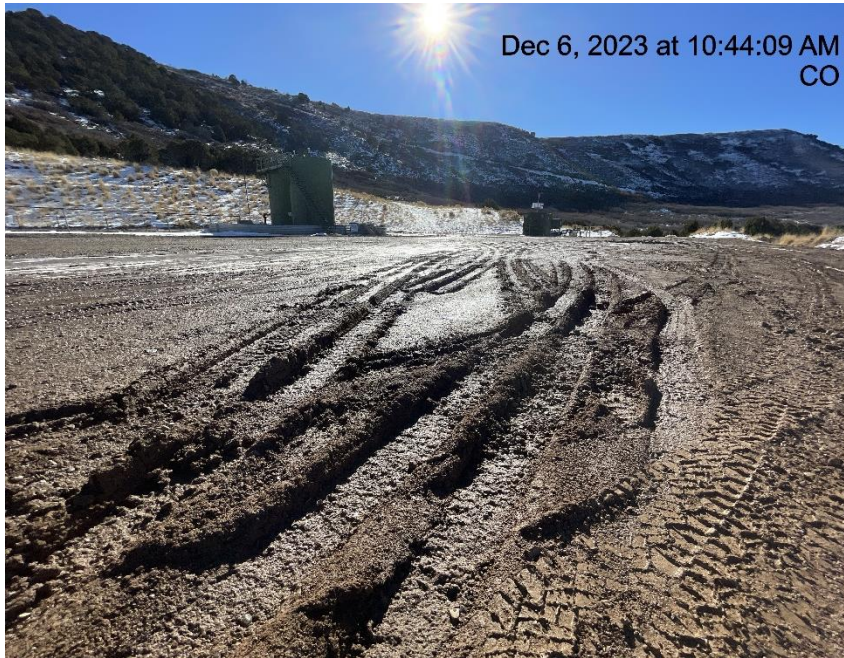
Photo # 8625 Lack of stabilization/compaction/insufficient BMP's

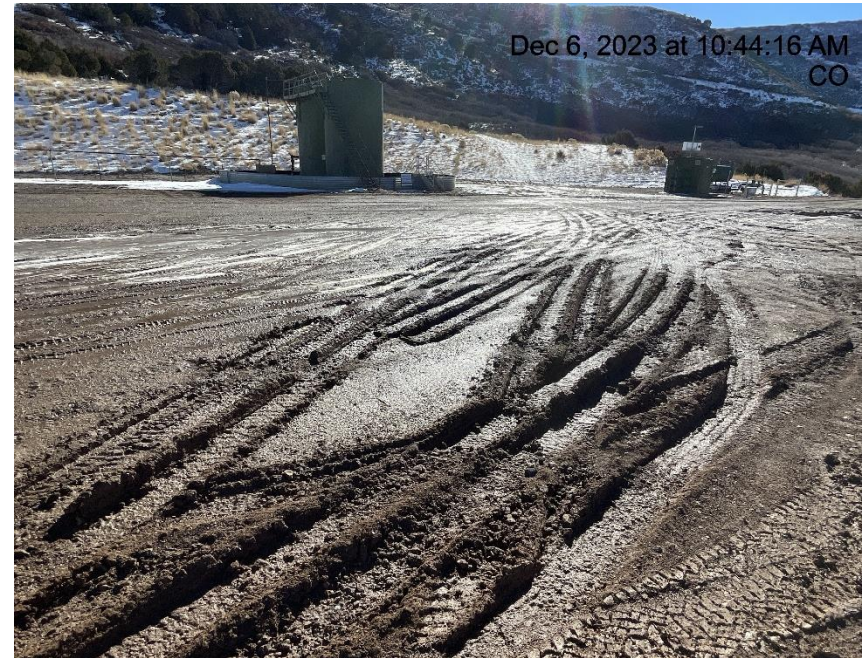
Photo # 8626 Lack of stabilization/compaction/insufficient BMP's

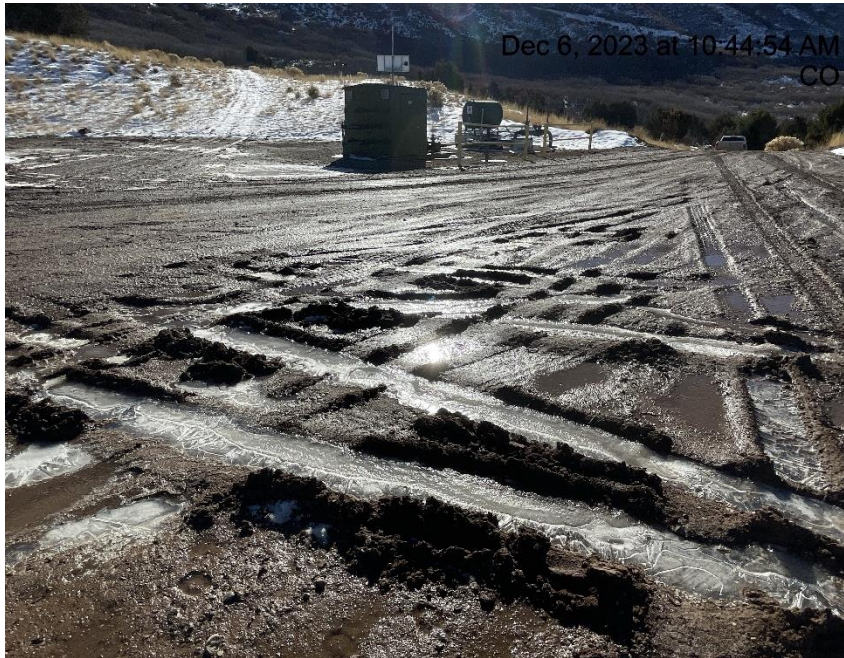
Photo # 8627 Lack of stabilization/compaction/insufficient BMP's

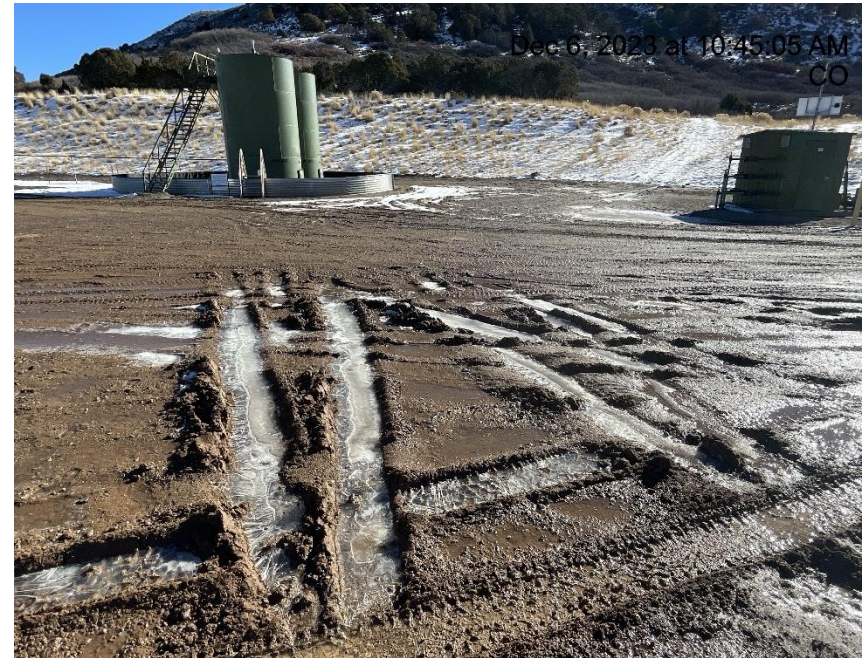
Photo # 8628 Lack of stabilization/compaction/insufficient BMP's

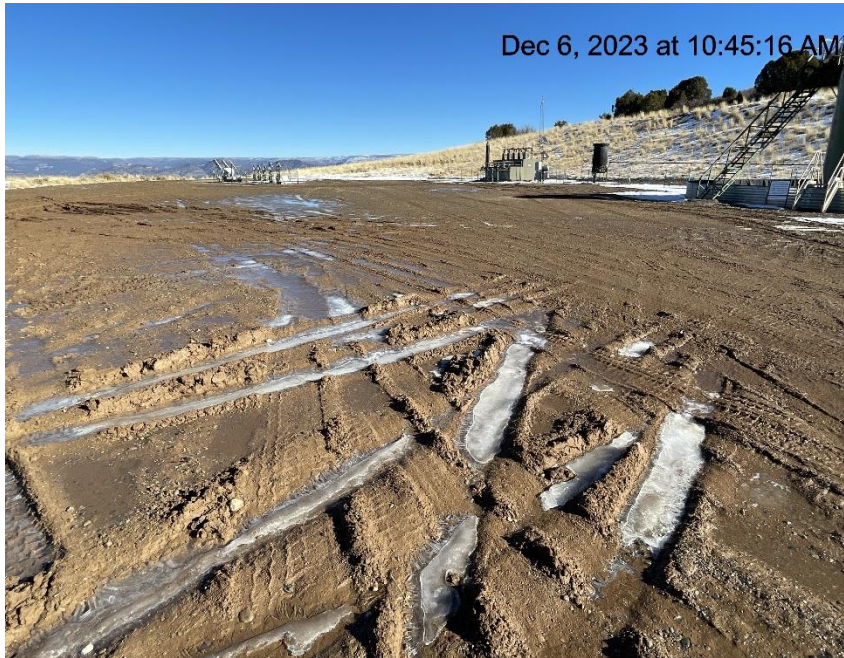
Photo # 8629 Lack of stabilization/compaction/insufficient BMP's

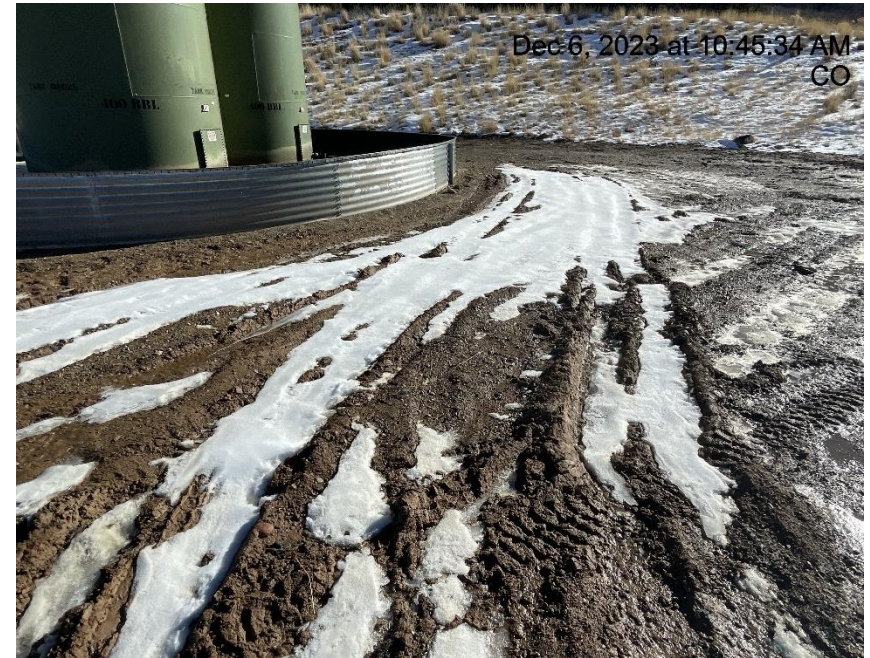
Photo # 8630 Lack of stabilization/compaction/insufficient BMP's

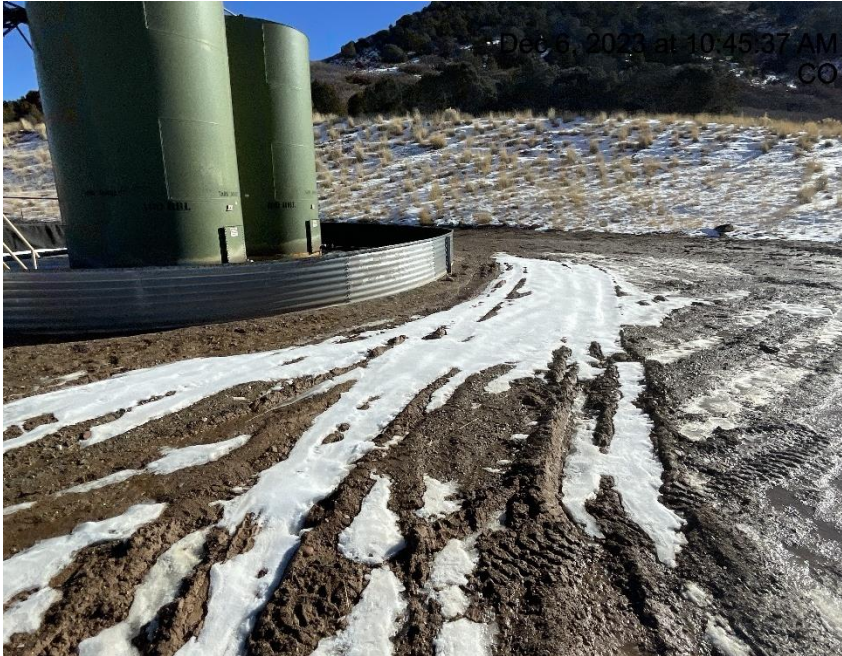
Photo # 8631 Lack of stabilization/compaction/insufficient BMP's

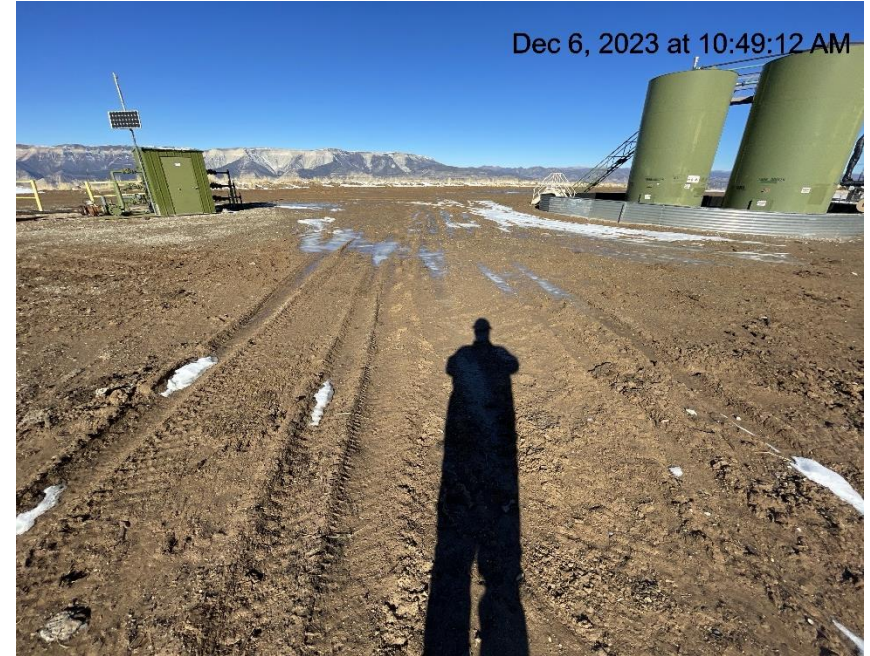
Photo # 8632 Lack of stabilization/compaction/insufficient BMP's

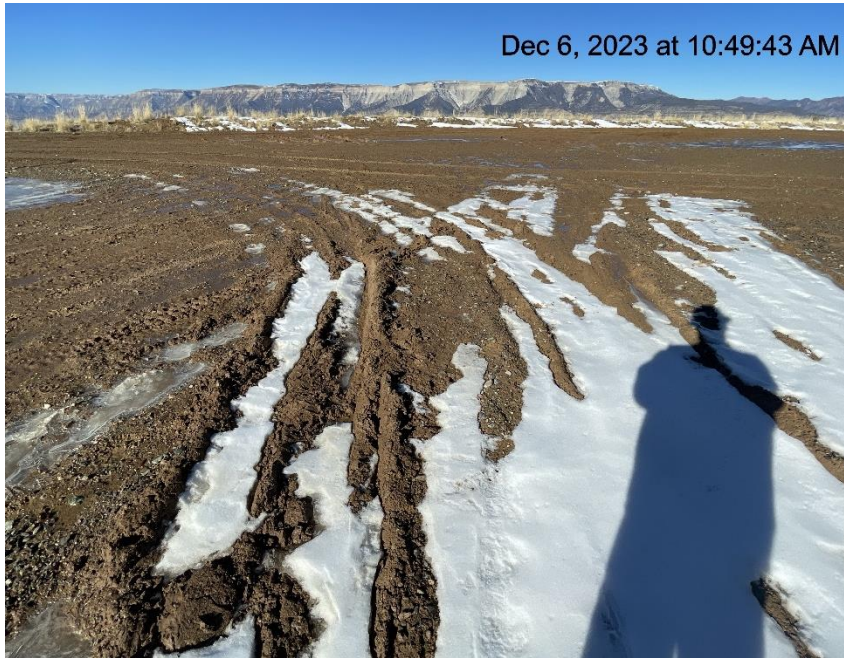
Photo # 8633 Lack of stabilization/compaction/insufficient BMP's

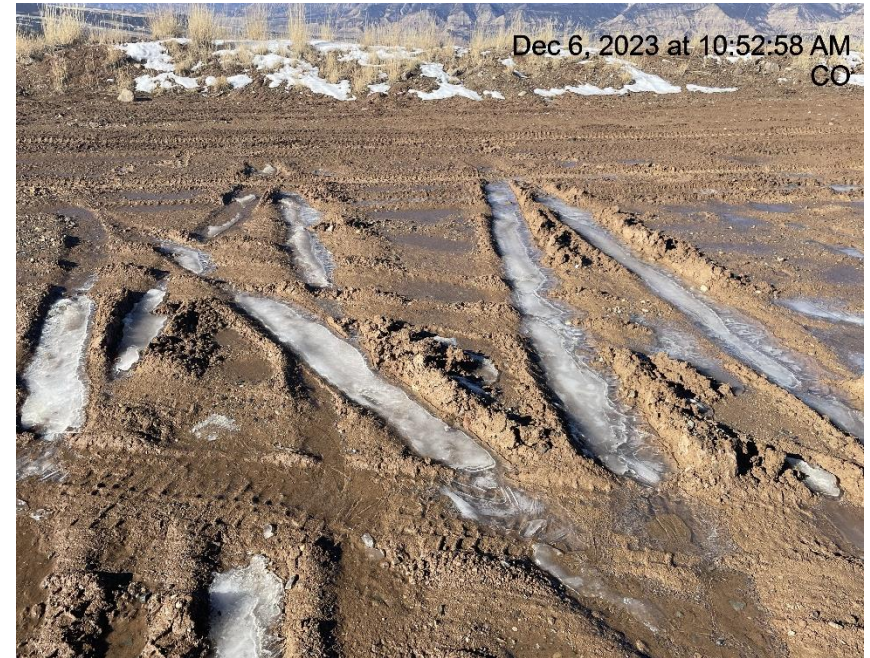
Photo # 8634 Lack of stabilization/compaction/insufficient BMP's

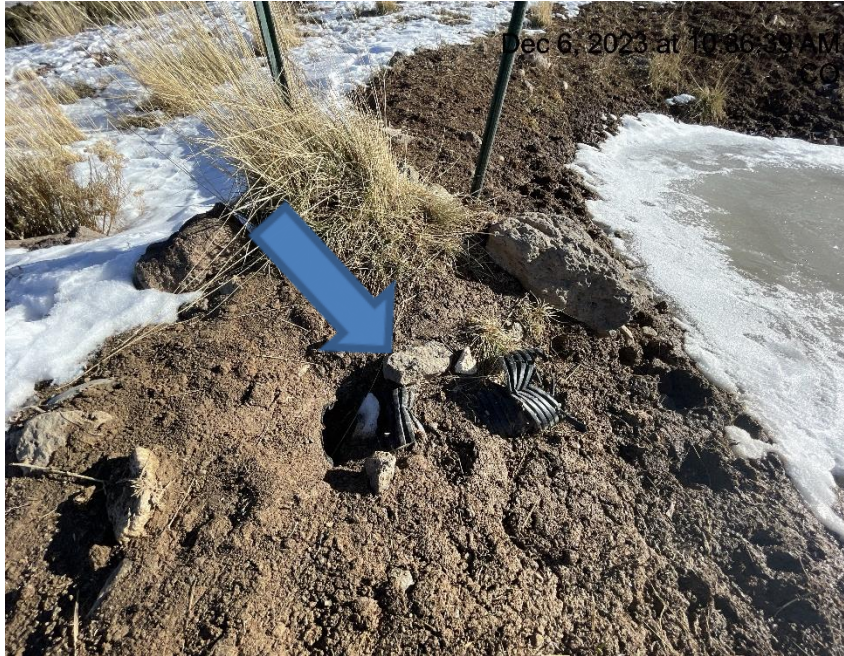
Photo # 8635 Drain needs maintenance

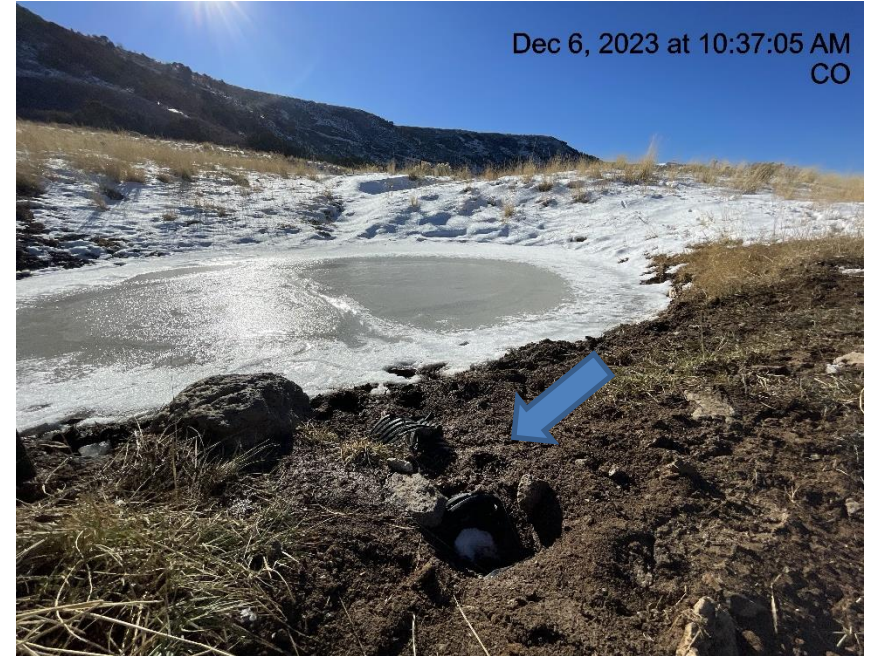
Photo # 8636 Drain needs maintenance

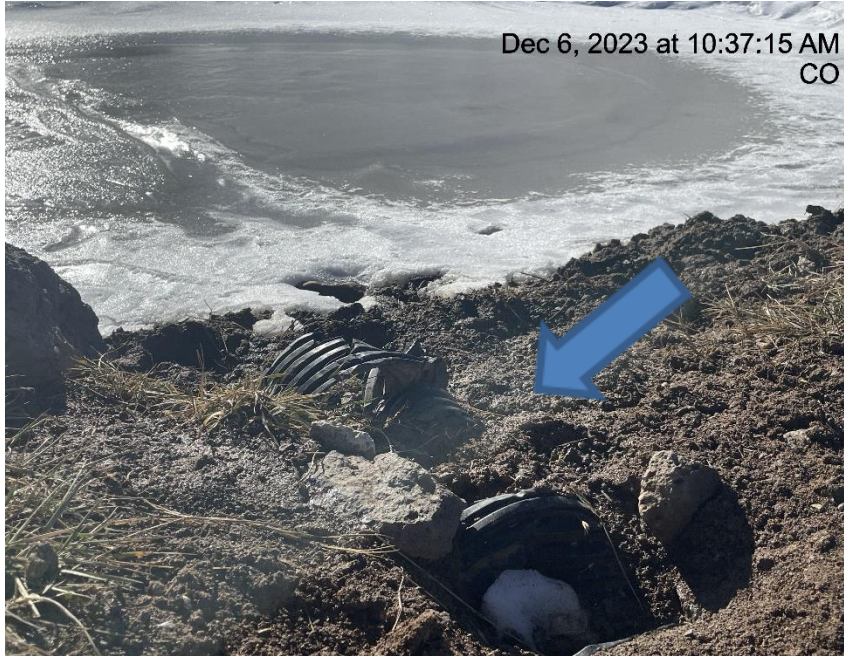
Photo # 8637 Drain needs maintenance
