**Storm Water Management and Erosion control**  
**Location Name: CAERUS PICEANCE LLC RULISON FEDERAL 1-13 (RM1) Pad**  
**Location #: 334667**

**Section/Township/Range: 1 7S94W**

**COLORADO**  
Energy & Carbon Management  
Commission  
Department of Natural Resources

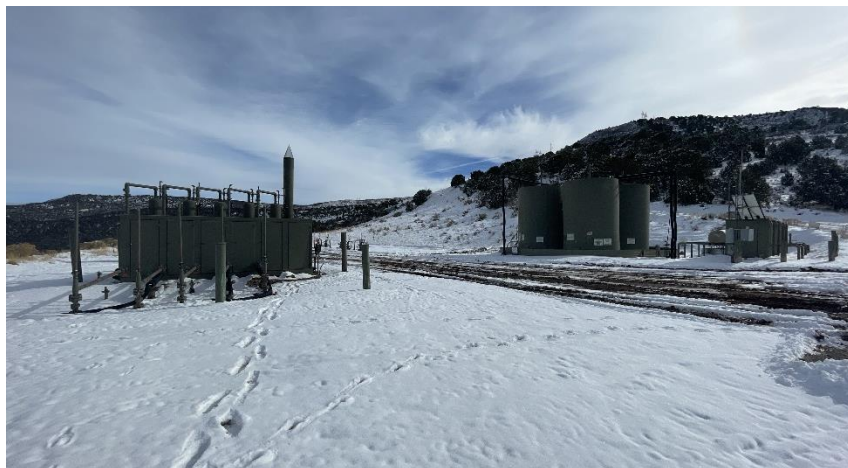
**North West corner of location.**

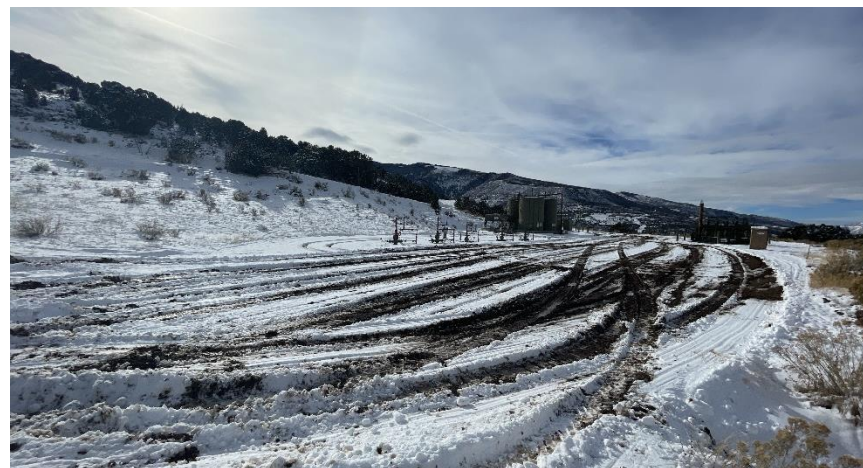
**North East corner of location.**

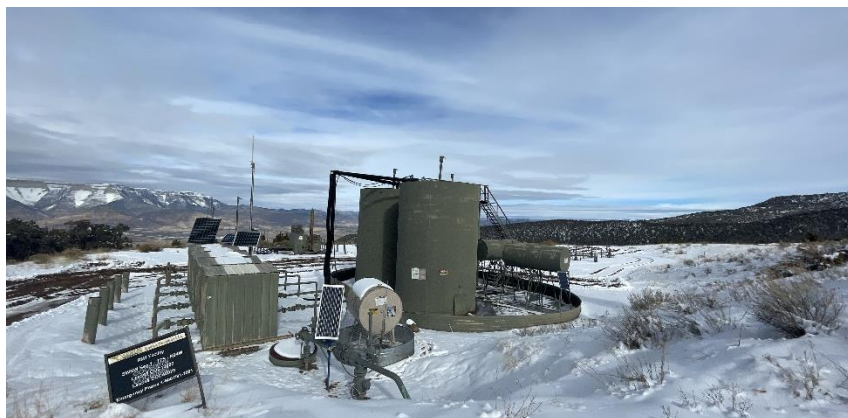
**South West corner of location.**

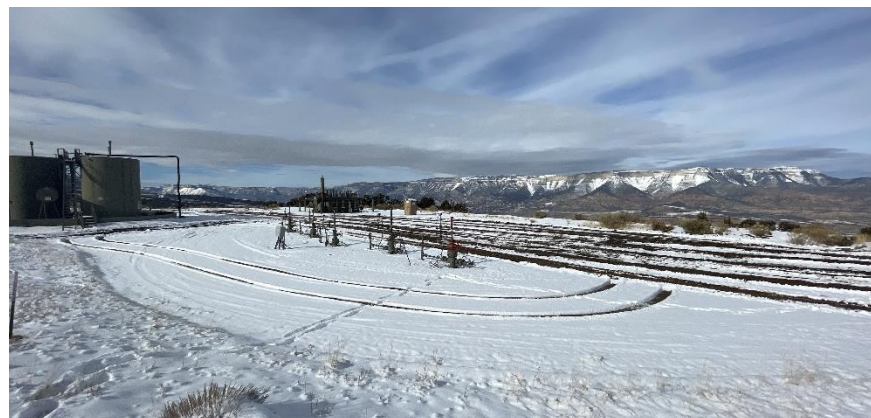
**South East corner of location.**

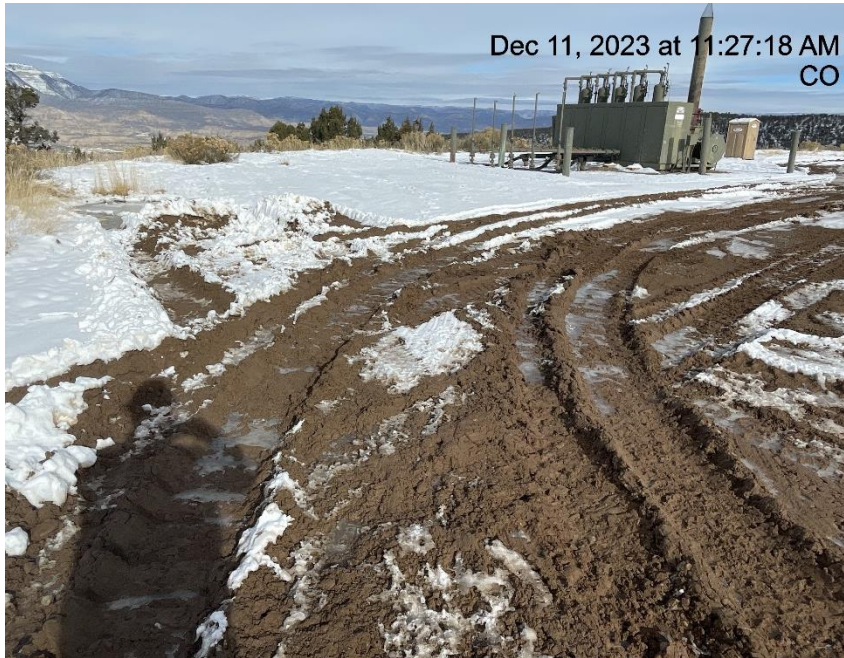
**Photo # 9269 Lack of stabilization/compaction/insufficient BMP's**

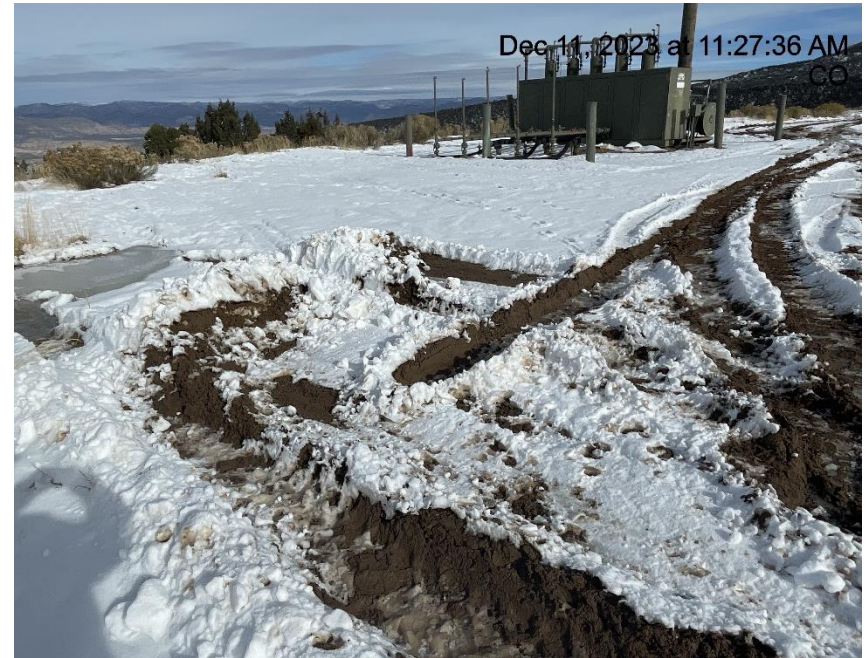
**Photo # 9270 Lack of stabilization/compaction/insufficient BMP's**

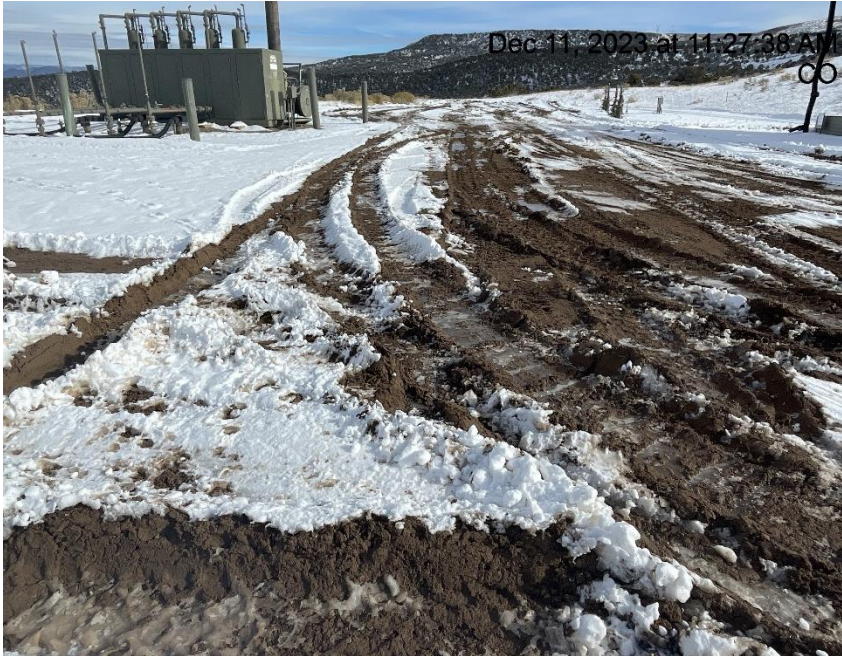
**Photo # 9271 Lack of stabilization/compaction/insufficient BMP's**

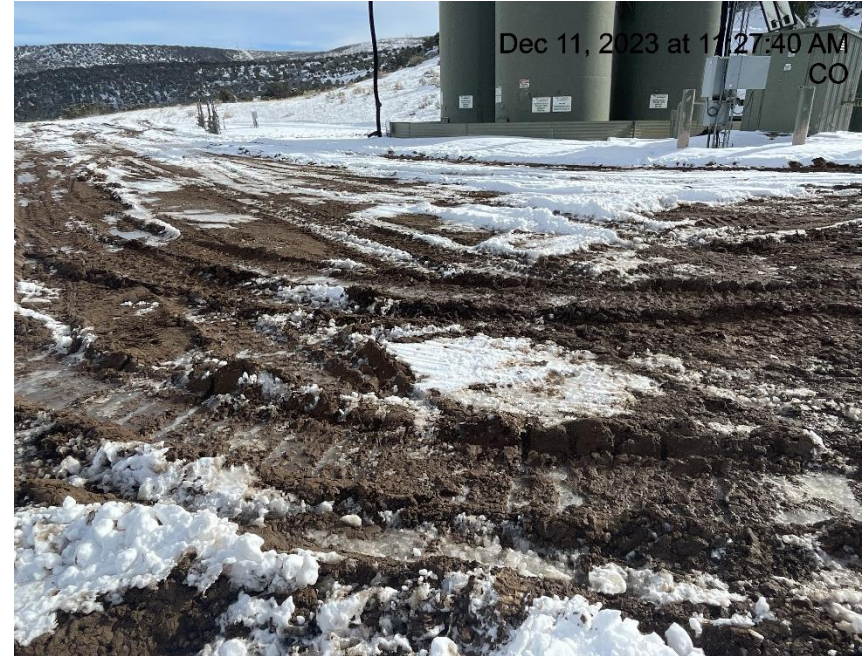
**Photo # 9272 Lack of stabilization/compaction/insufficient BMP's**

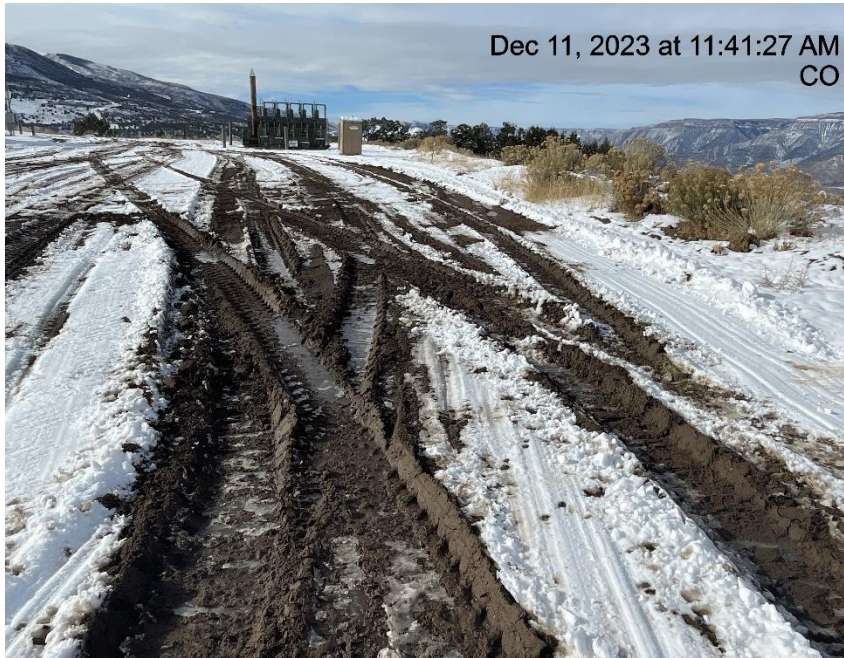
**Photo # 9273 Lack of stabilization/compaction/insufficient BMP's**

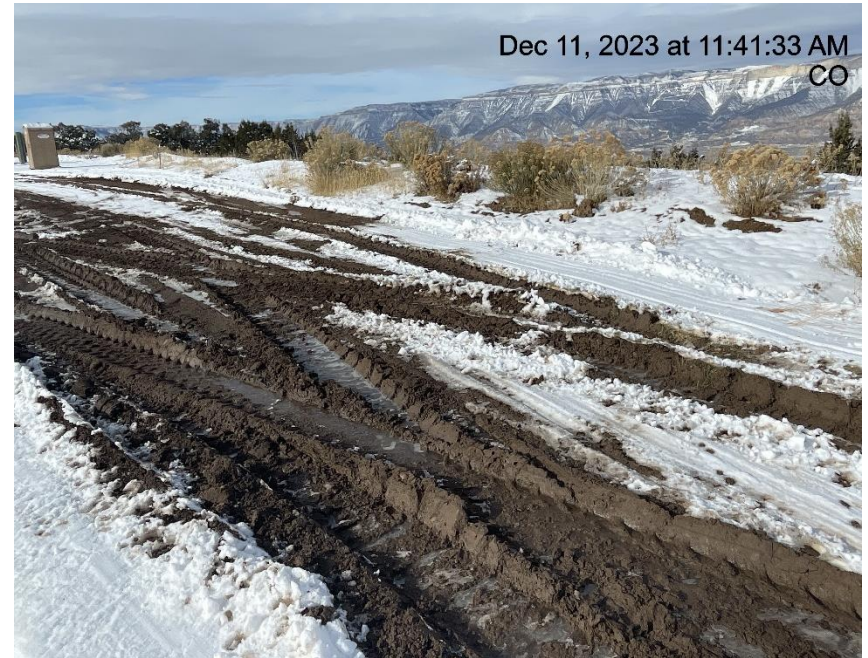
**Photo # 9274 Lack of stabilization/compaction/insufficient BMP's**

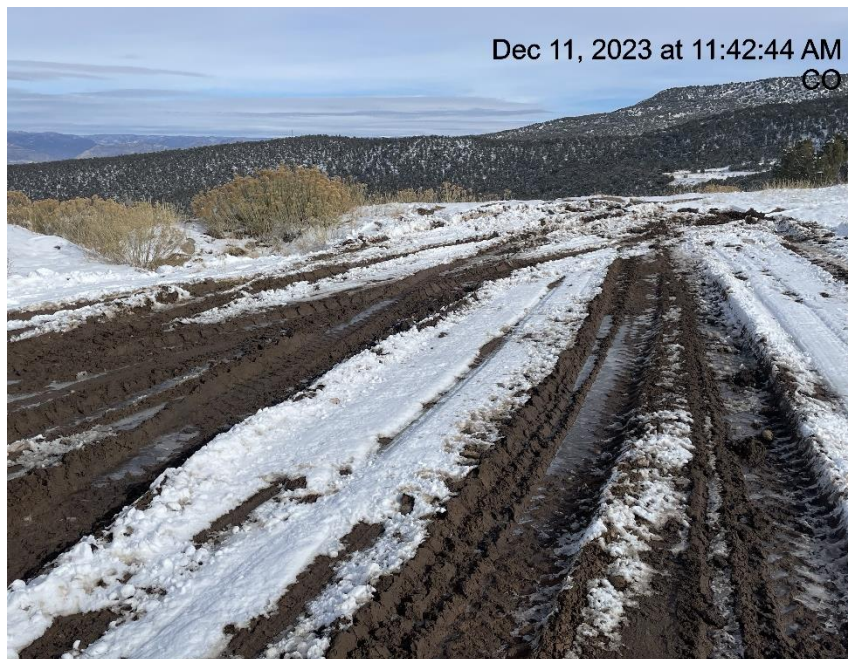
**Photo # 9275 Lack of stabilization/compaction/insufficient BMP's**

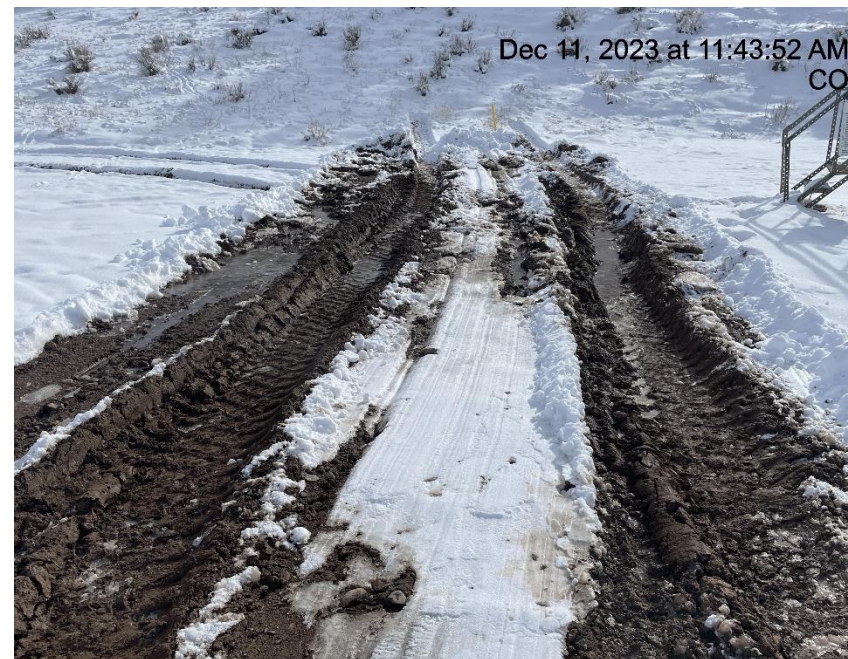
**Photo # 9276 Lack of stabilization/compaction/insufficient BMP's**

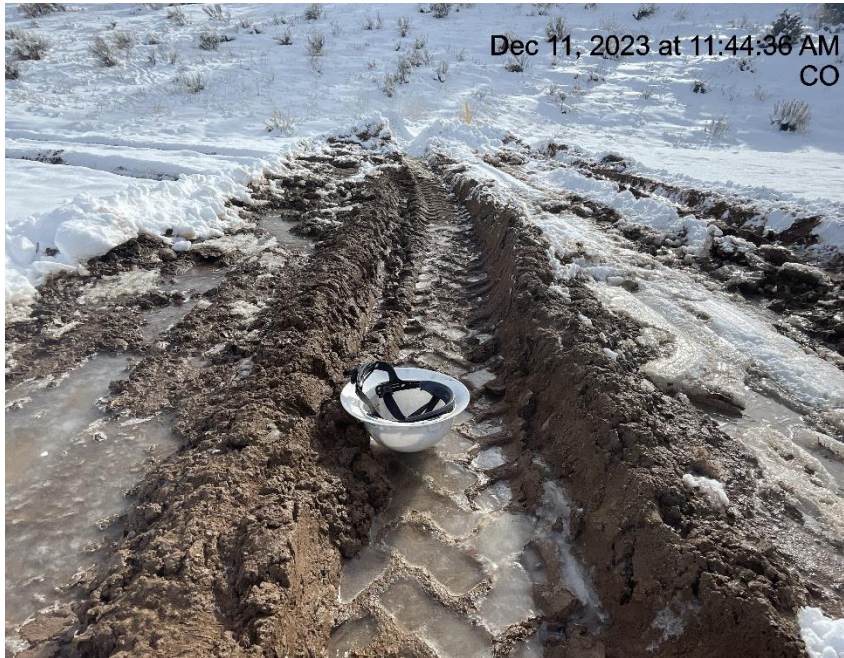
**Photo # 9277 Lack of stabilization/compaction/insufficient BMP's**

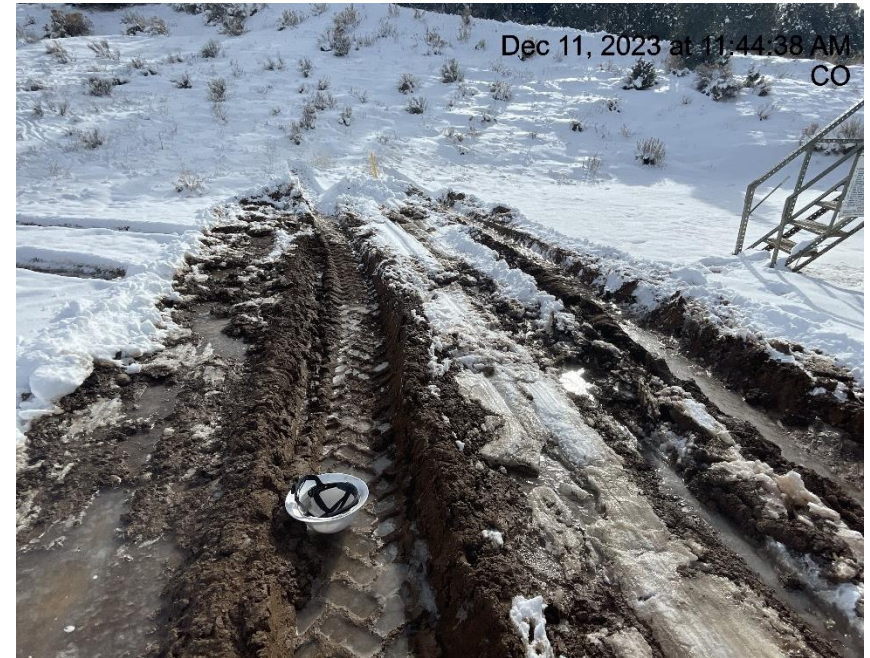
**Photo # 9278 Lack of stabilization/compaction/insufficient BMP's**

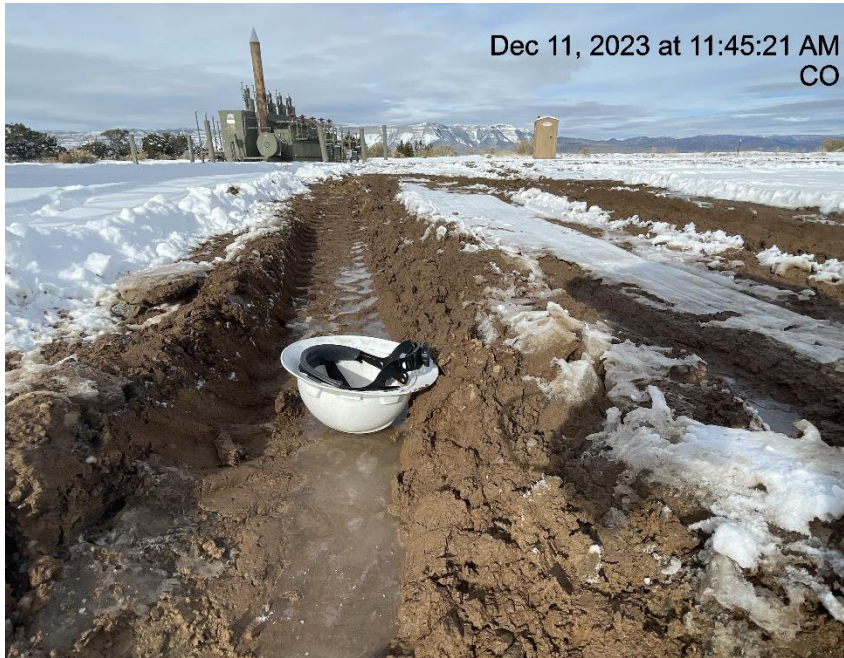
**Photo # 9279 Lack of stabilization/compaction/insufficient BMP's**

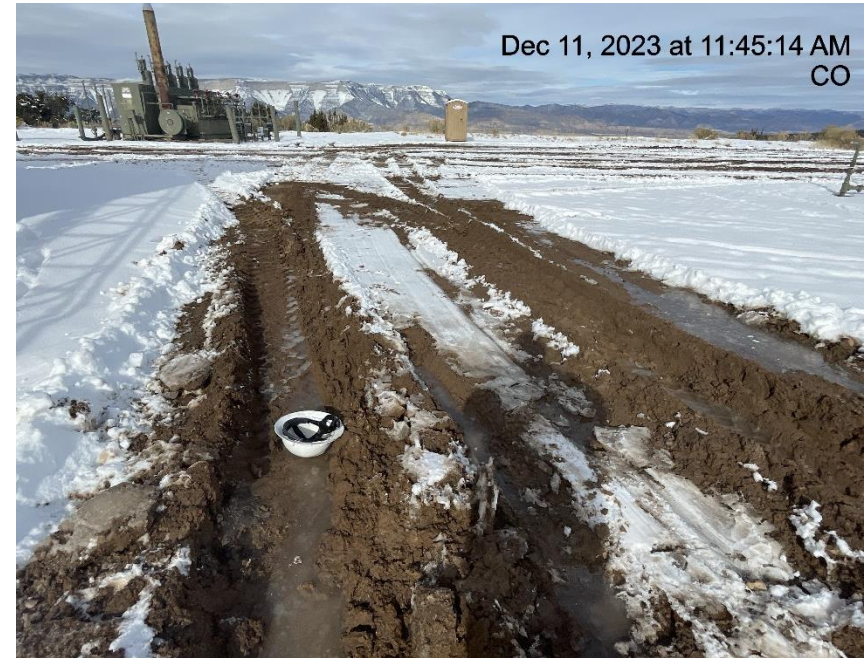
**Photo # 9280 Lack of stabilization/compaction/insufficient BMP's**

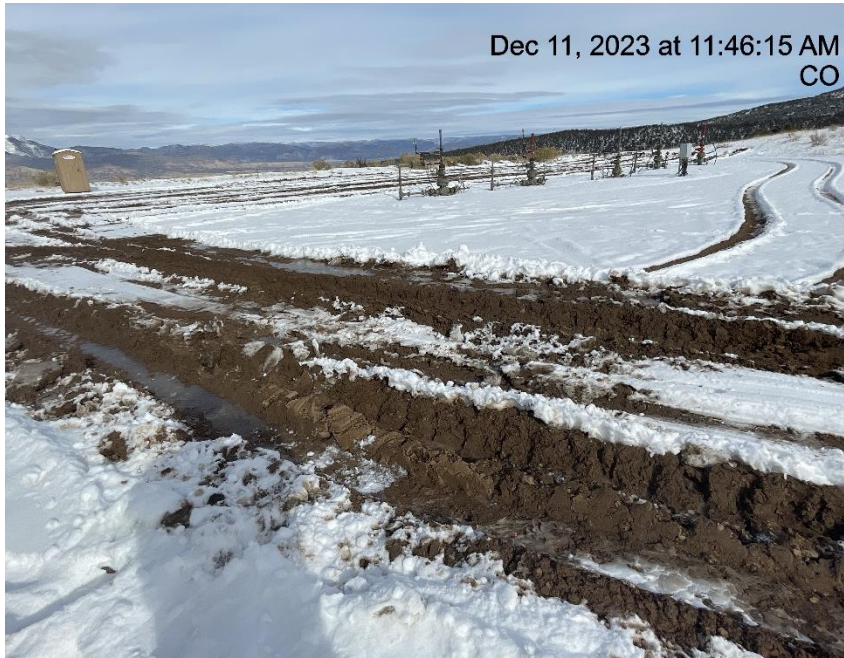
**Photo # 9281 Lack of stabilization/compaction/insufficient BMP's**

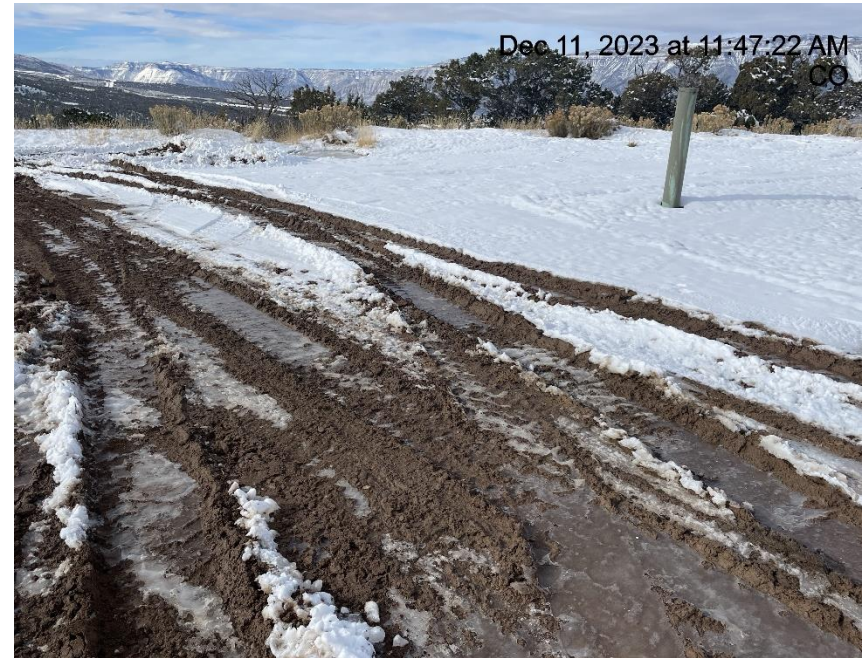
**Photo # 9282 Lack of stabilization/compaction/insufficient BMP's**

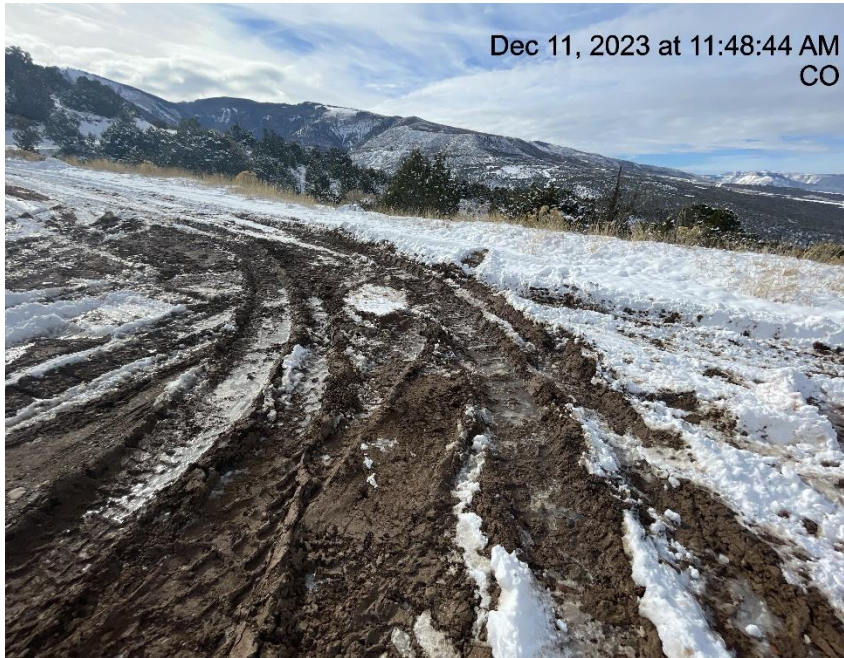
**Photo # 9283 Lack of stabilization/compaction/insufficient BMP's**

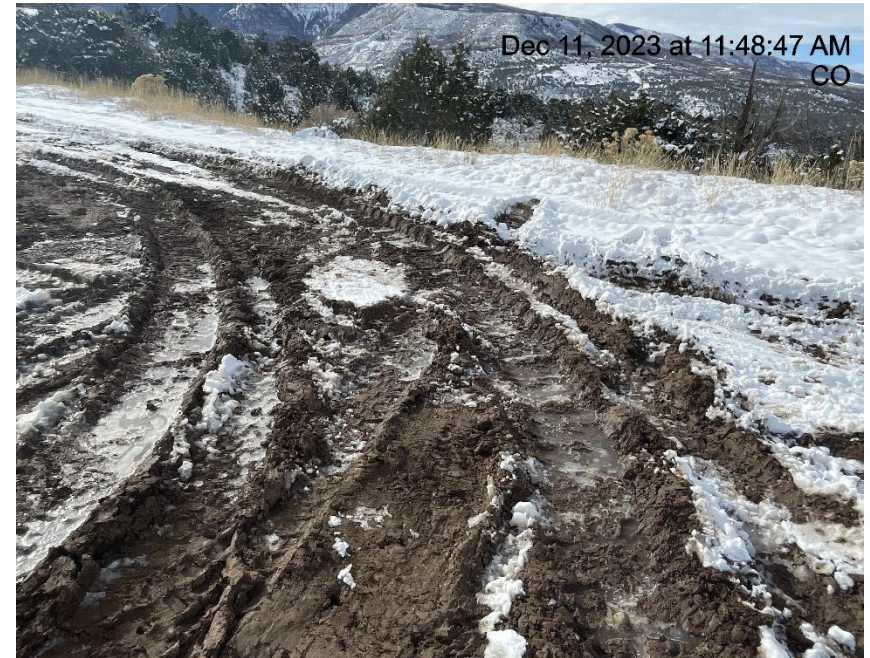
**Photo # 9284 Lack of stabilization/compaction/insufficient BMP's**

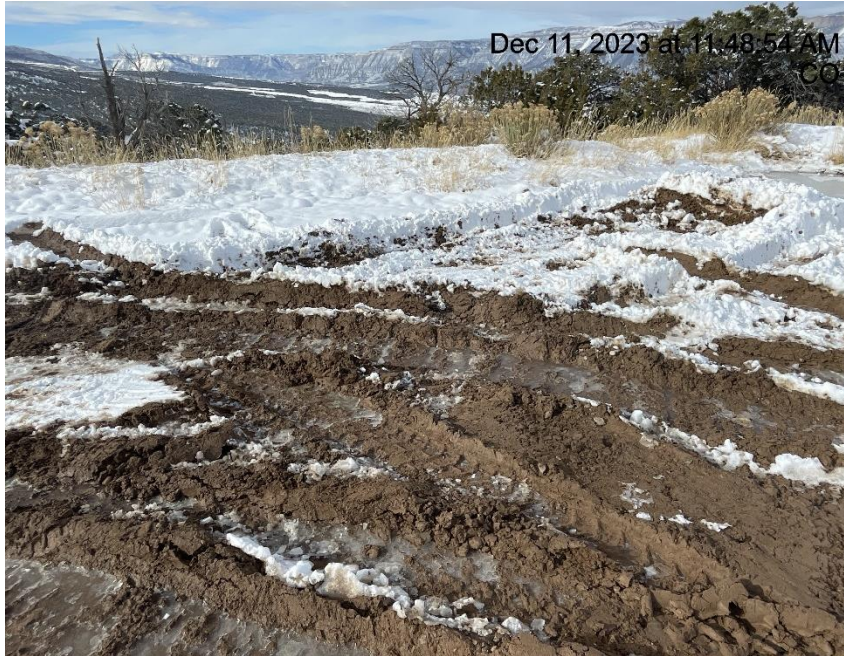
**Photo # 9285 Lack of stabilization/compaction/insufficient BMP's**

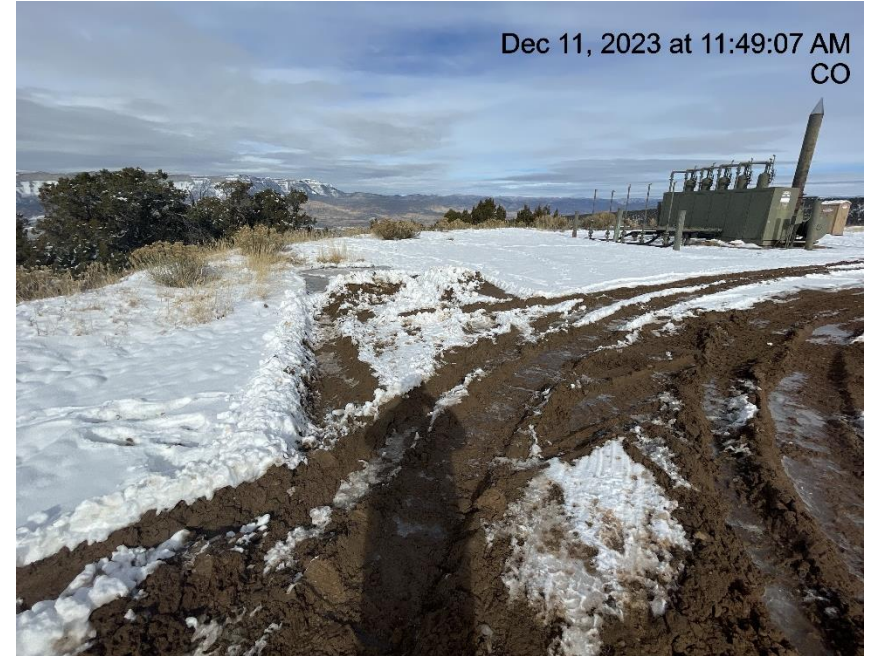
**Photo # 9286 Lack of stabilization/compaction/insufficient BMP's**
