## Inspection Photos

Location Name: CAERUS PICEANCE LLC RULISON FEDERAL 1-13 (RM1) Pad

Location #: 334667

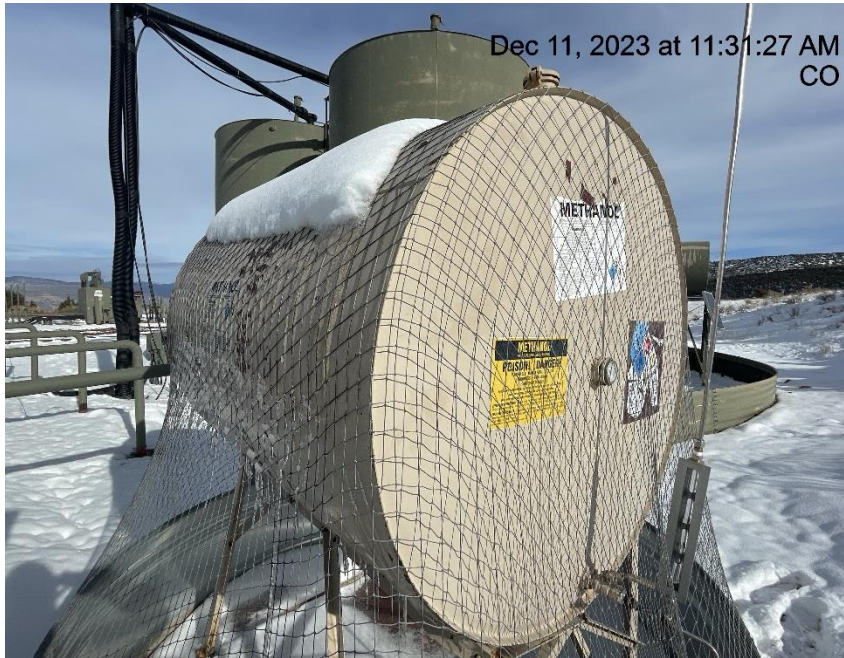
**Photo # 9266 Tank improperly labeled/lacks required information**

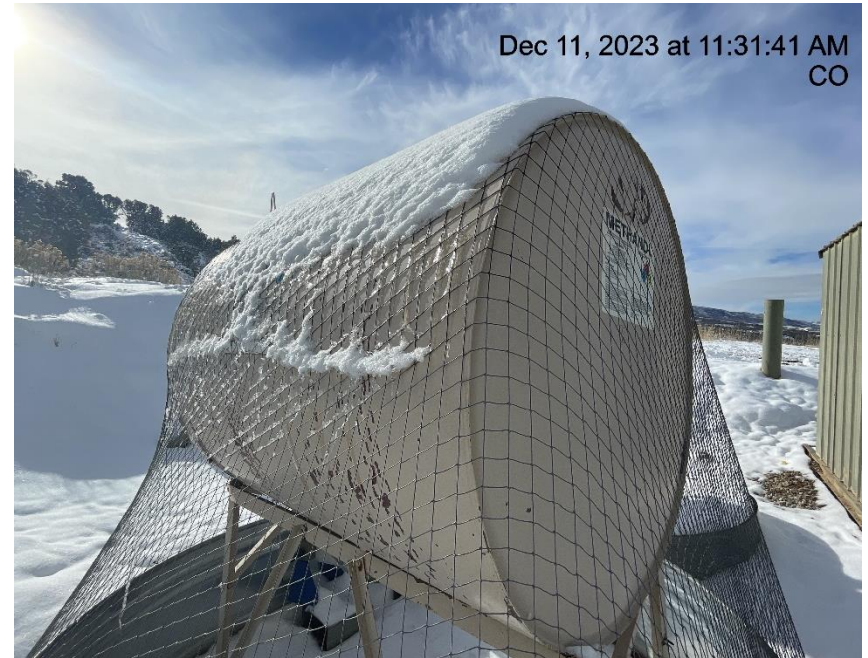
**Photo # 9267 Tank improperly labeled/lacks required information**

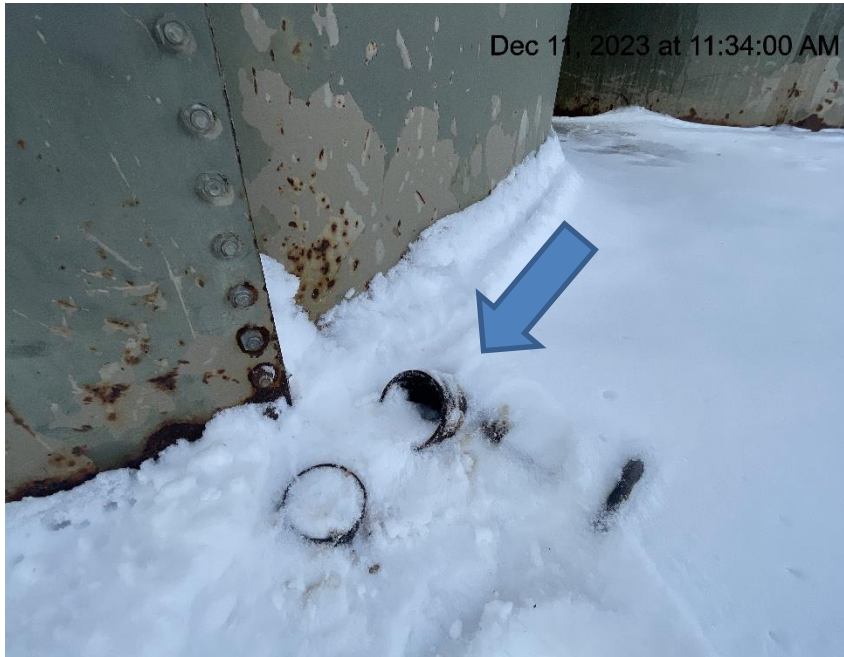
Photo # 9268 Open ended load line
