Inspection Photos

Location Name: CAERUS PICEANCE LLC, CHEVRON-66S96W/4SWSW

Location ID: 335766

Date: 12/11/2023

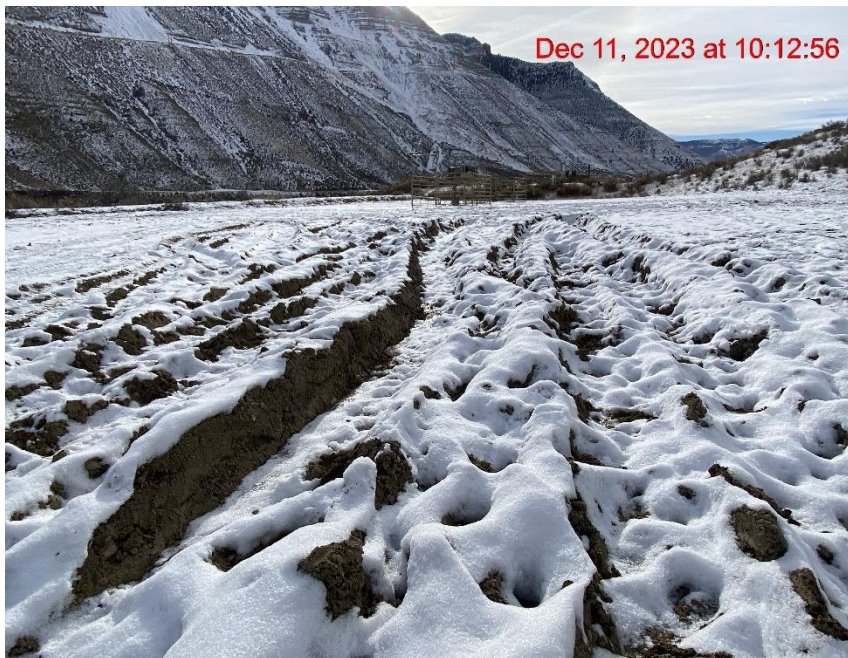
Lack of Stabilization – Photo #08087

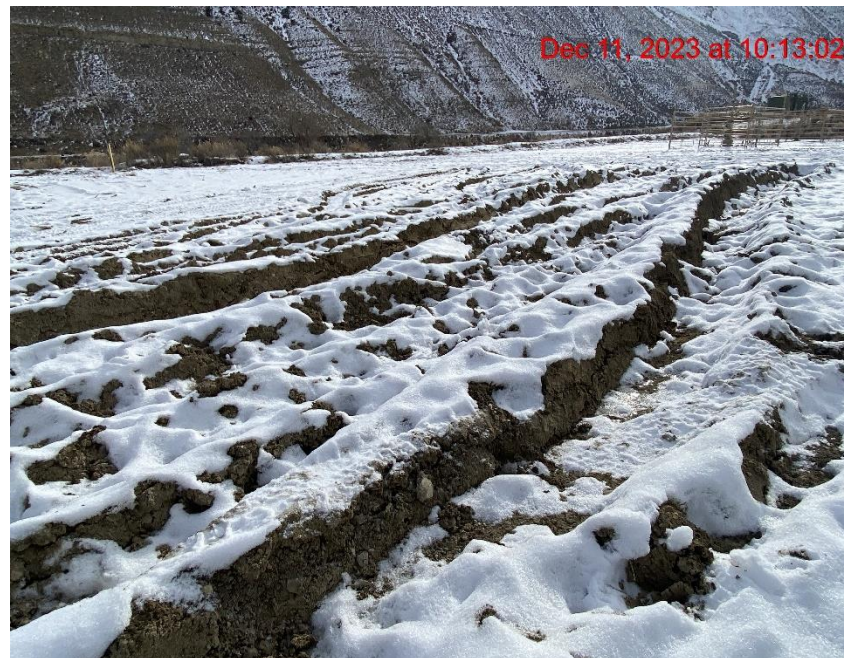
Lack of Stabilization – Photo #08088

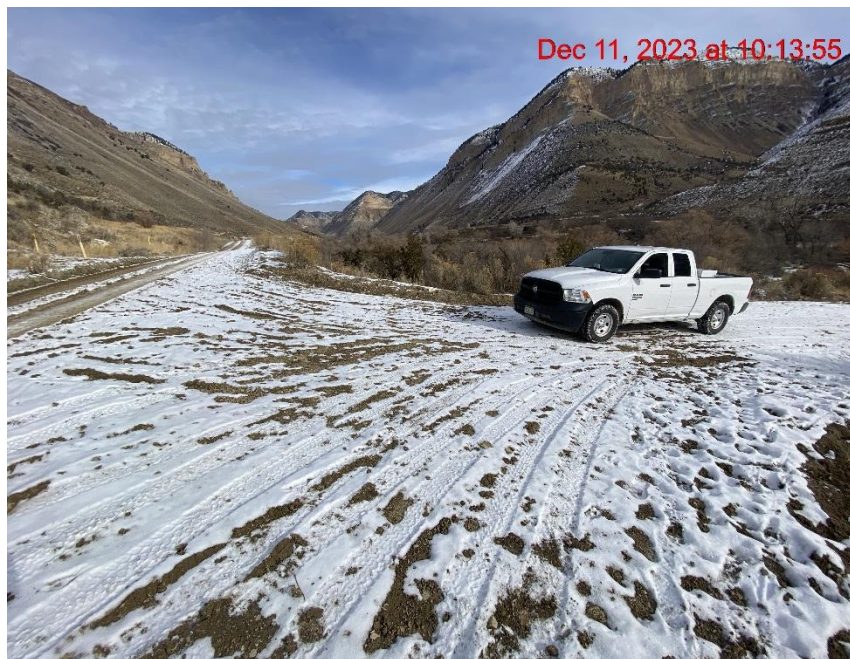
**Insufficient Vehicle Tracking BMPs at Location Entrance/Exit
– Photo #08090**

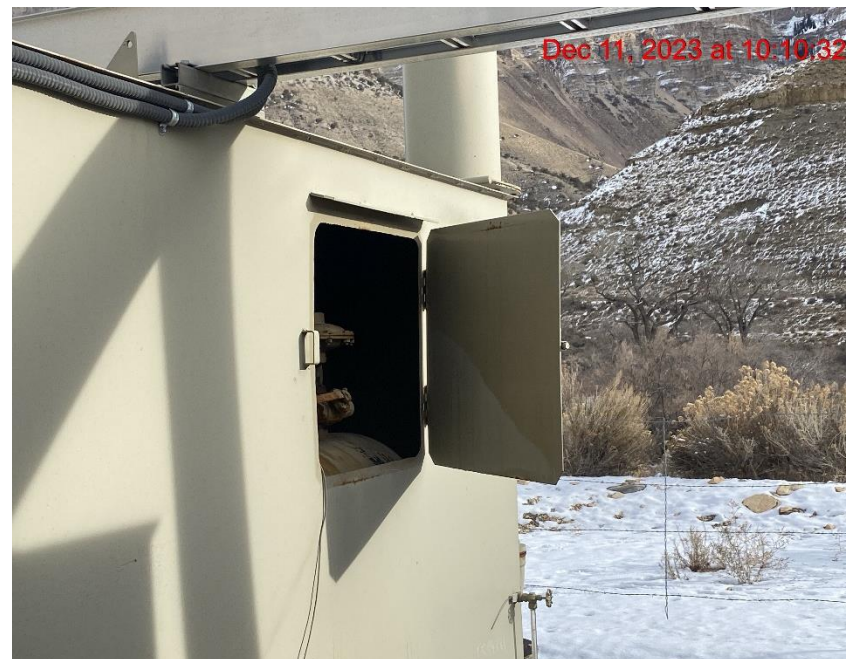
Unsecured Separator – Photo #08084
