Storm Water Management and Erosion control
Location Name: CAERUS PICEANCE LLC SAVAGE RK1 Pad
Location #: 334638

Location Overview: Location is within Black Bear Habitat area & in close proximity to High Priority/Density/NSO Habitat areas. Location is within Rule 411a Surface Water Intermediate Buffer. Location is approximately 379 yards from Beaver Creek.

Section/Township/Range: 1 7S94W

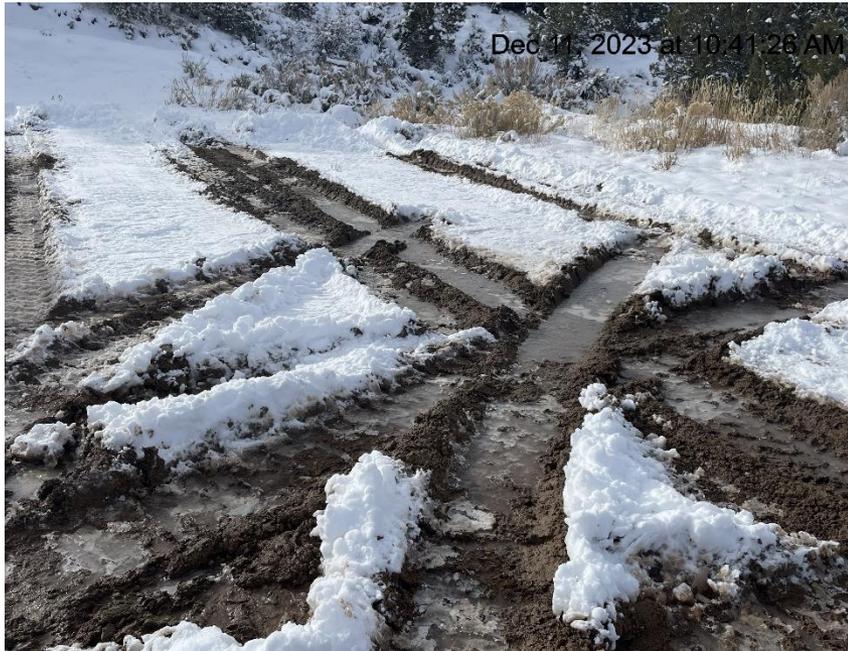
Photo # 9103 Lack of stabilization/compaction/insufficient BMP's on location

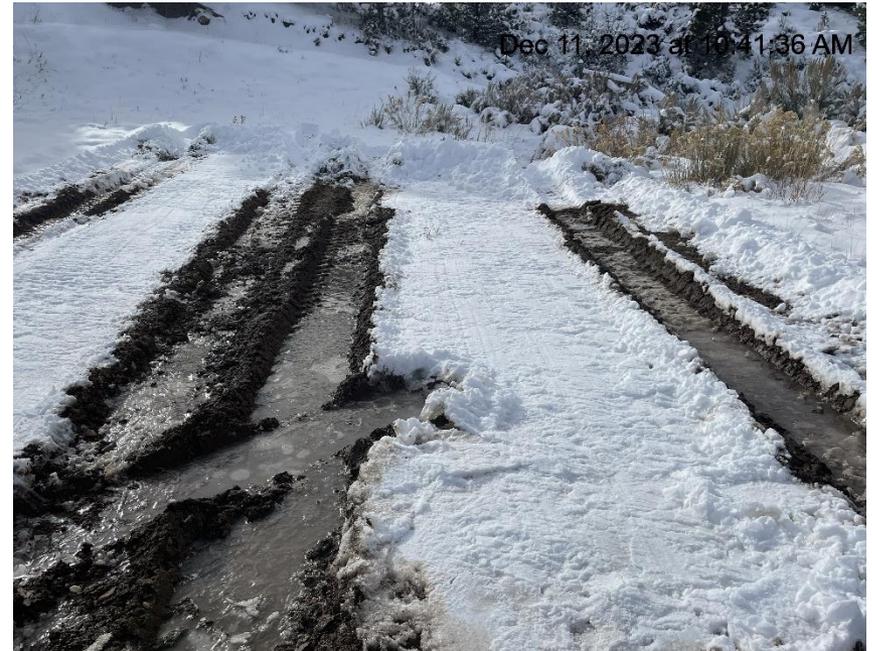
Photo # 9104 Lack of stabilization/compaction/insufficient BMP's on location

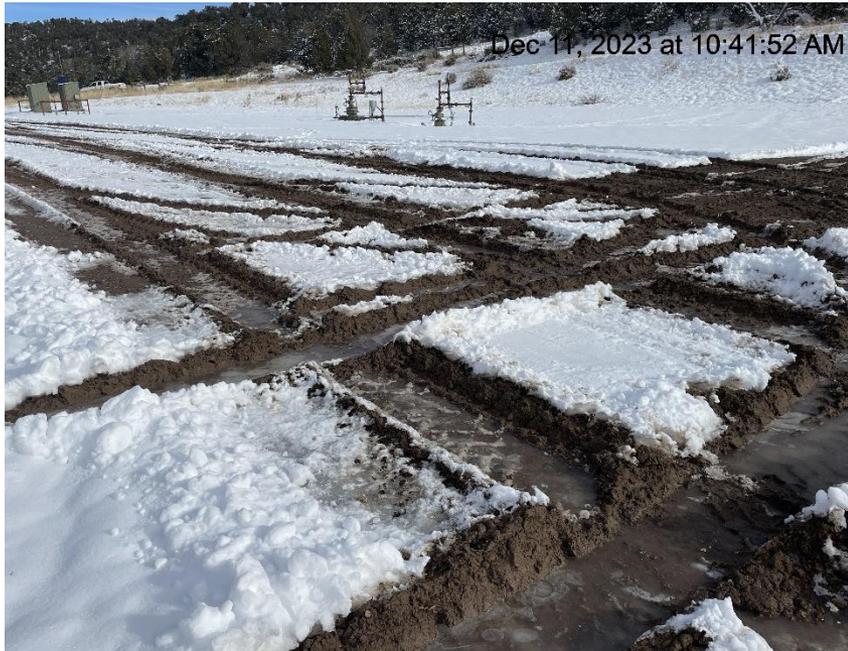
Photo # 9105 Lack of stabilization/compaction/insufficient BMP's on location

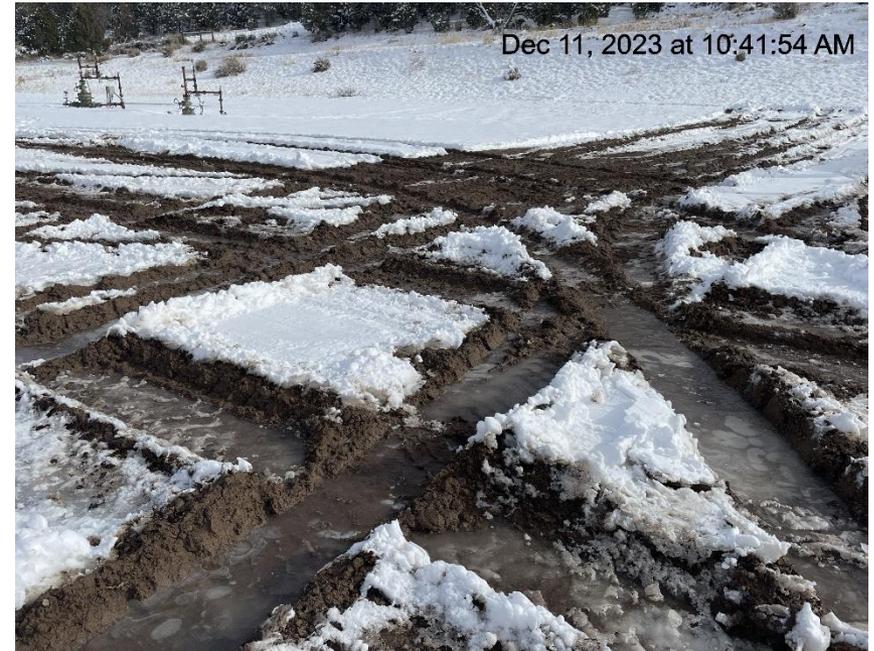
Photo # 9106 Lack of stabilization/compaction/insufficient BMP's on location

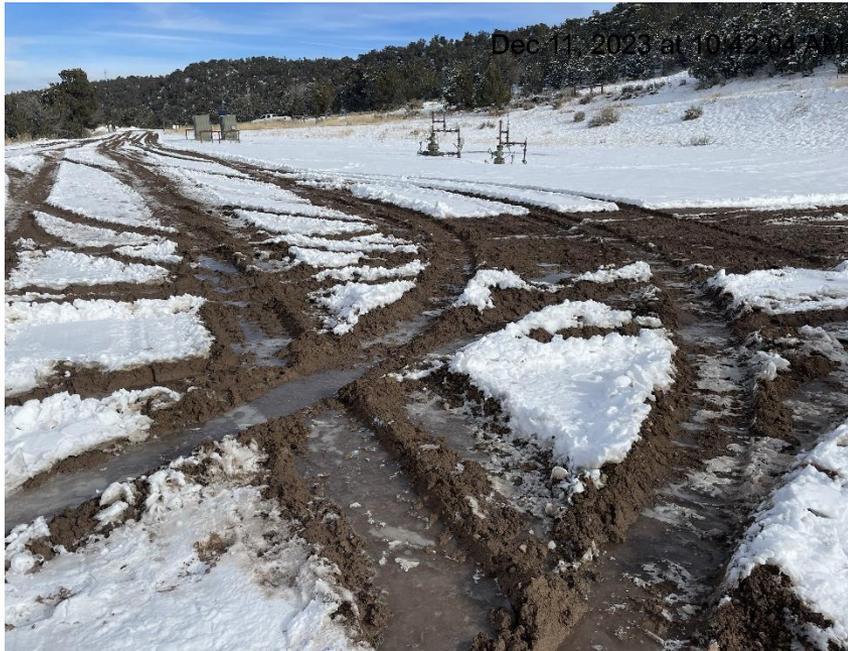
Photo # 9107 Lack of stabilization/compaction/insufficient BMP's on location

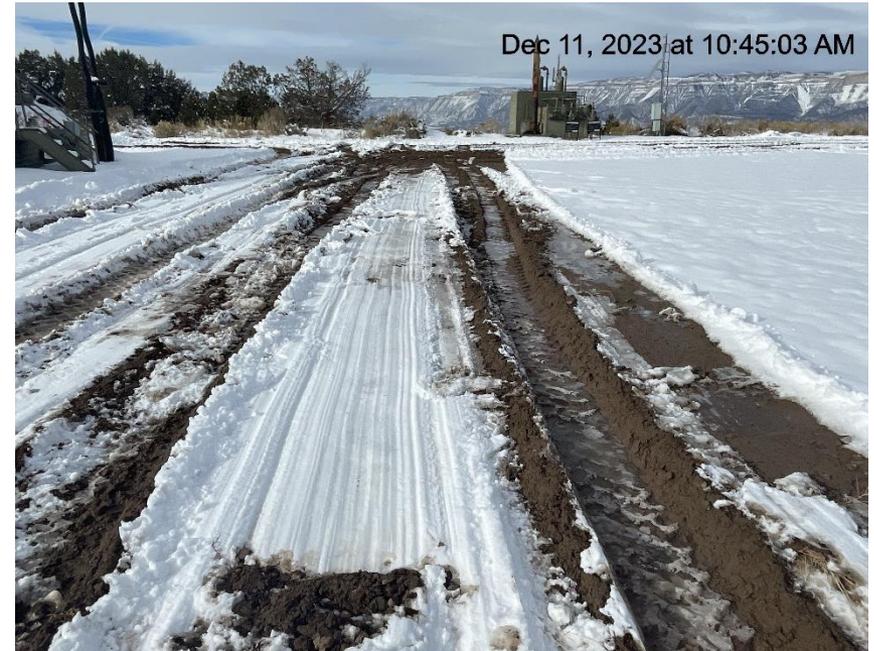
Photo # 9108 Lack of stabilization/compaction/insufficient BMP's on location

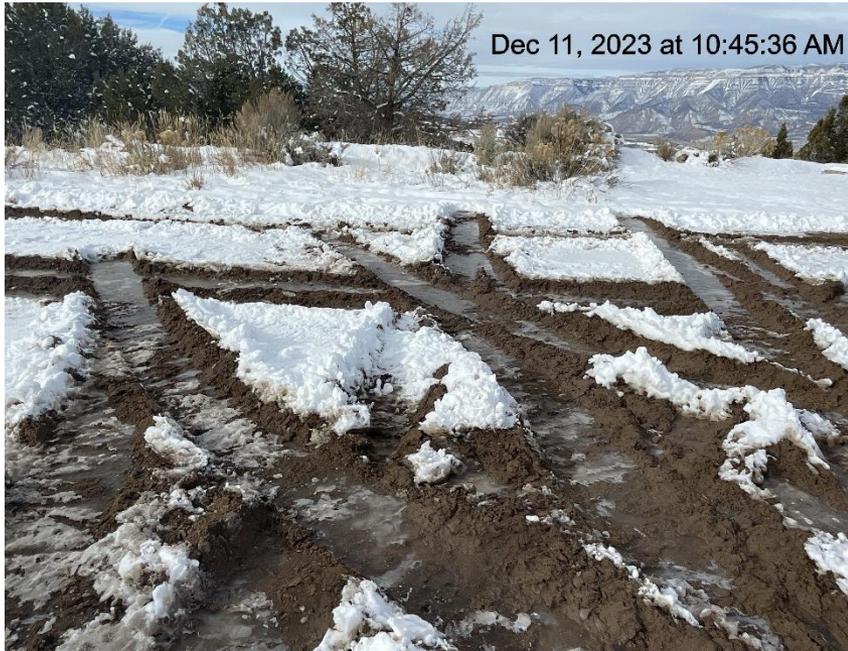
Photo # 9109 Lack of stabilization/compaction/insufficient BMP's on location

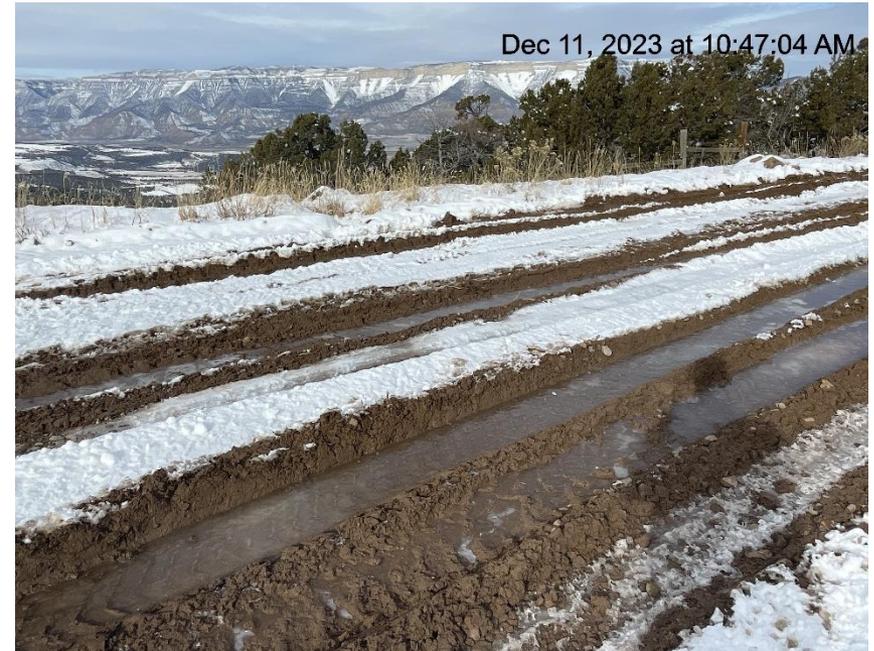
Photo # 9110 Lack of stabilization/compaction/insufficient BMP's on location

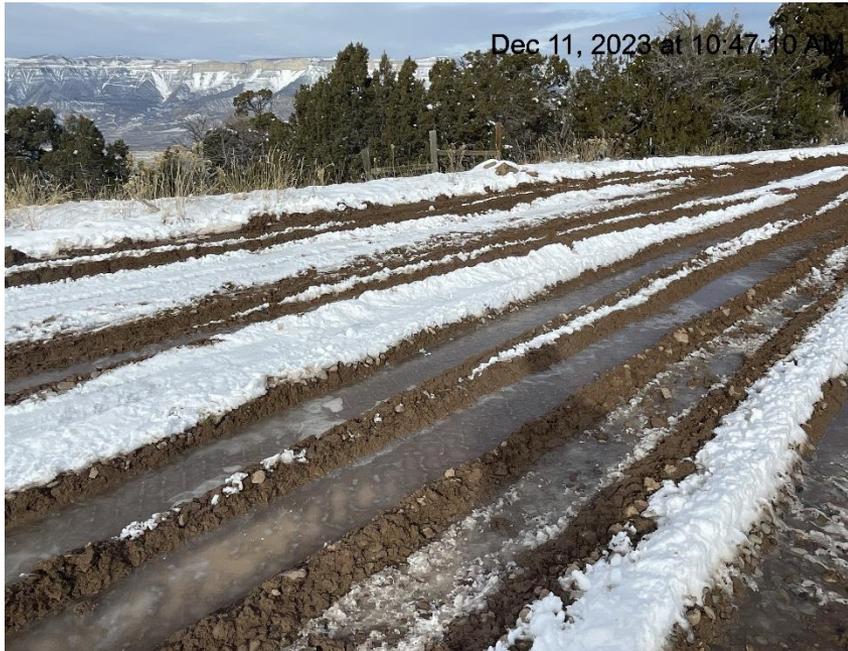
Photo # 9111 Lack of stabilization/compaction/insufficient BMP's on location

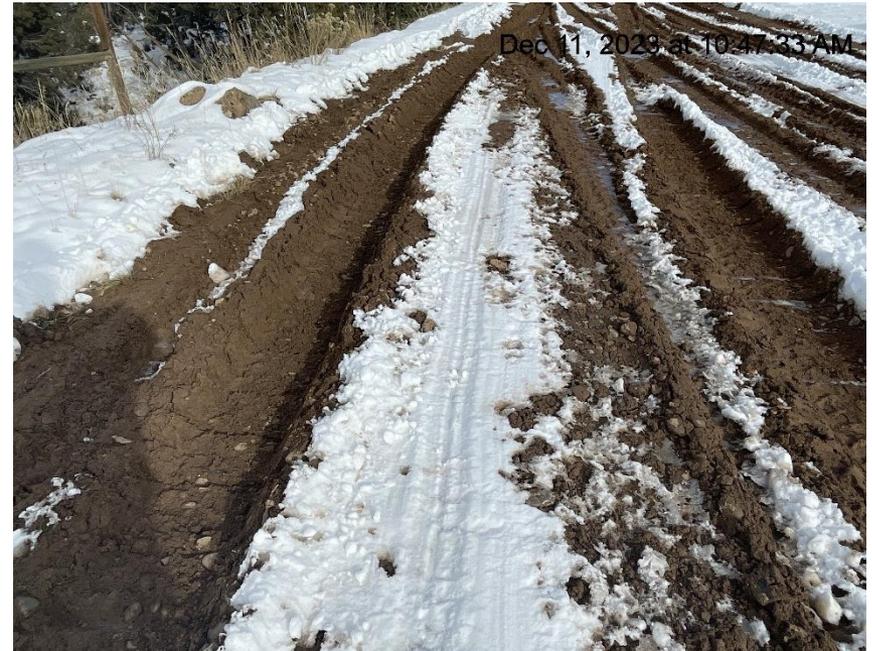
Photo # 9112 Lack of stabilization/compaction/insufficient BMP's on location

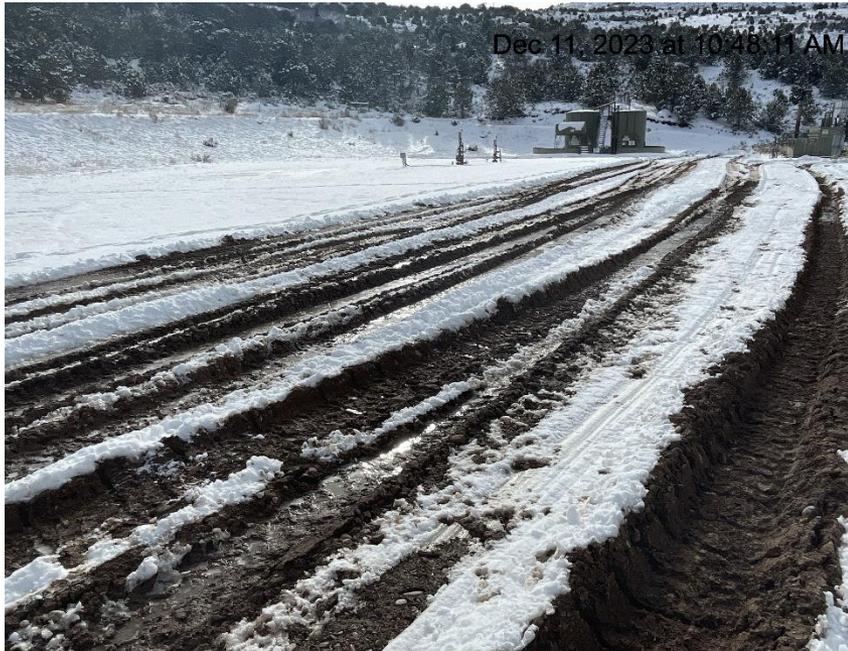
Photo # 9113 Lack of stabilization/compaction/insufficient BMP's on location

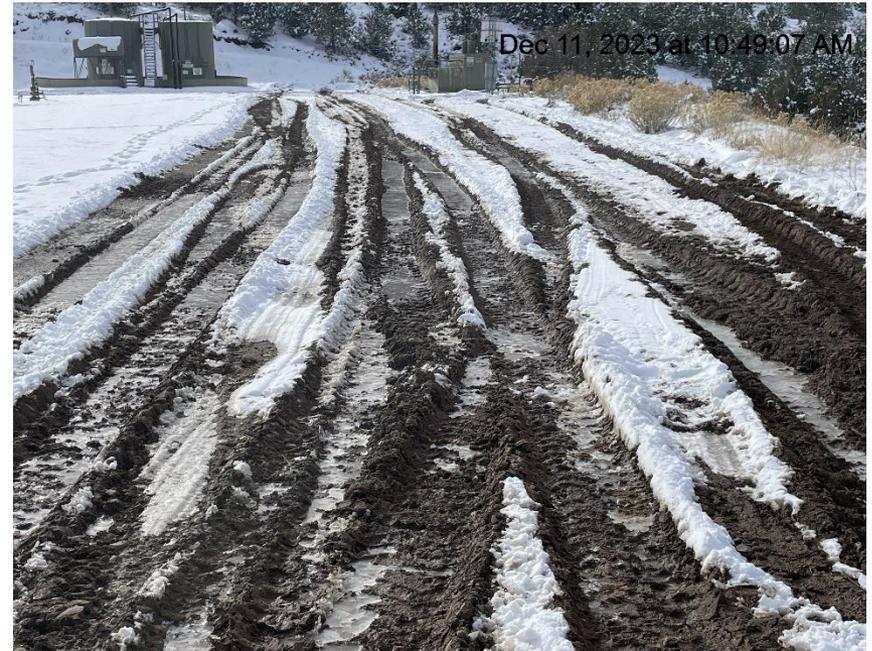
Photo # 9114 Lack of stabilization/compaction/insufficient BMP's on location

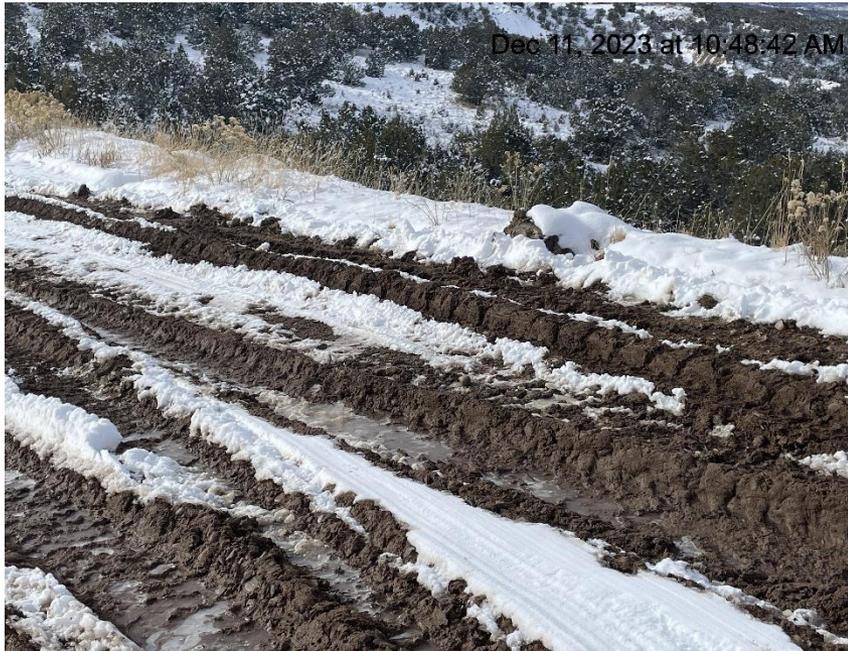
Photo # 9115 Lack of stabilization/compaction/insufficient BMP's on location

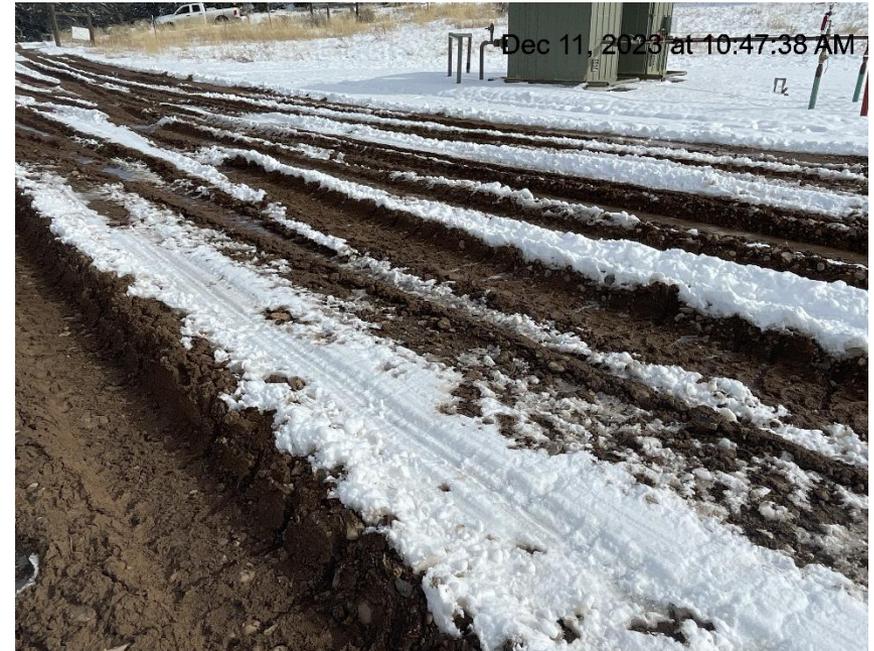
Photo # 9116 Lack of stabilization/compaction/insufficient BMP's on location

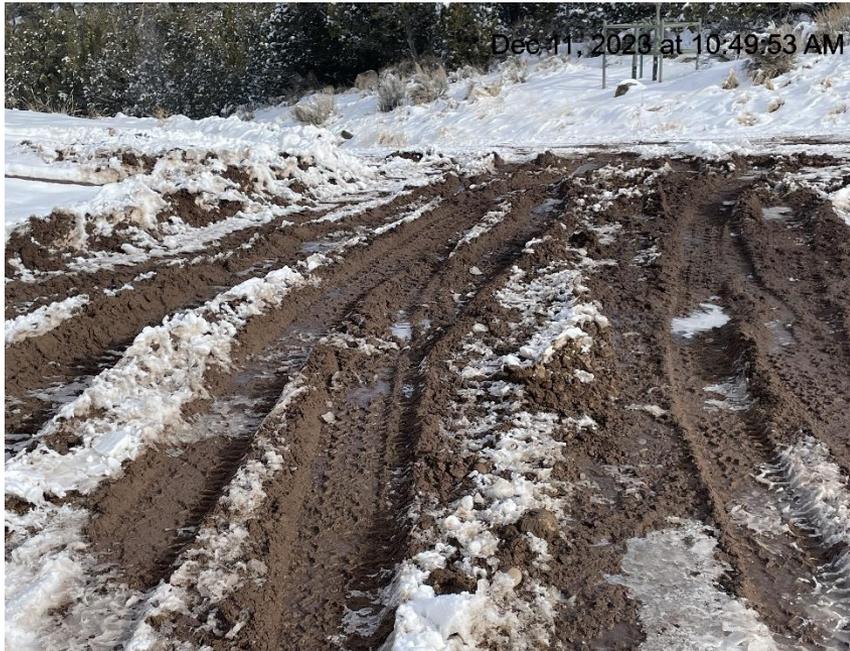
Photo # 9117 Lack of stabilization/compaction/insufficient BMP's on lease road near entrance to location

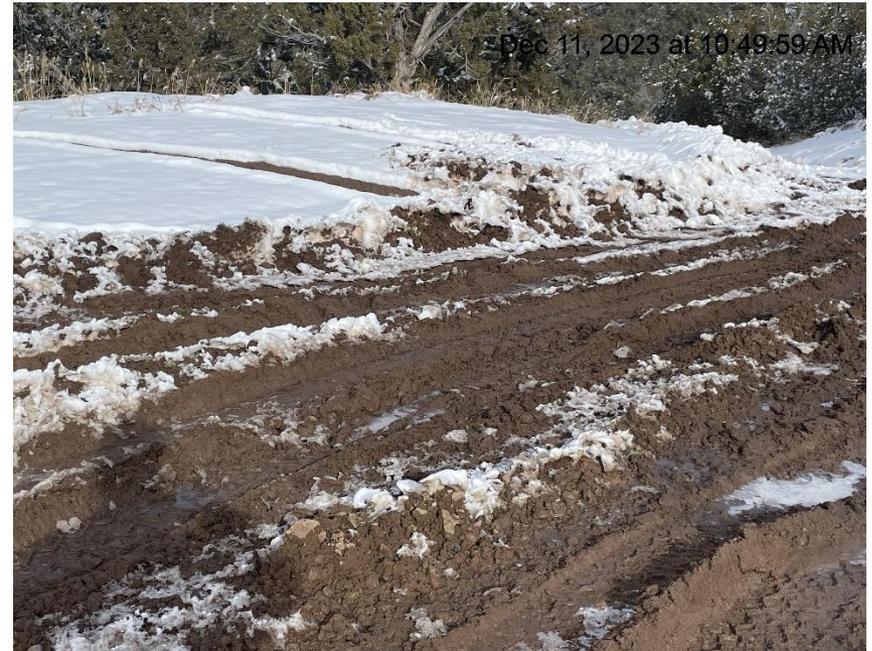
Photo # 9118 Lack of stabilization/compaction/insufficient BMP's on lease road near entrance to location

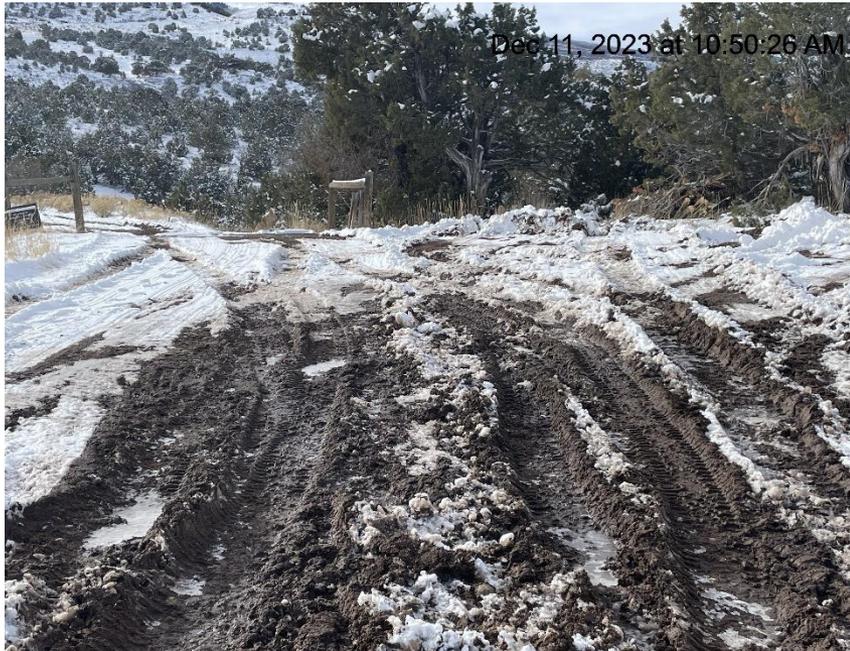
Photo # 9119 Lack of stabilization/compaction/insufficient BMP's on lease road near entrance to location

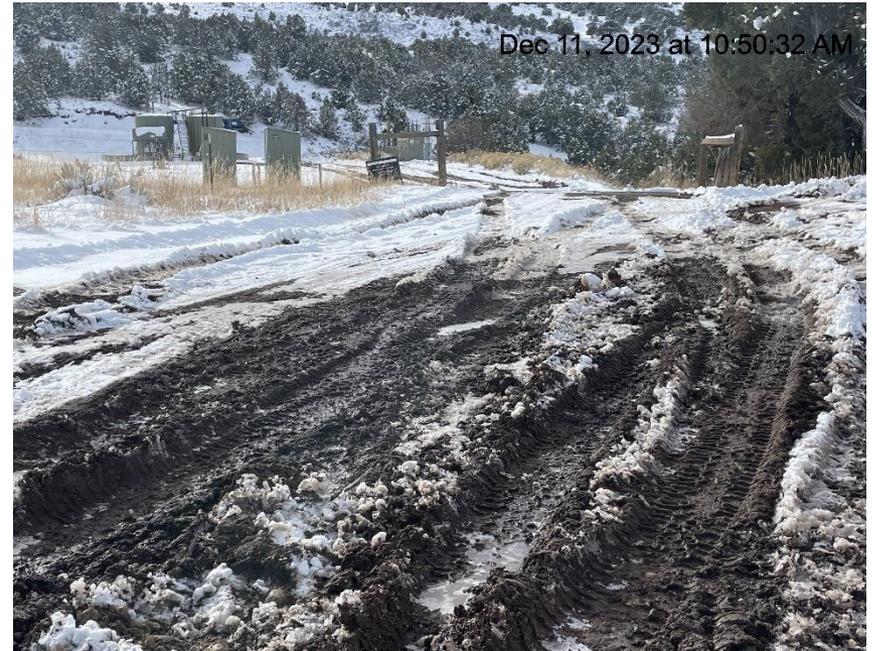
Photo # 9120 Lack of stabilization/compaction/insufficient BMP's on lease road near entrance to location

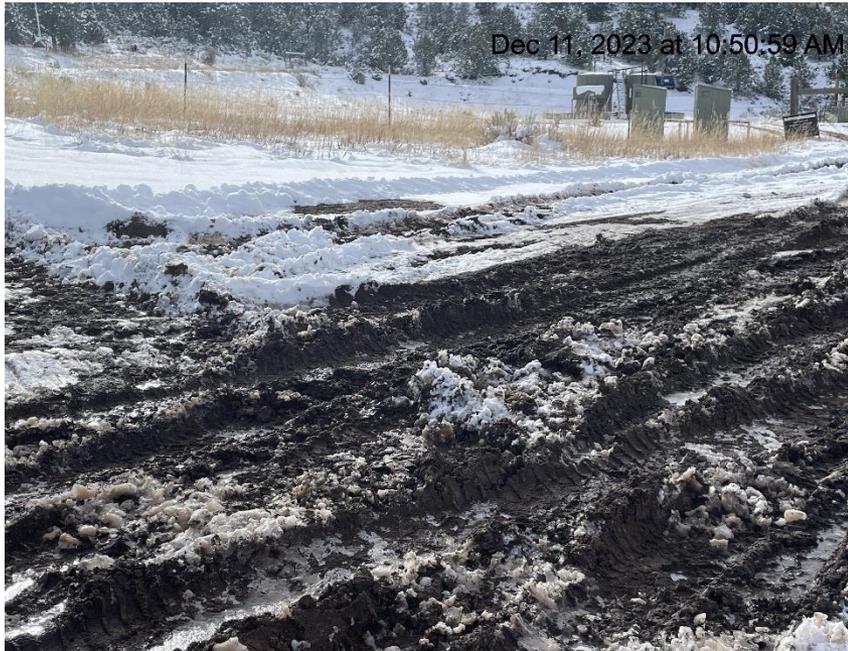
Photo # 9121 Lack of stabilization/compaction/insufficient BMP's on lease road near entrance to location

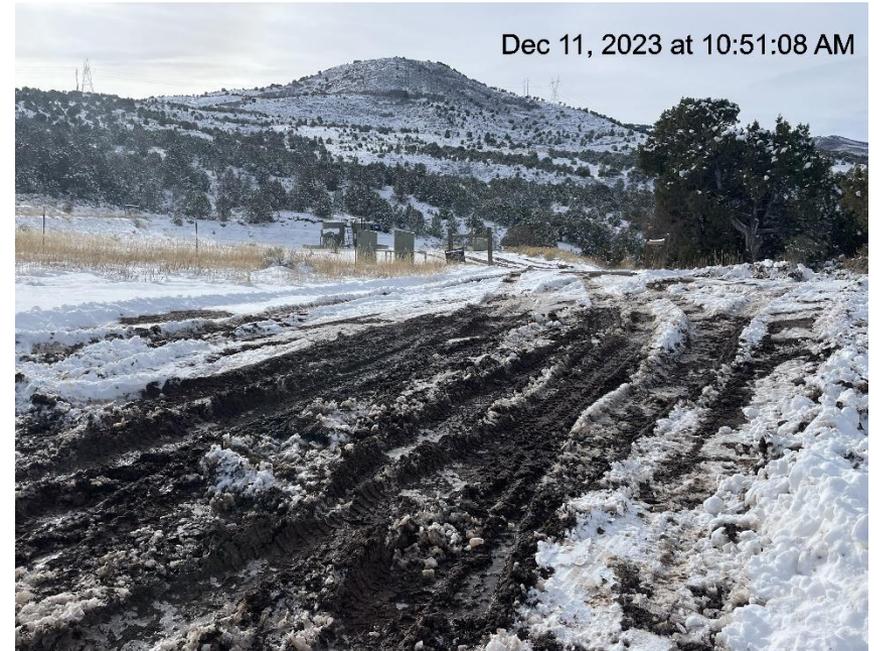
Photo # 9122 Lack of stabilization/compaction/insufficient BMP's on lease road near entrance to location
