Inspection Photos
Location Name: Antelope 18I PAD
Location ID: 418173

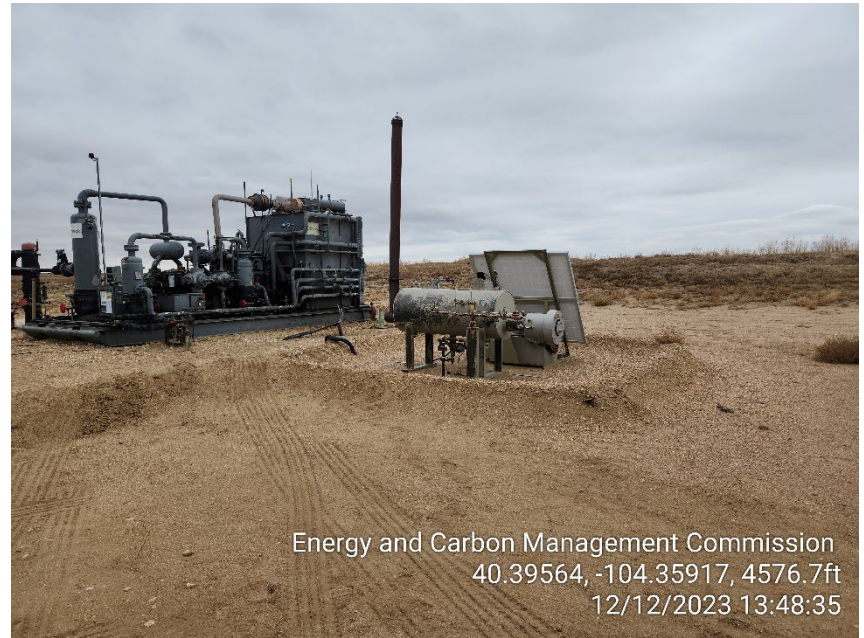
Photo 2 – Compressor and Glycol Unit

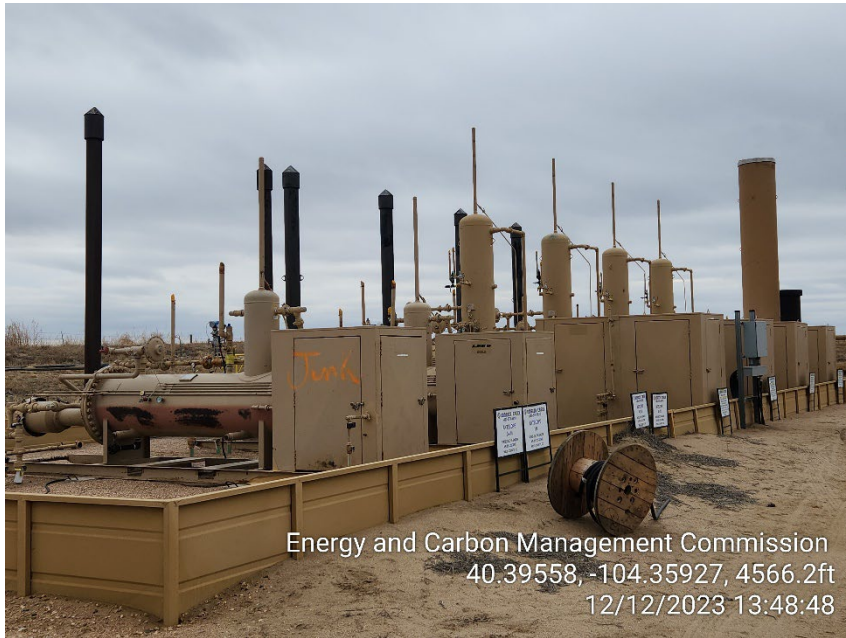
Photo 3 – Separators

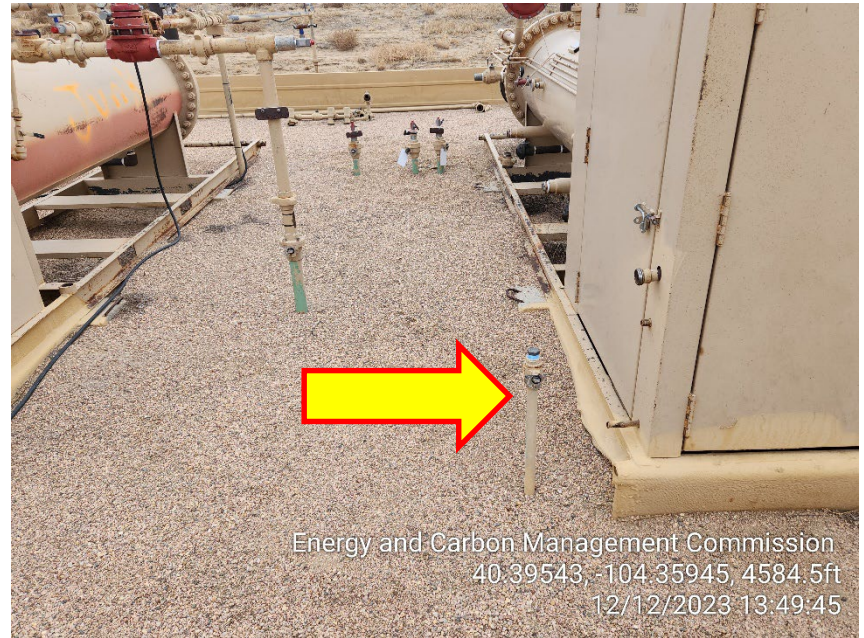
Photo 4 – Unmarked OOSLAT 1" Riser

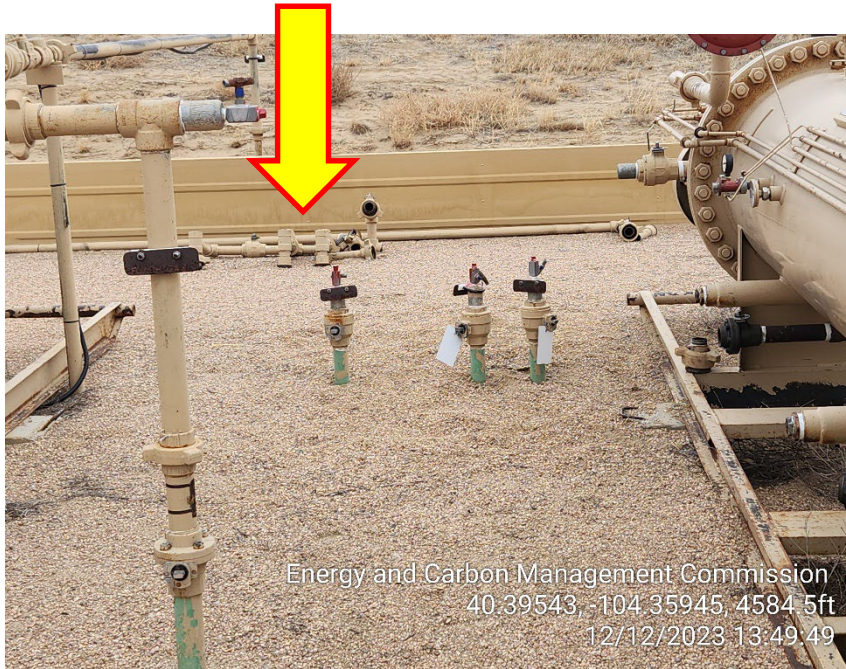
Photo 5 – Unused Pipe and Parts

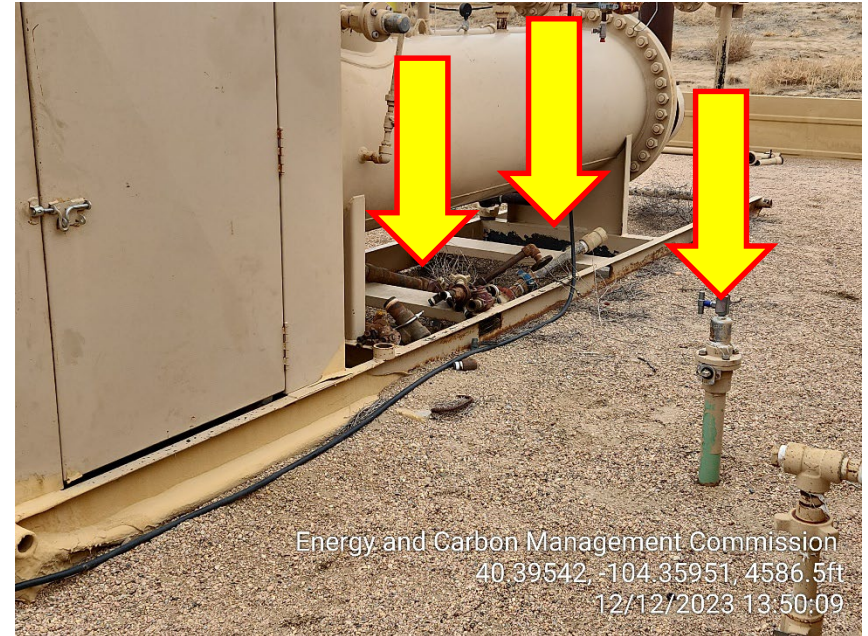
Photo 6 – Unmarked OOSLAT 2" Riser and unused Parts and Piping

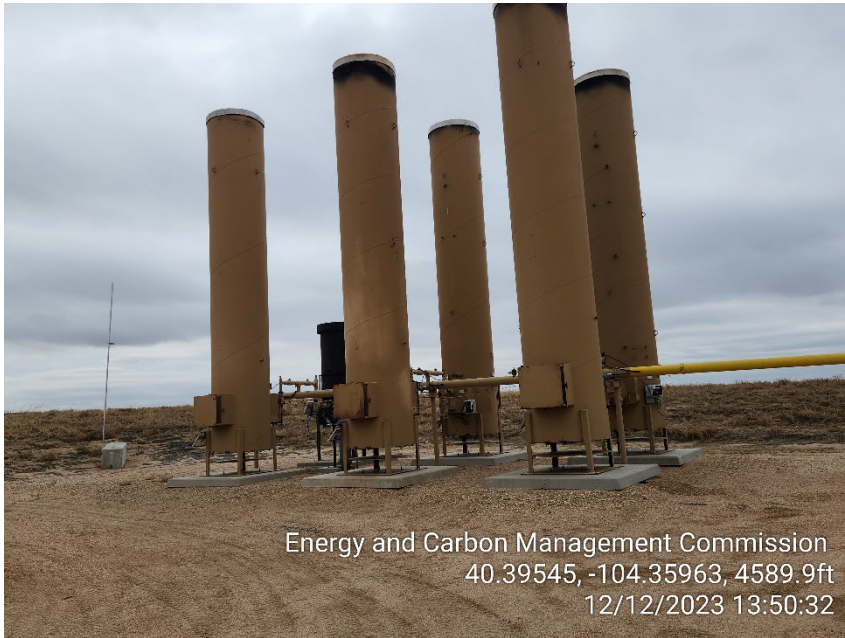
Photo 7 – ECDs

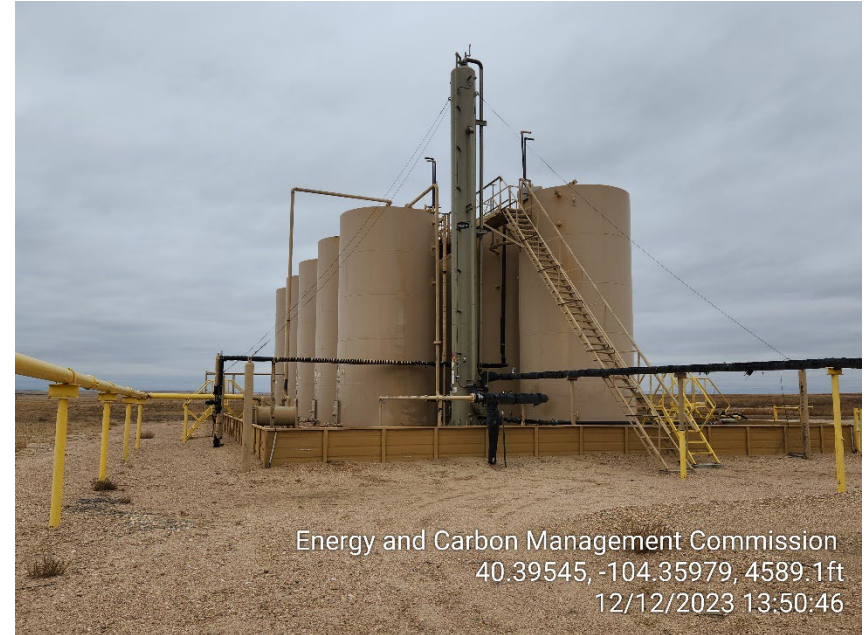
Photo 8 – Tank Battery

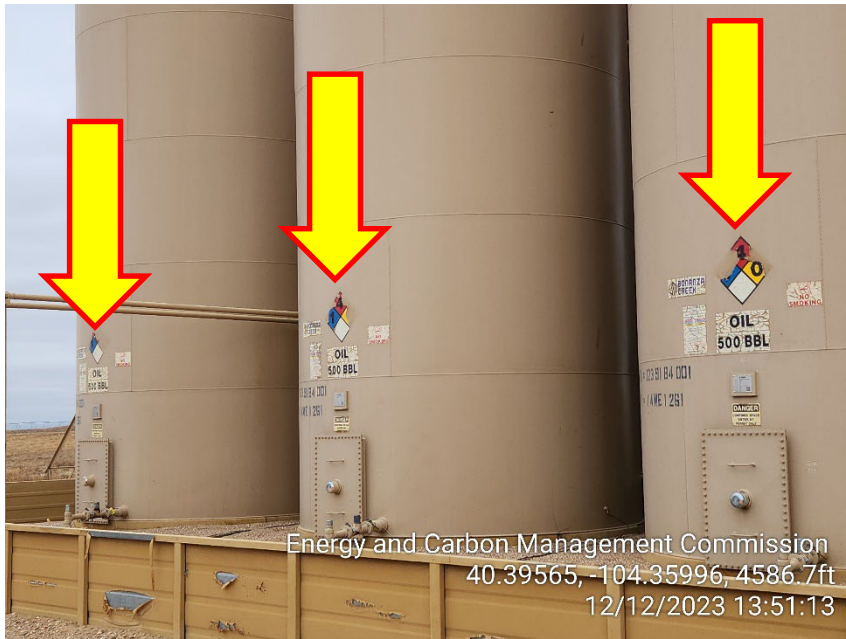
Photo 9 – NFPA Labels on West Side Tanks

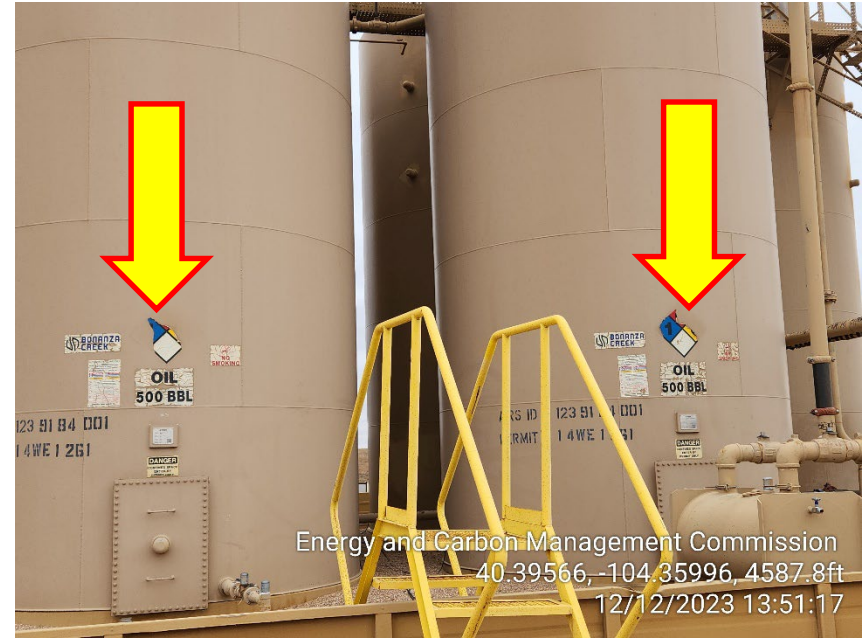
Photo 10 – NFPA Labels on West Side Tanks

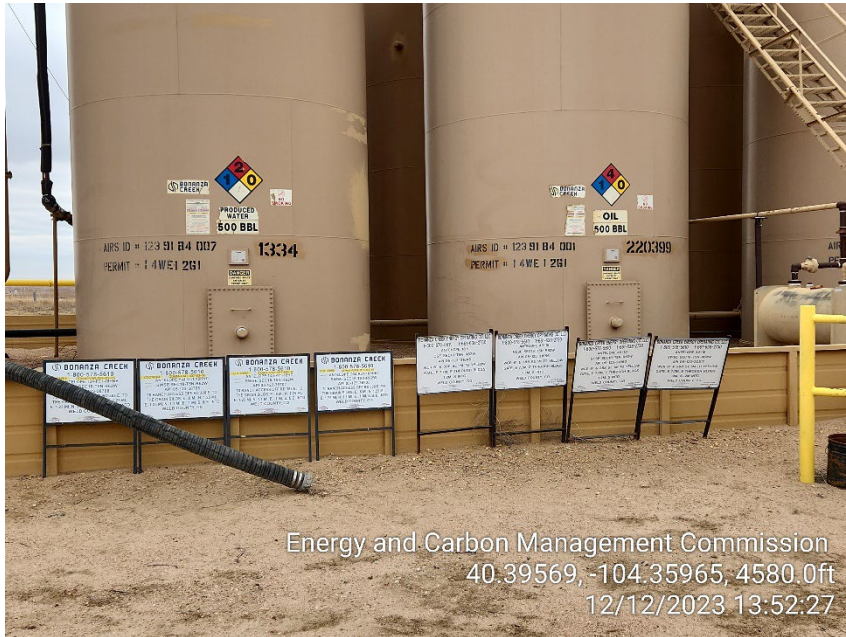
Photo 11 – Tank Battery Signs

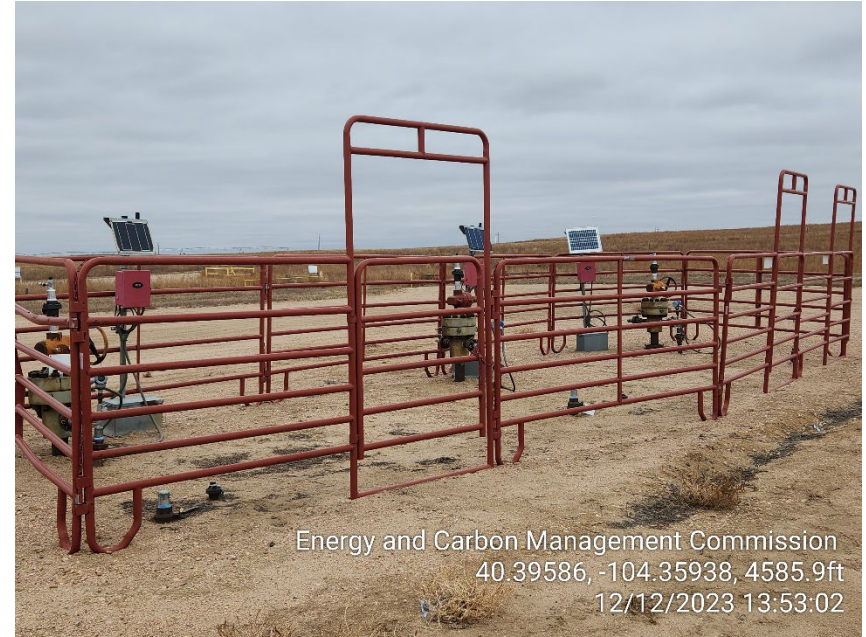
Photo 12 – Wellheads

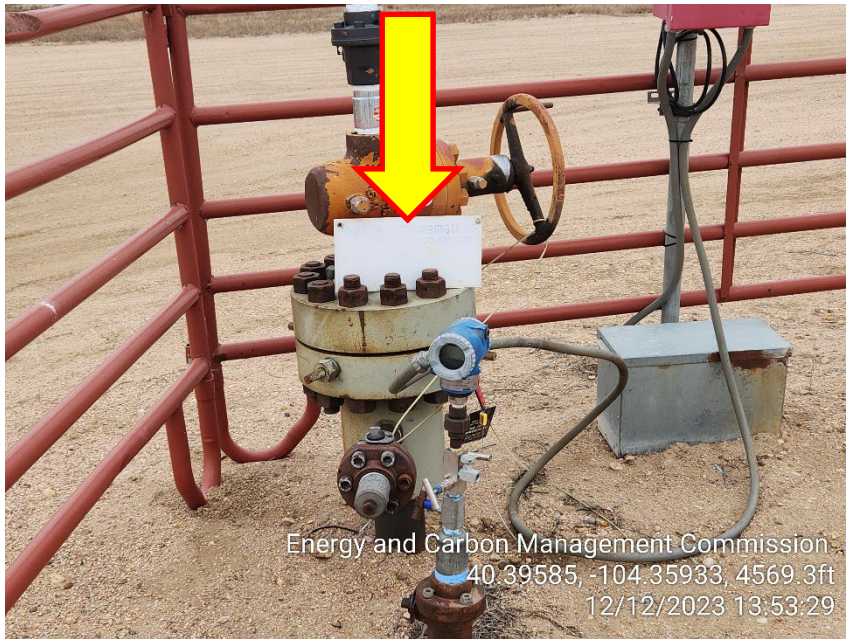
Photo 13 – Wellhead Sign Faded no longer visible

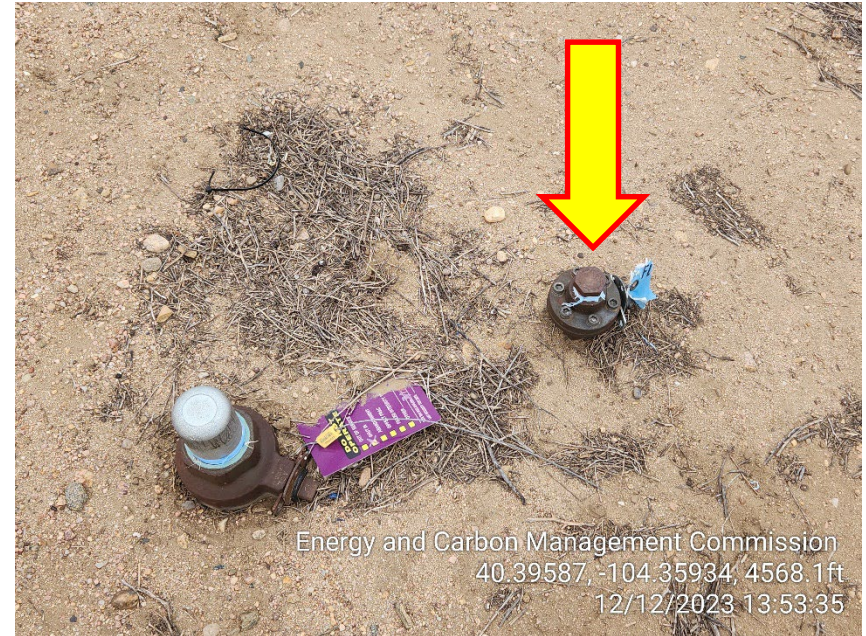
Photo 14 – Unmarked OOSLAT 1" Riser

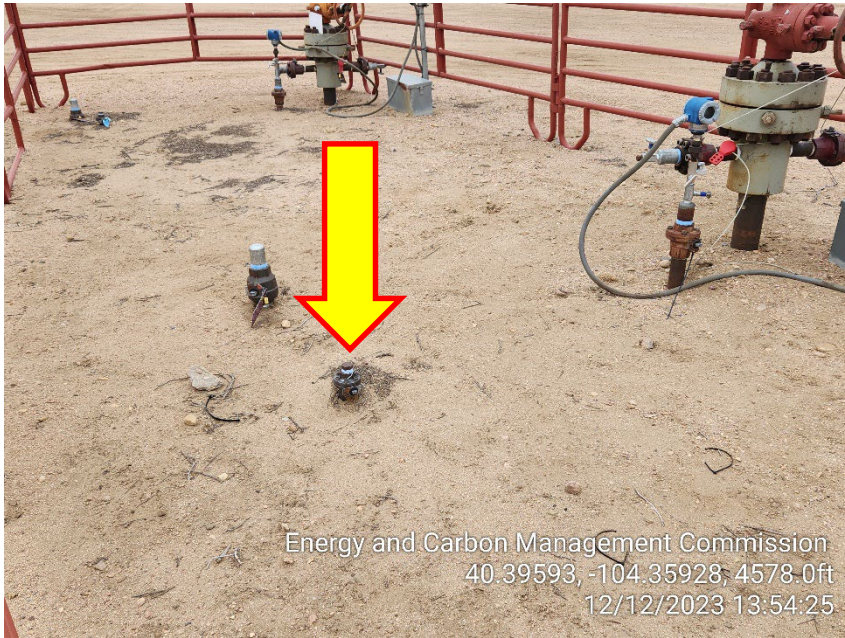
Photo 15 – Unmarked OOSLAT 1" Riser

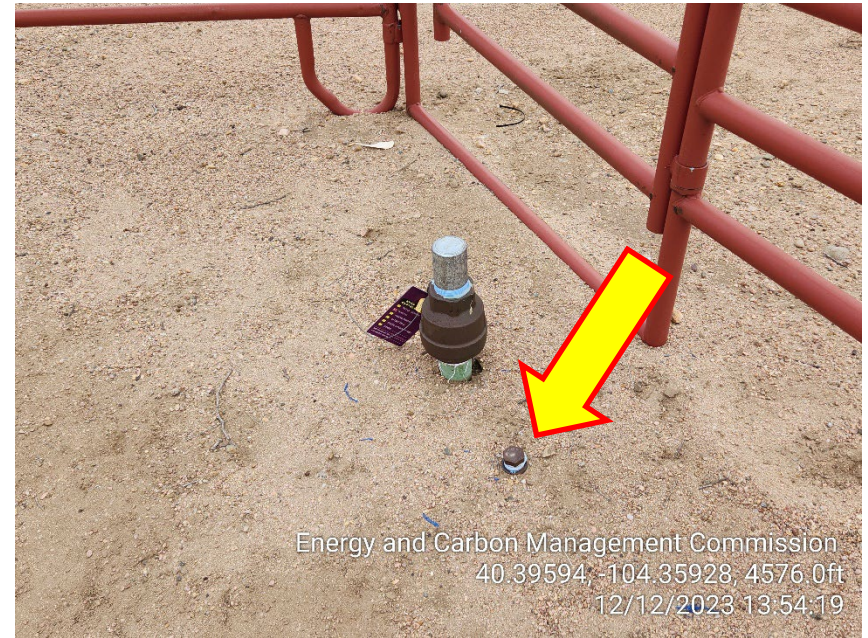
Photo 16 – Unmarked OOSLAT 1" Riser

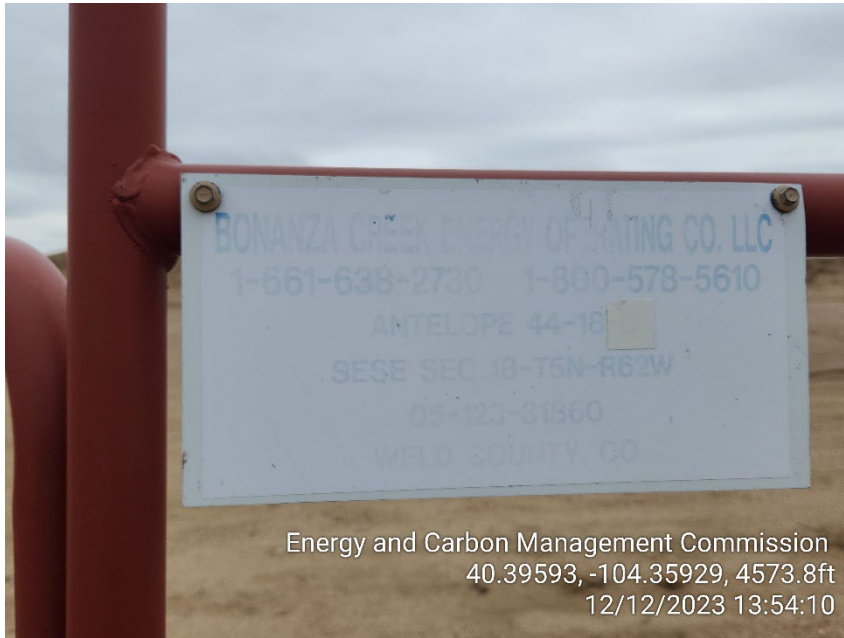
Photo 17 – Wellhead Sign faded no longer visible

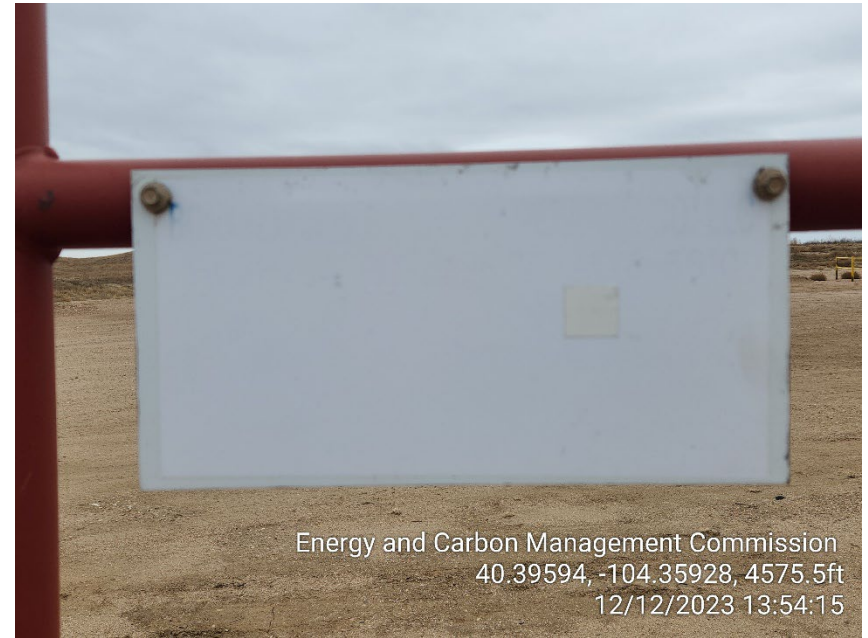
Photo 18 – Wellhead Sign faded no longer visible
