Inspection Photos

Operator: ANSCHUTZ EXPLORATION CORP
#3104

Location ID: 484545

Inspection Doc: 696205471

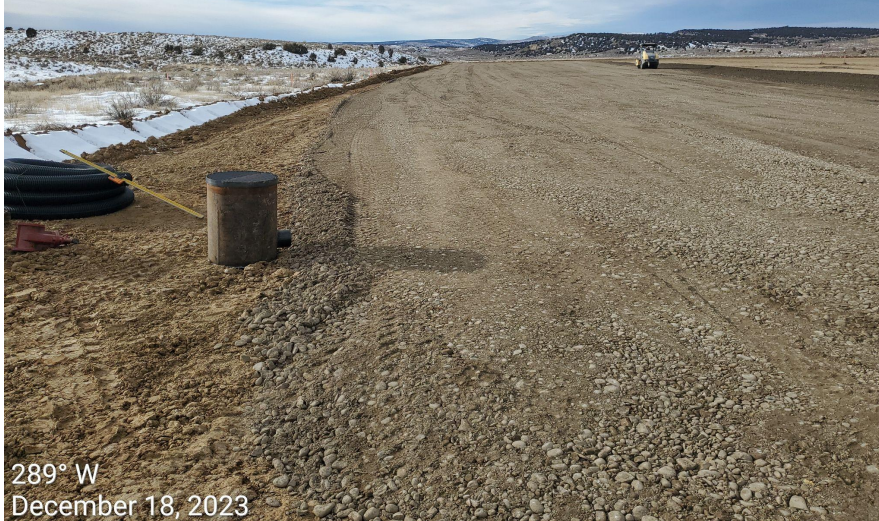
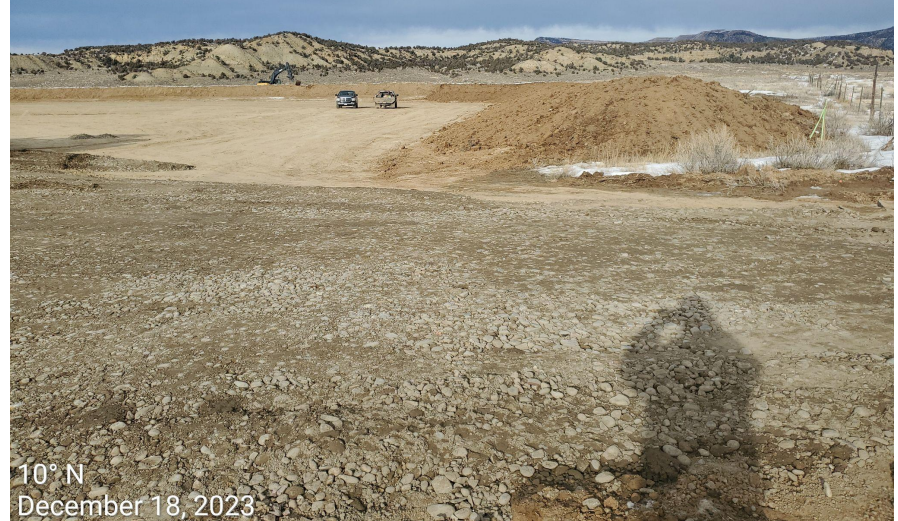
Photo 1: Photos taken from the Location entrance, on the southeast end of the Location. Photos provide an overview of the Location from west to north.

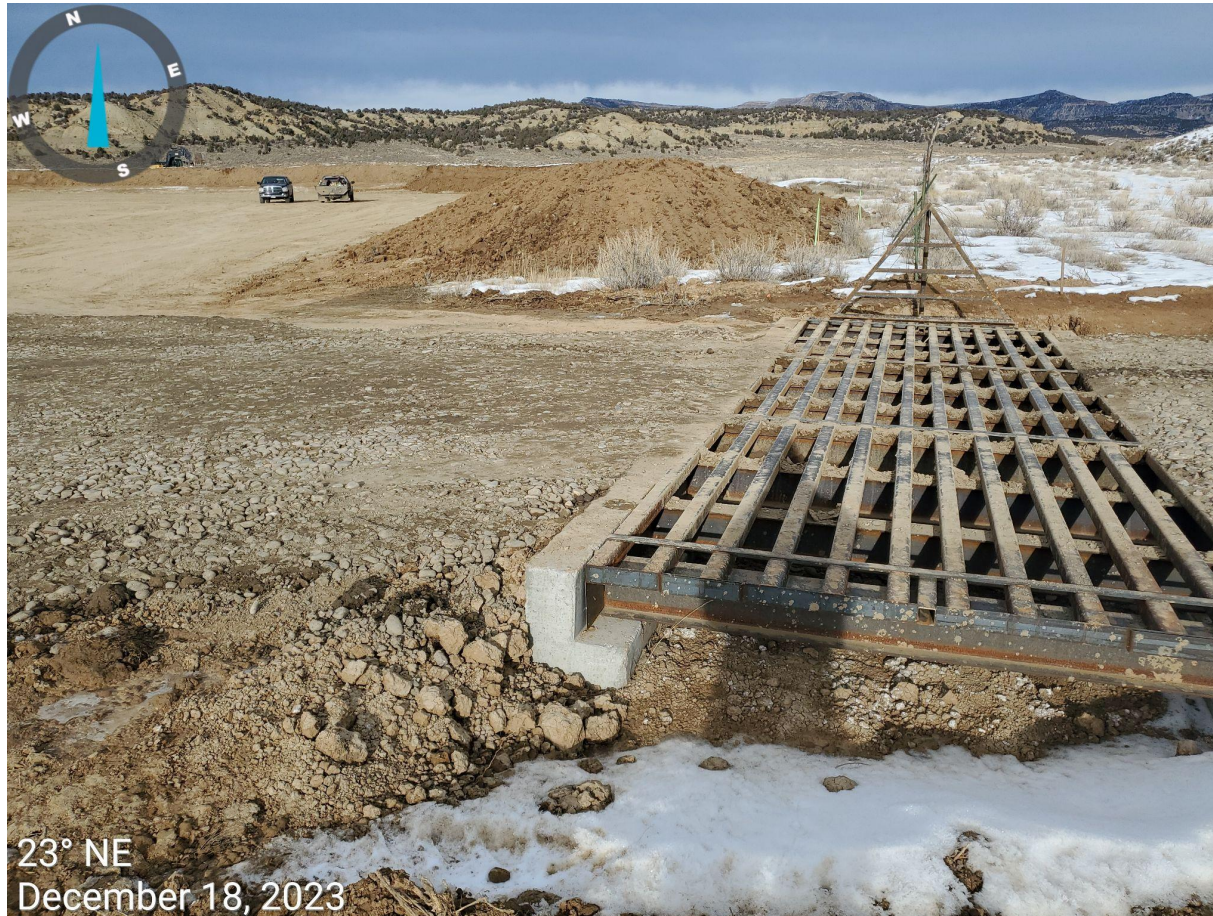
Photo 2: Photo shows Location entrance on the southeast end of the Location.

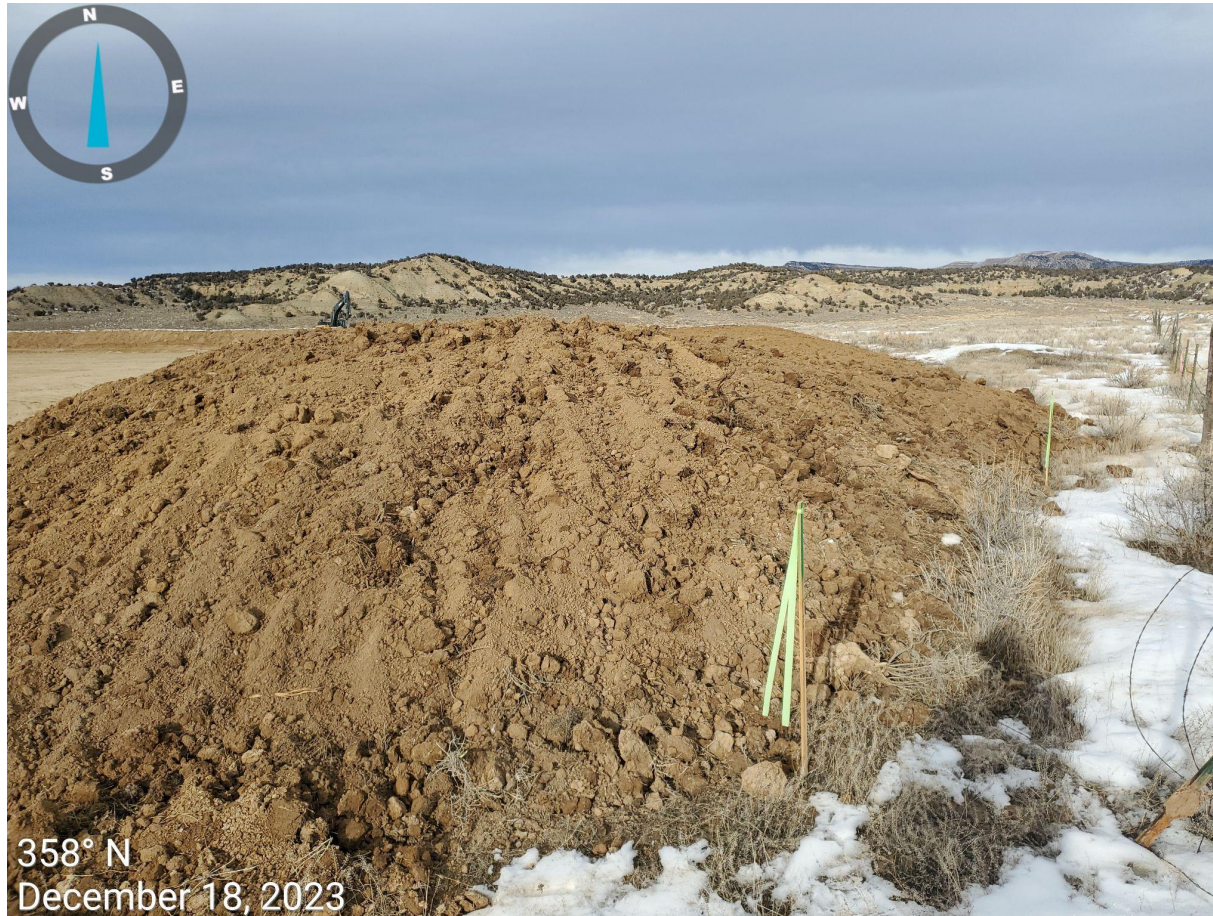
Photo 3: Photo taken from the topsoil stockpile on the southeast end of the Location, facing north. BMPs to protect the topsoil stockpile, as well as BMPs to minimize erosion, degradation and sediment transport have not been installed at the stockpiles, and perimeter of the Location.

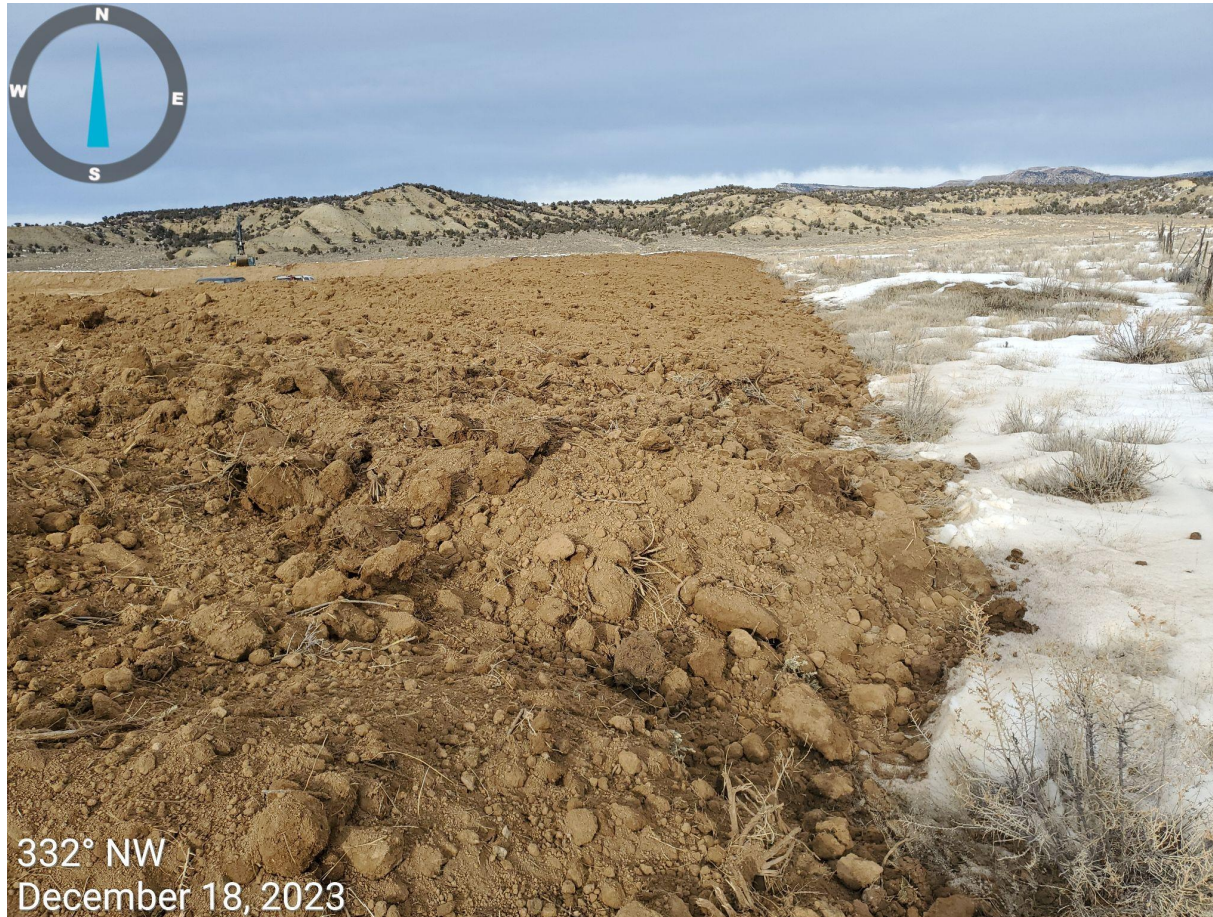
Photo 4: Photo taken from the topsoil stockpile on the east end of the Location, facing north. BMPs to protect the topsoil stockpile, as well as BMPs to minimize erosion, degradation and sediment transport have not been installed at the stockpiles, and perimeter of the Location.

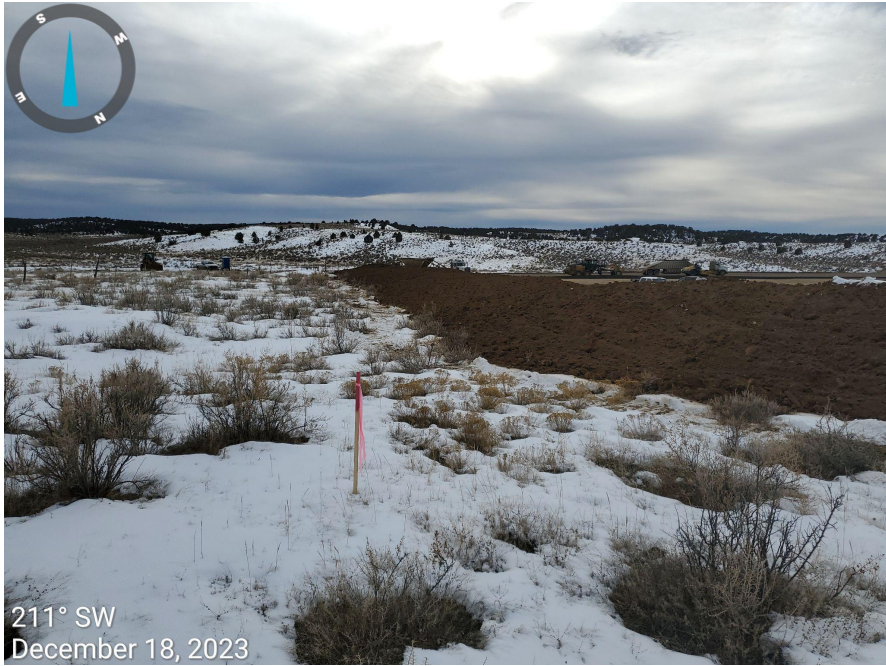
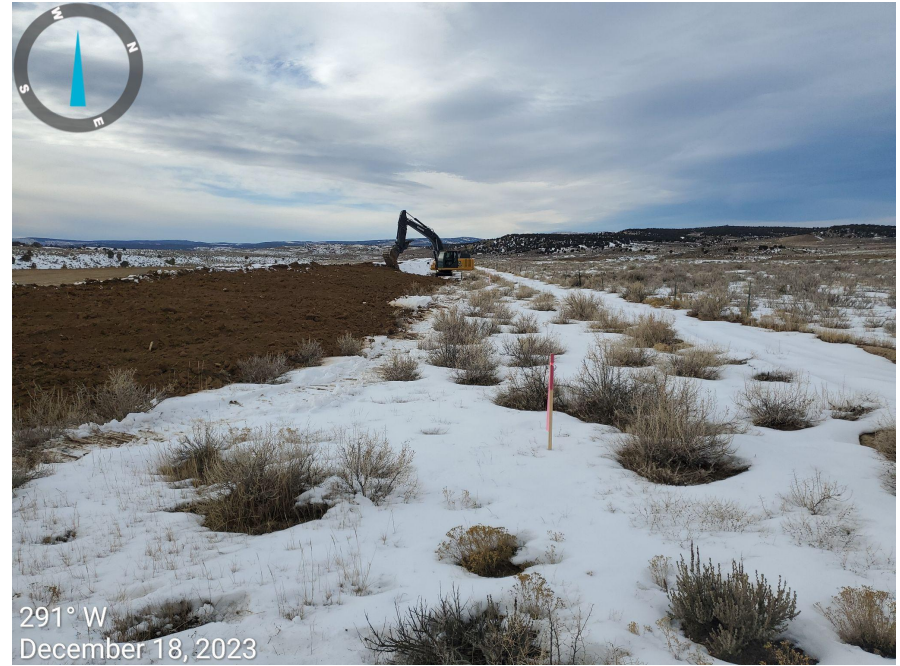
Photo 5: Photos taken from the northeast corner of the Location. Photos provide an overview of the Location, and the Location's perimeter/disturbance, from southwest to northwest. Photos show stormwater and erosion control measures have not been implemented along the location's perimeter, and topsoil stockpiles.

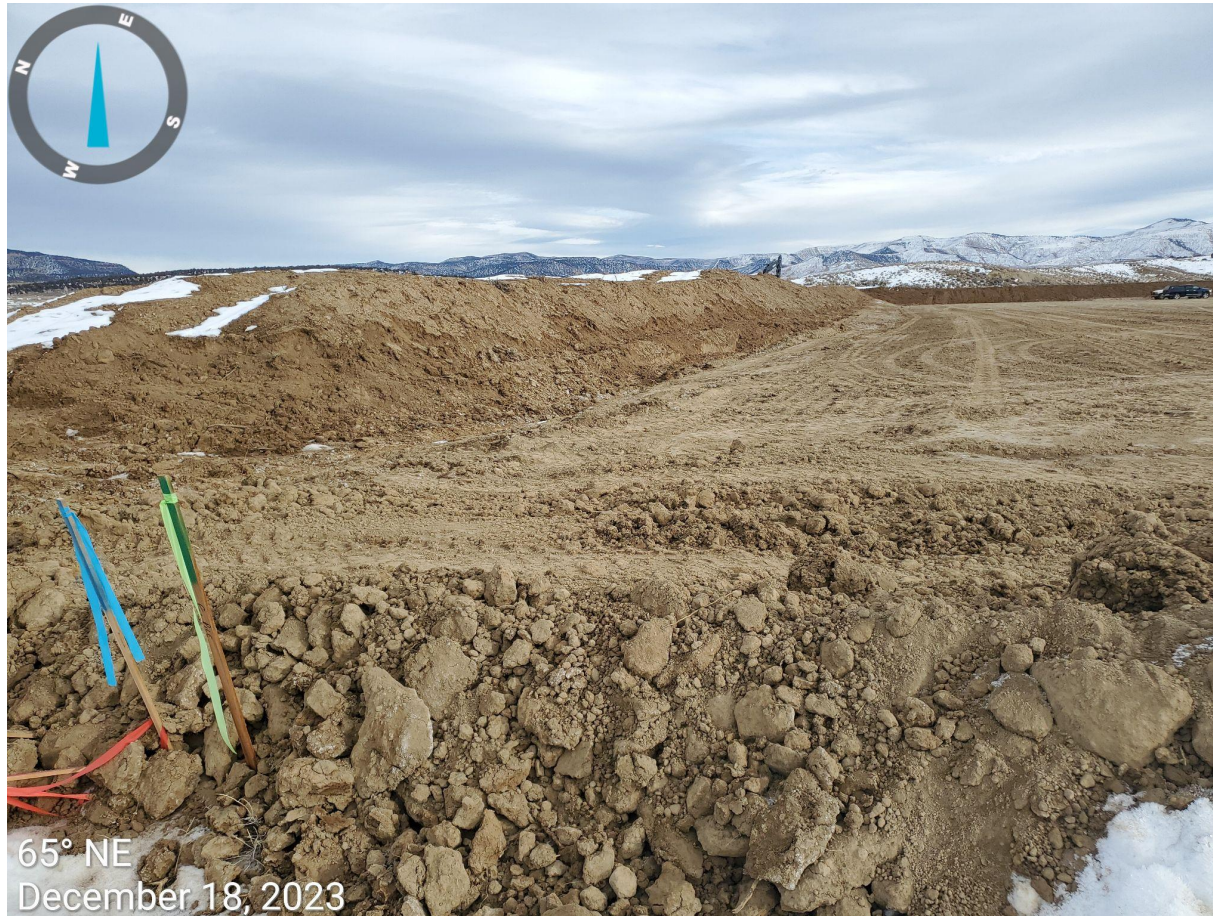
Photo 6: Photo shows the topsoil stockpile along the east end of the Location. BMPs to protect the topsoil, as well as to minimize erosion, degradation, sediment transport, and to ensure topsoil remains segregated have not been implemented.

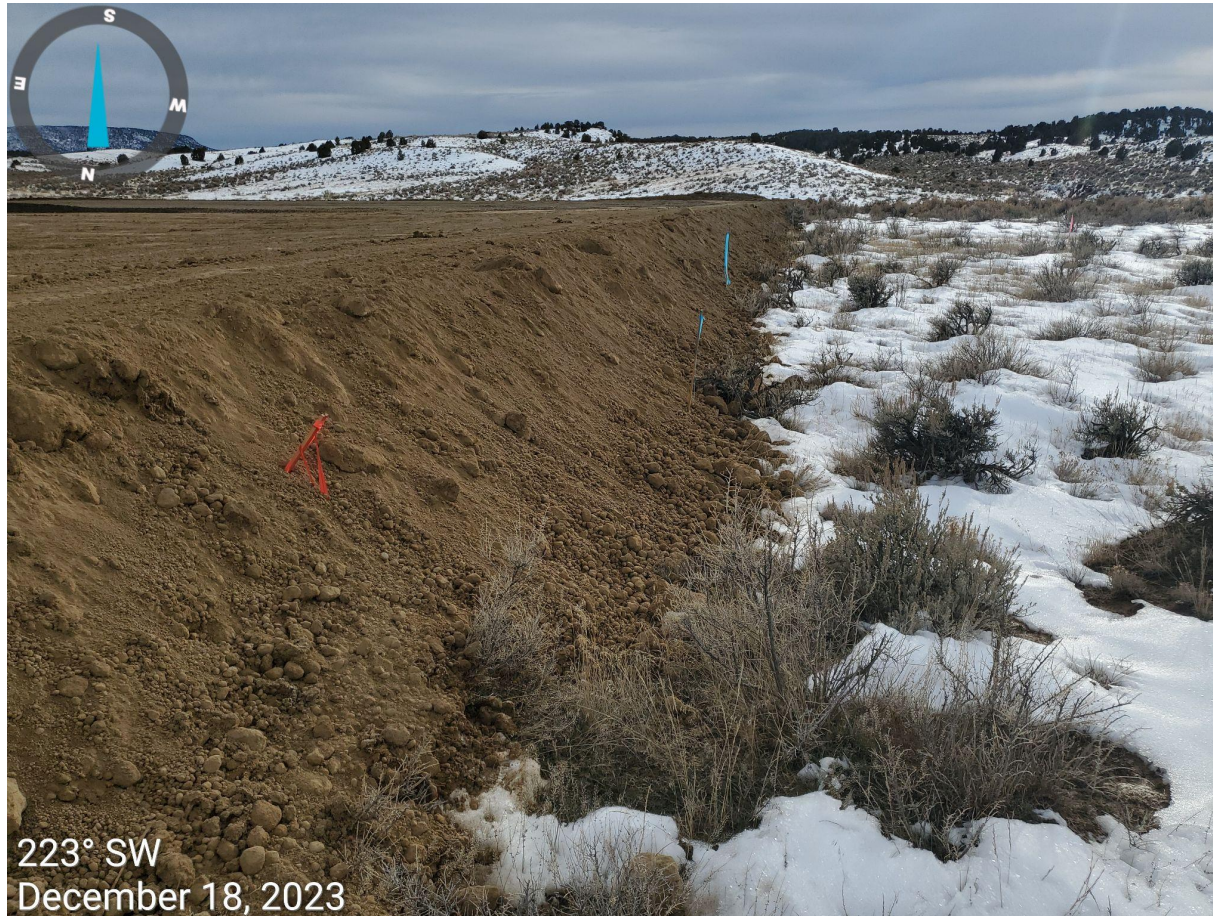
Photo 6: Photo taken from the north end of the Location. Photo shows fill slopes lack stabilization. Photo also shows stormwater and erosion control measures to minimize erosion, degradation and sediment transport have not been implemented along the location's perimeter.

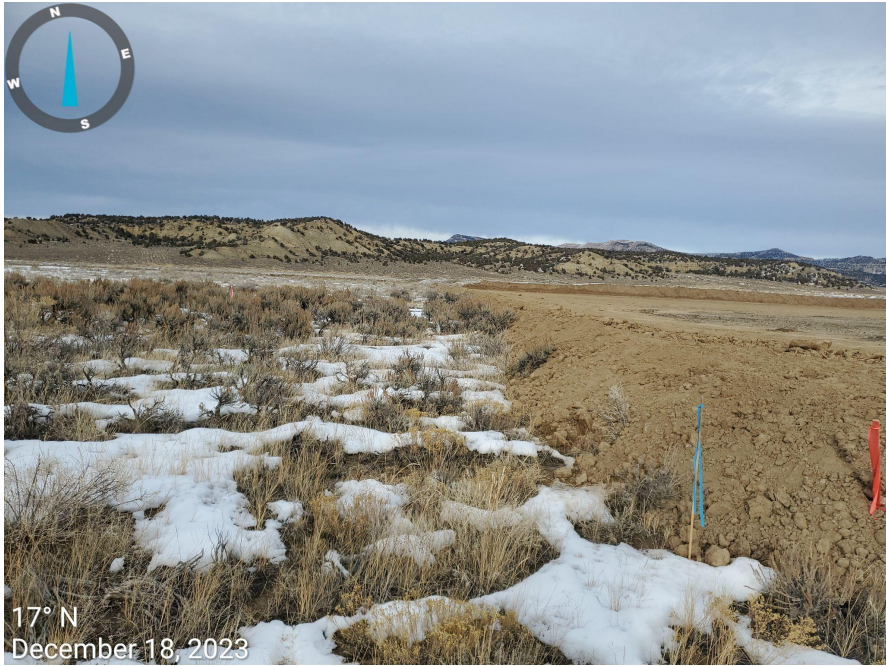
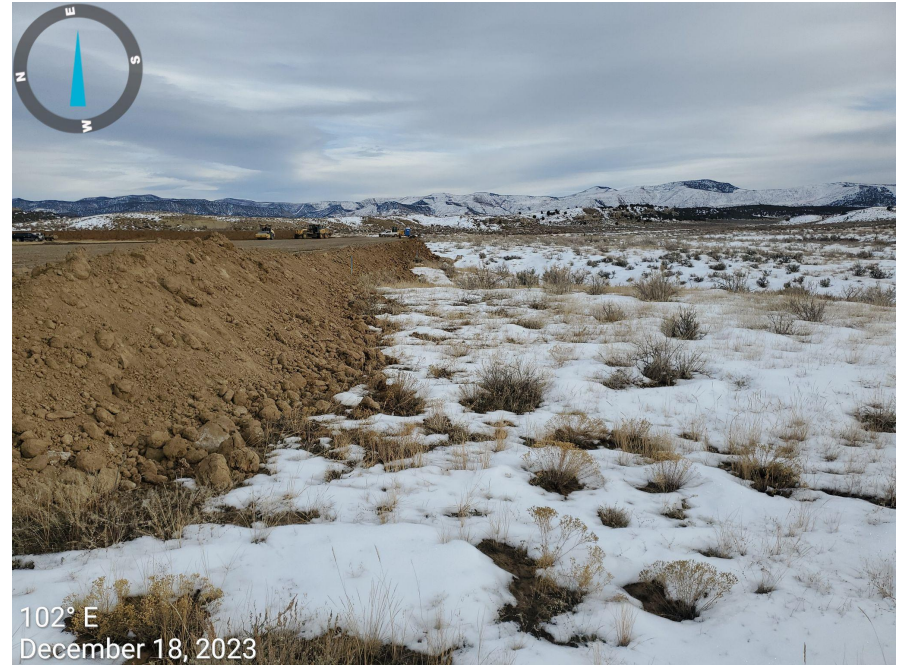
Photo 6: Photos taken from the southwest corner of the Location. Photos provide an overview of the Location, and the Location's perimeter/disturbance, from north to west. Photos show stormwater and erosion control measures have not been implemented along the location's perimeter. Photos also show fill slopes lack stabilization.

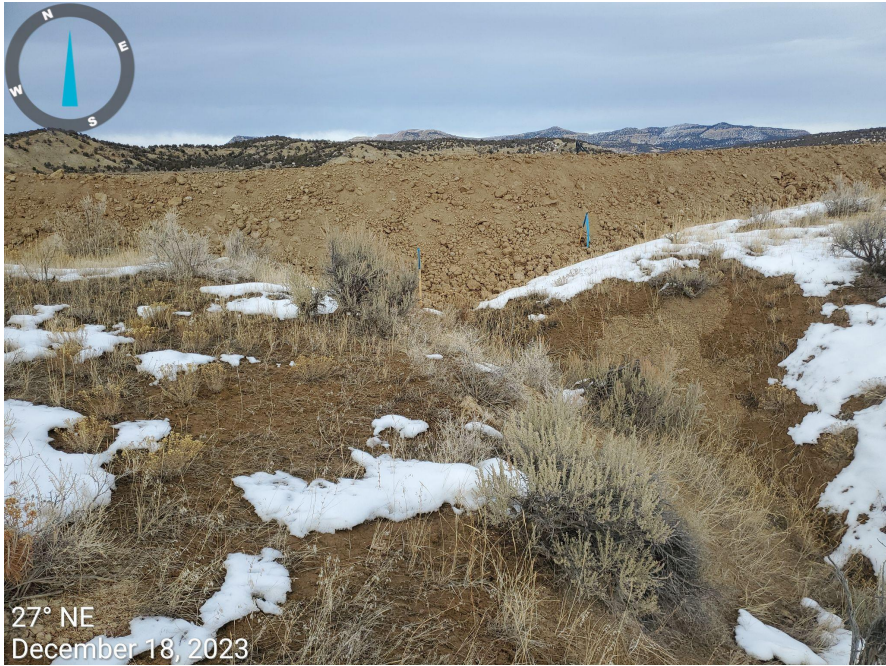
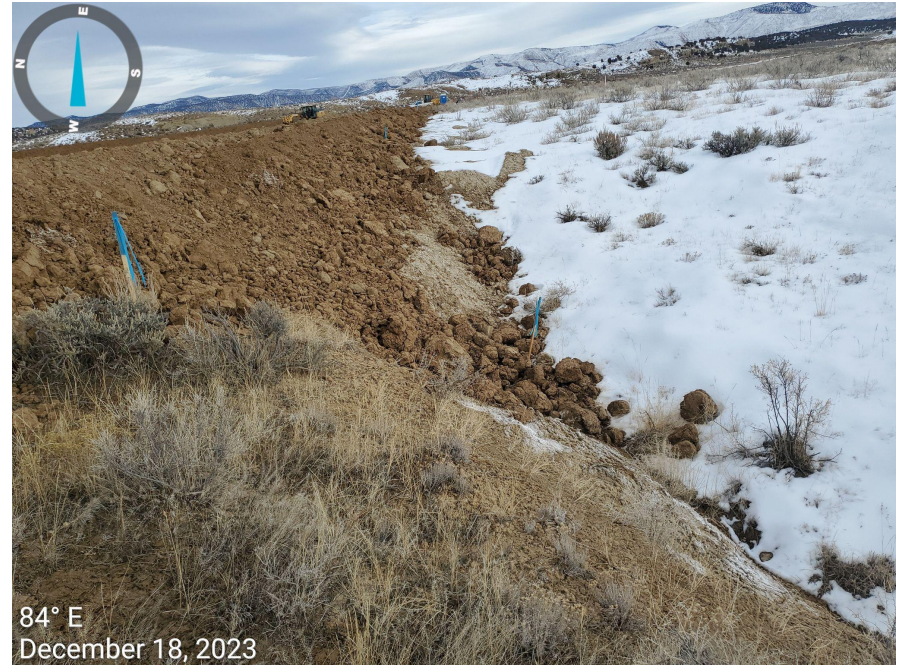
Photo 9: Photos taken from the southern end of the Location. Photos examples showing fill material has been pushed into drainages of Rimrock Gulch, an intermittent stream and designated Aquatic Sportfish Management Waters. Photos show fill slopes lack stabilization, and stormwater and erosion control measures have not been implemented along the location's perimeter. Location at risk of off-site sediment transport and impacting waters of the state.

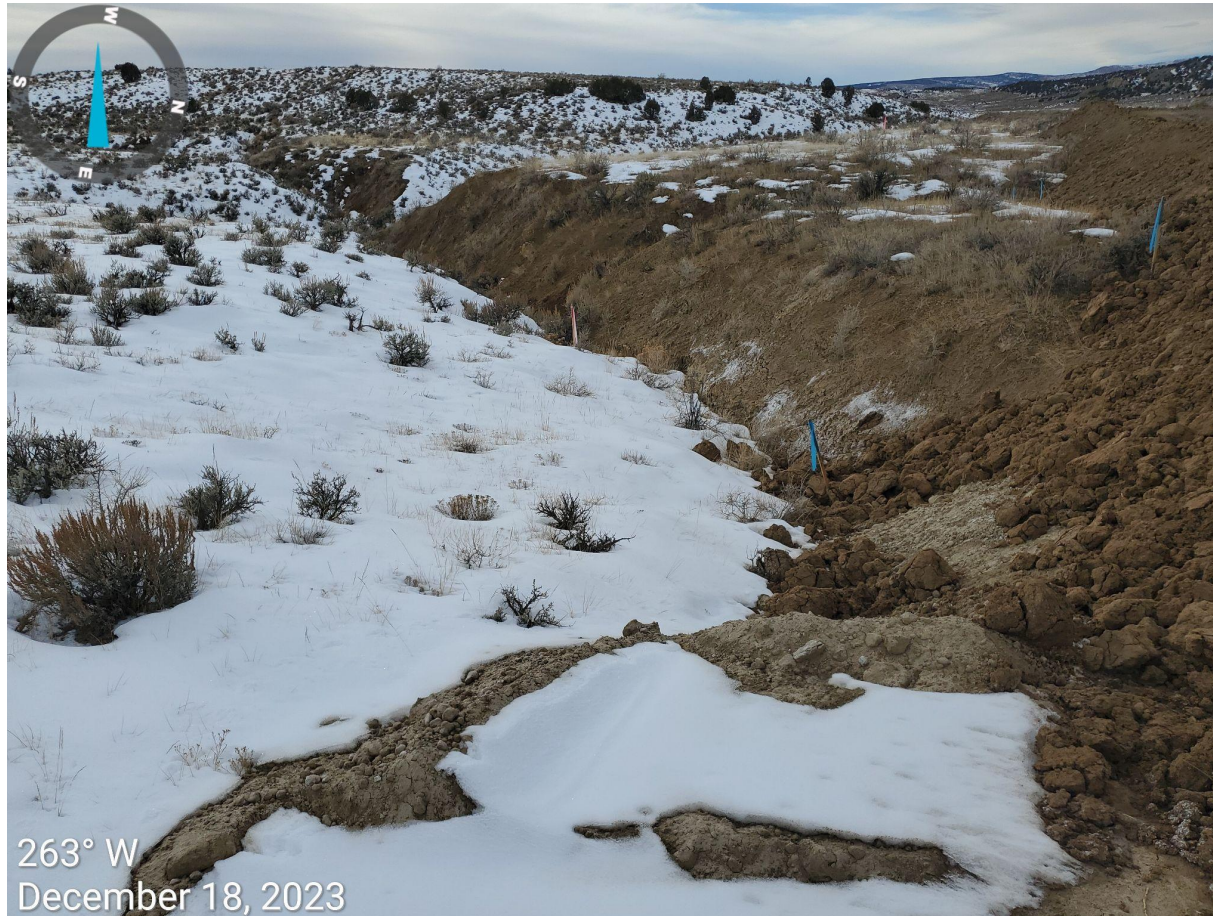
Photo 10: See comments under photo 9.

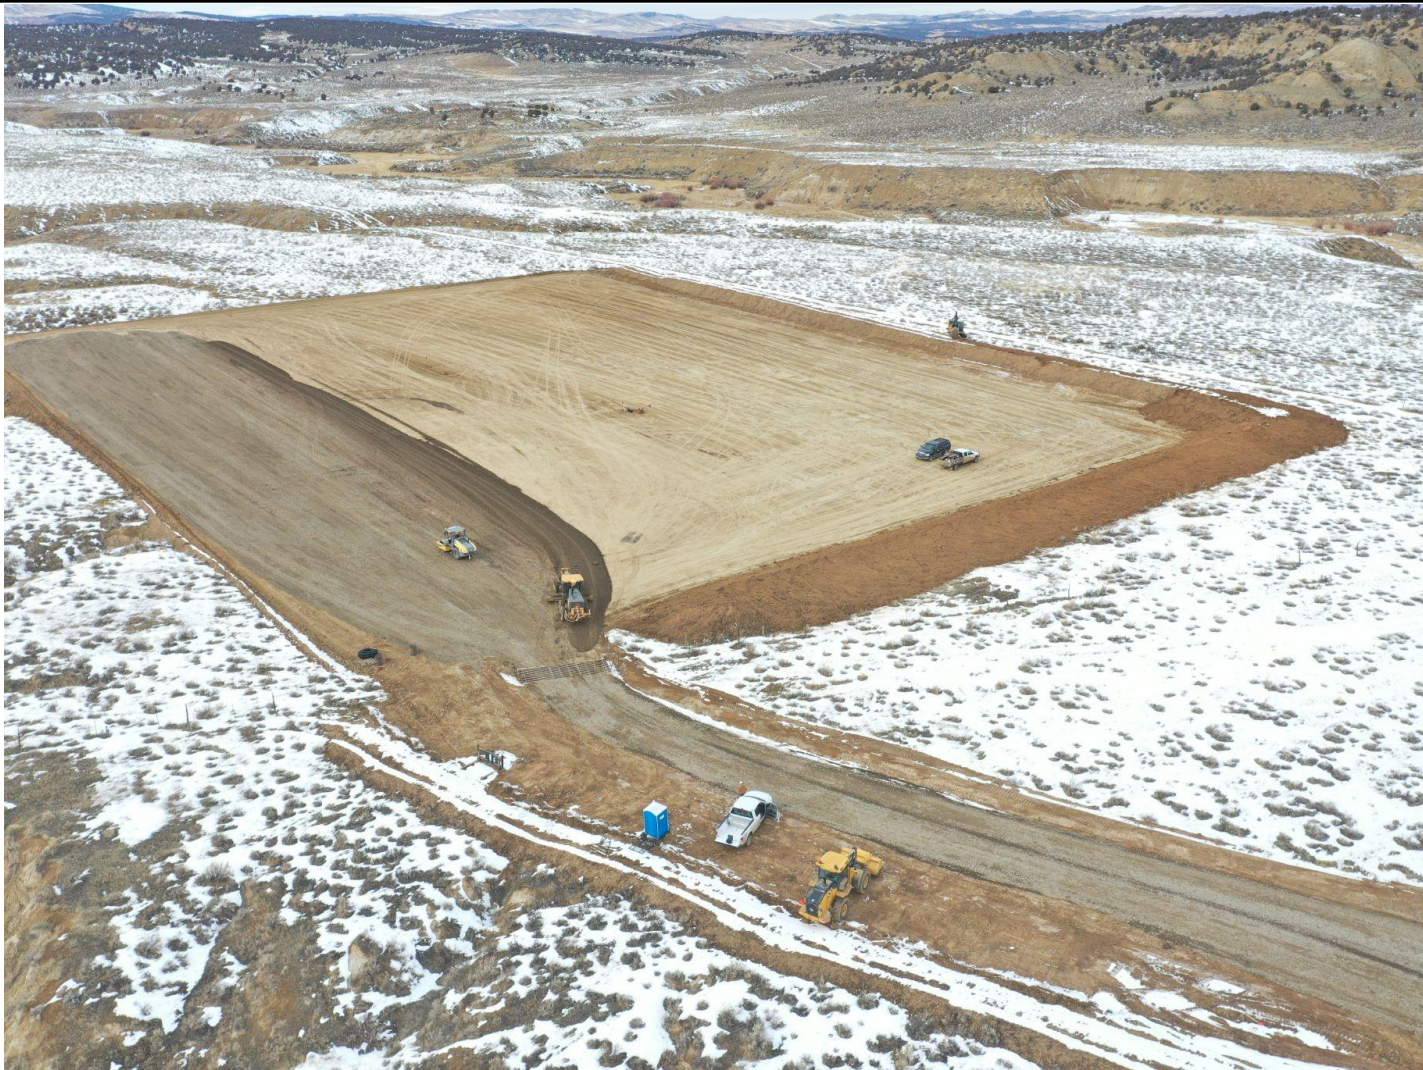
Photo 11: Photo taken with use of a sUAS. Photo provides an aerial overview of the Location, facing northeast.

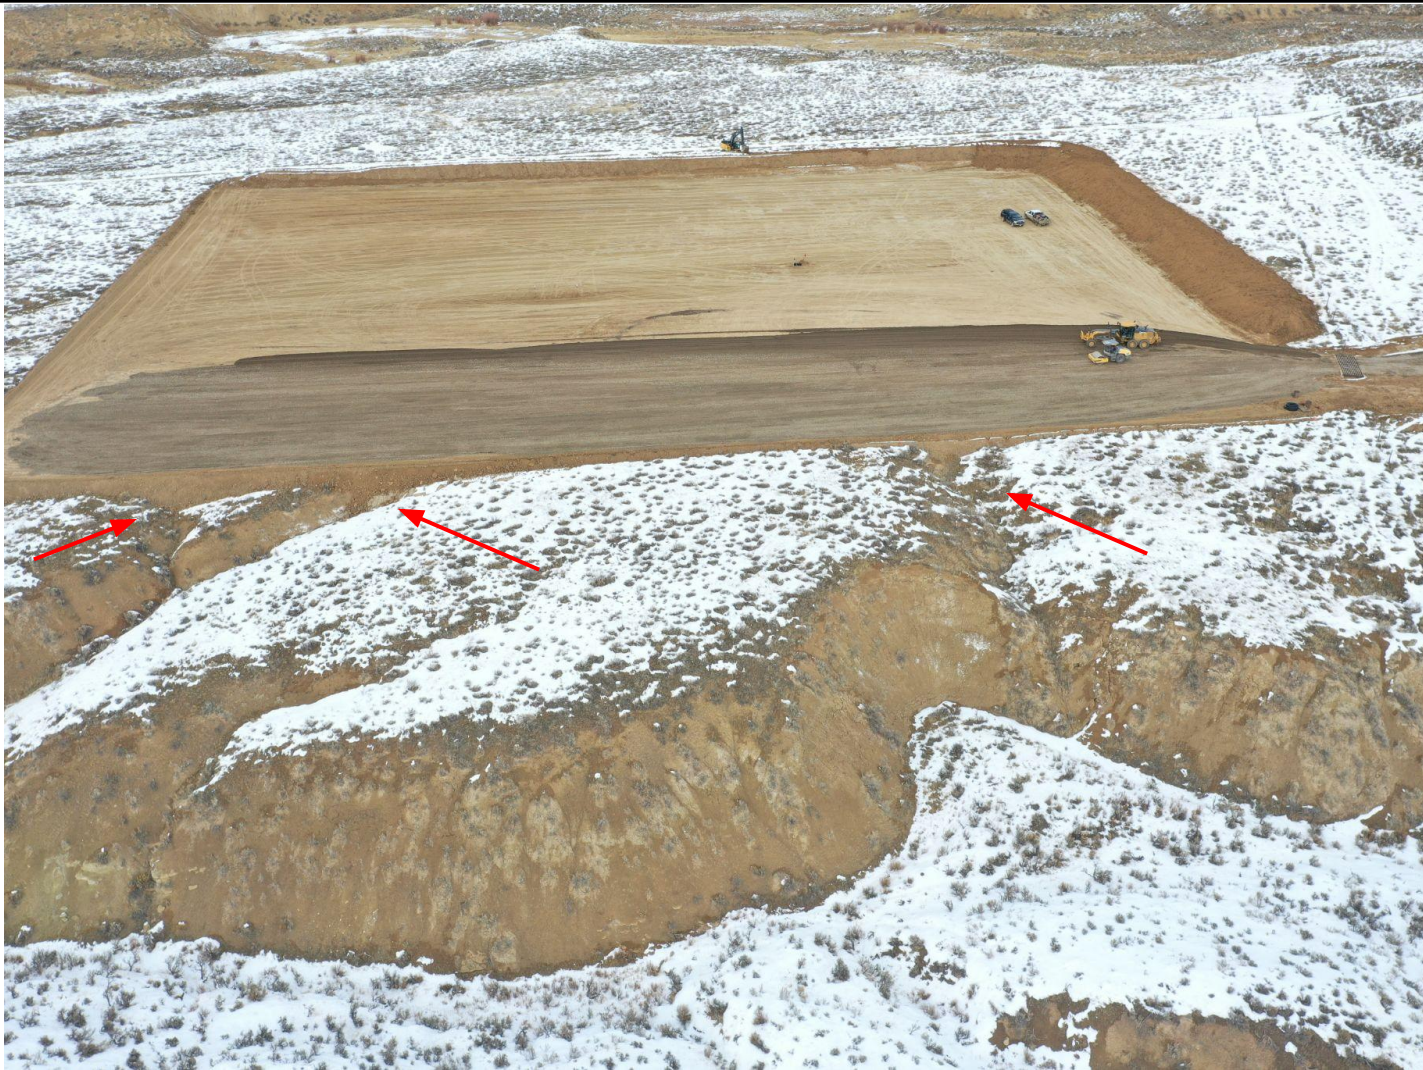
Photo 12: Photos 12-14 taken with use of a sUAS. Photos show Rimrock Gulch, and drainages where fill material has been placed within (arrows). Refer to Photos 9 & 10 for additional comments.
