Inspection Photos

12/18/2023

Operator: ANSCHUTZ EXPLORATION CORP

Location ID: 430927

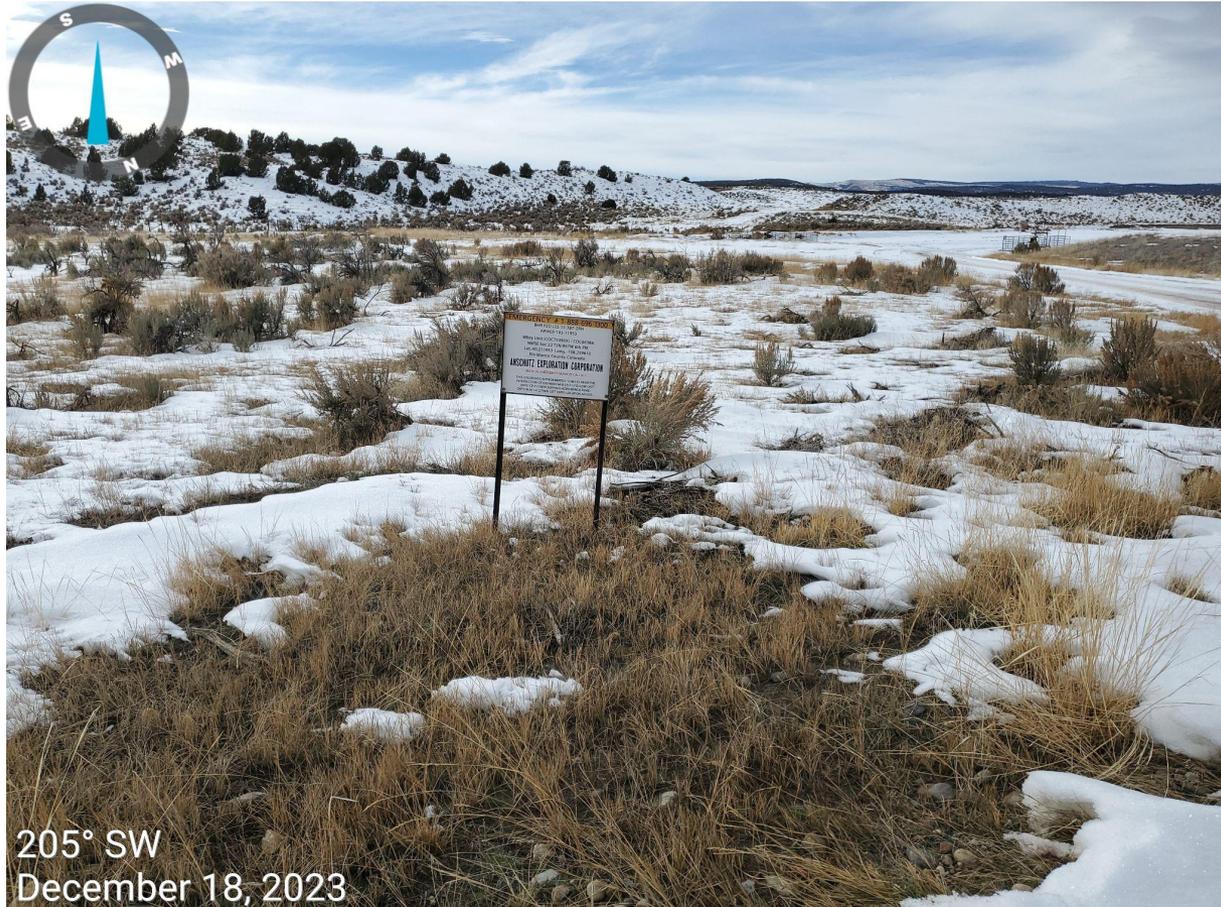
Photo 1: Photo shows Location entrance on the southeast end of the Location.

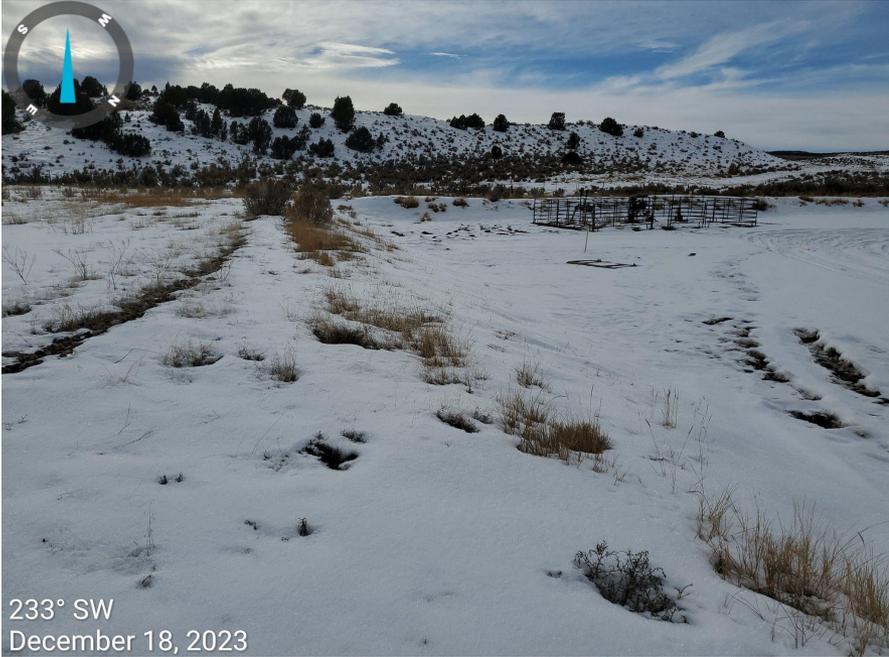
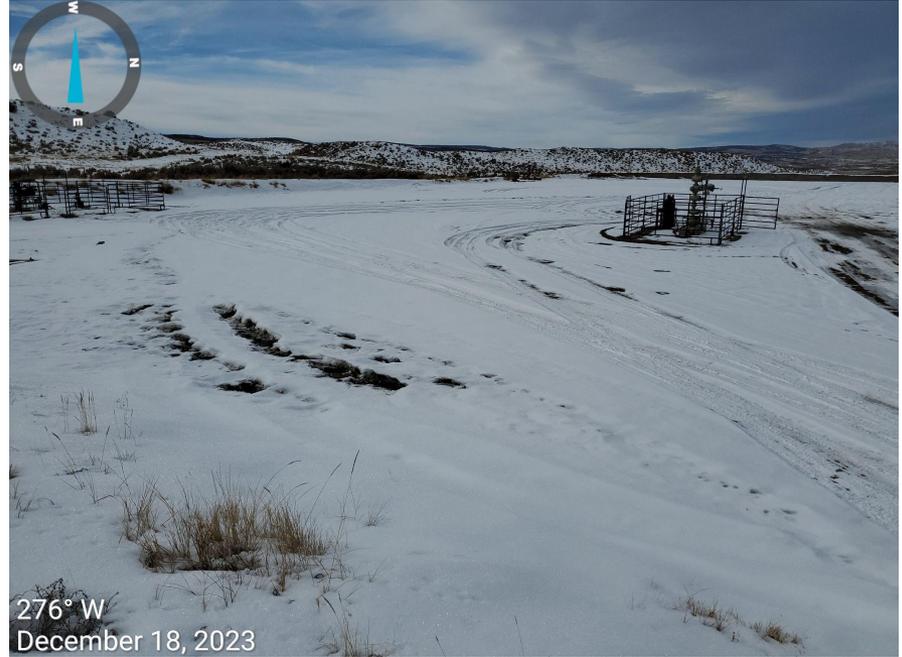
Photo 2: Photos 2-3 taken from the southeast end of the Location (Location entrance). Photos provide an overview of the Location.

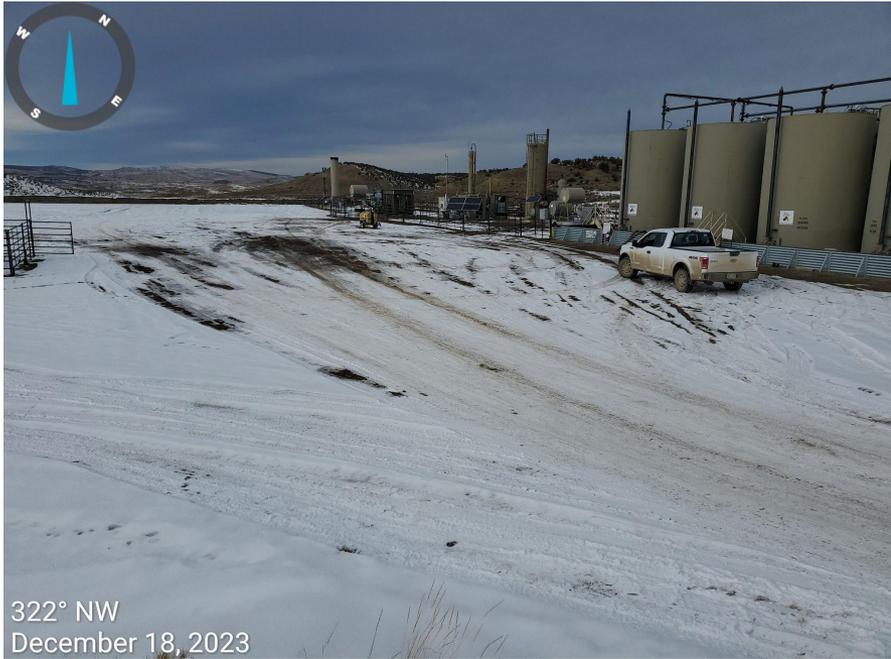
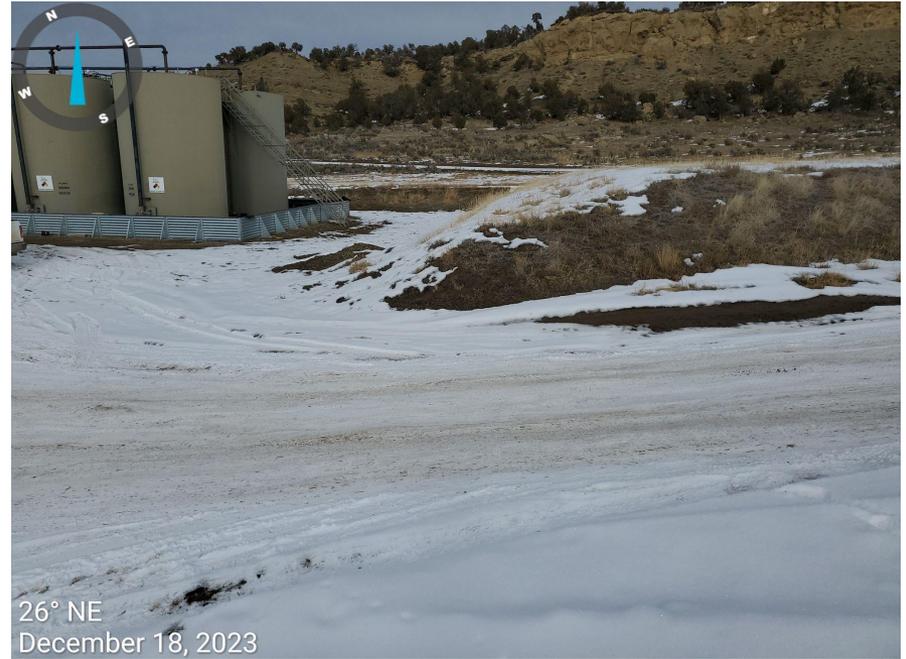
Photo 3: See comments under photo 2.

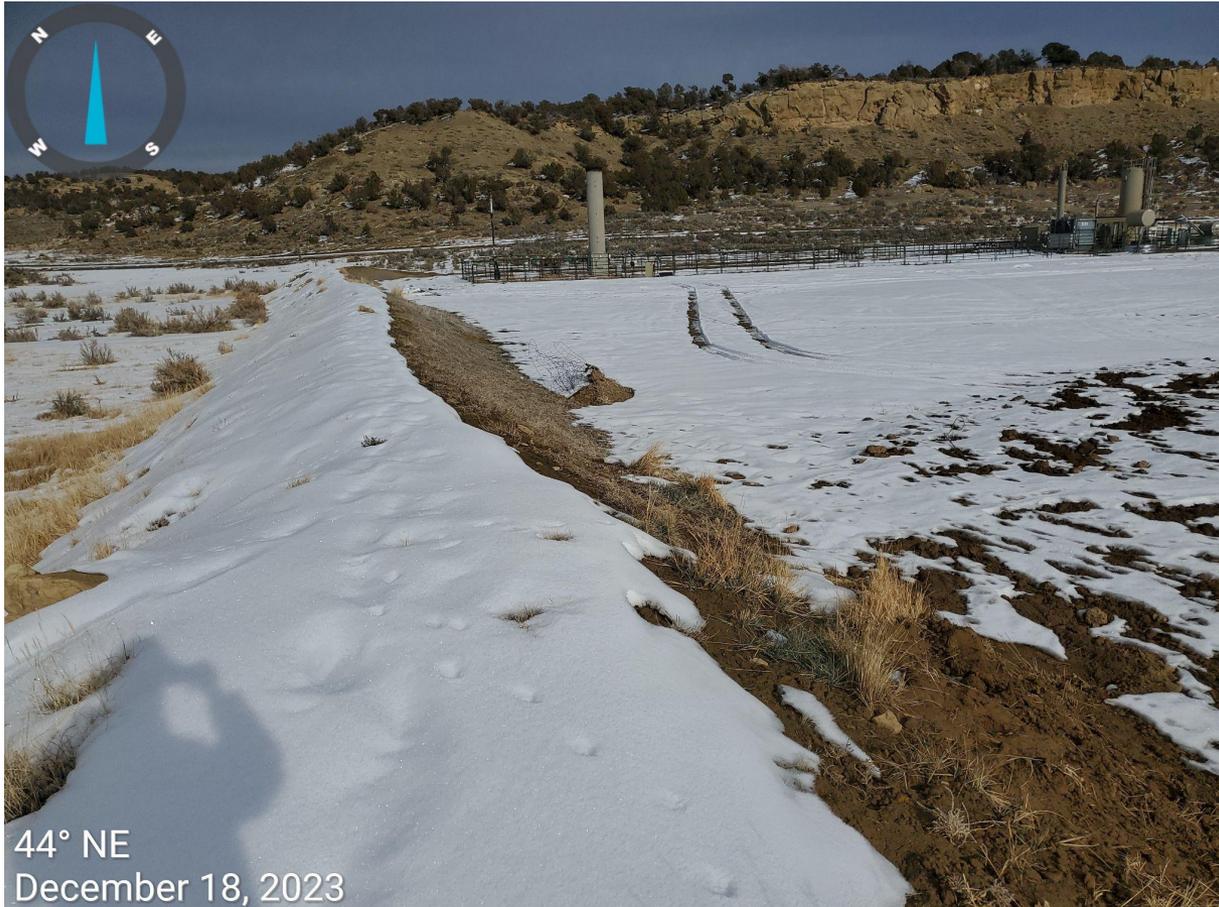
Photo 4: Photos 4-6 taken from the western corner of the current working pad surface. Photo shows areas of the Location not reasonable needed for production, requiring reclamation pursuant to Rule 1003.b. Operator is currently storing various unused equipment within these areas.

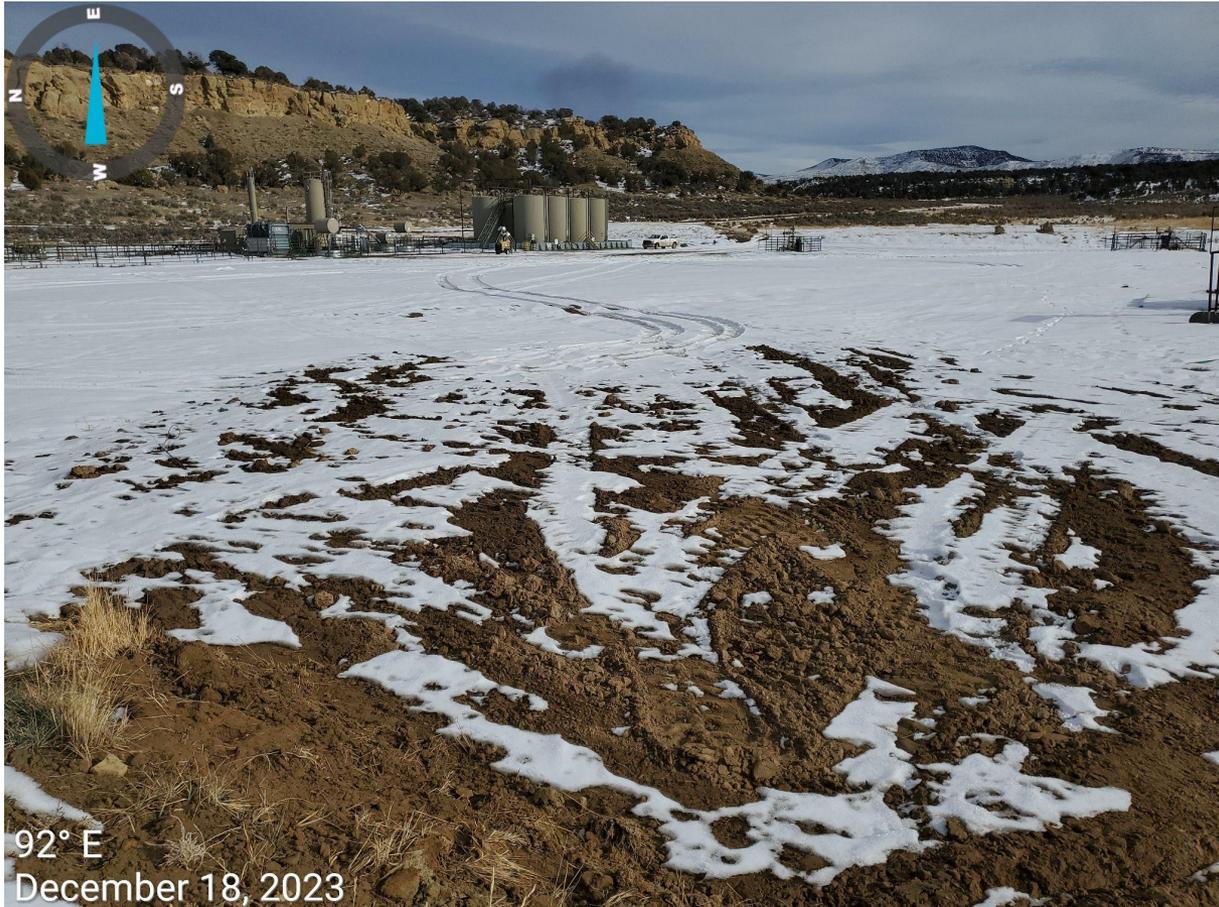
Photo 5: See comments under photo 4.

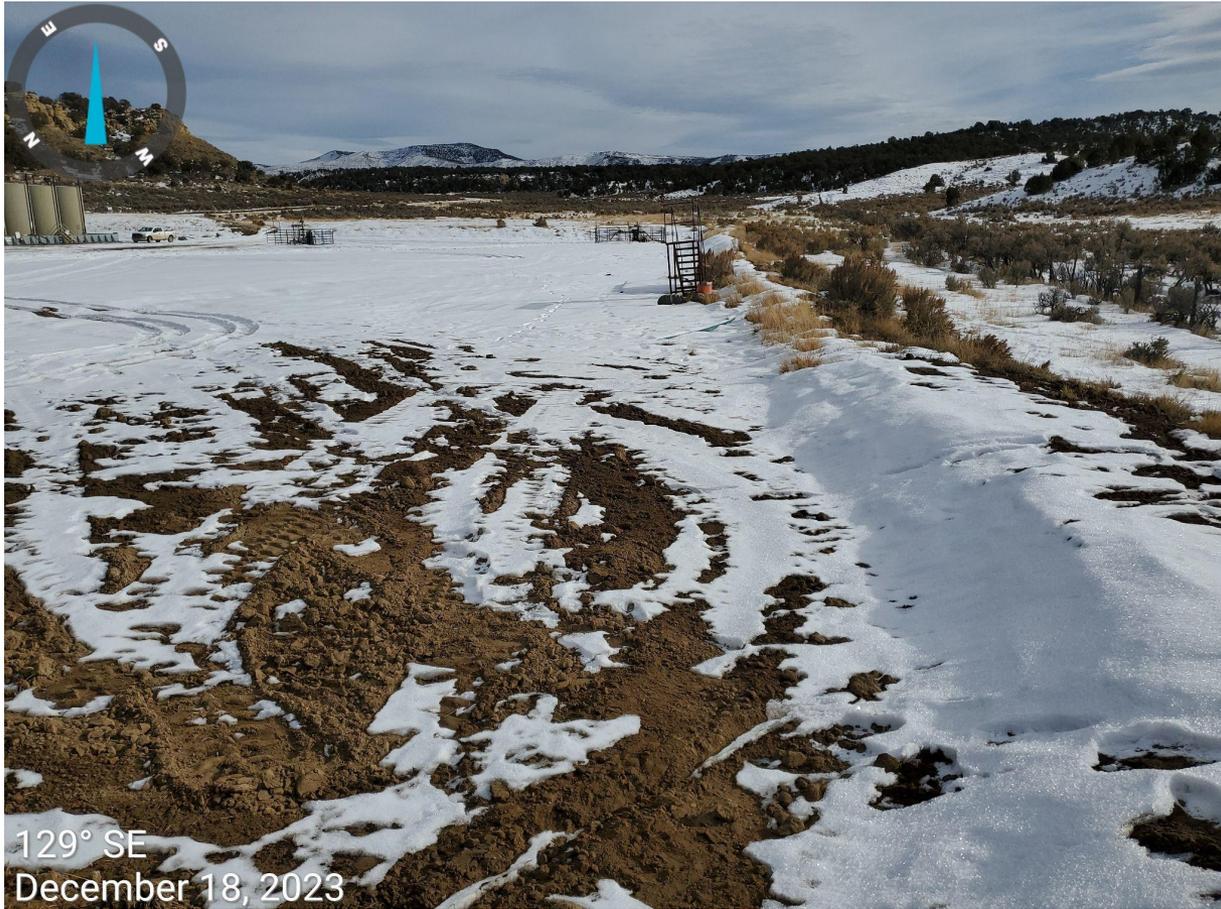
Photo 6: See comments under photo 4.

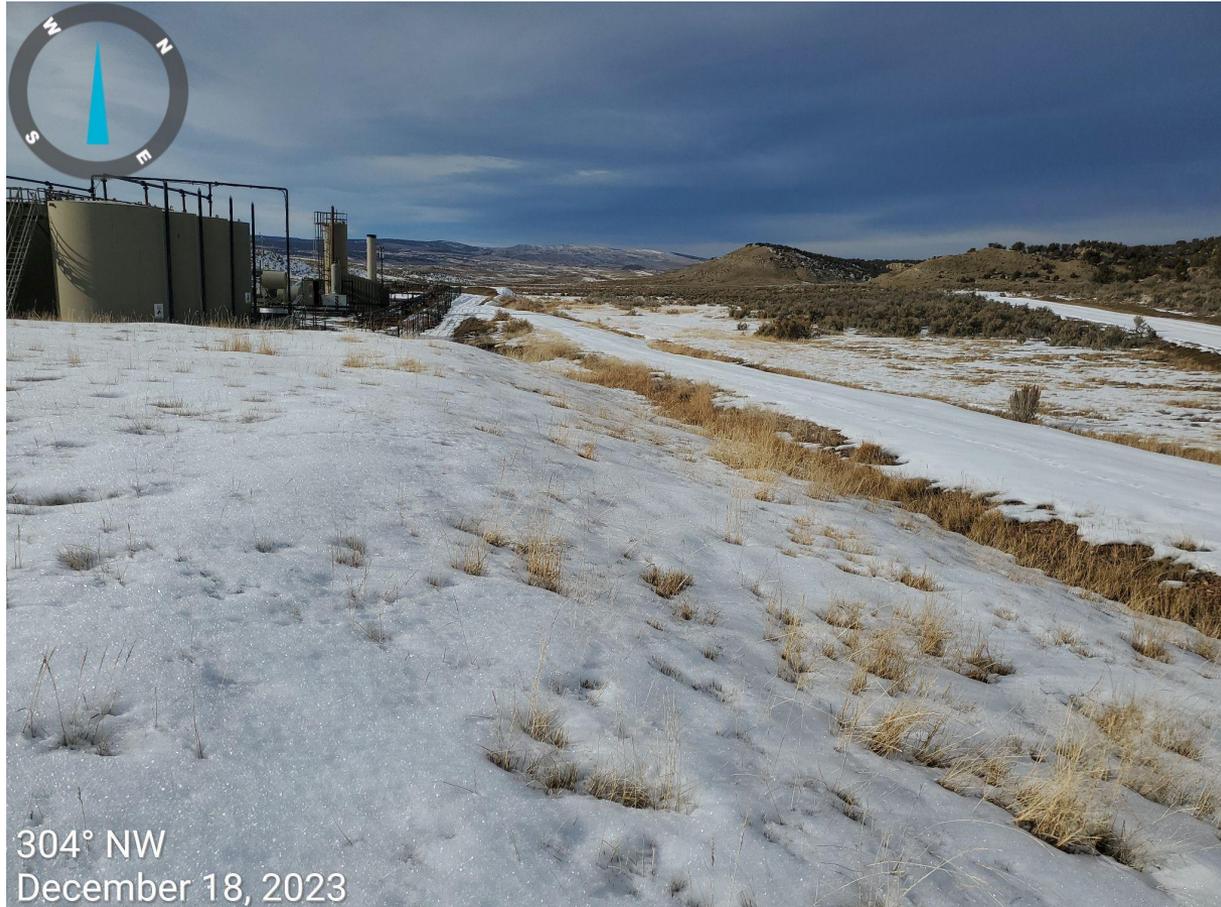
Photo 7: Photos 7-8 taken from the east ends of the Location. Photos shows a second access road constructed on the Location; Road is ~800 feet and unnecessary.

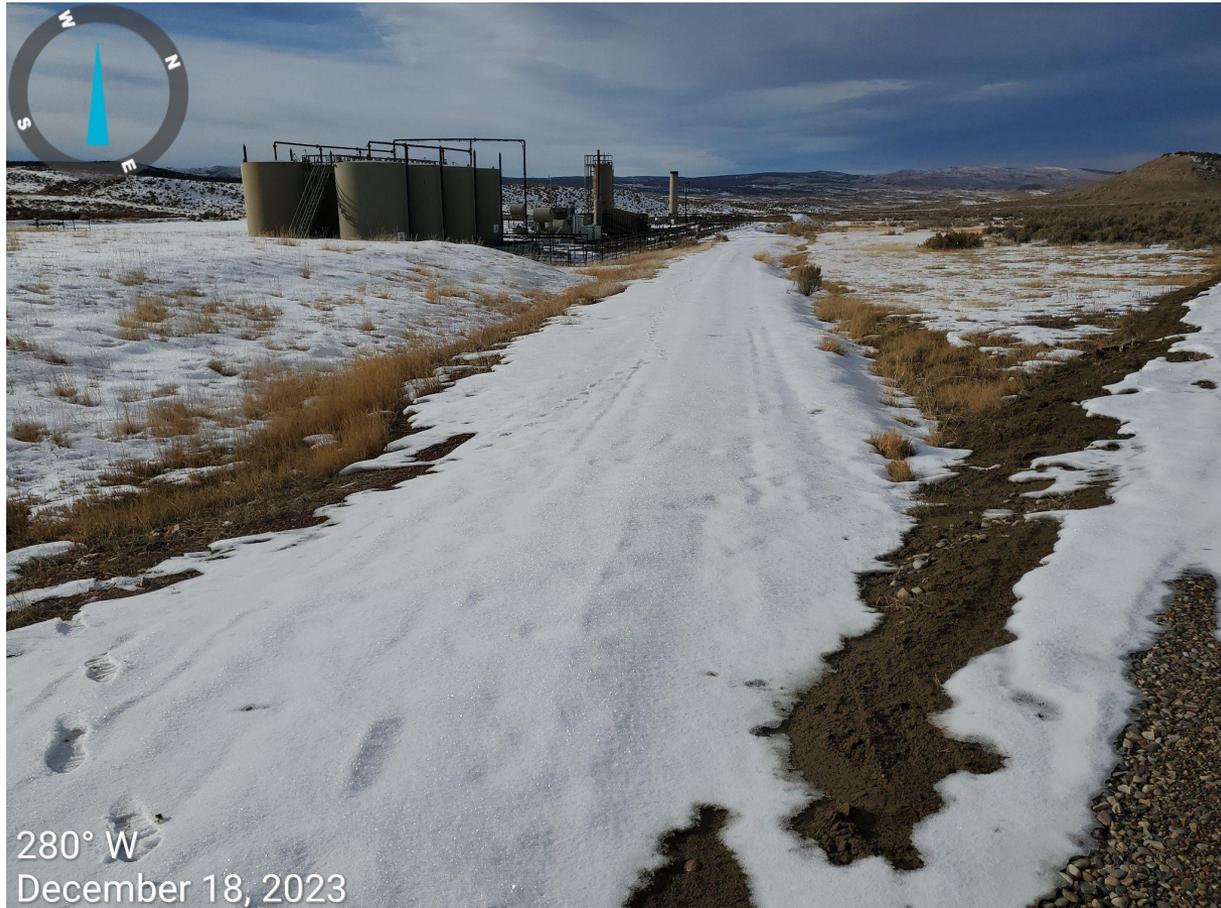
Photo 8: See comments under photo 7.

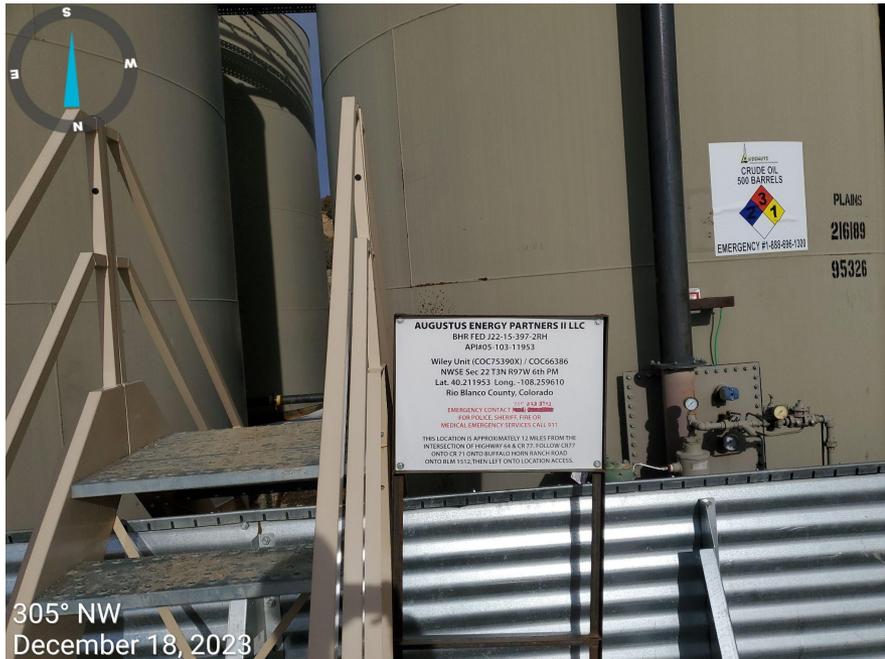
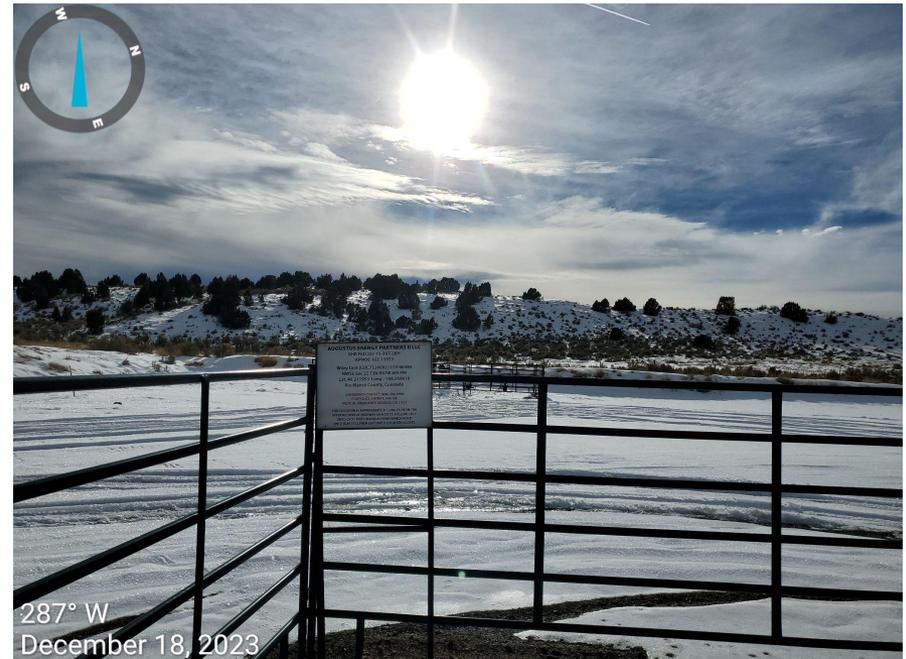
Photo 9: Photos show incorrect Operator information at tank battery and wellhead sign.

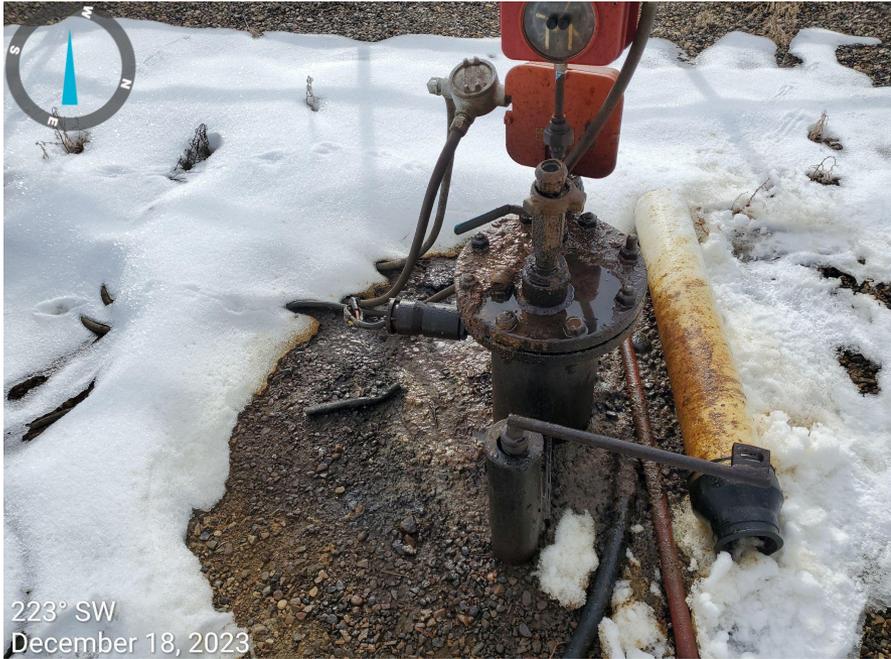
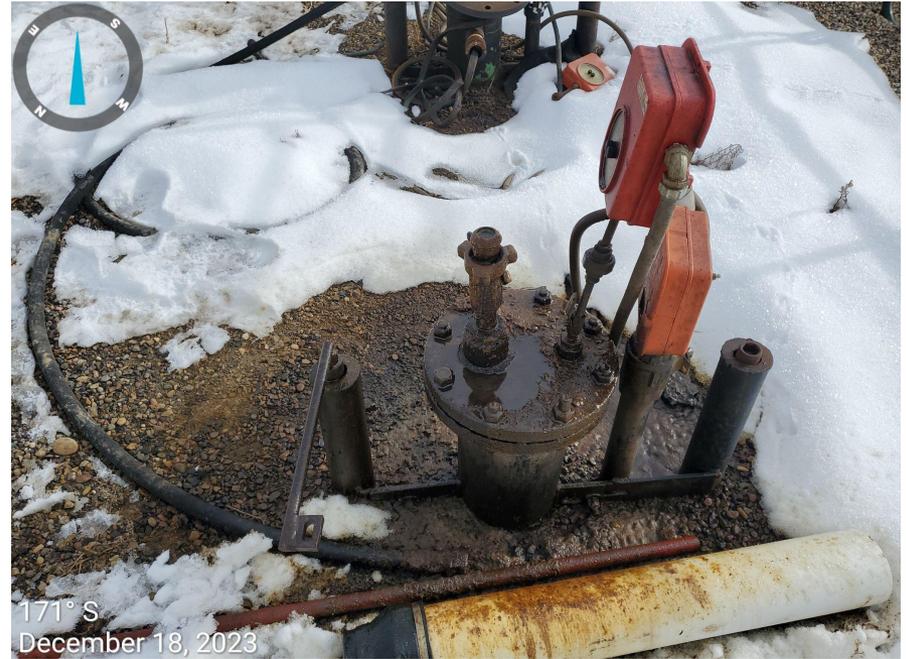
Photo 10: Photos 10-11 taken from the southern corner of the Location. Photo shows spill at the “water pump” risers.

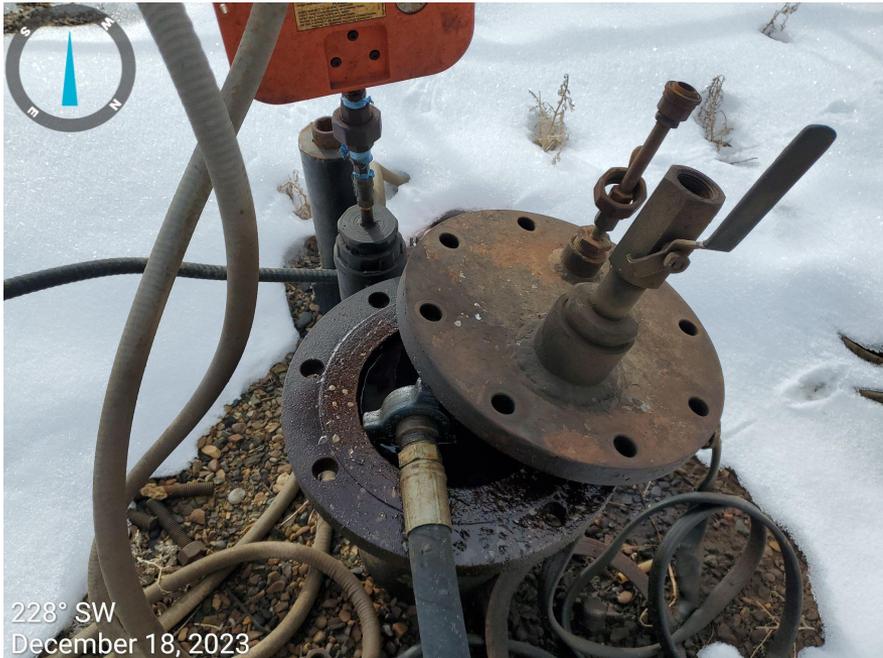
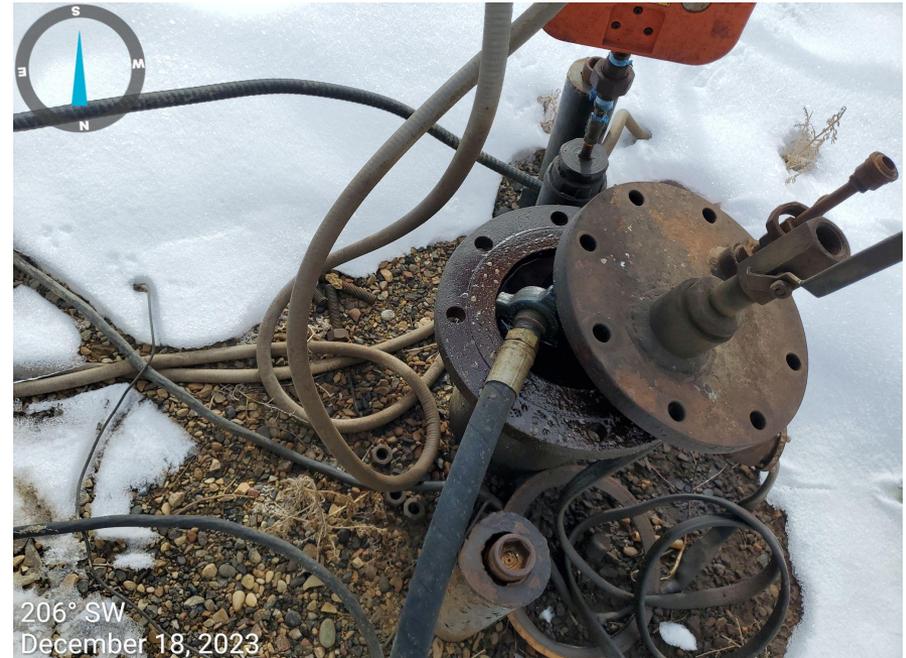
Photo 11: See comments under photo 10.

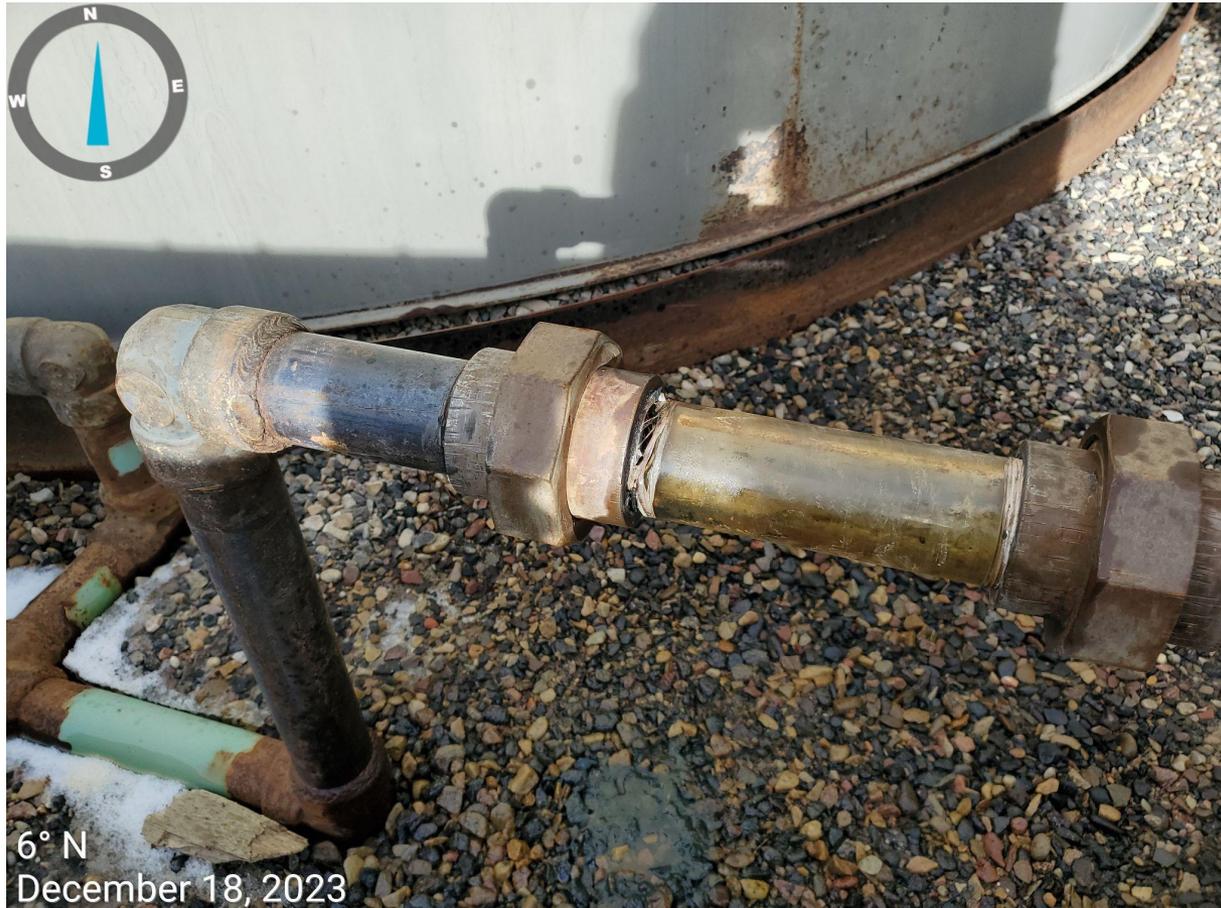
Photo 12: Photo taken from the tank battery facility. Photo shows crack at the “recycling line”, resulting in a leak/spill.

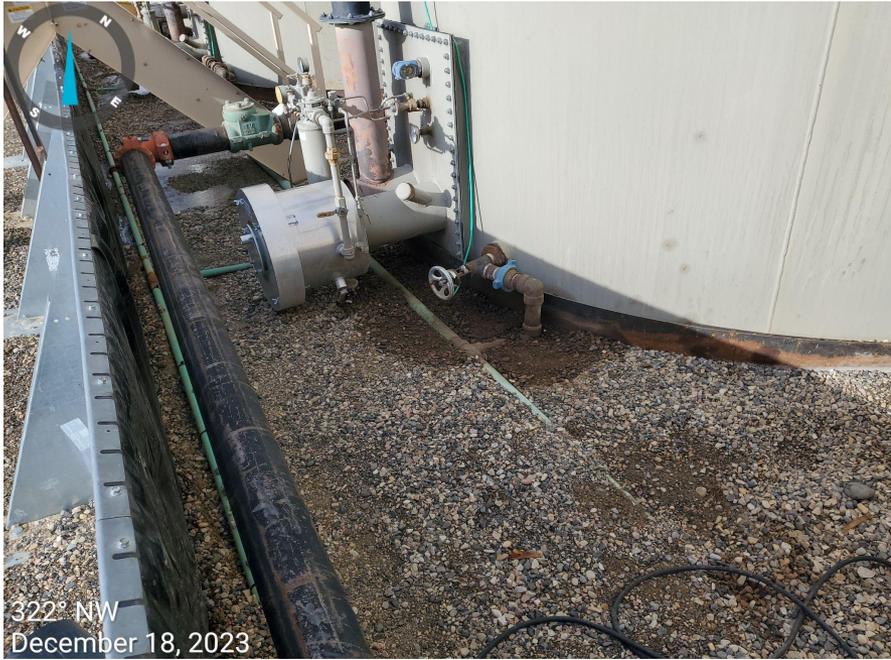
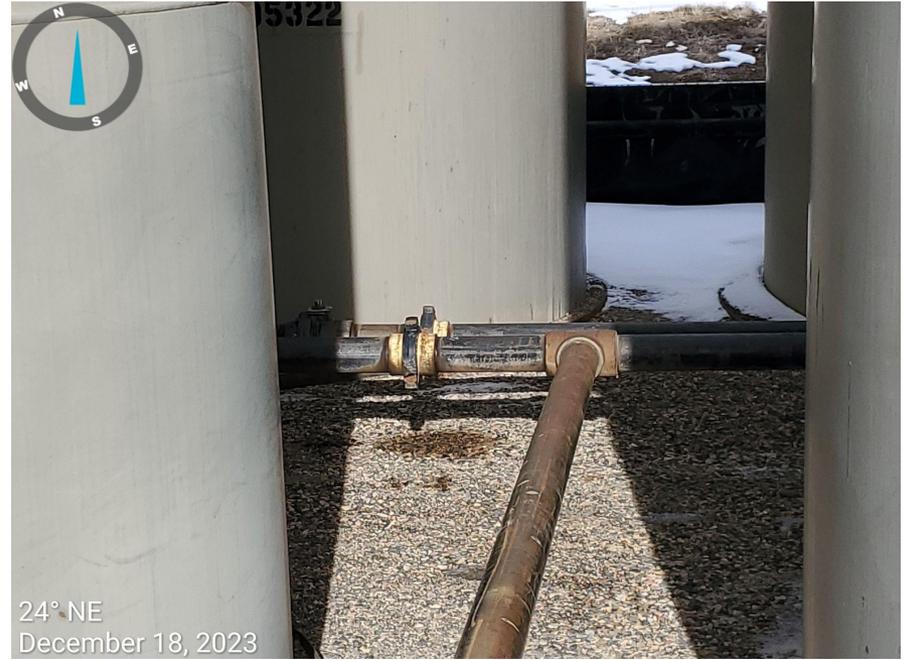
Photo 13: Photos example of stained soils observed.

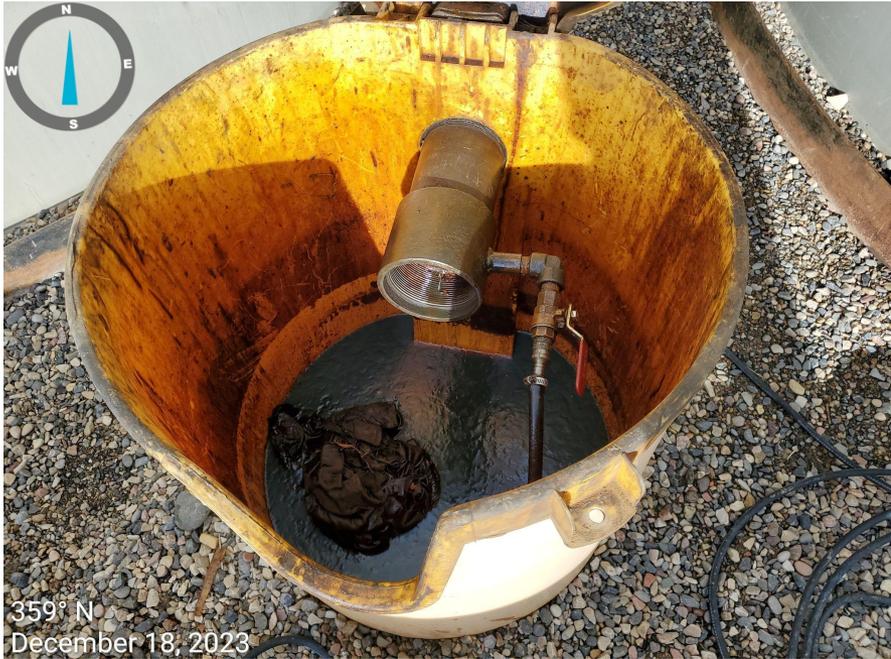
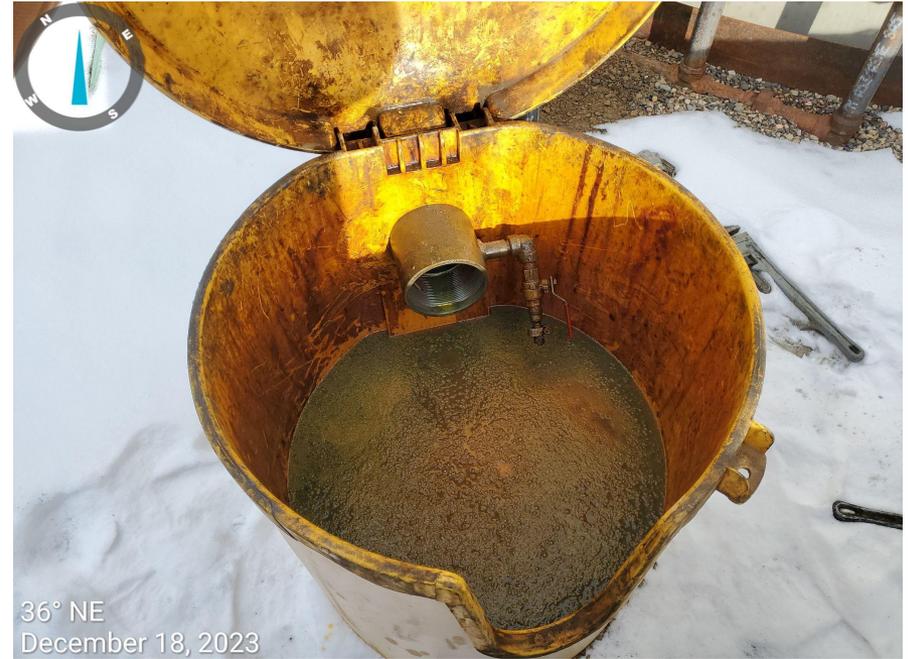
Photo 14: Photos example showing lines at tanks have not been capped/plugged. Photo also shows produced fluids have spilled into the honeypots.

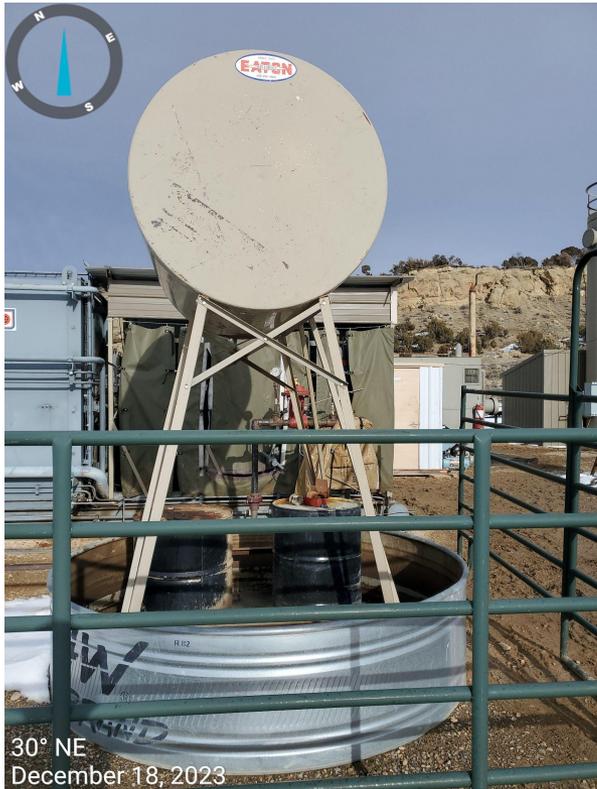
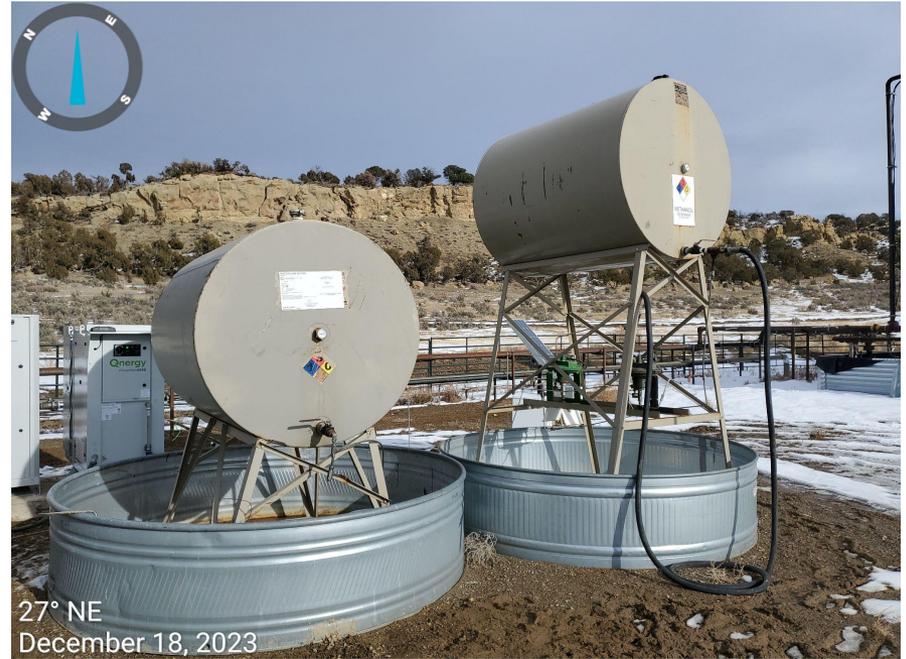
Photo 15: Photos 15-16 example showing wildlife protection measures to prevent wildlife ingress, and to allow for egress (such as netting, or escape ramps) are missing from containment measures at tanks on the Location.

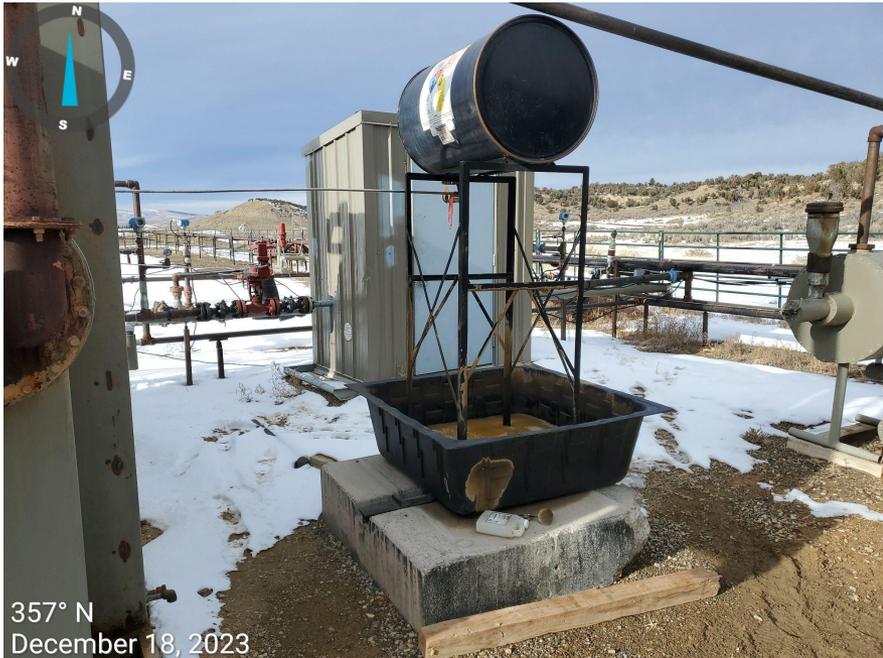
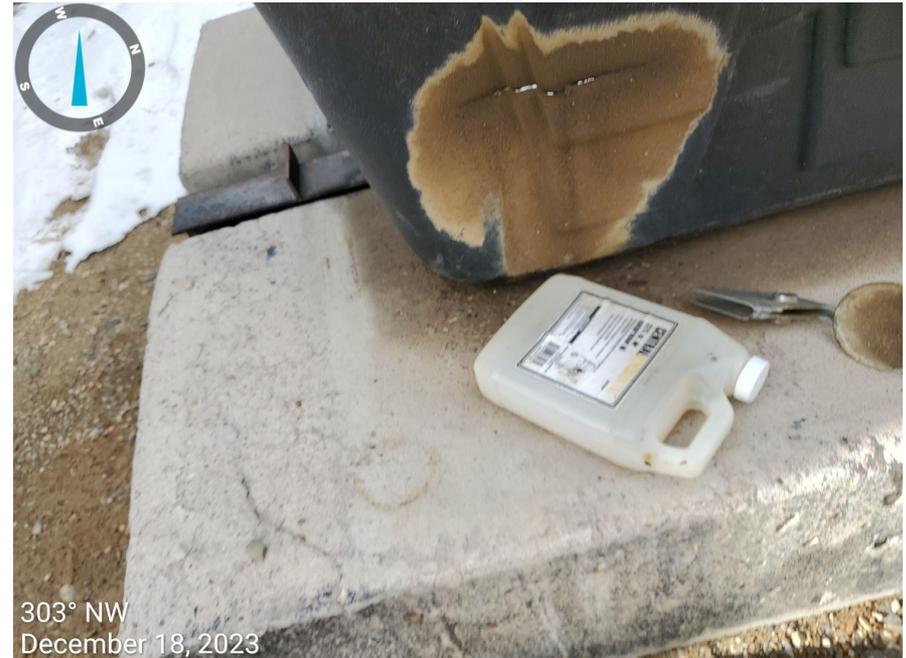
Photo 16: See comments under photo 15. Photo right also shows the containment BMP has cracked, and is no longer in proper functioning condition. Photo also example showing various trash/debris observed throughout the Location.

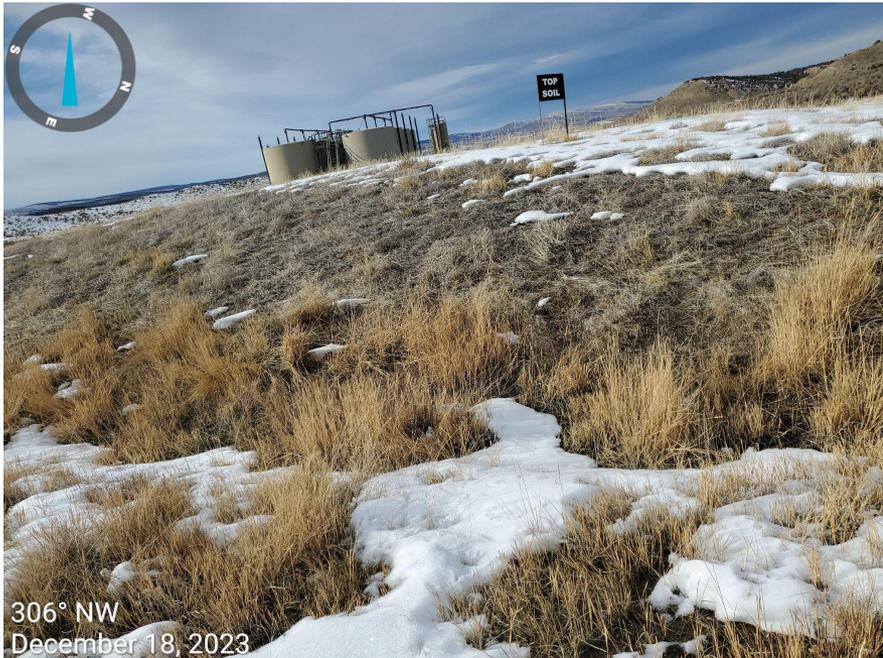
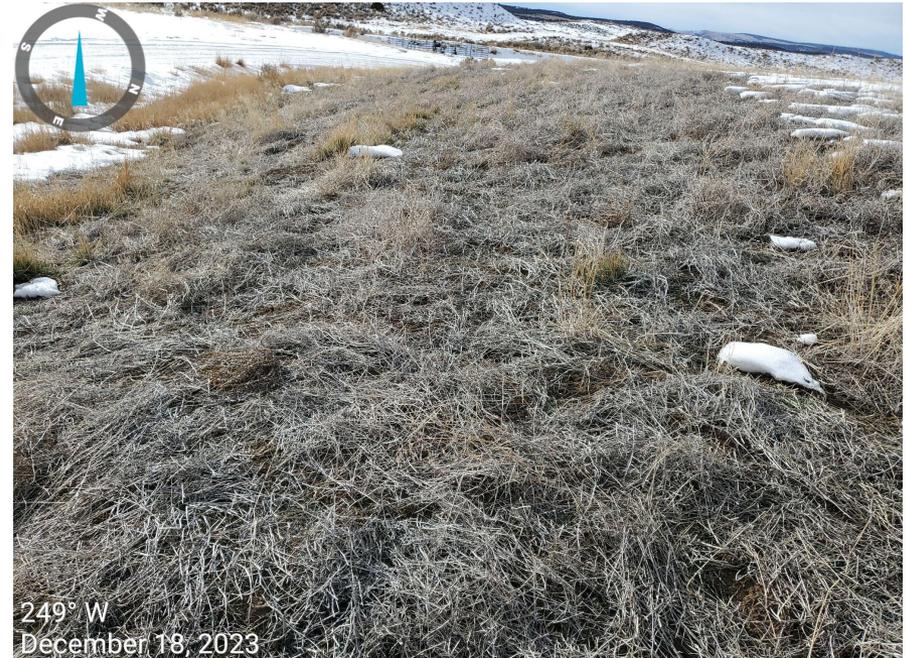
Photo 17: Photos taken from the topsoil stockpile on the east end of the Location. Vegetation observed established on the stockpile is predominantly Undesirable Plant Species. BMPs to prevent the spread or establishment of weeds are inadequate.

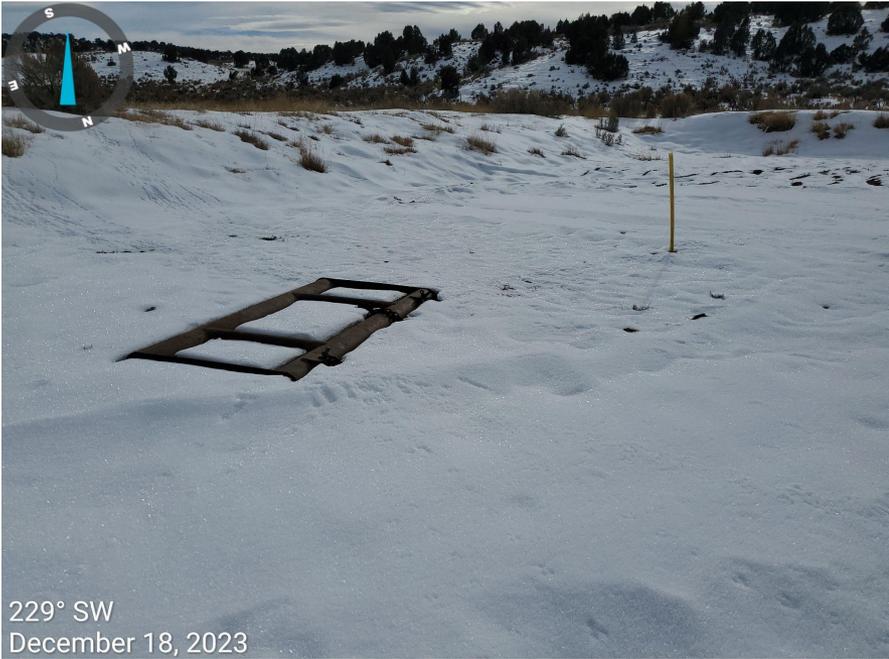
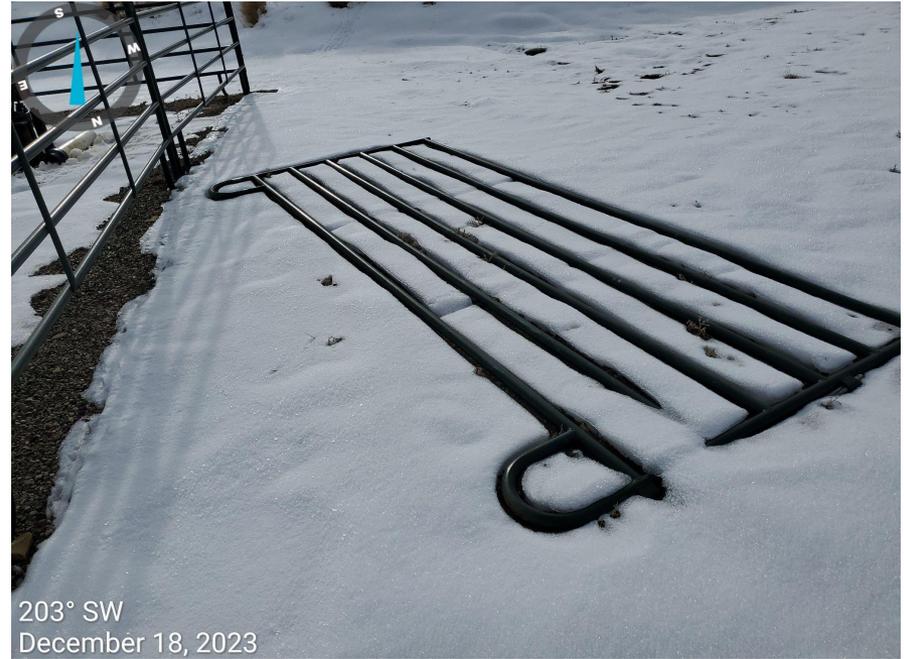
Photo 18: Various trash/debris/unused equipment/container/etc... observed improperly stored on the Location.

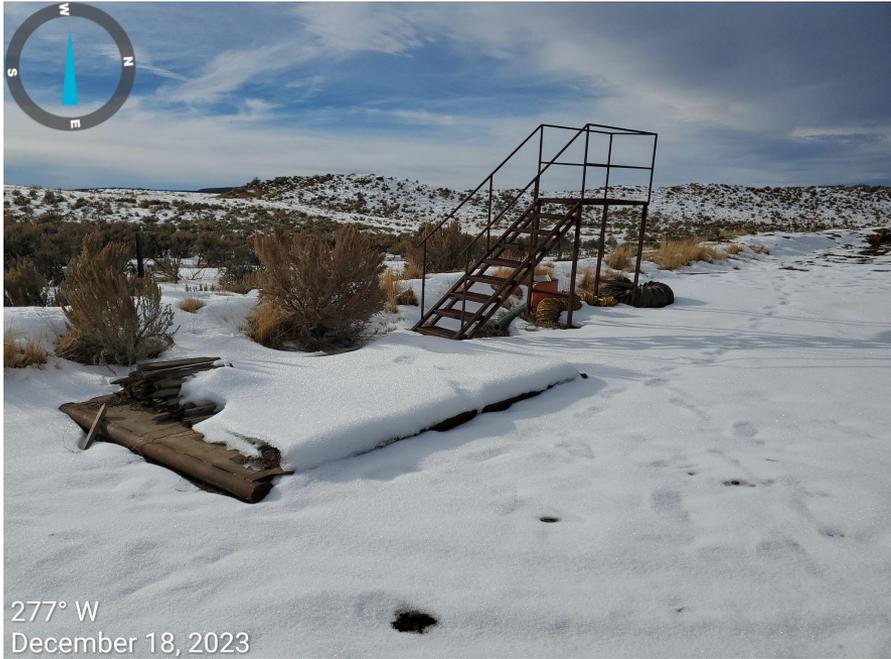
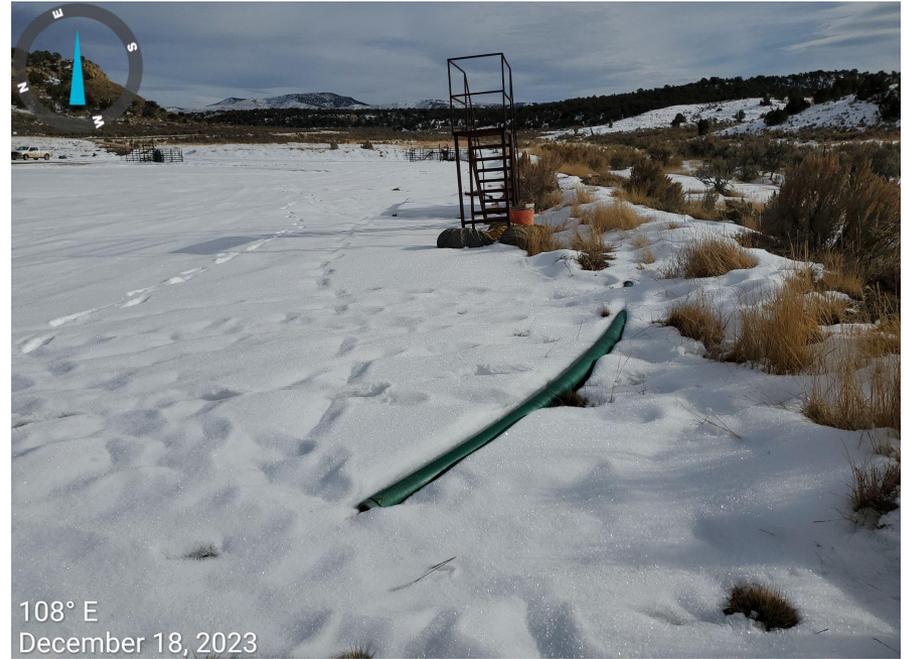
Photo 19: Various trash/debris/unused equipment/container/etc... observed improperly stored on the Location.
