Inspection Photos

12/18/2023

Operator: ANSCHUTZ EXPLORATION CORP

Location ID: 430927

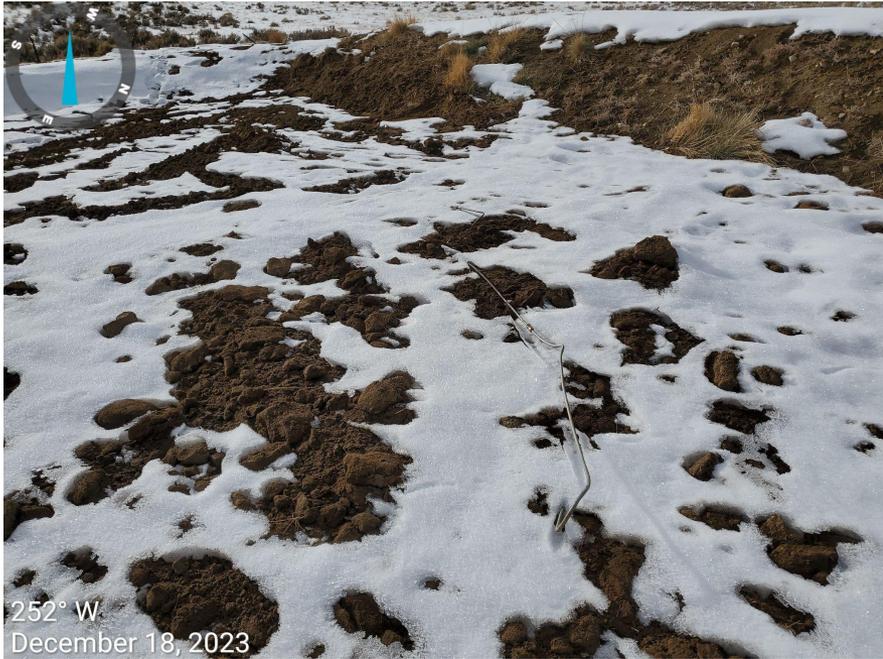
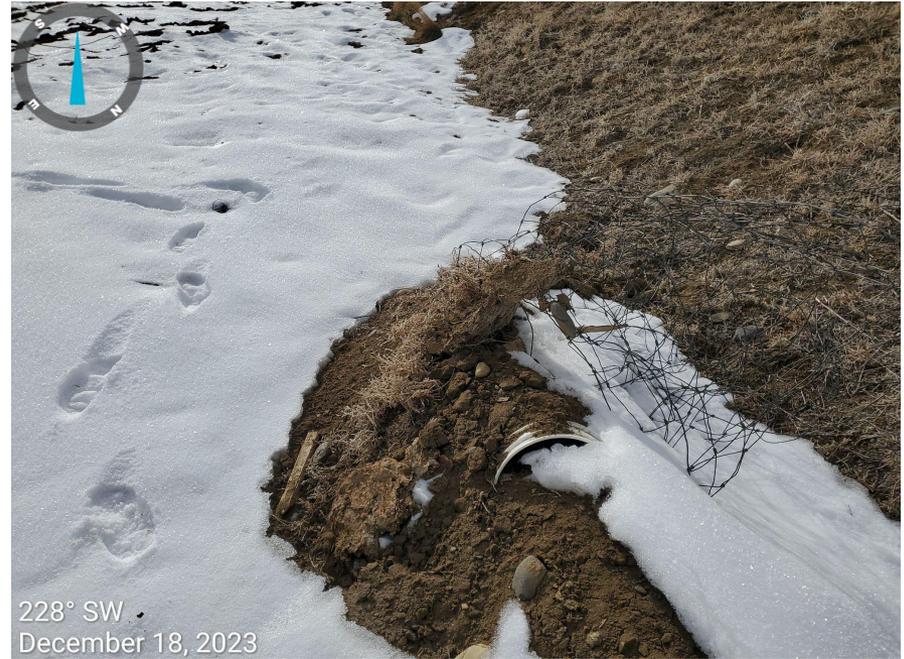
Photo 20: Various trash/debris/unused equipment/container/etc... observed improperly stored on the Location.

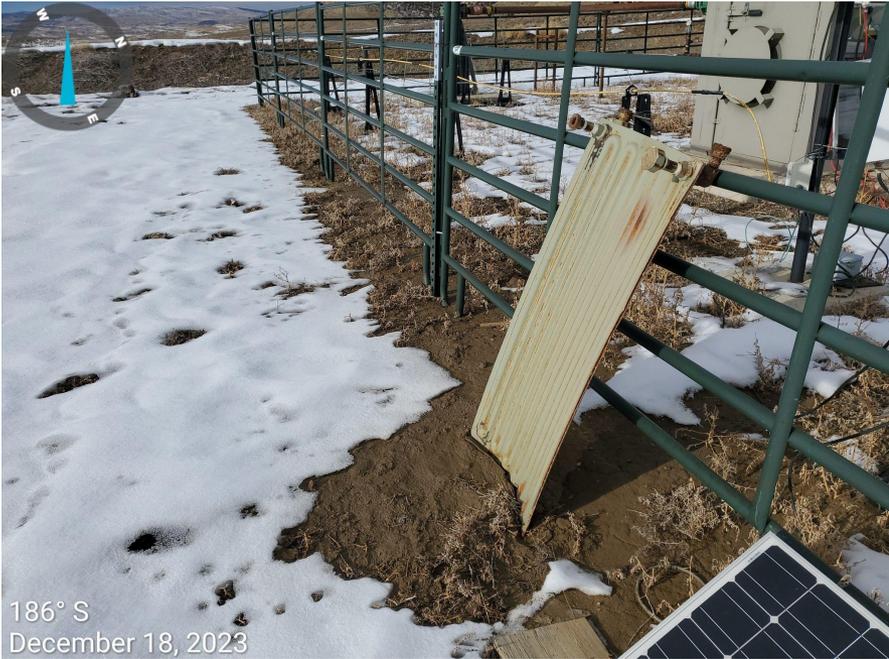
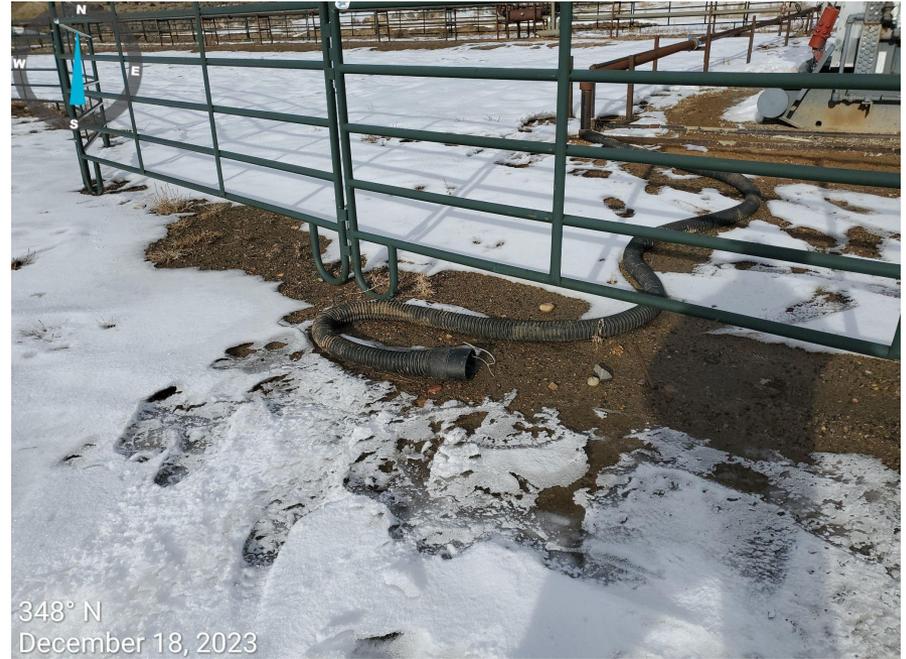
Photo 21: Various trash/debris/unused equipment/container/etc... observed improperly stored on the Location.

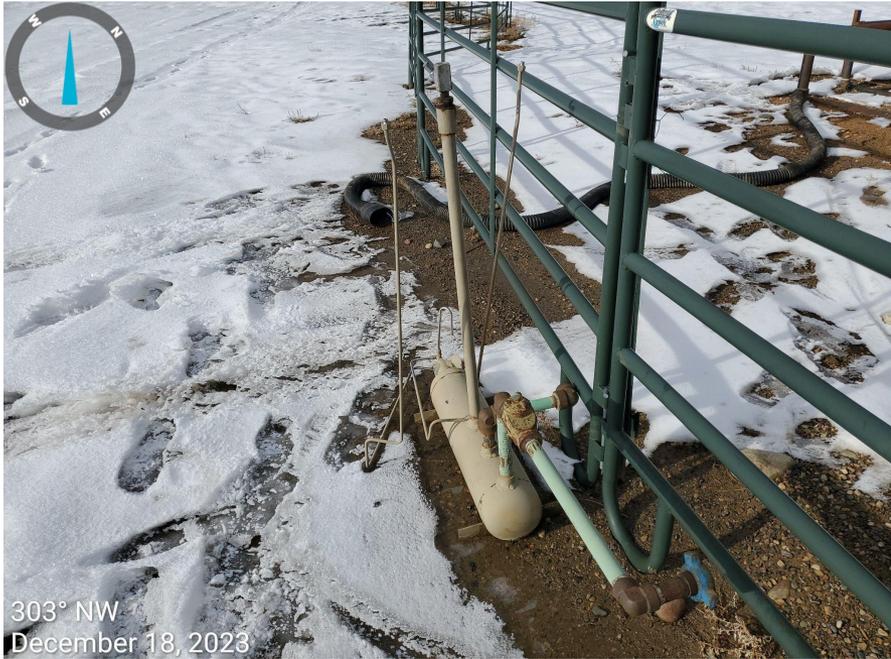
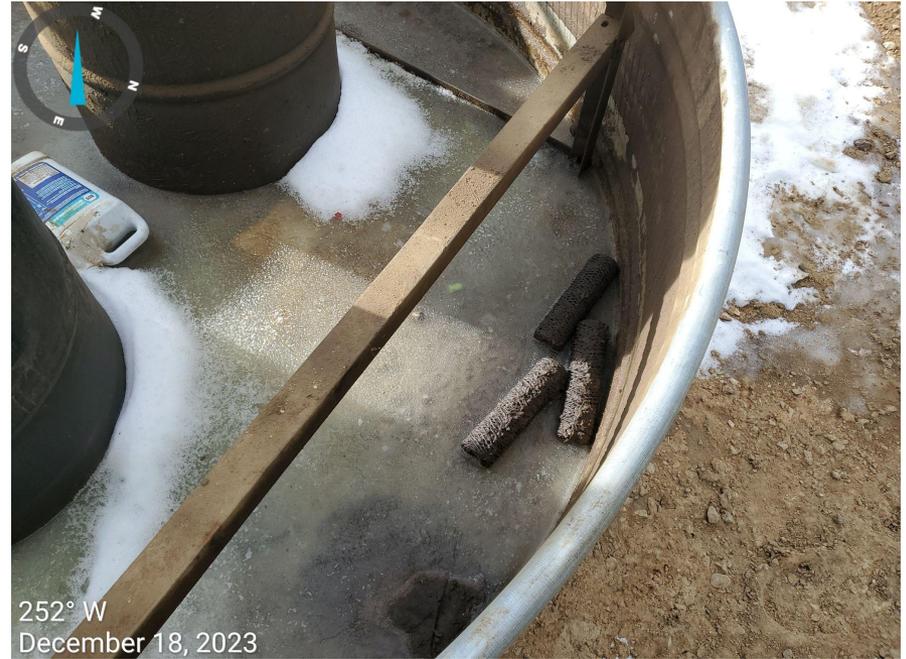
Photo 22: Various trash/debris/unused equipment/container/etc... observed improperly stored on the Location.

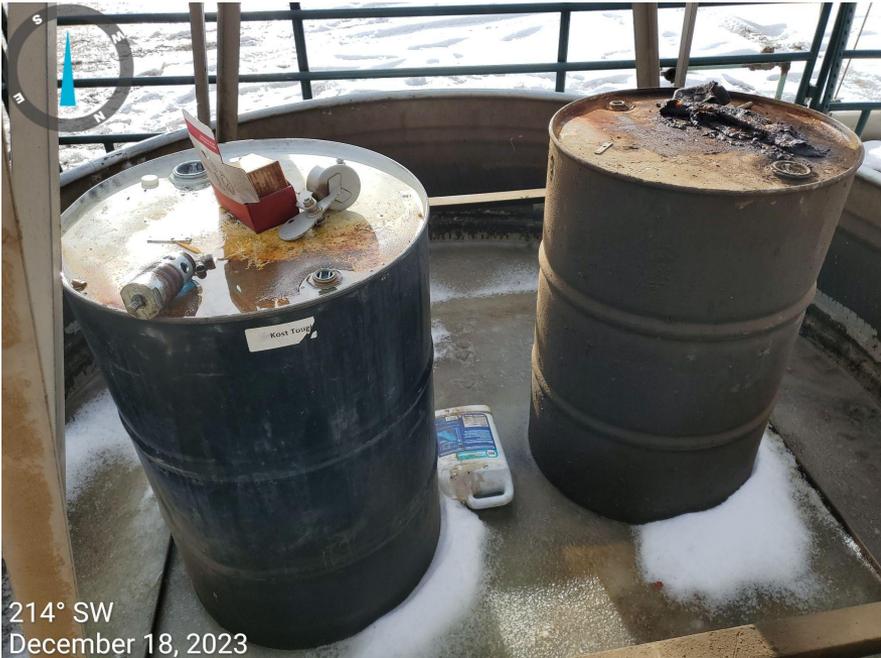
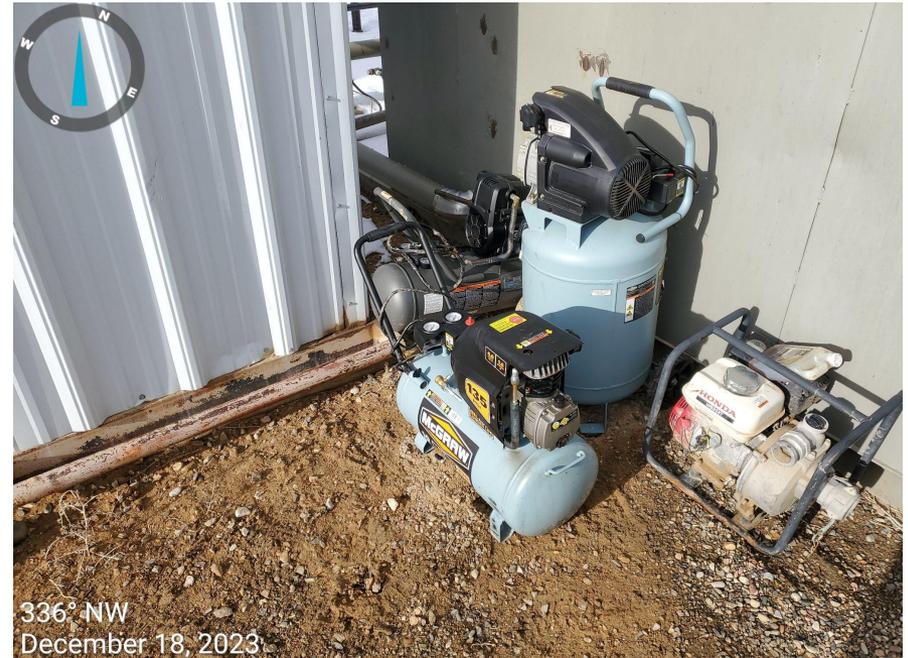
Photo 23: Various trash/debris/unused equipment/container/etc... observed improperly stored on the Location.

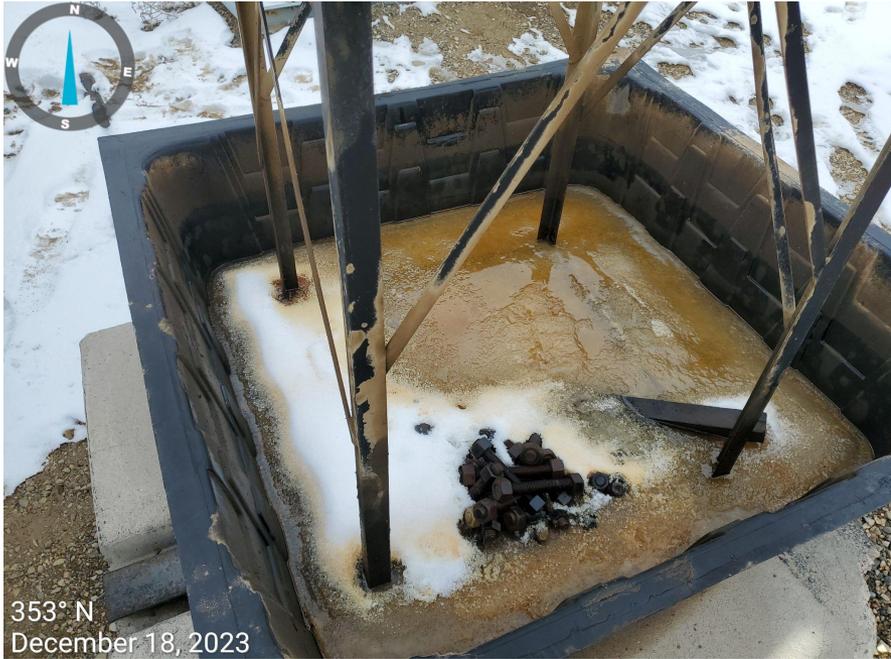
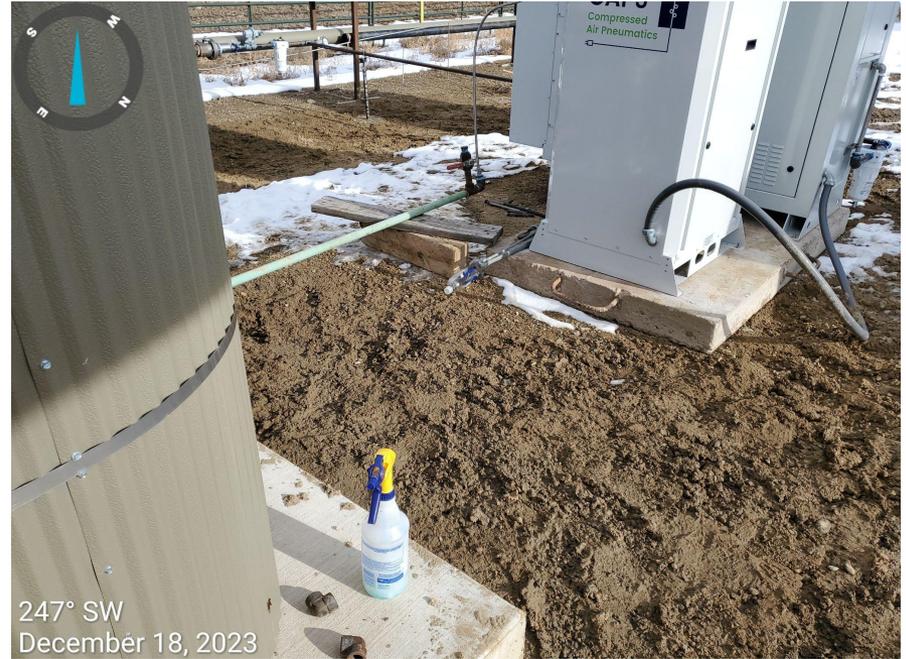
Photo 24: Various trash/debris/unused equipment/container/etc... observed improperly stored on the Location.

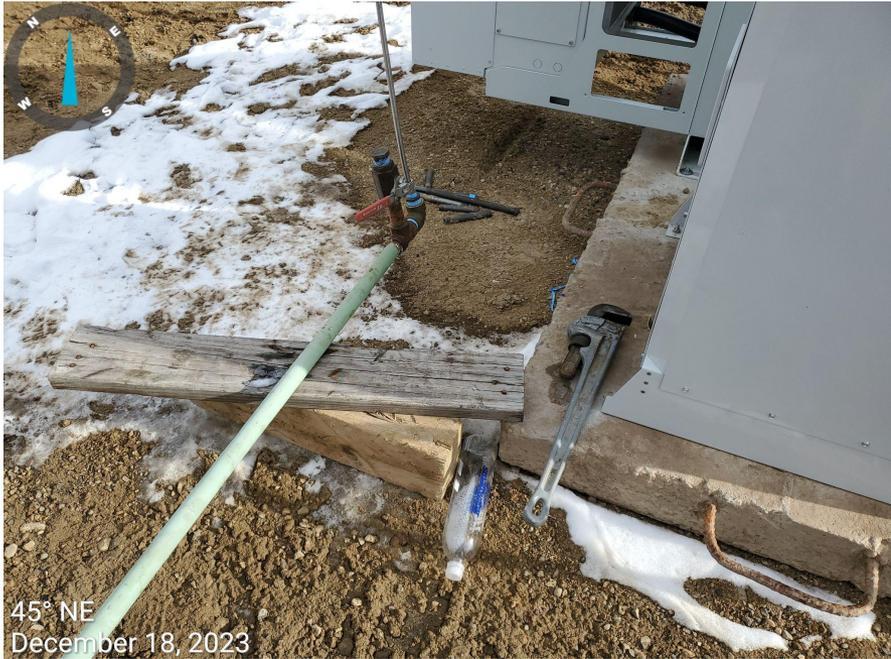
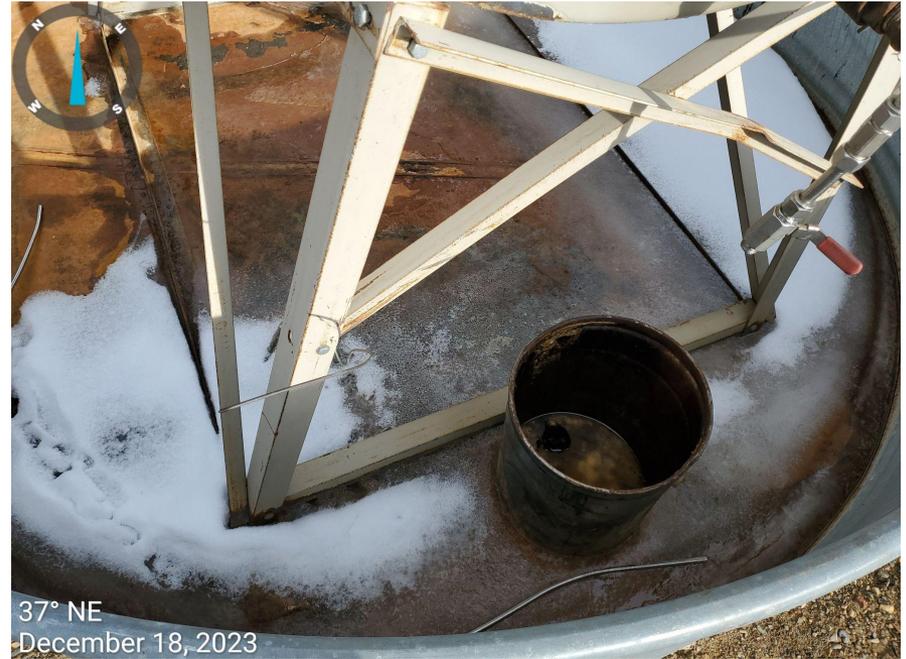
Photo 25: Various trash/debris/unused equipment/container/etc... observed improperly stored on the Location.

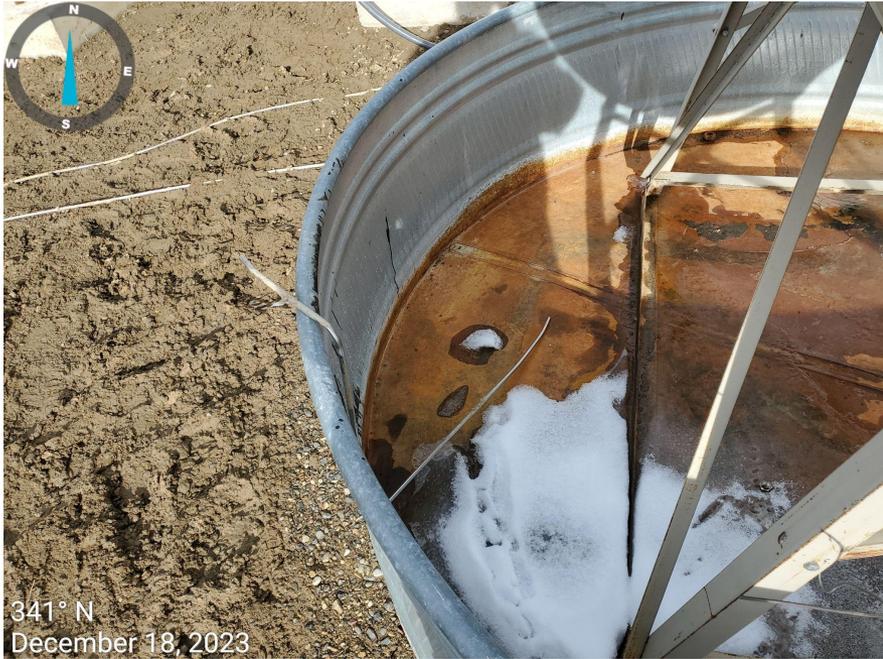
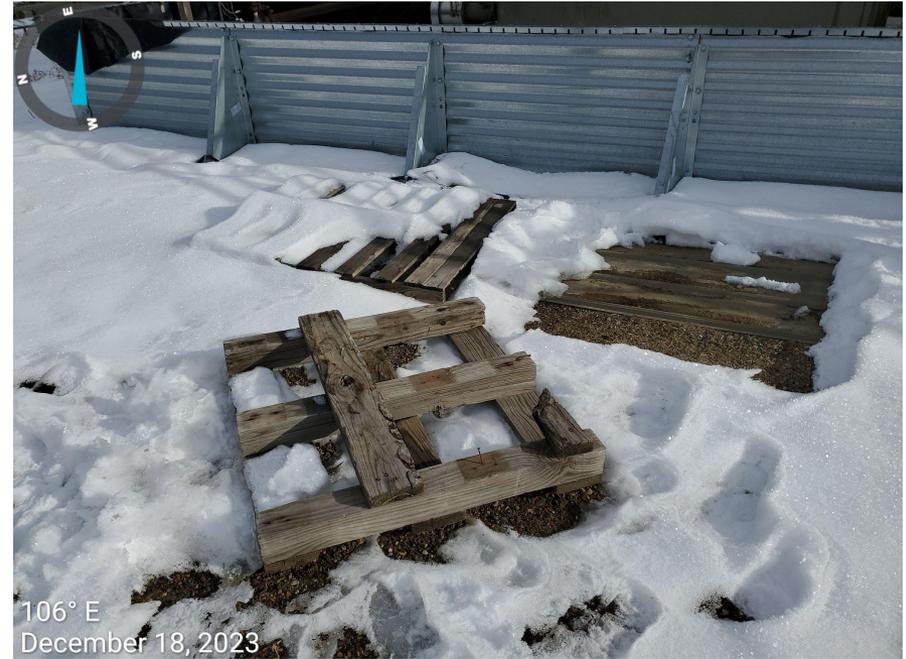
Photo 26: Various trash/debris/unused equipment/container/etc... observed improperly stored on the Location.

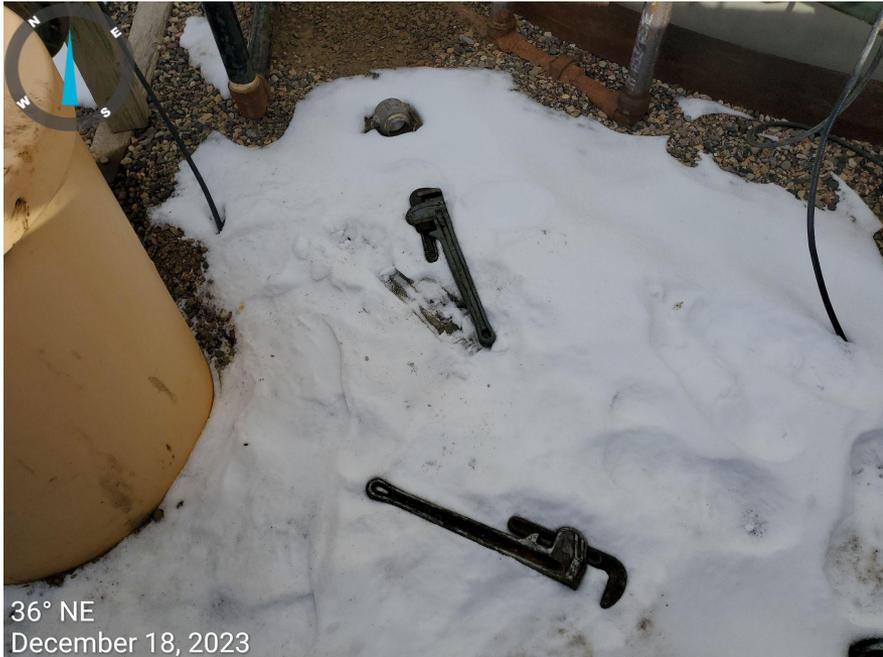
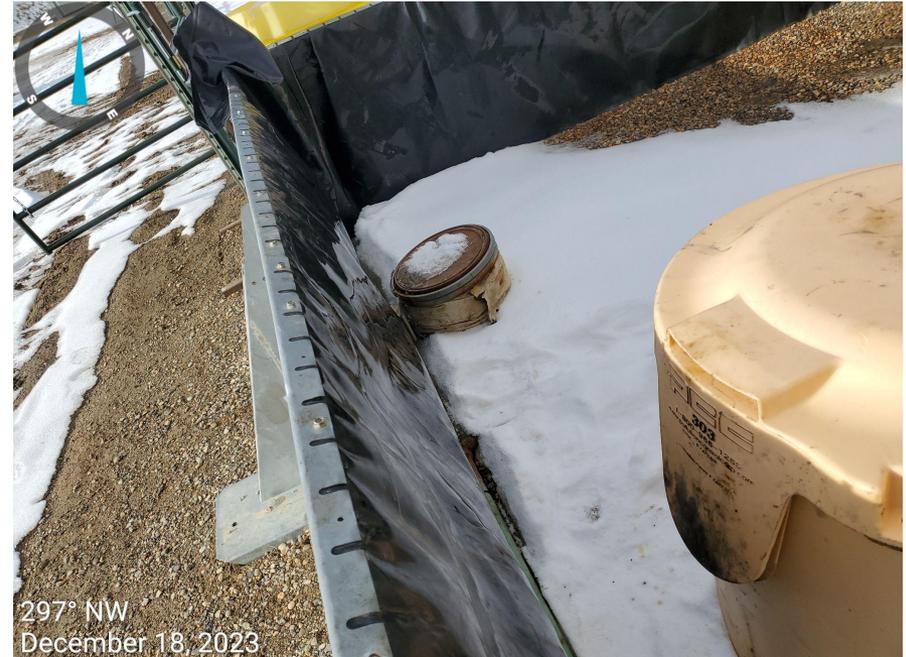
Photo 27: Various trash/debris/unused equipment/container/etc... observed improperly stored on the Location.

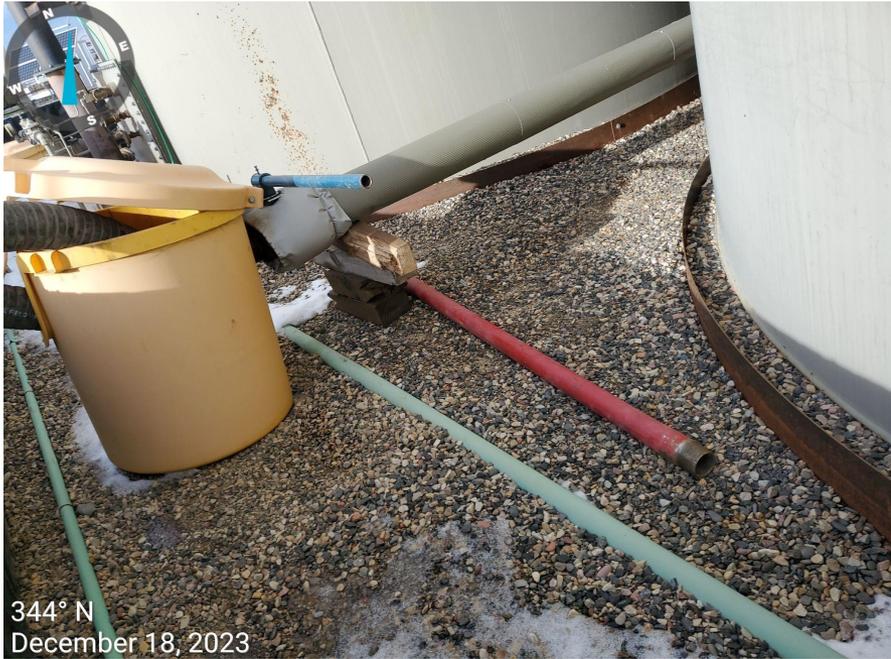
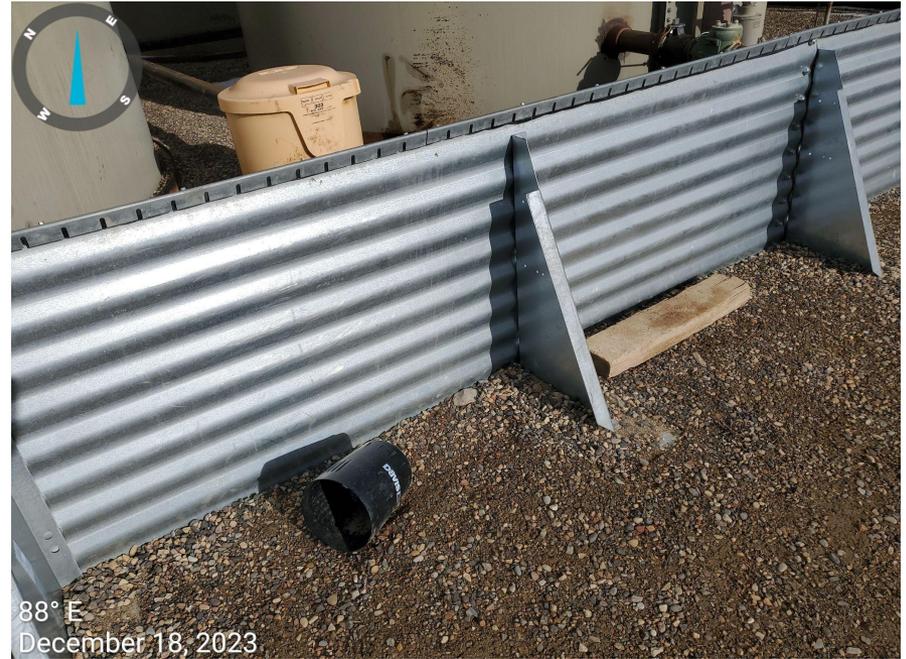
Photo 28: Various trash/debris/unused equipment/container/etc... observed improperly stored on the Location.

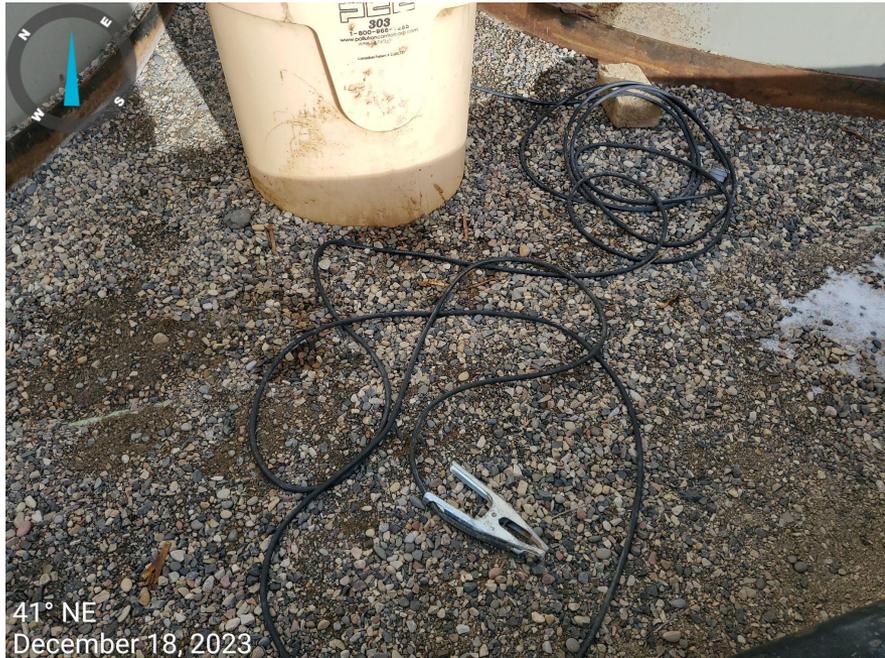
Photo 29: Various trash/debris/unused equipment/container/etc... observed improperly stored on the Location.
