Interim Reclamation and Stormwater Inspection

Operator: NOBLE ENERGY INC - 100322

Location ID: 421829

Inspection Document #: 708200738

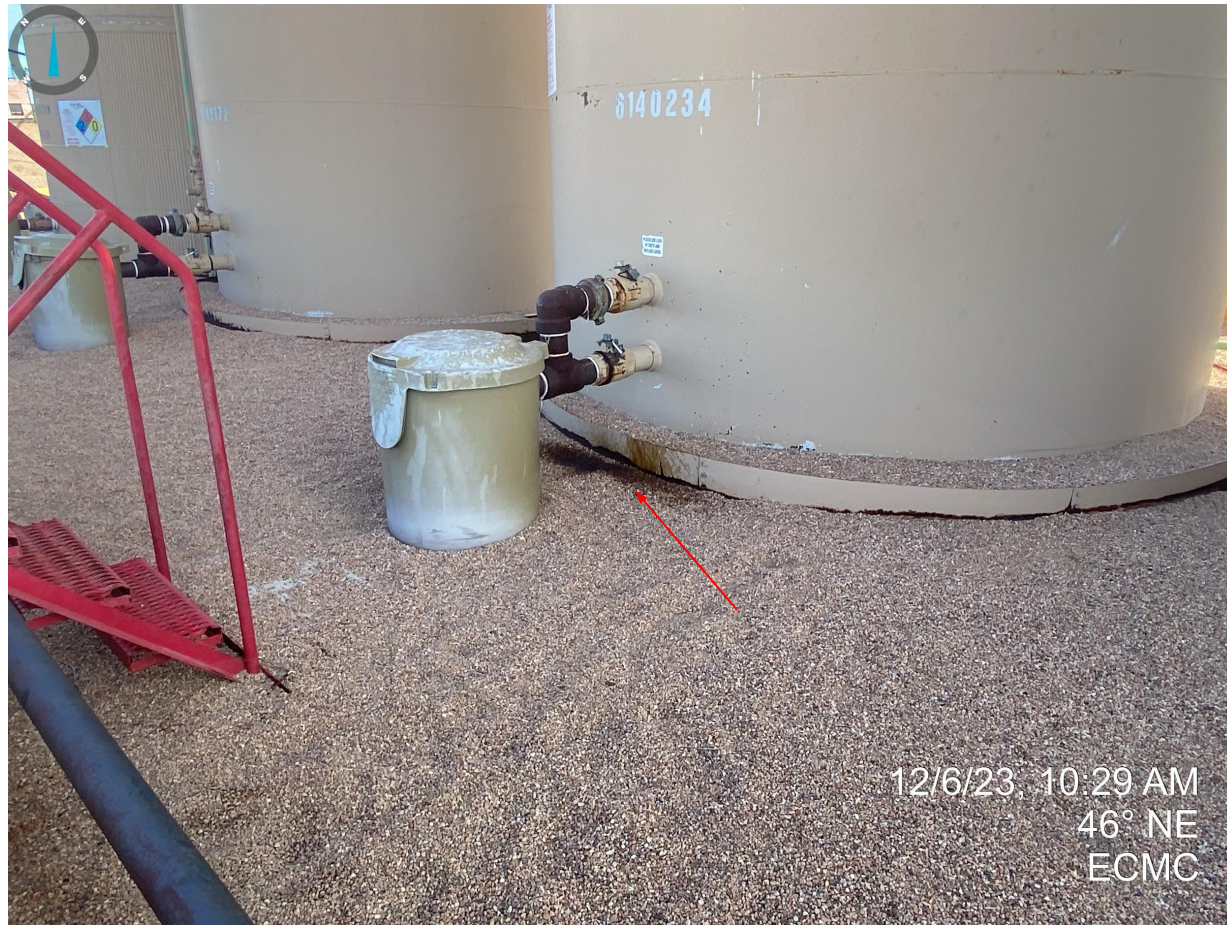
Photo 1. Stained soil observed near loadout line at tank battery.

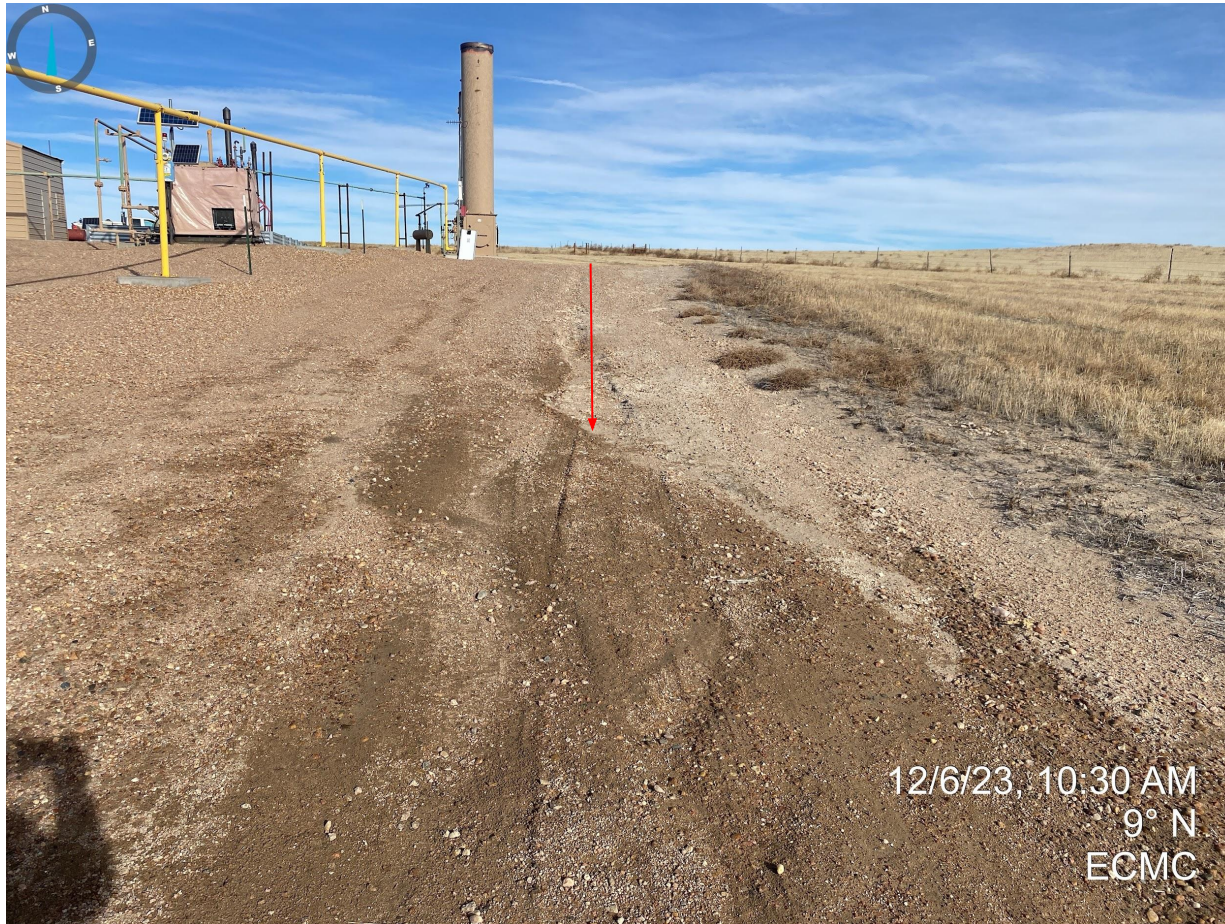
Photo 2. Erosion degradation (rilling) occurring on the eastern portion of the production areas.

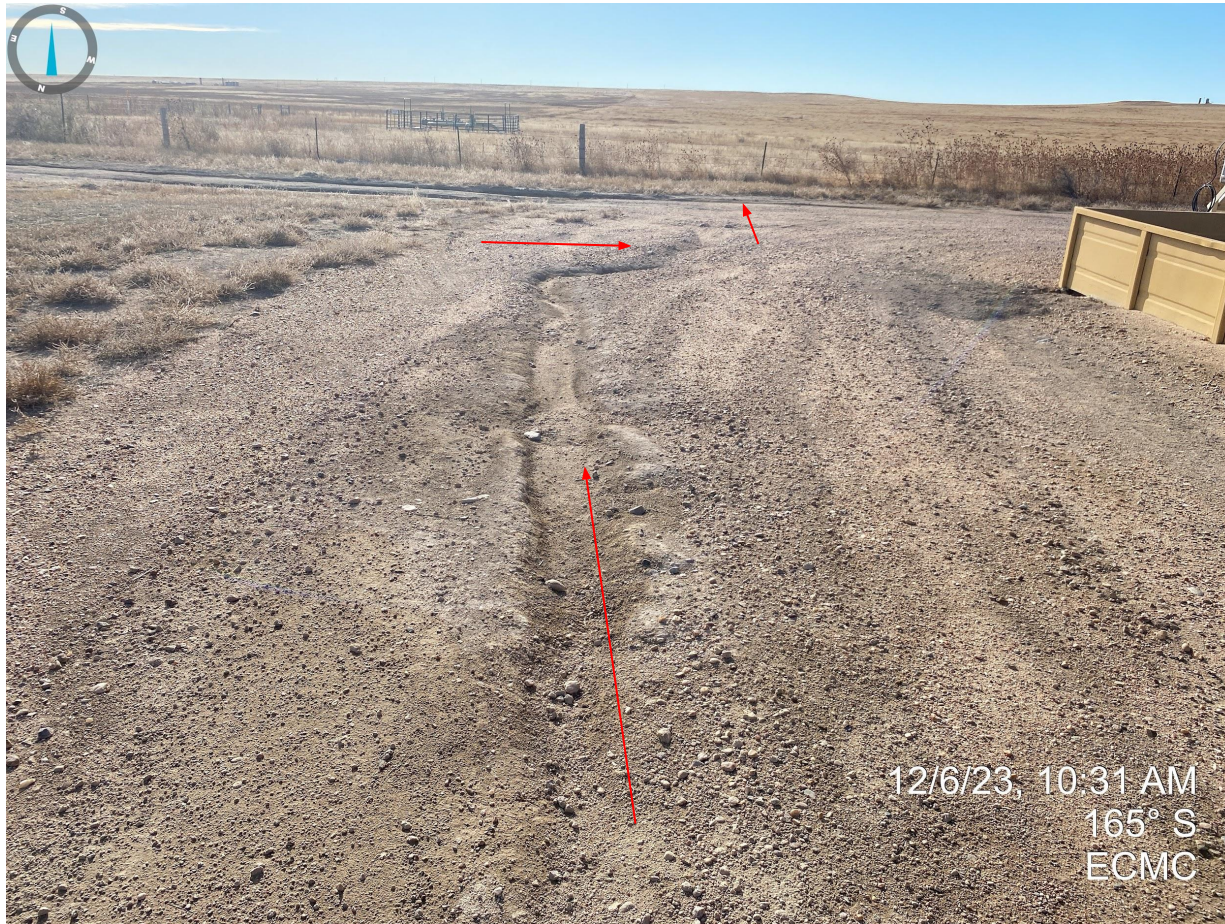
Photo 3. Continued from photo 3, facing south. See comments in Photo 2.

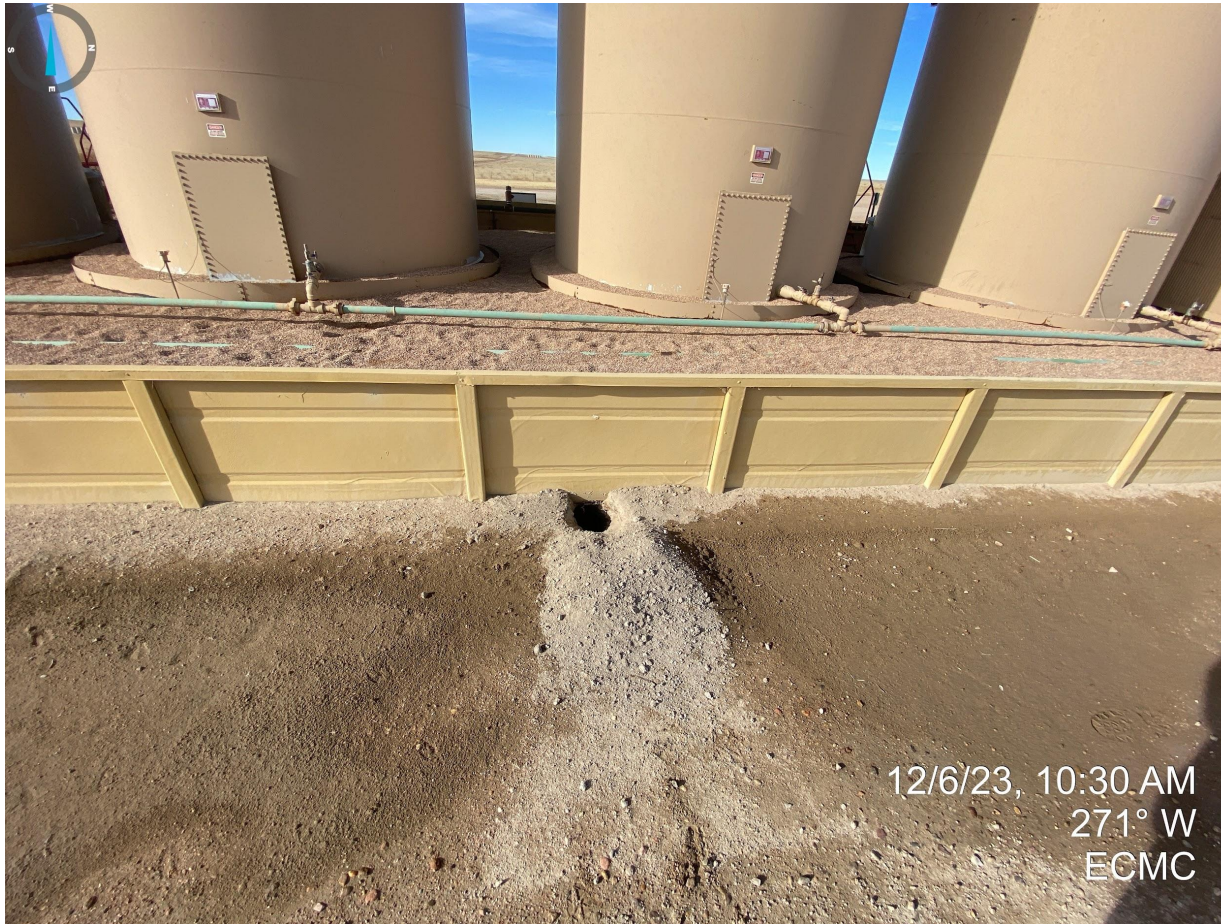
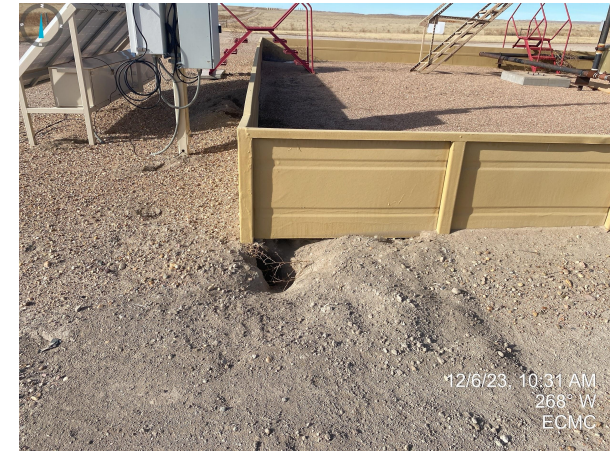
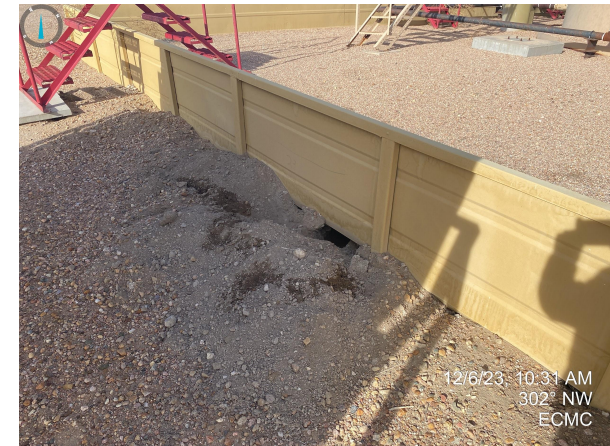
Photos 4-6. Animal burrows observed around the eastern and southern edges of the tank battery secondary containment.

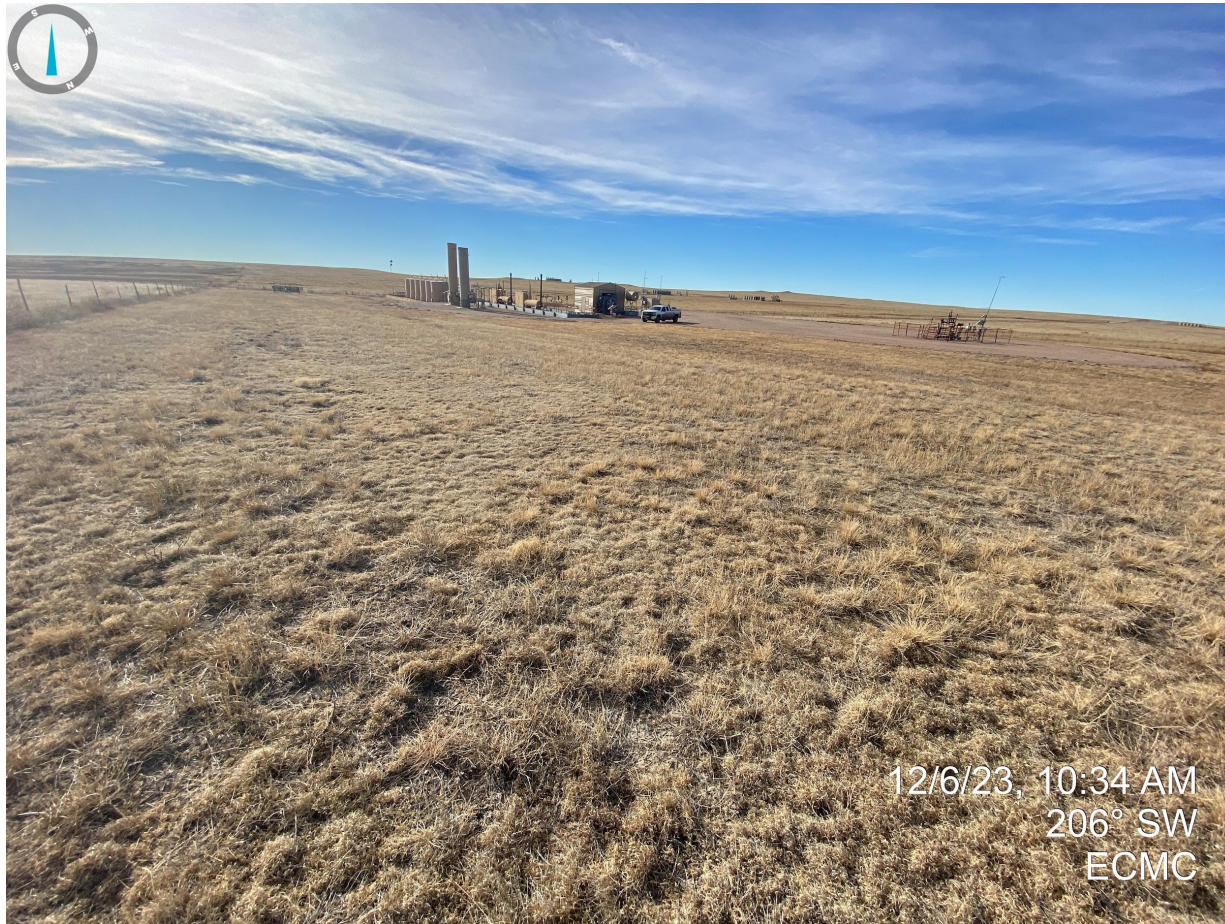
Photo 7. Taken from the northeast corner of the fenced production area. Interim reclamation activities appear to have been performed and areas within the fenced portion appear to be progressing towards Rule 1003 vegetation standards.

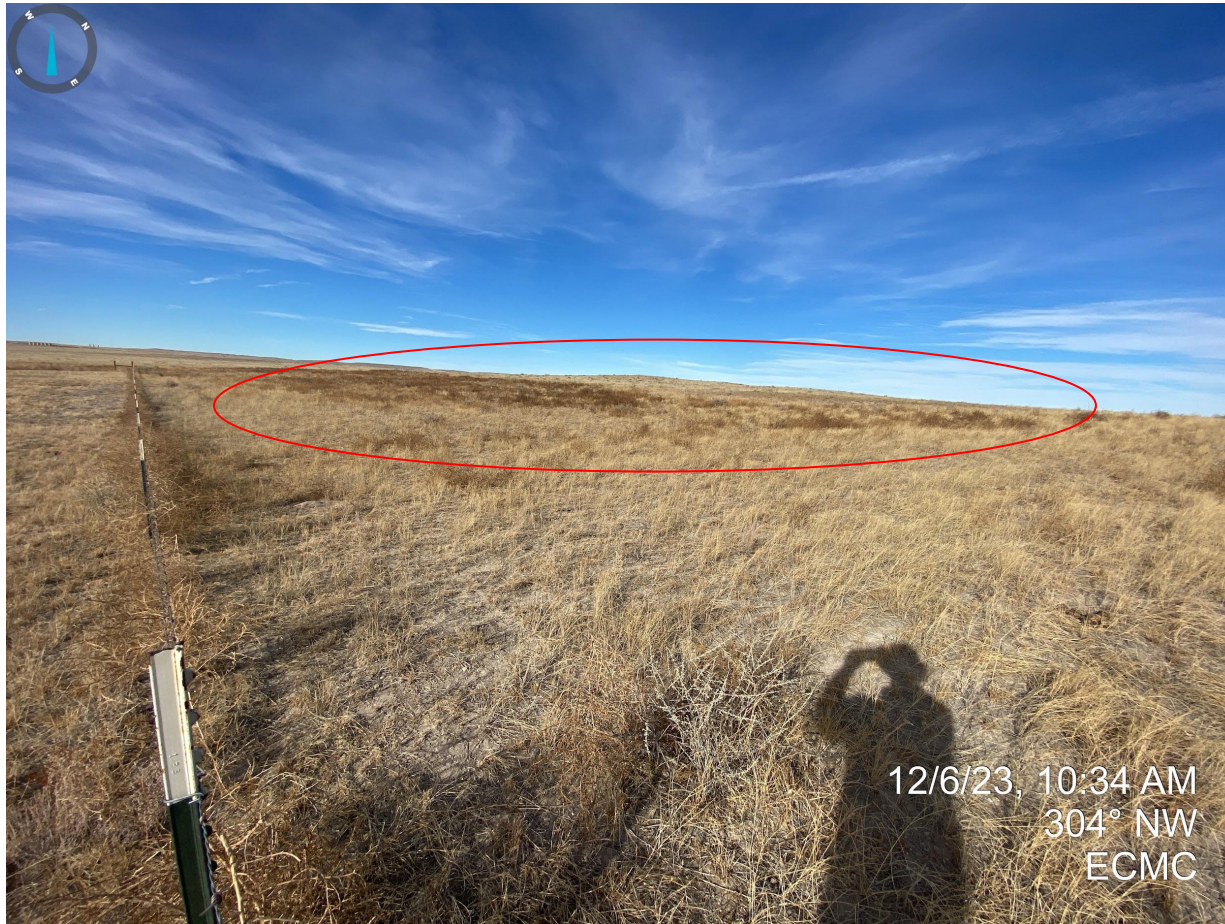
Photo 8. Taken from the northeast corner of the production areas, facing northwest into reclaimed portions. The red highlight illustrates undesirable vegetation (e.g. russian thistle) within the interim areas. Additional weed management is required to comply with Rule 1003.

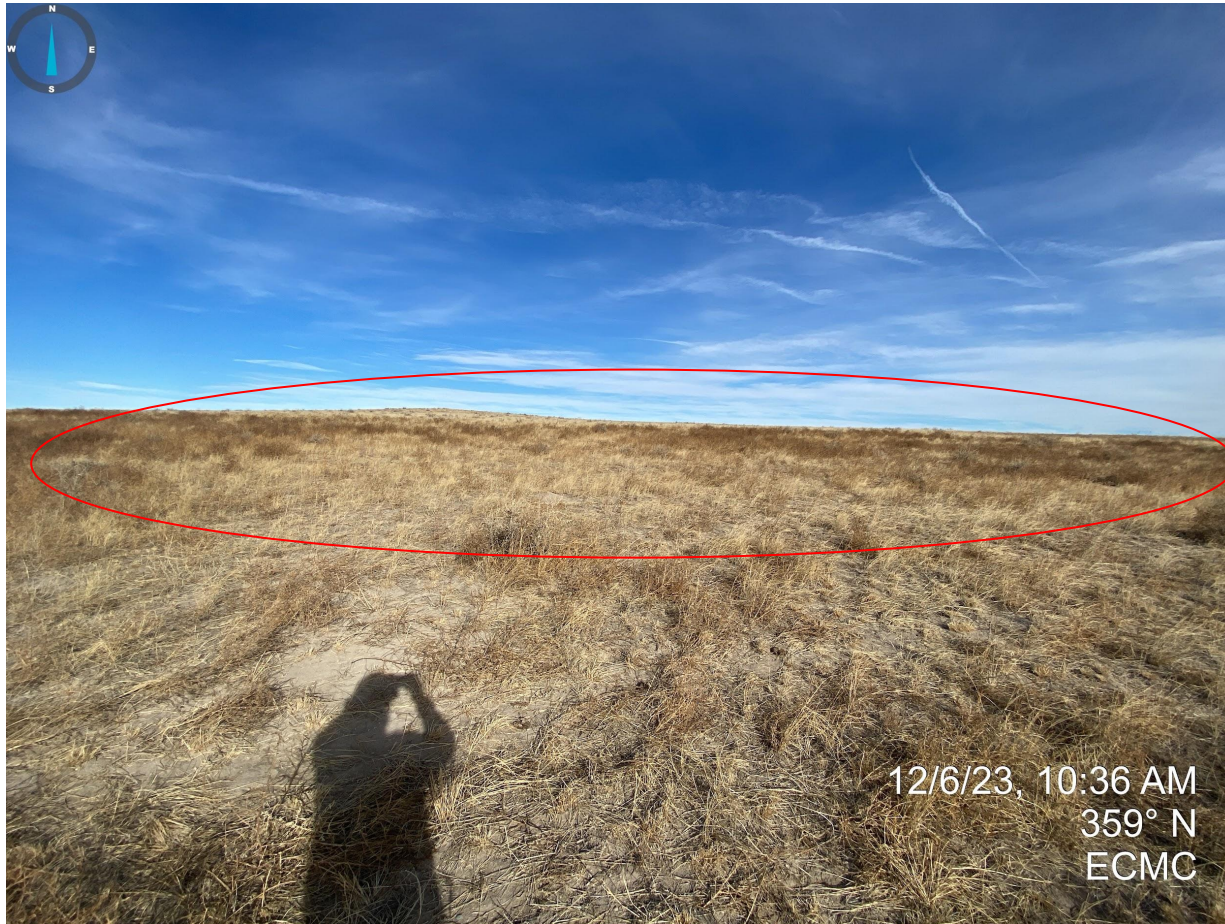
Photo 9. Taken from the northwest corner of the production areas, facing north into the reclaimed interim areas. See comments in Photo 8.

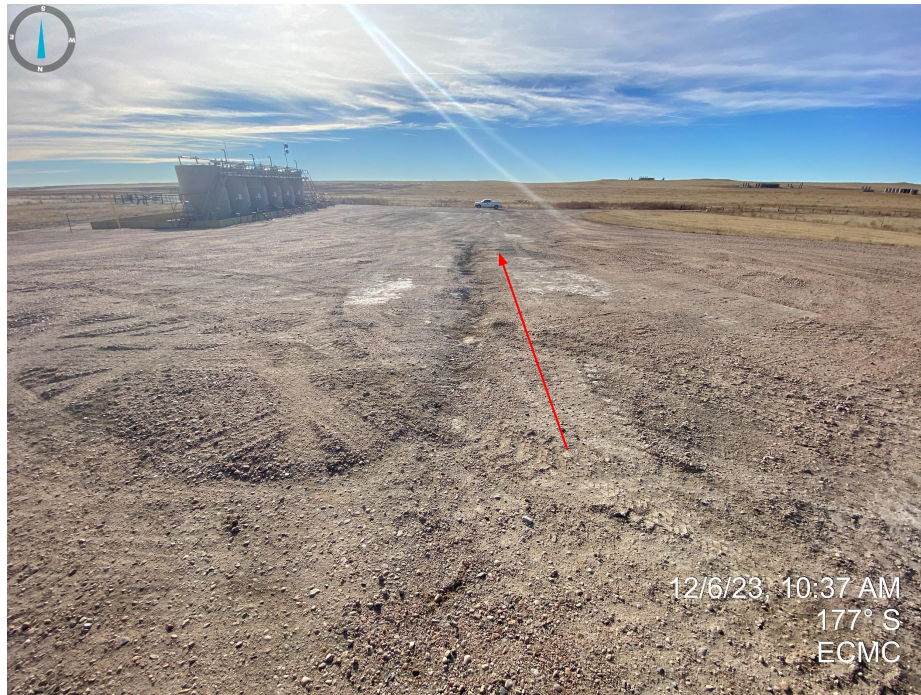
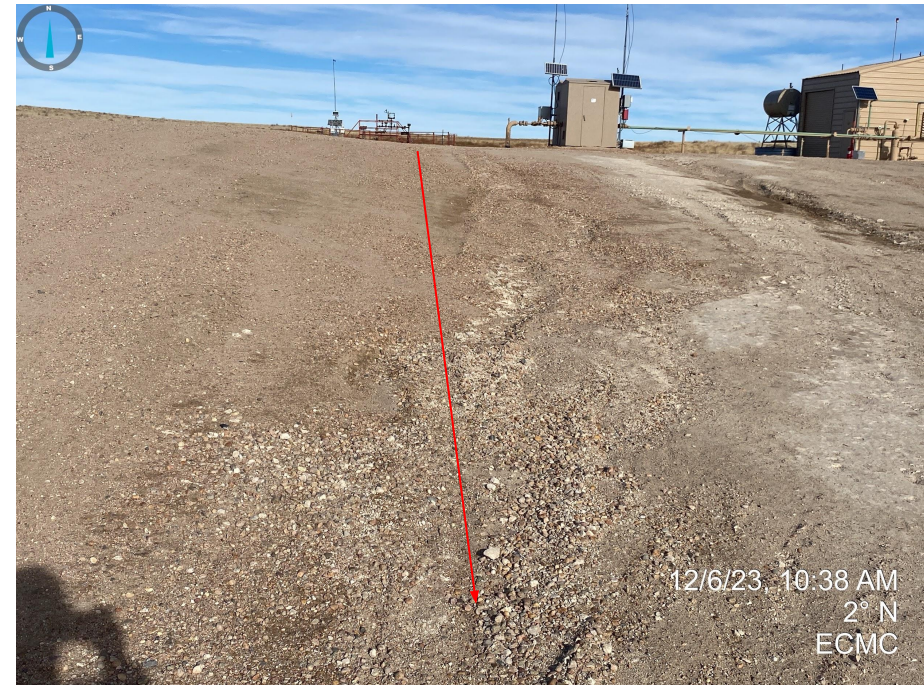
Photos 10 & 11. Erosion degradation (rilling) occurring within the center portion of the production areas.
