Construction and Stormwater Inspection

Operator: BISON IV OPERATING LLC - 10670

Location ID: 485658

Inspection Photos
Location Name: Boomhog/8-59 3
Location ID: 485658

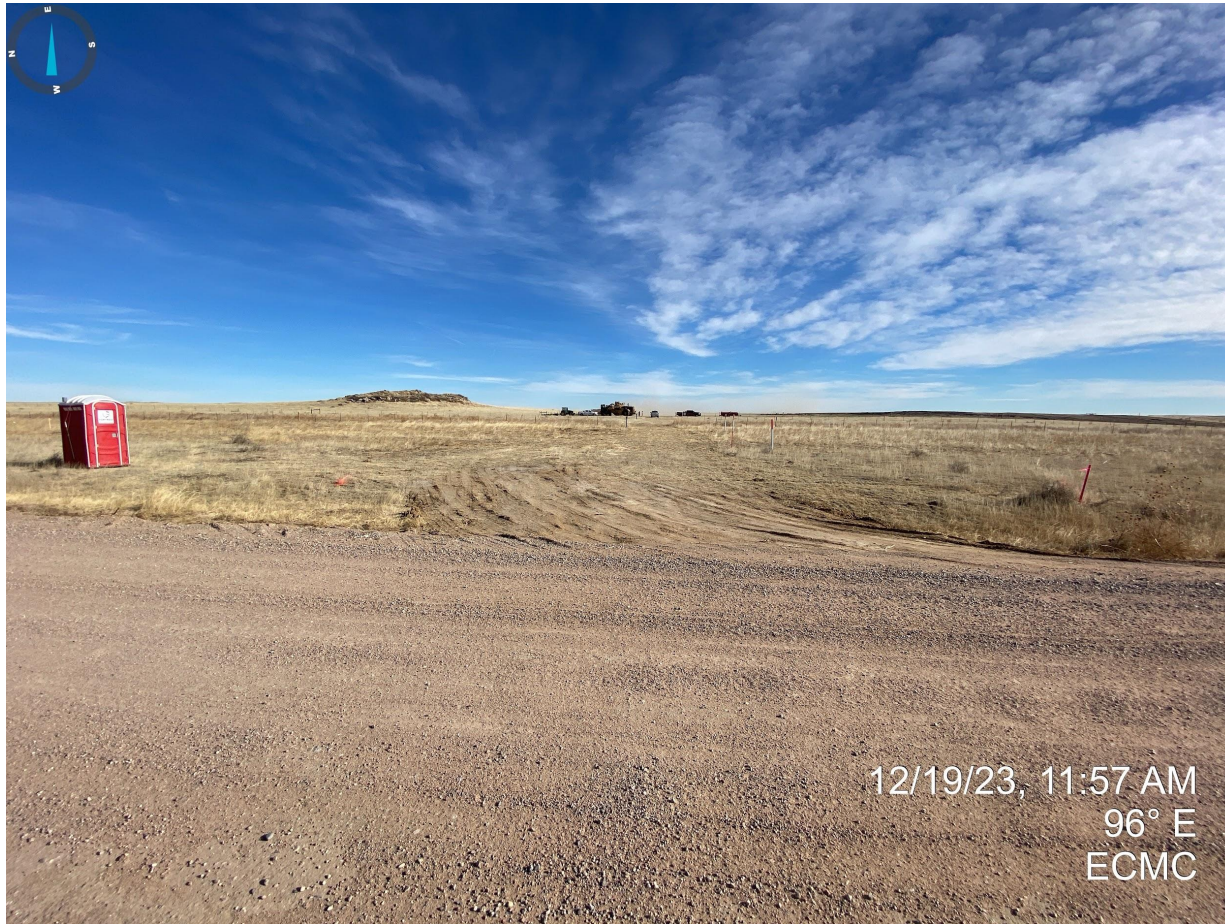
Photo 1. Taken from the county road, looking towards the location. No location signage was observed at the intersection of the access road and adjacent county road, or near the location's construction area. Additionally, it does not appear that topsoil salvage has occurred along the access road at the time of this inspection; topsoil salvage operations were ongoing.

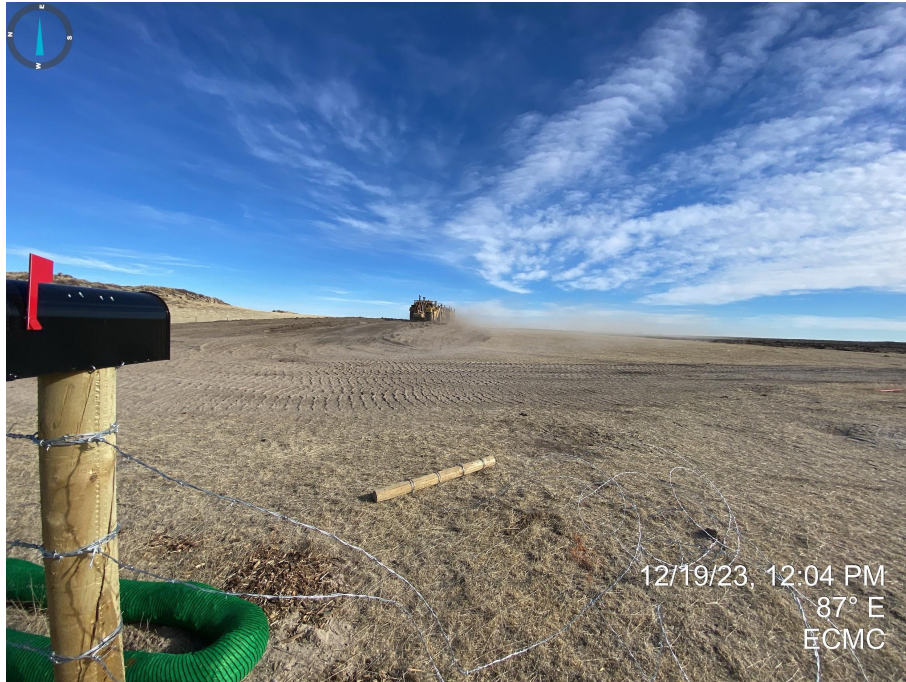
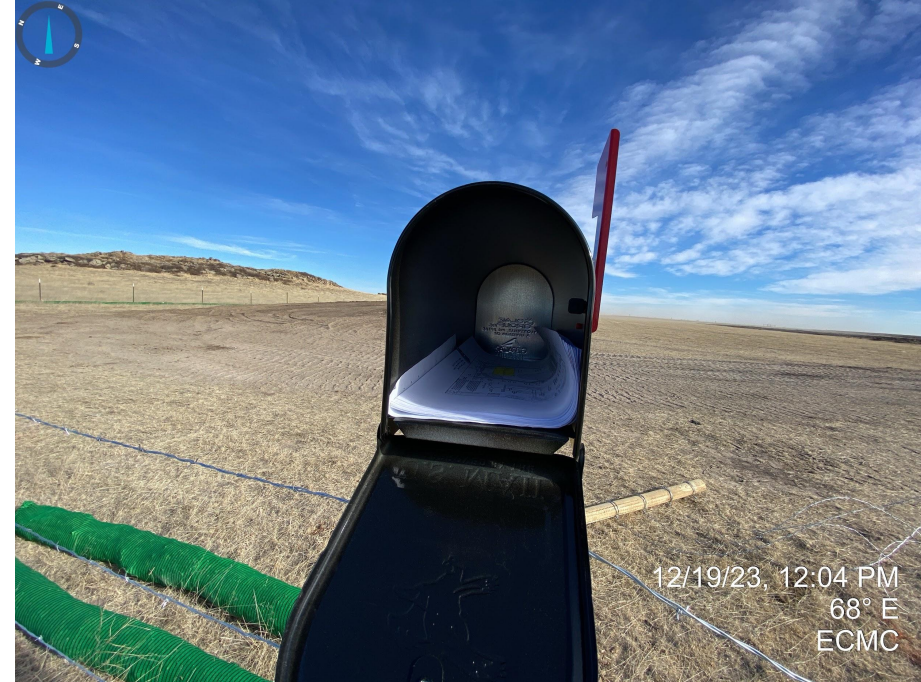
Photos 2 & 3. Taken from the location's entrance. A copy of the approved Form 2A was not located within the mailbox. Staff observed that the box contained only the construction layout drawings.

Per Rule 406.c. a copy of the approved Form 2A, and any Form 4 modifying the approved Form 2A, will be posted in a protected and conspicuous place on location upon commencement of operations with heavy equipment until the conclusion of interim reclamation.

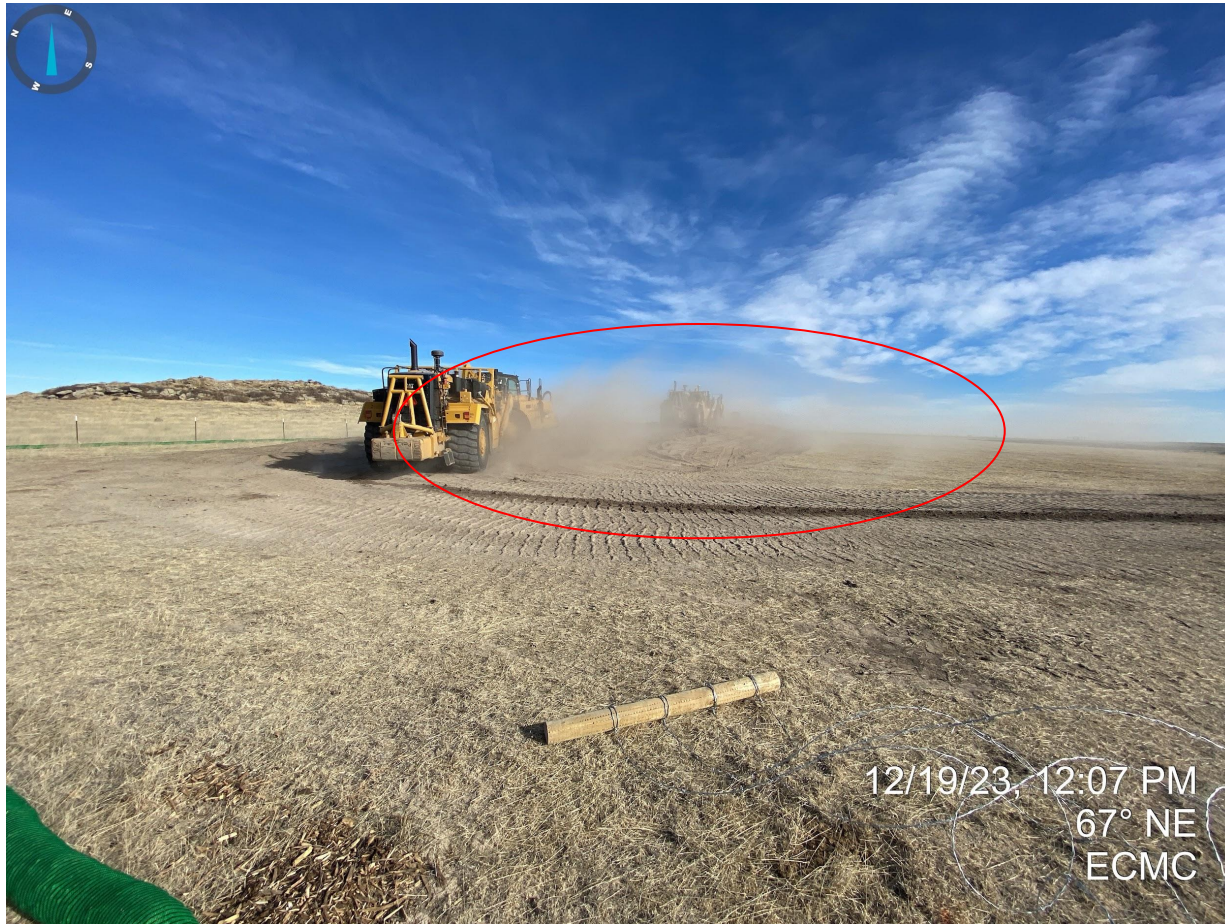
Photo 4. Taken from the location's entrance, facing northeast towards the topsoil stockpile. Photo illustrates that fugitive dust is occurring from topsoil salvage operations.

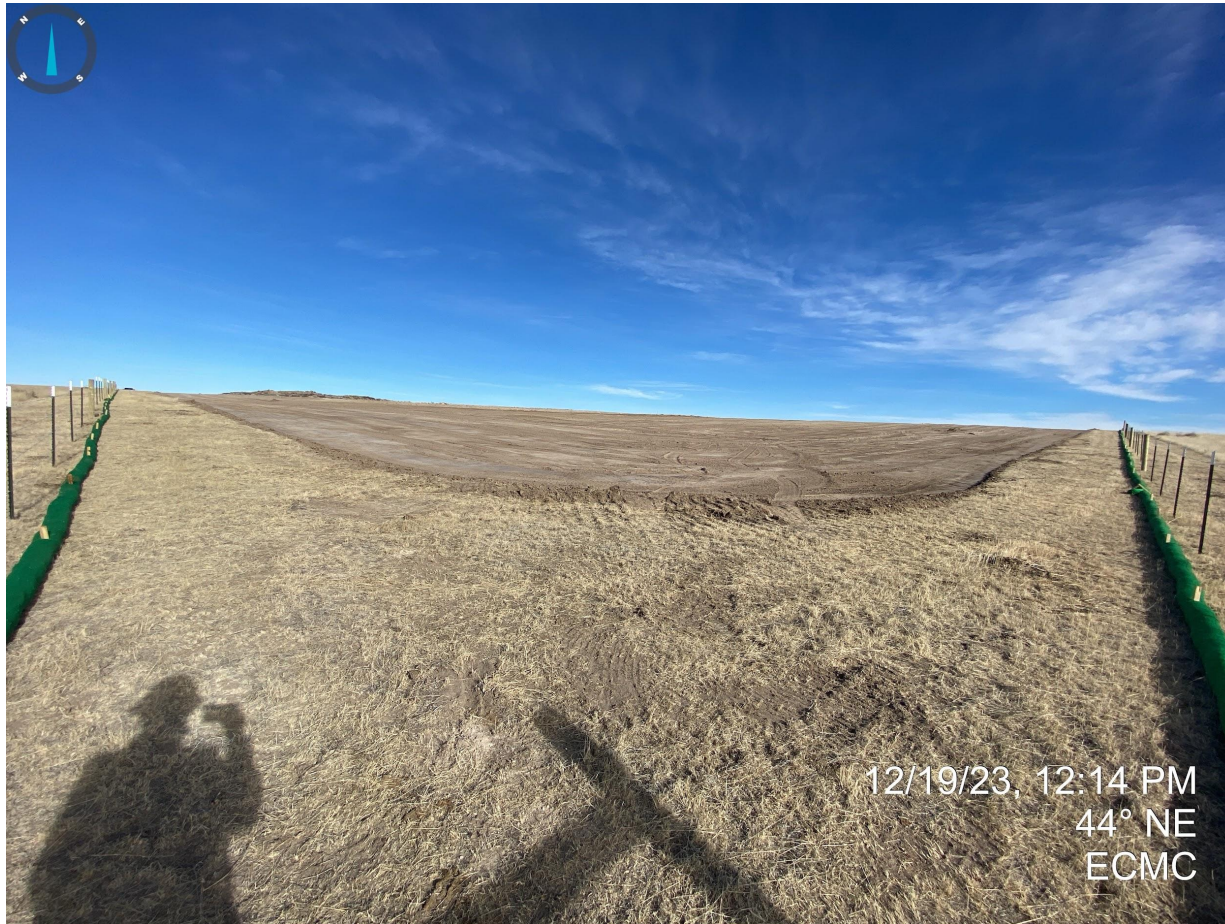
Photo 5. Taken from the southwest corner of the construction/disturbance area. It appears that topsoil salvage operations have commenced. The Operator shall ensure that all topsoil is salvaged per Rule 1002.b. A follow up inspection will be conducted at a later date to ensure topsoil salvage operations comply with the reclamation rules. Photo also illustrates temporary stormwater controls (filtrexx) installed around the entire perimeter of the location.

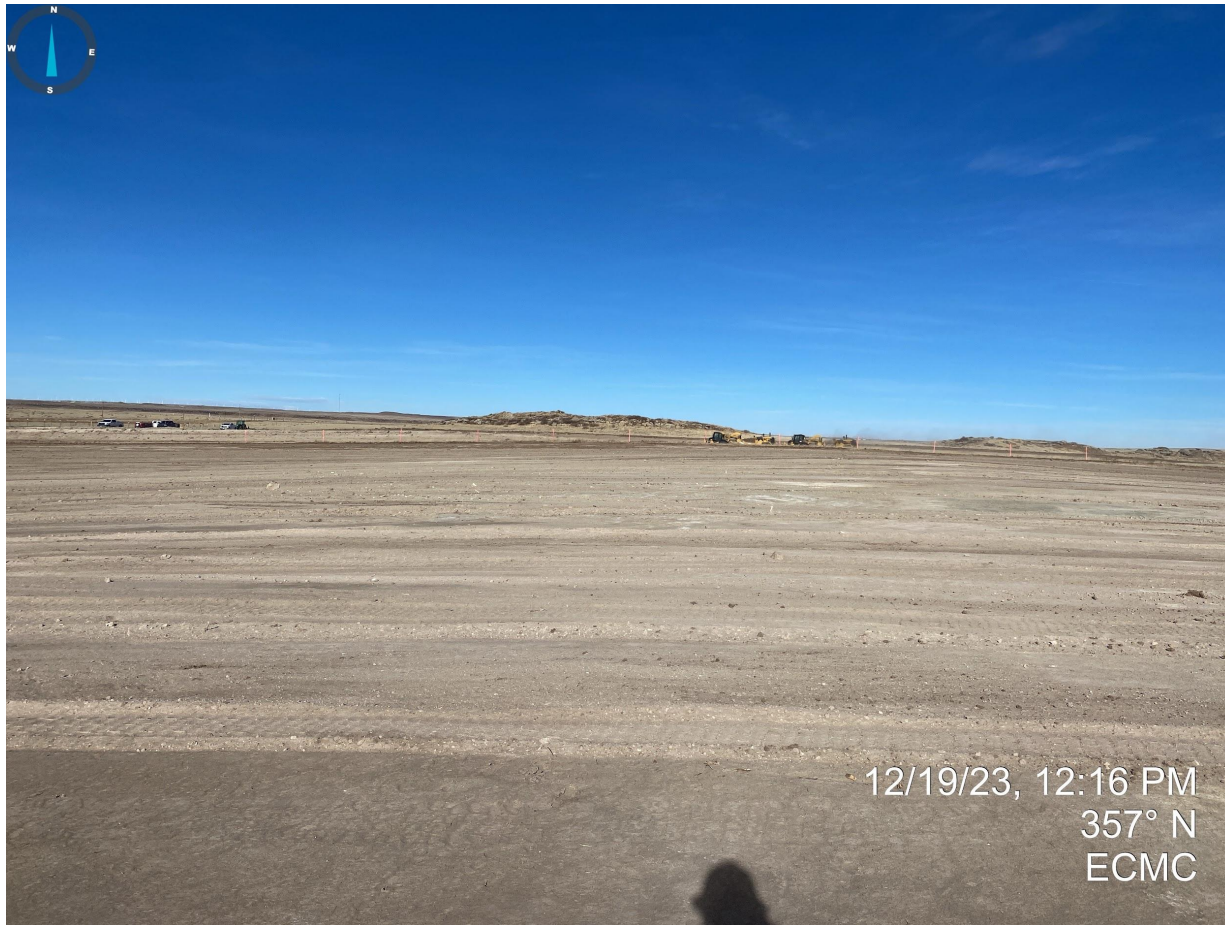
Photo 6. Taken from the center/southern portion of the disturbance area. See comments in Photo 5.

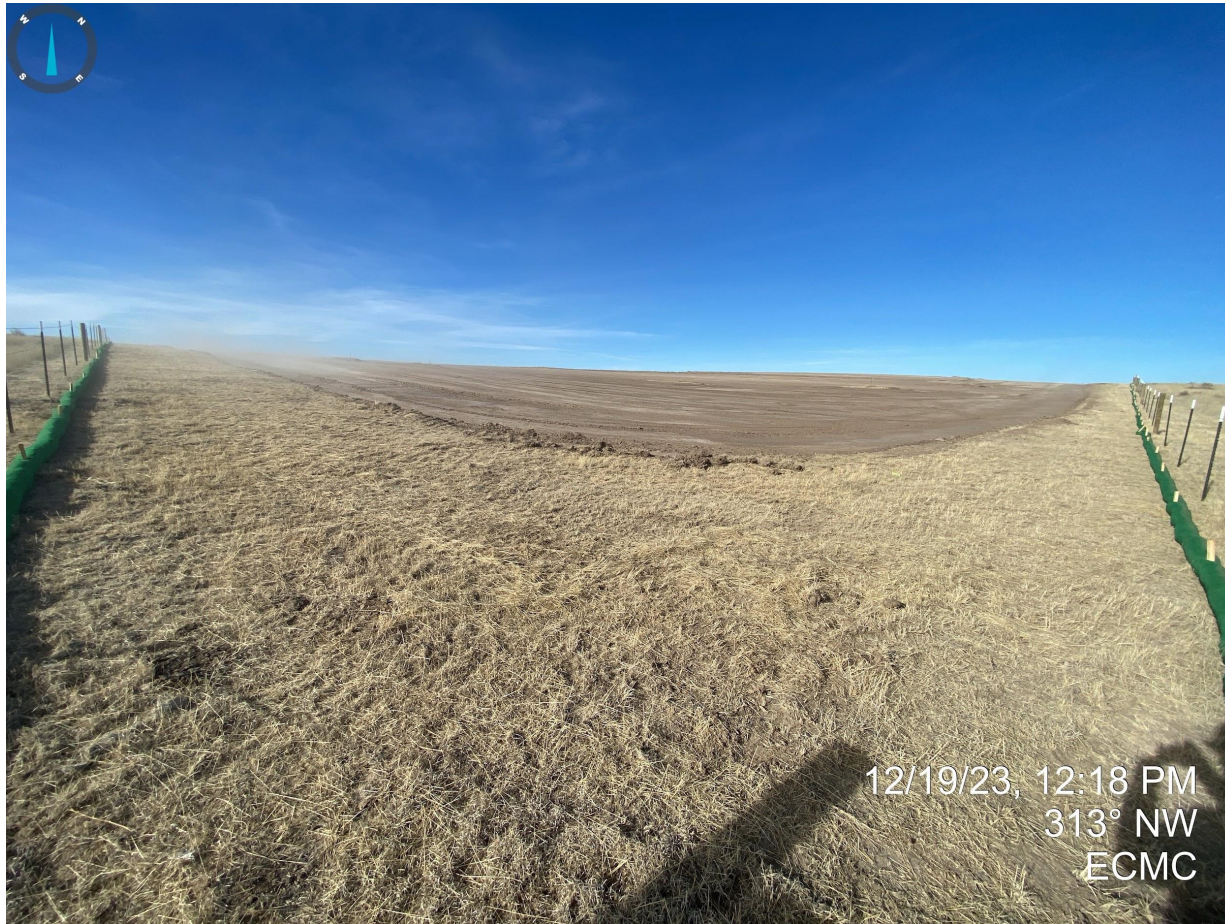
Photo 7. Taken from the southeast corner of the disturbance area. See comments in Photo 5.

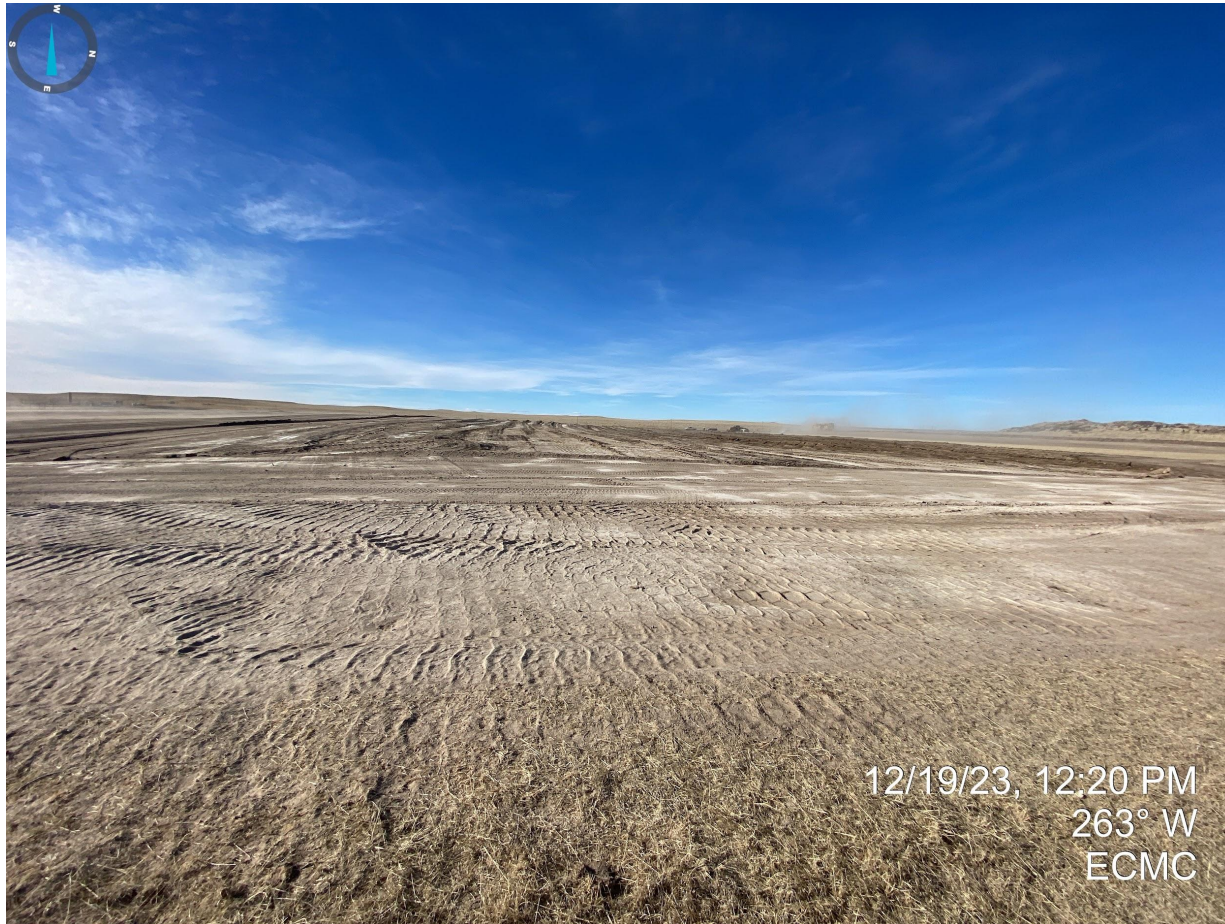
Photo 8. Taken from the center/eastern portion of the disturbance area. See comments in Photo 5.

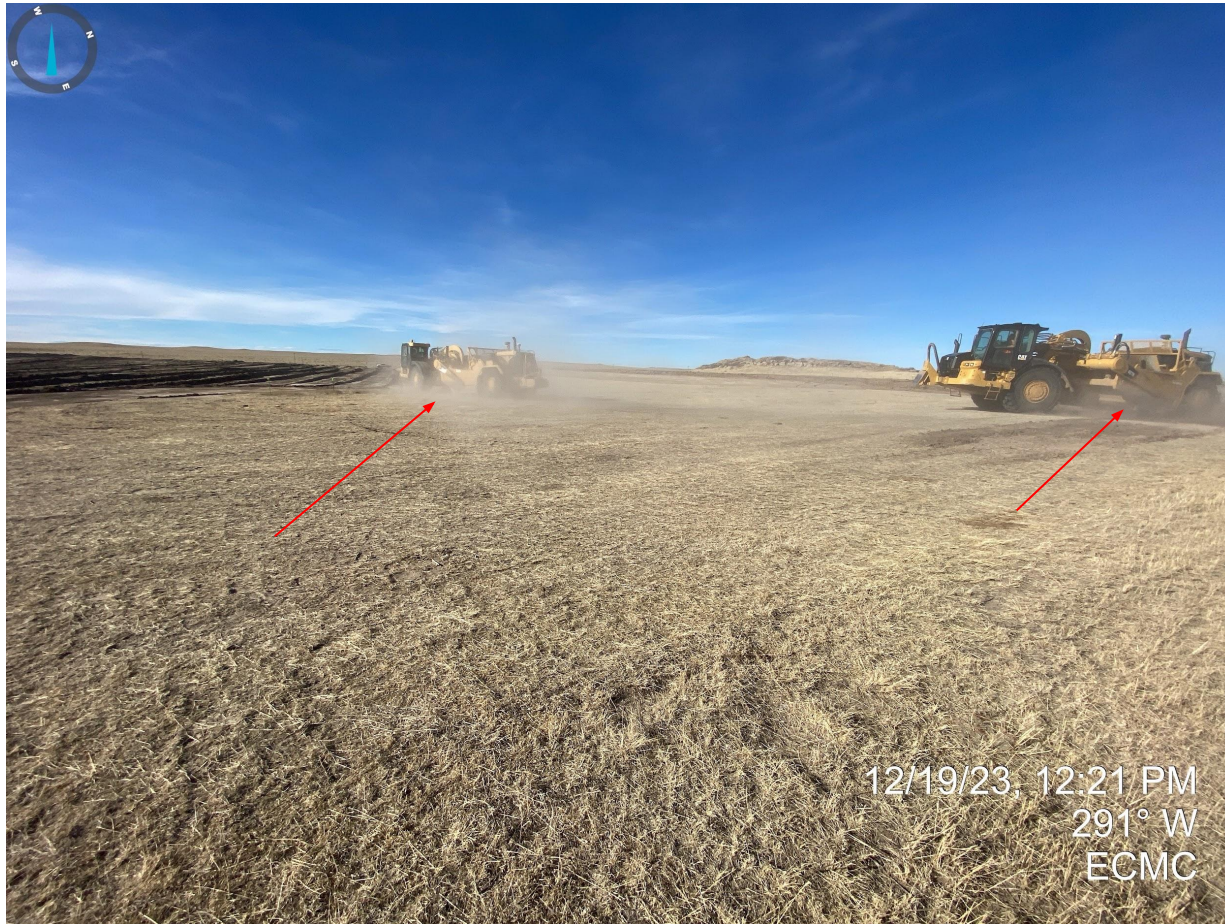
Photo 9. Taken near the northeast corner of the disturbance area. Photo illustrates that fugitive dust is occurring from topsoil salvage operations.

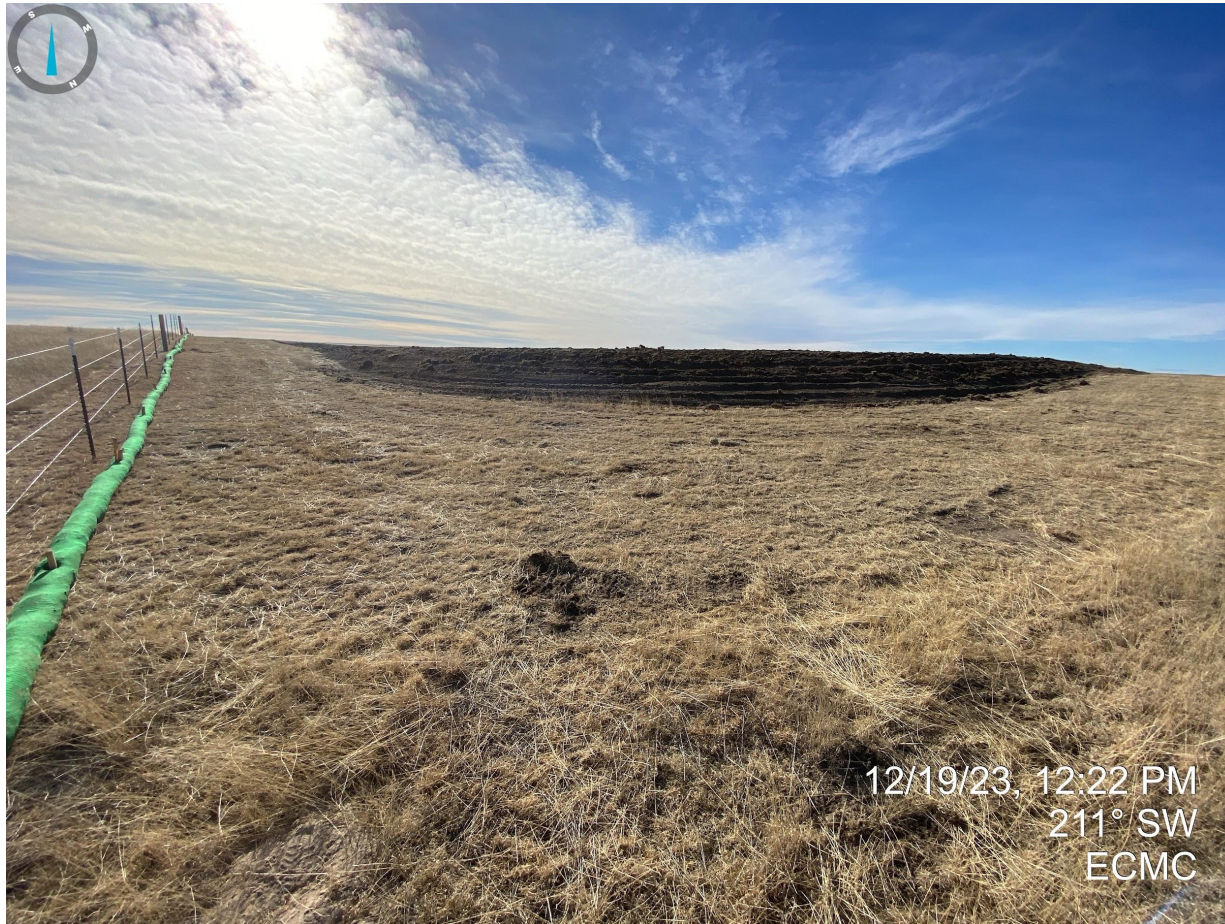
Photo 10. Taken from the northeast corner of the disturbance area, facing the topsoil stockpile. See comments in Photo 5.

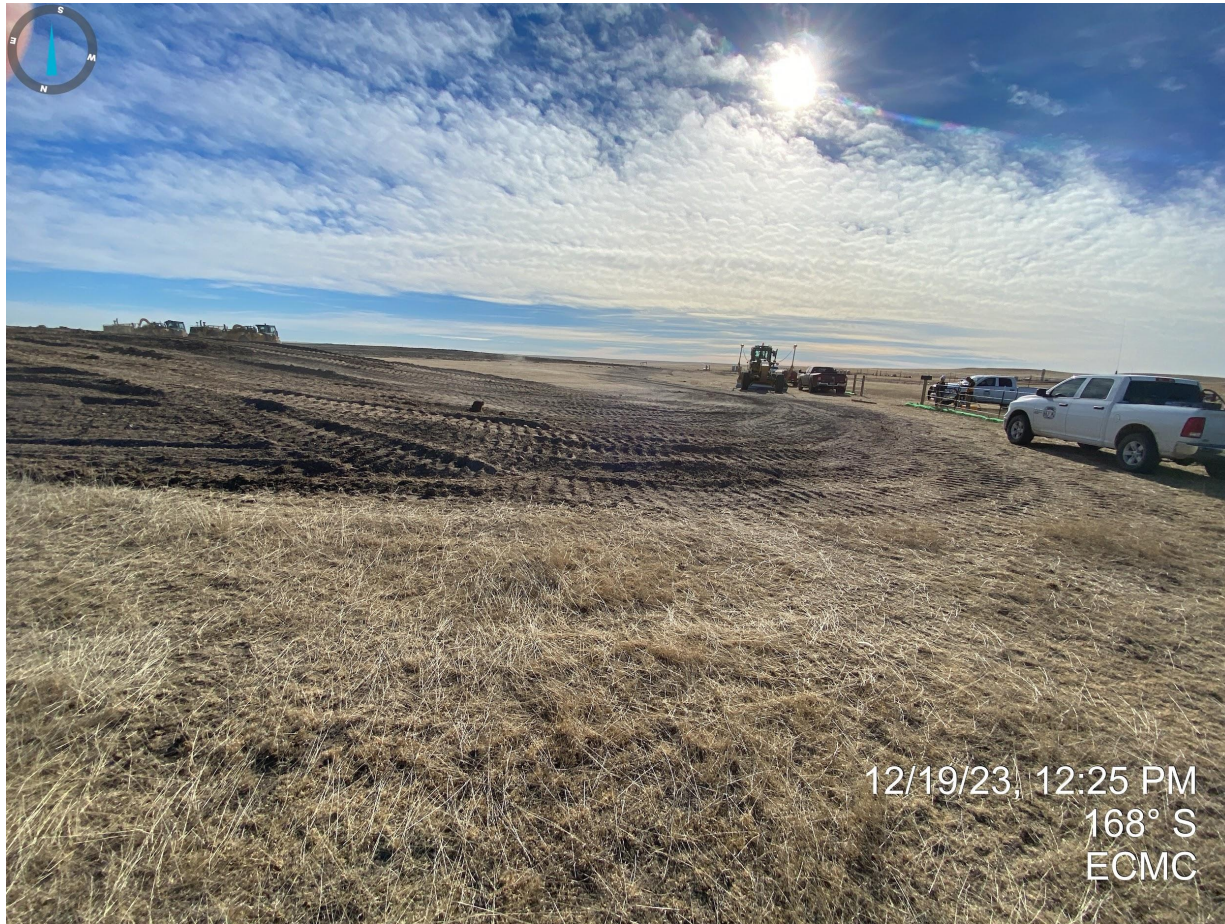
Photo 11. Taken near the northwest corner of the disturbance area, facing the topsoil stockpile. See comments in Photo 5.

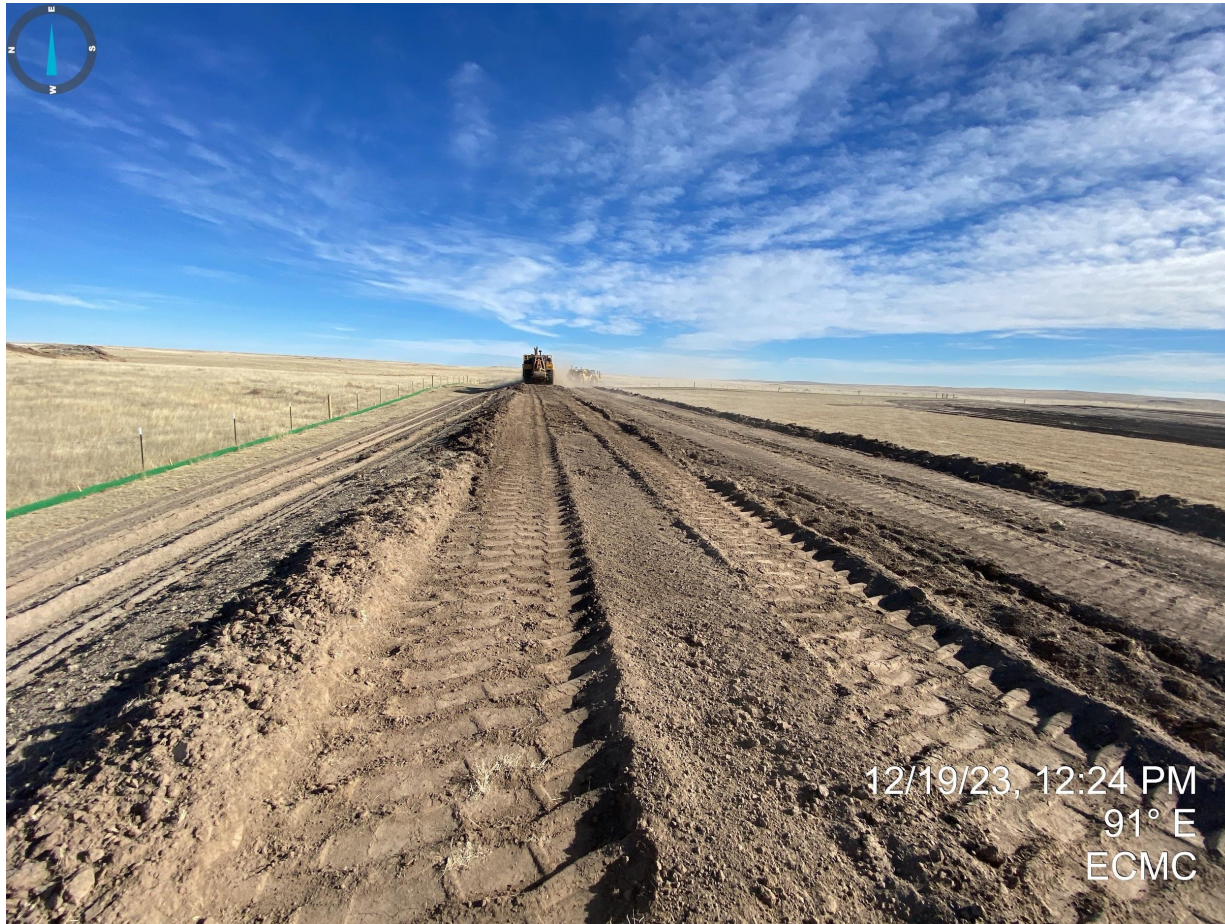
Photo 12. Taken from the center portion of the topsoil stockpile, facing east. Topsoil salvage operations are still ongoing at the time of this inspection. The Operator shall ensure that all stockpiled soils have adequate BMPs to prevent erosion degradation from wind and water.

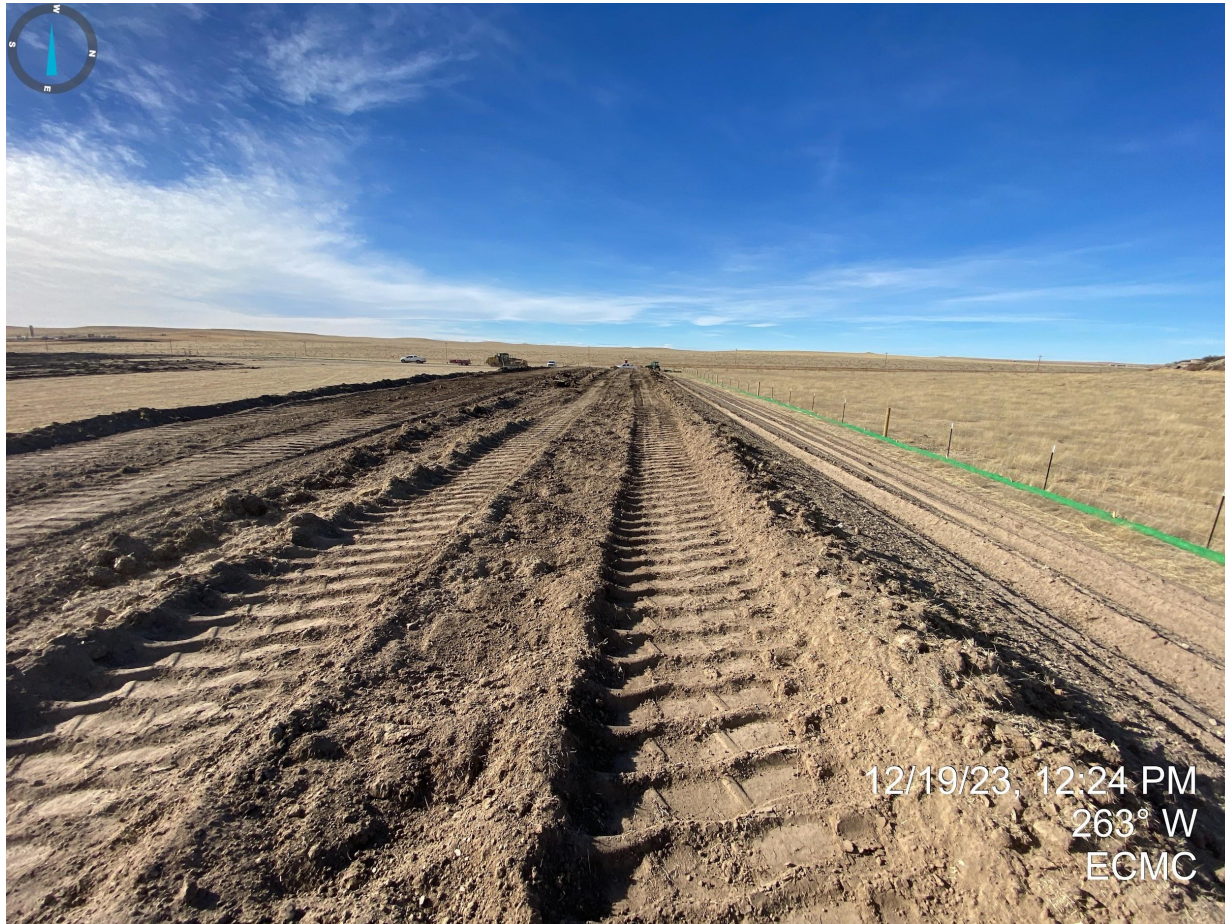
Photo 13. Taken from the center portion of the topsoil stockpile, facing west. See comments in Photo 12.
