Henderson 1

ECMC Inspection 696305448

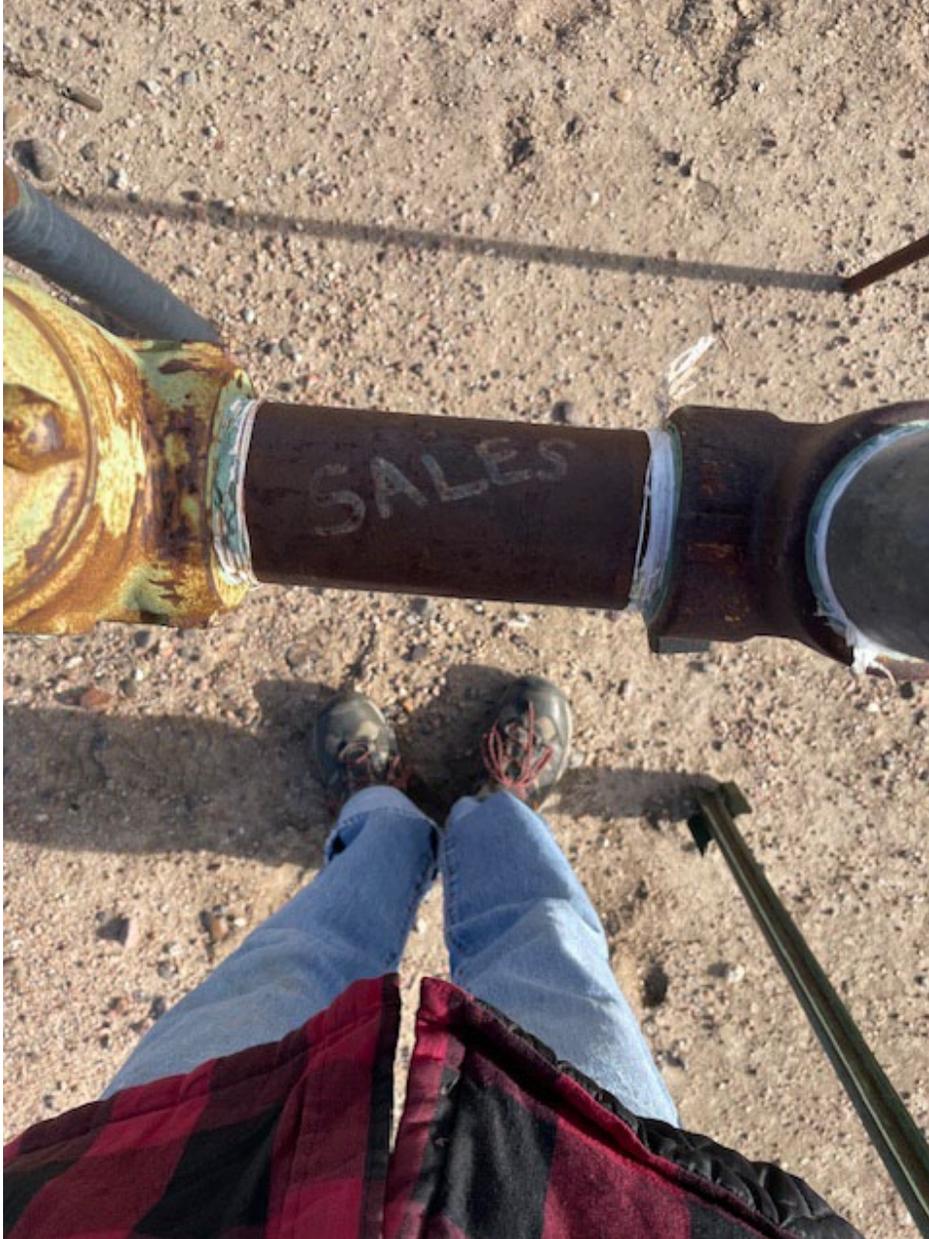
Corrective Action: Disconnected flowline risers not OOSLAT

Operator Response: Risers have been marked. Risers are still in use.

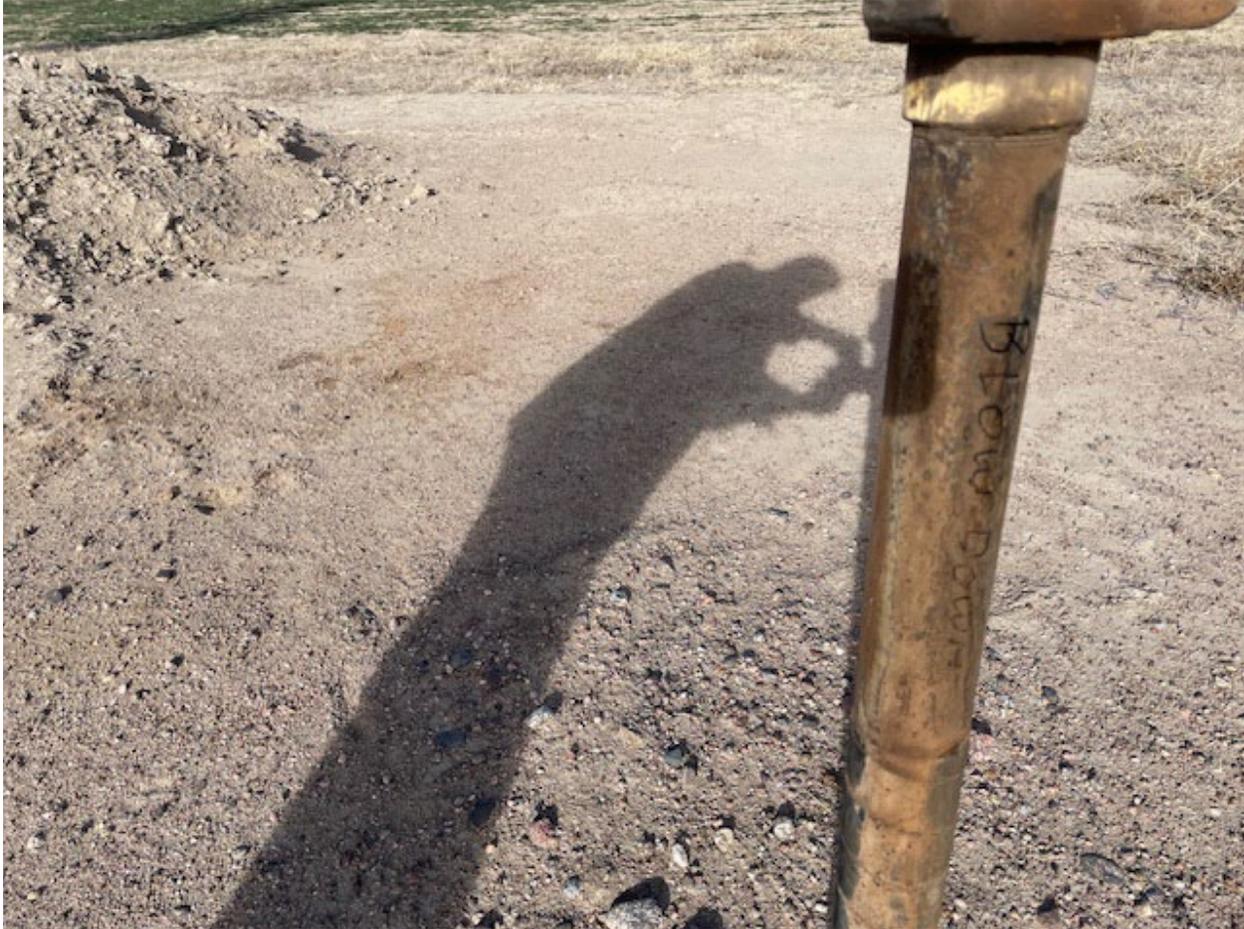
Corrective Action: Disconnected flowline risers not OOSLAT

Operator Response: Risers have been marked. Risers are still in use.
