Inspection Photos

Location Name: TEP ROCKY MOUNTAIN LLC, CLOUGH-66S95W/33NESW

Location ID: 335292

Date: 12/18/2023

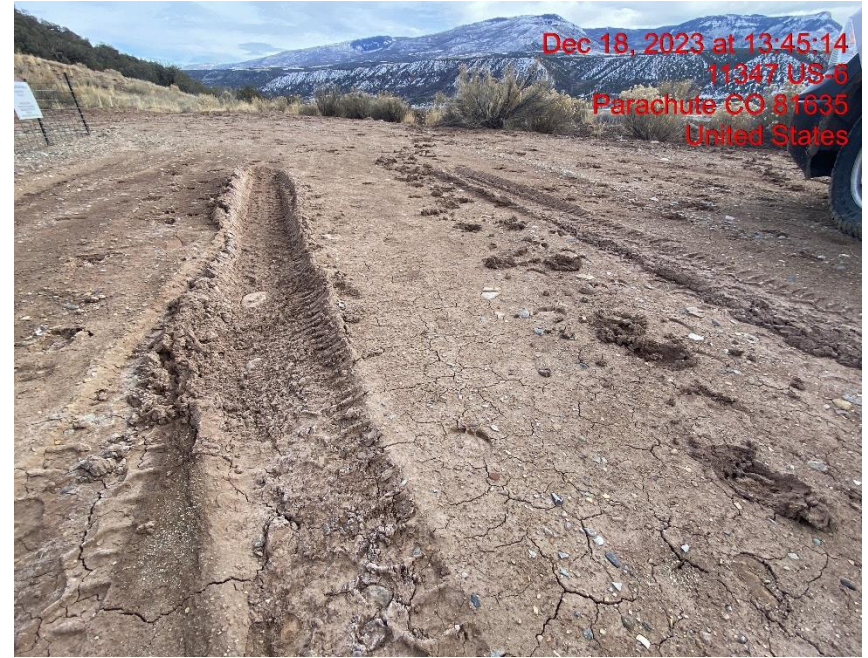
Lack of Stabilization – Photo #08285

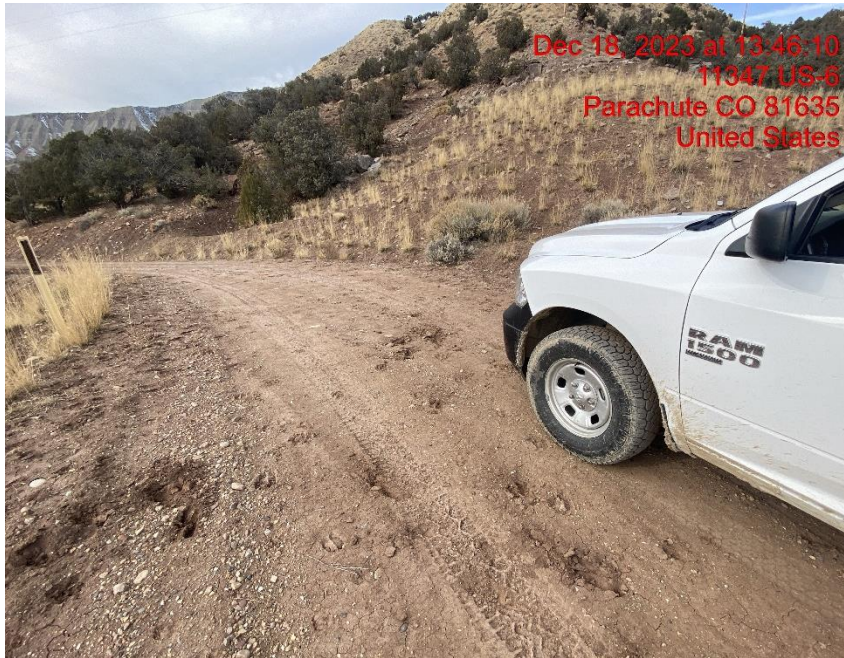
Insufficient Vehicle Tracking BMPs at Location Entrance/Exit
– Photo #08286
