Interim Reclamation and Stormwater Inspection

Operator: PDC Energy Inc. - 69175

Location ID: 459972

Inspection Photos
Location Name: Sunlight 5N64W8 1-11
Location ID: 459972

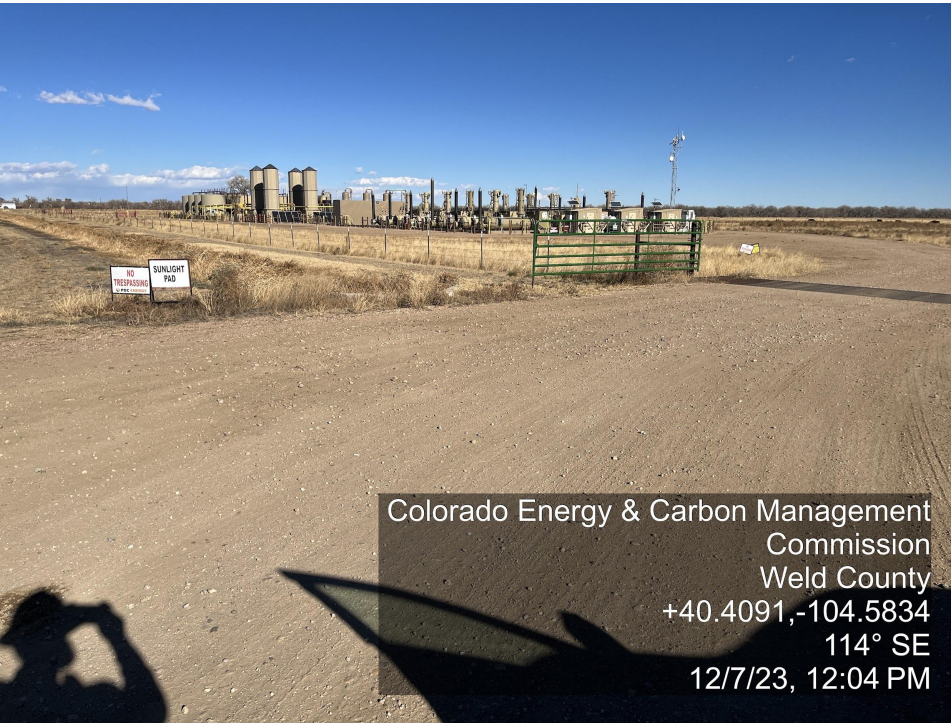
Photo 1. The photo was taken at the well location entrance facing Southeast. The photo illustrates the entrance gates and some operator signage.

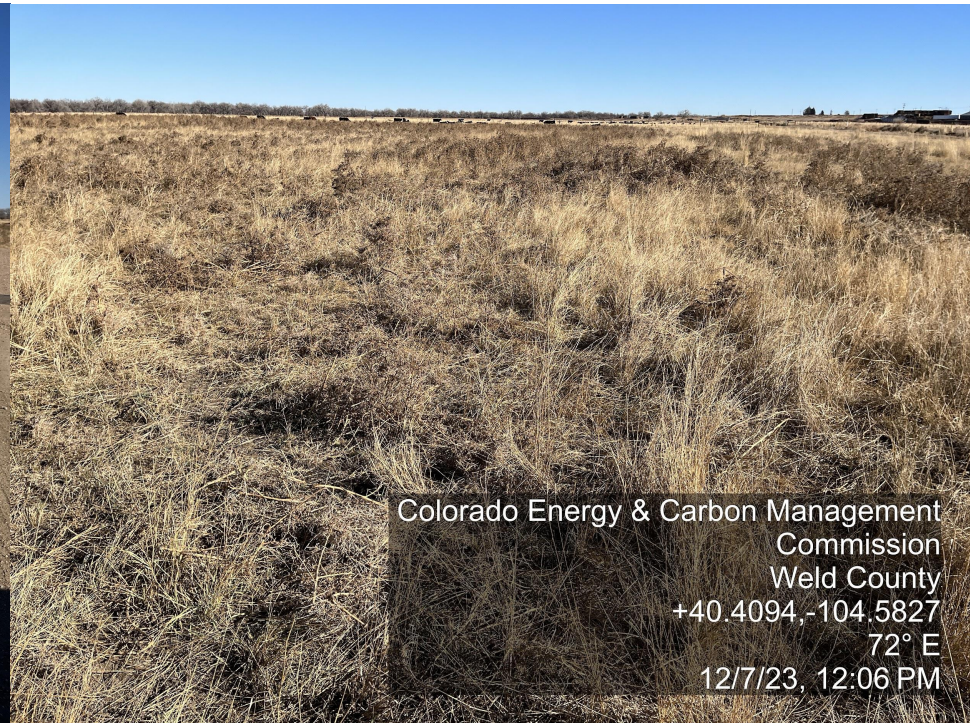
Photo 2. The photo was taken from the well location facing East. The photo illustrates the southeast portion of the interim areas are dominated in places by kochia.

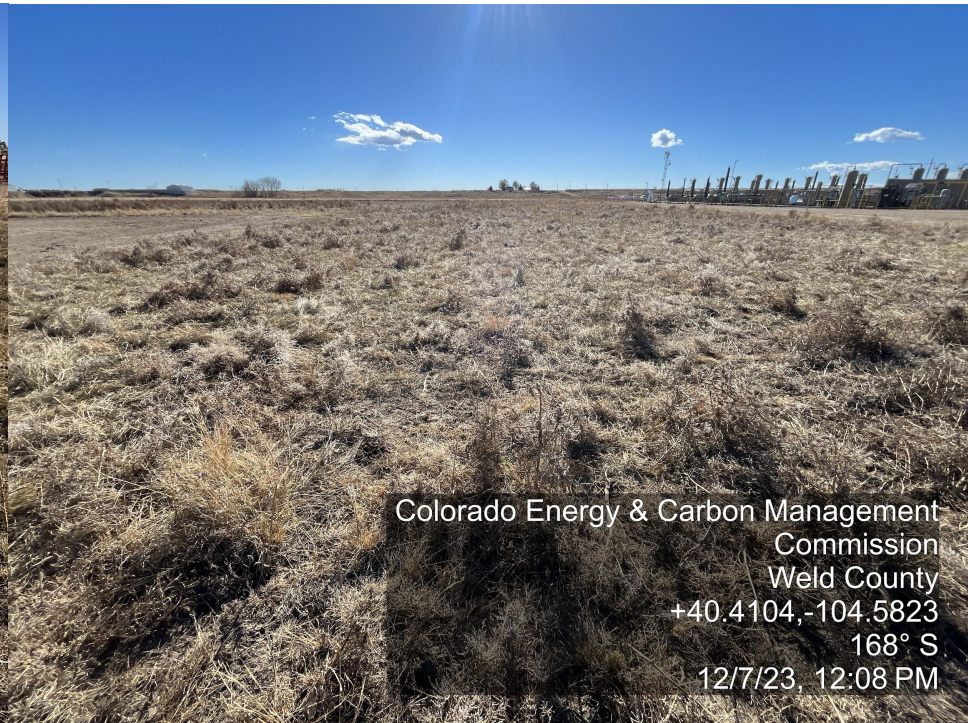
Photo 4. The photo was taken at the well location facing South. The photo illustrates the interim area between the tank battery and O&G equipment and the wellheads with good perennial cover in this area.

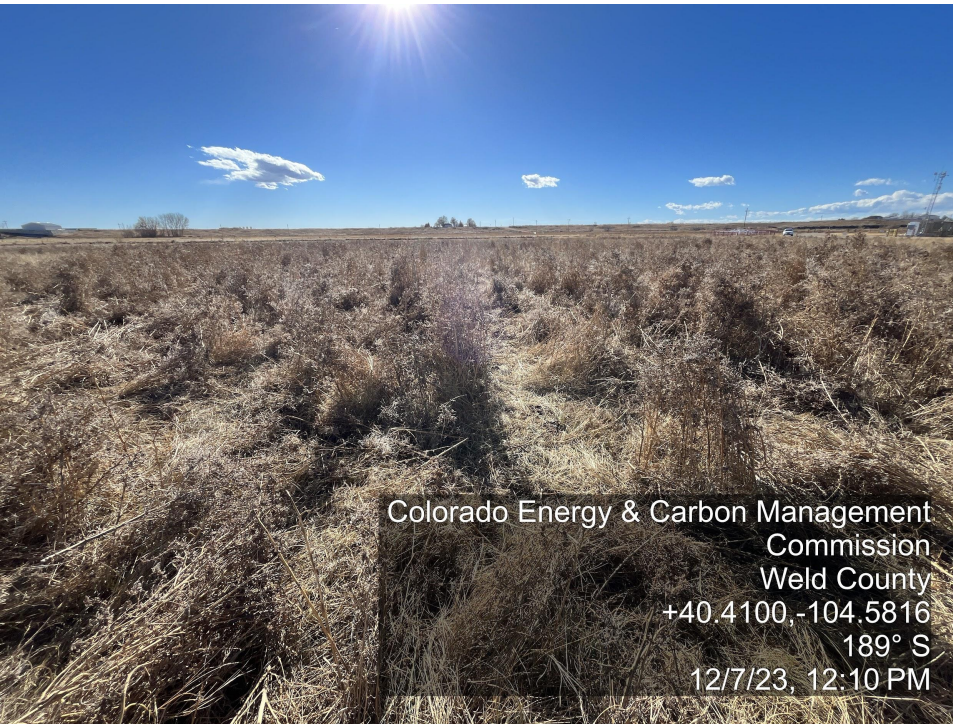
Photo 5. The photo was taken at the well location facing South. The photo illustrates a large stand of kochia growing in the Southeast area of the interim reclamation area.

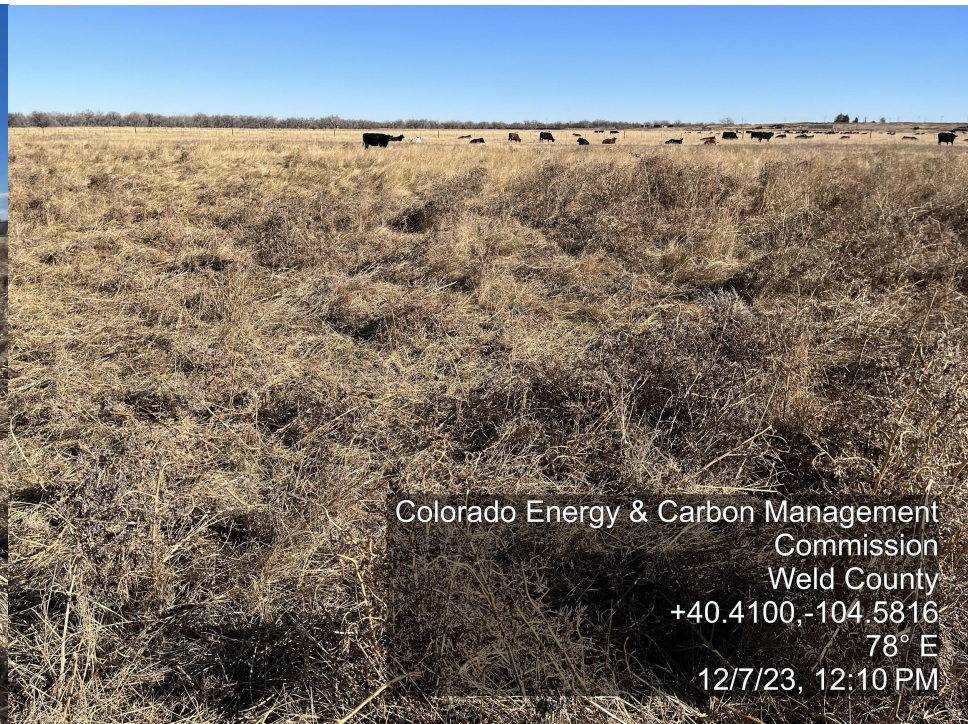
Photo 6. The photo was taken at the well location facing East. The photo illustrates cattle grazing inside the location fencing.

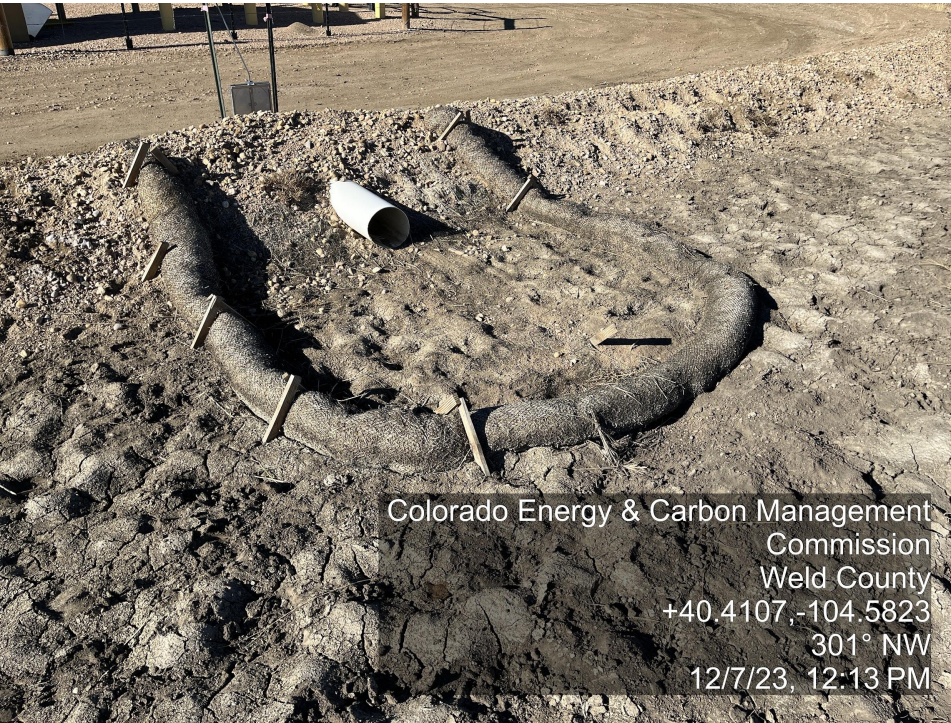
Photo 7. The photo was taken at the well location facing Northwest. The photo illustrates a temporarily stabilized outlet through the perimeter gravel berm. The BMP will need some maintenance as stakes and wattle are sedimented and beginning to fall apart potentially due to cattle.

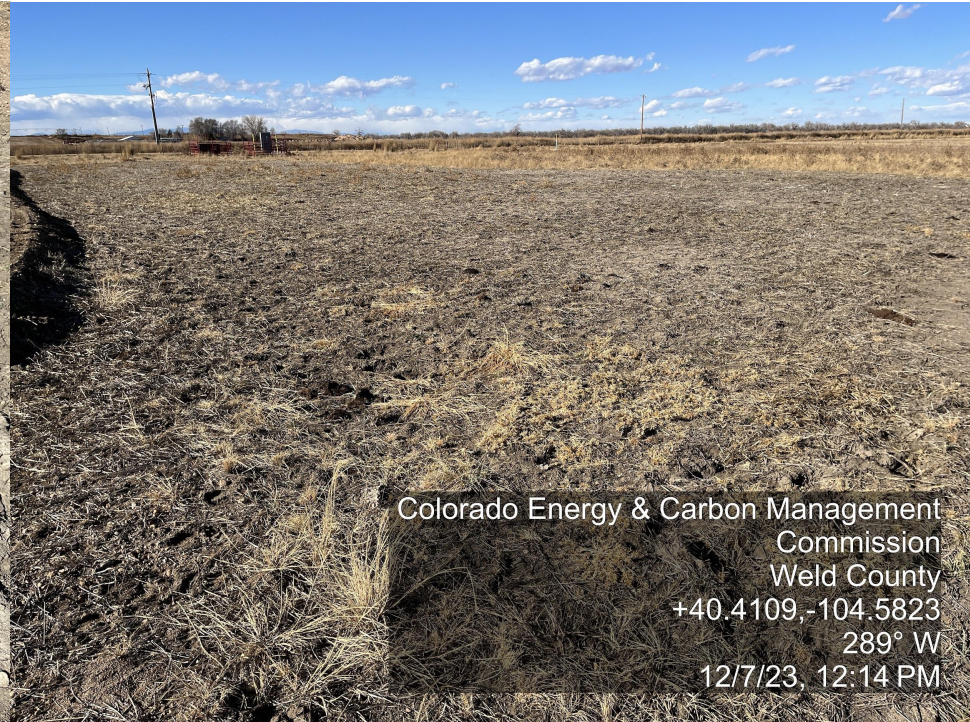
Photo 8. The photo was taken at the well location facing Northwest. The photo illustrates a large patch of interim reclamation that still does not appear to be growing.

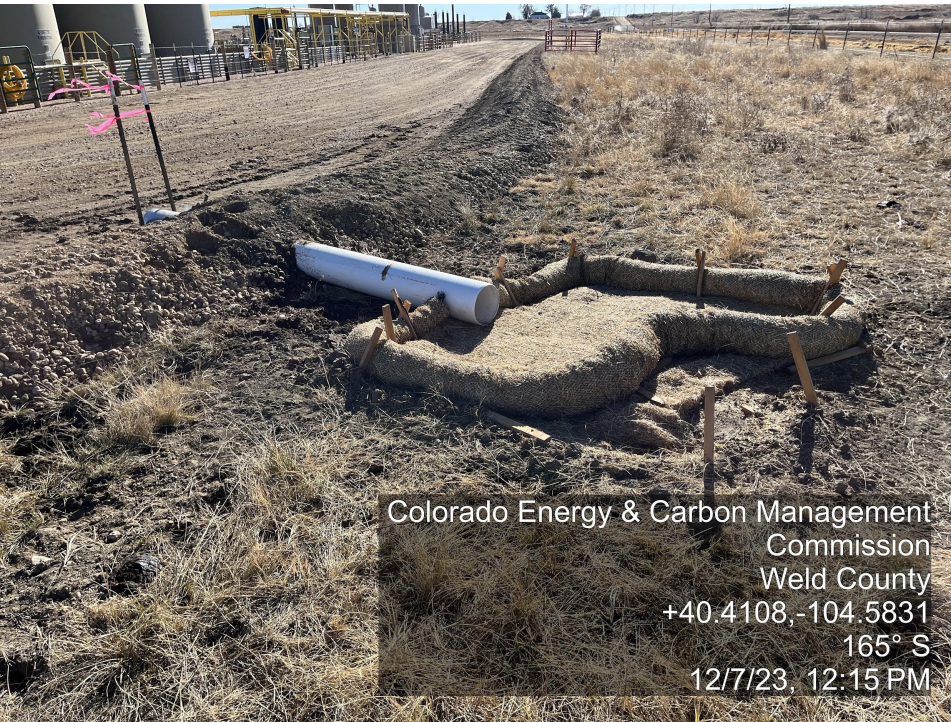
Photo 9. The photo was taken at the well location facing South. Refer to the comment for photo 7.

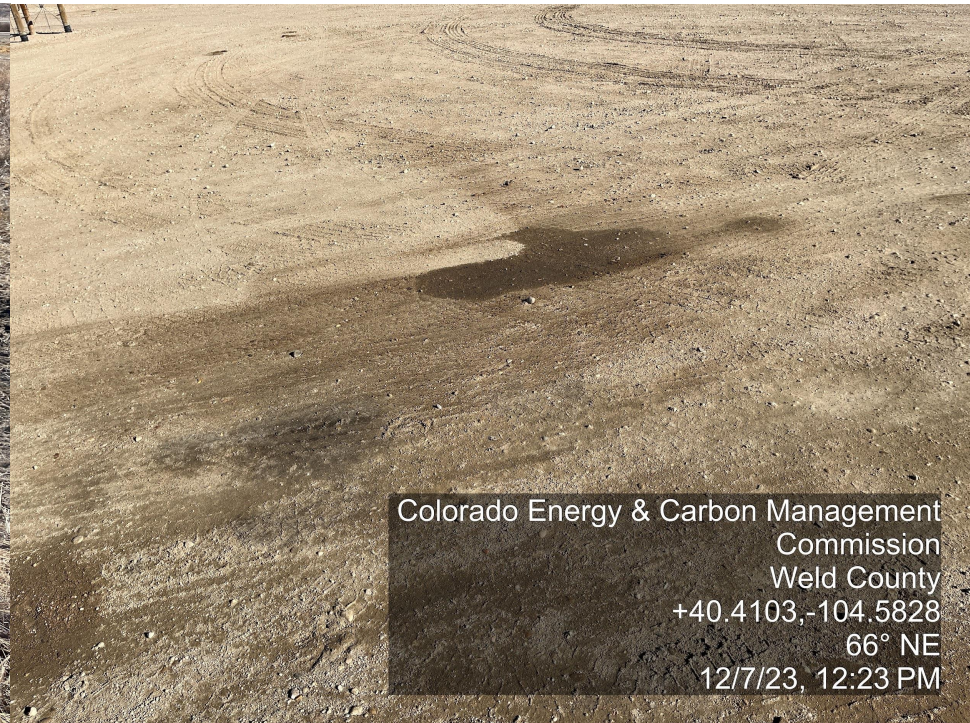
Photo 10. The photo was taken at the well location facing Northeast. The photo illustrates a small patch of stained soil that smelled of diesel.

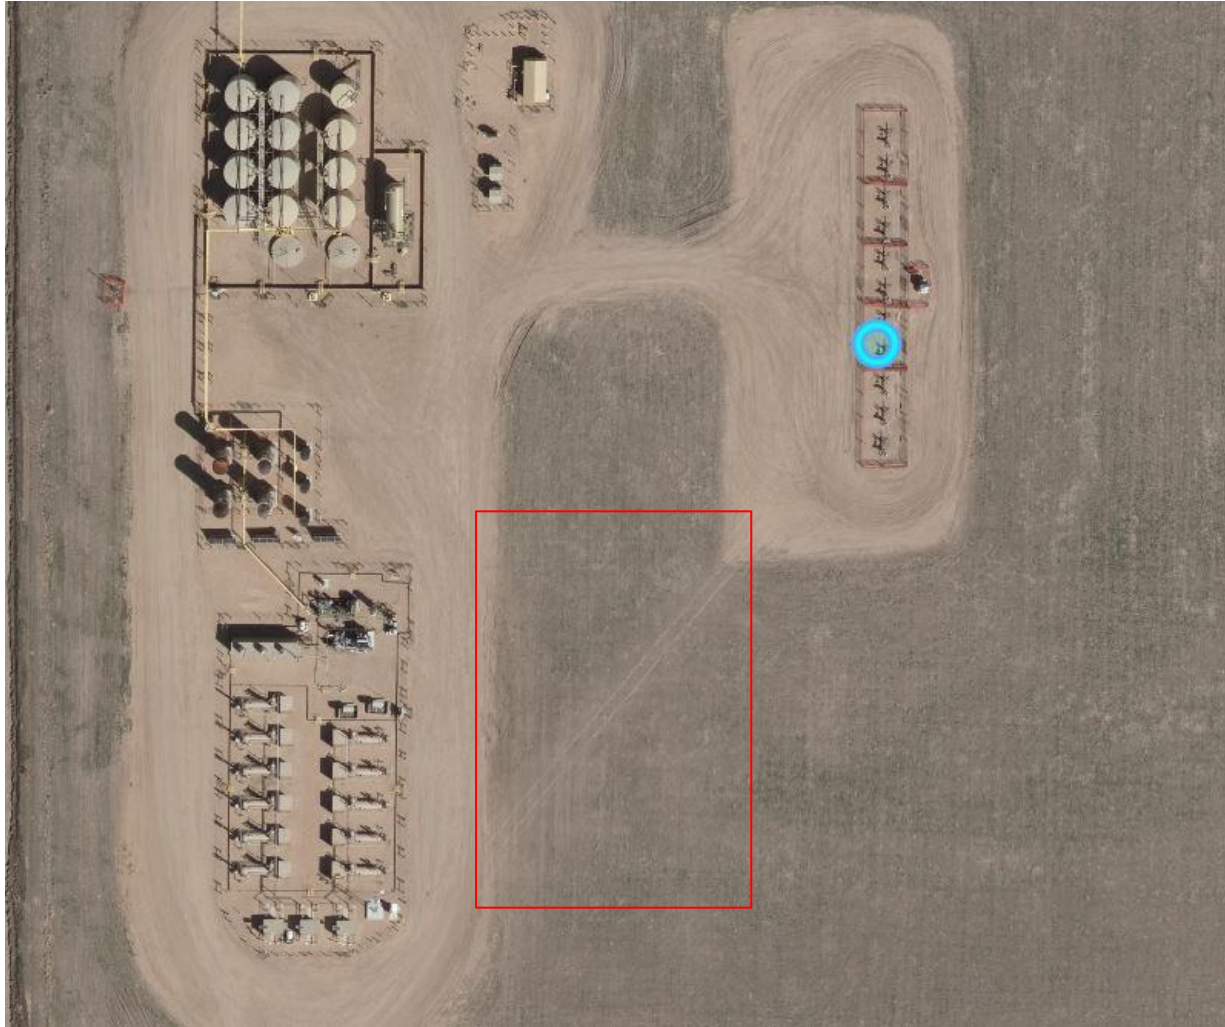
Photo 11. The photo was taken using Weld County 2022 aerial imagery. The photo illustrates a two-track cutting through interim areas on the well location.
