# Inspection Photos

API: 043-06157

Operator: **INCREMENTAL OIL & GAS (FLORENCE) LLC**

Inspection Date: 12/21/2023

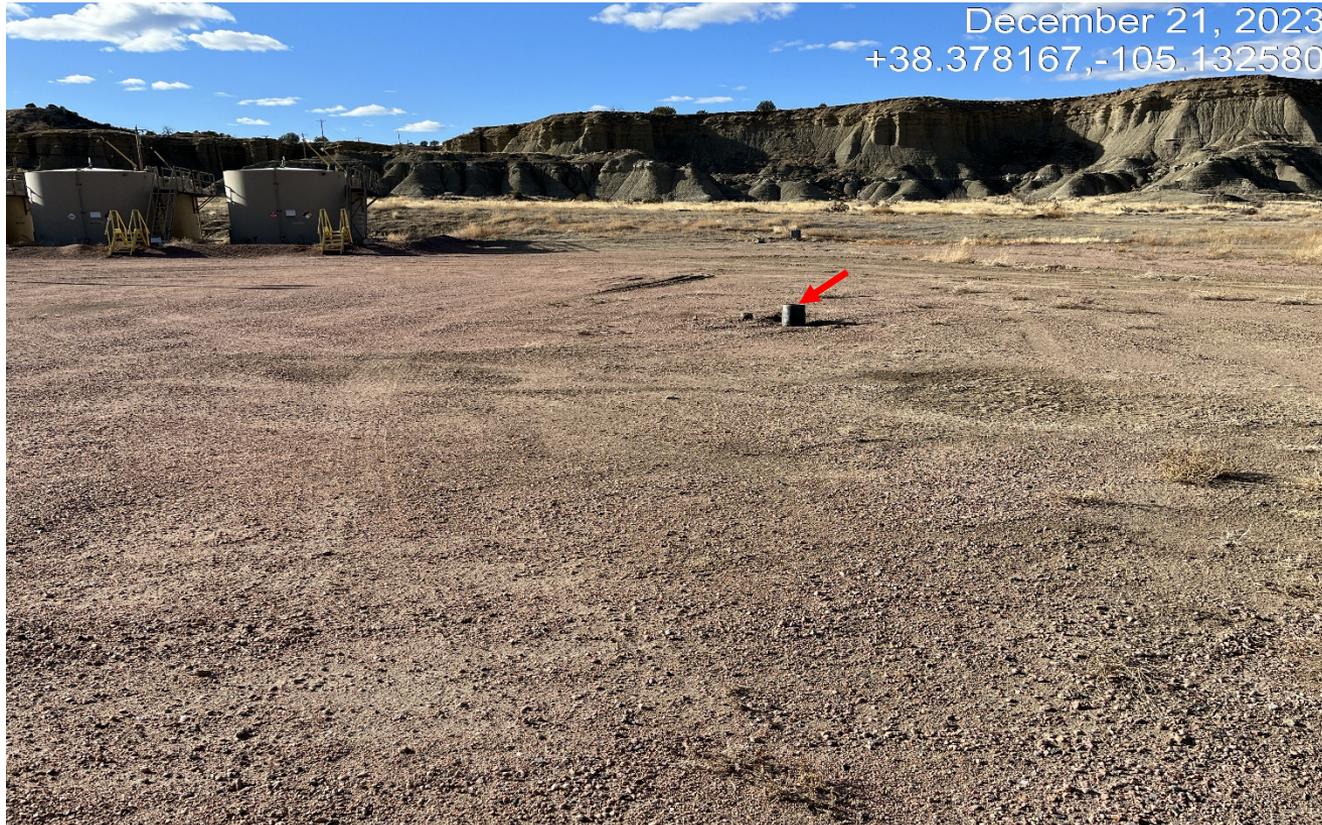
**Photo 1.** Facing west at the location. There is a plastic bucket covering an open wellbore at red arrow.

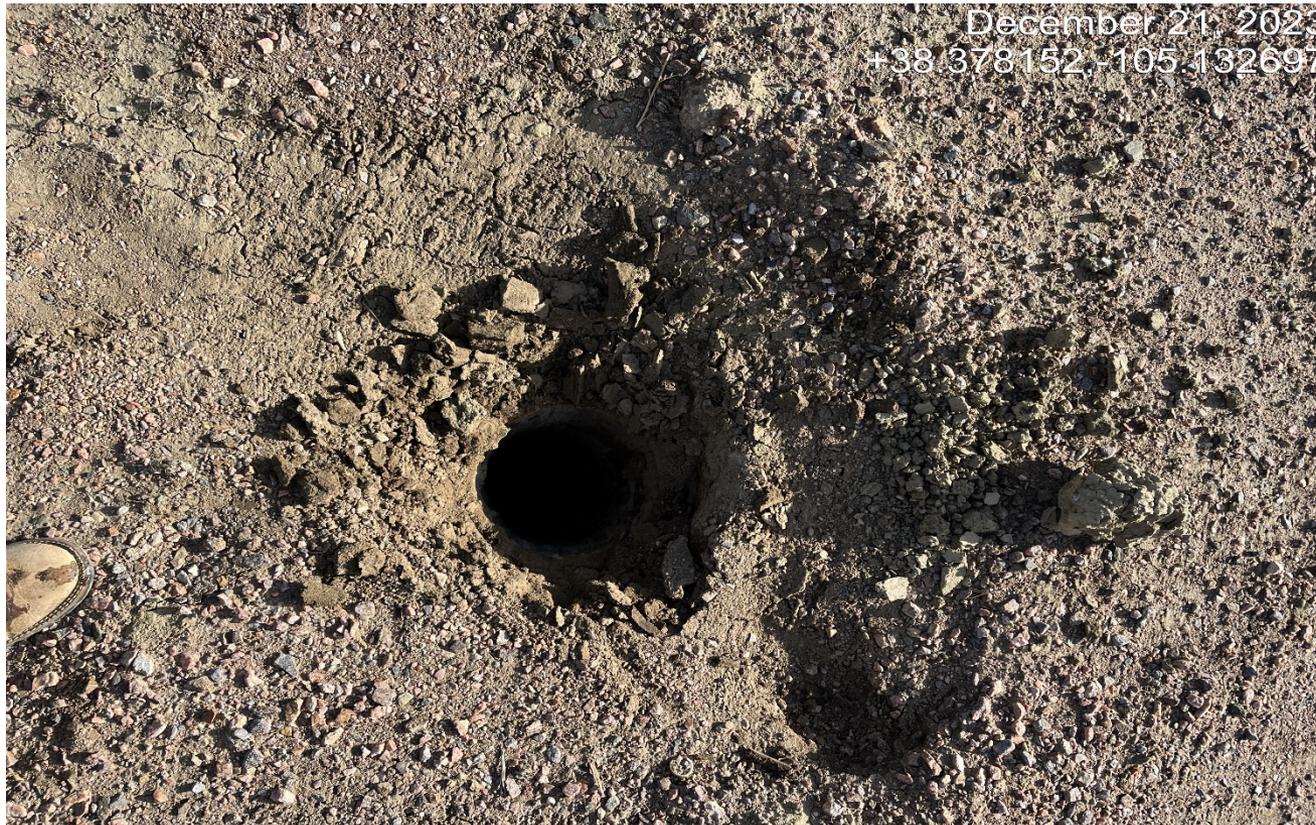
**Photo 2.** There is a well casing and deep wellbore which the plastic bucket was covering. This need to be immediately covered and plugged and abandoned..

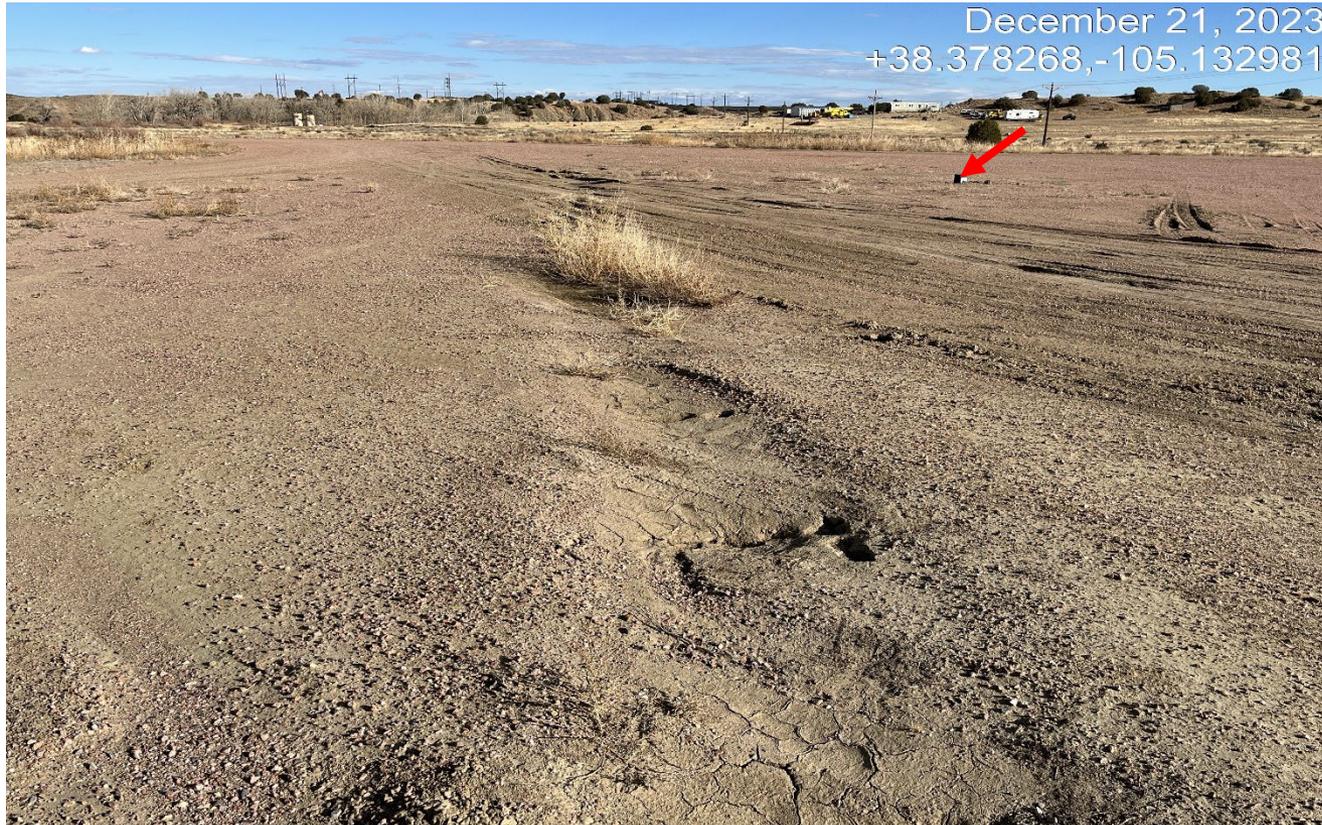
**Photo 3.** Facing back east at the location. There is a plastic bucket covering an open wellbore at red arrow.

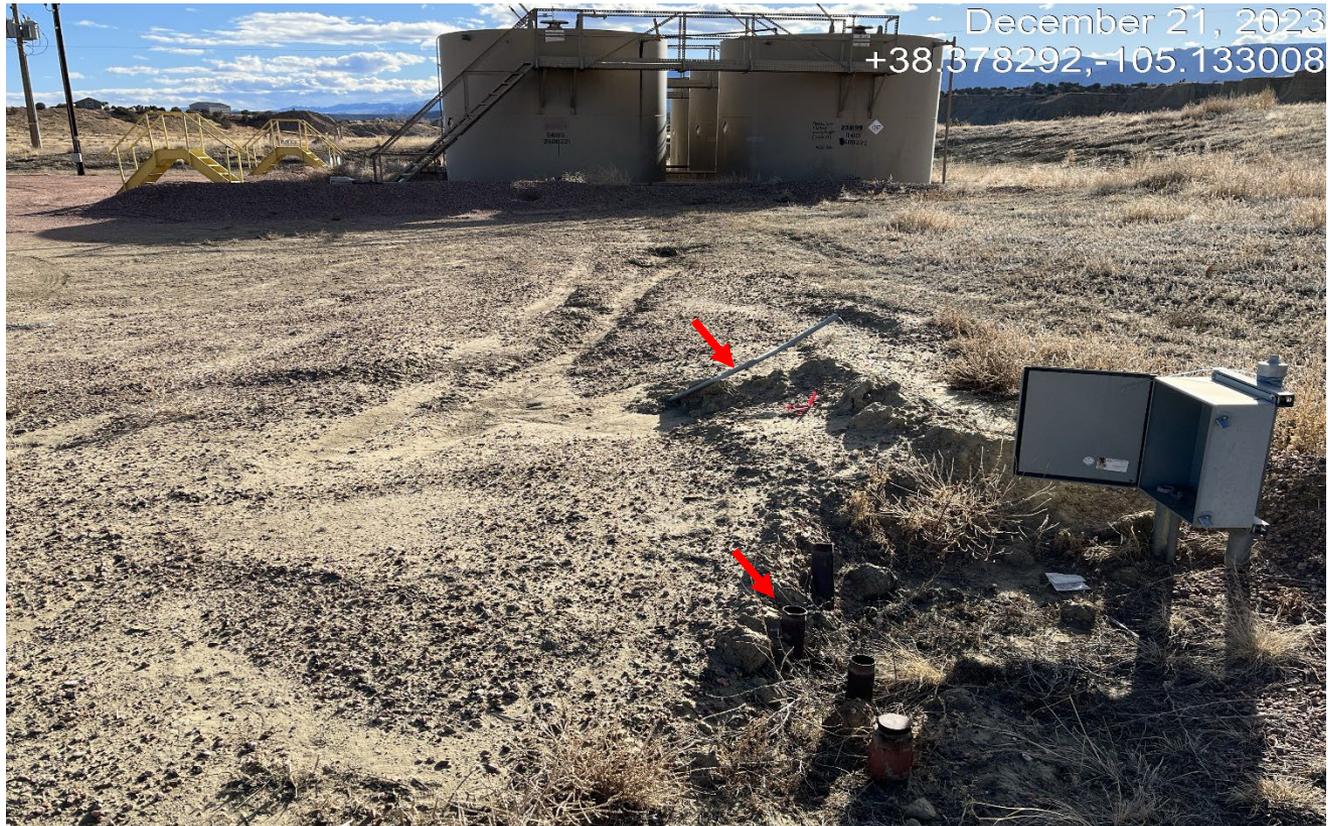
**Photo 4.** Facing south at the west side of the location. There is an exposed electric line at red arrow and multiple open pipe risers. All risers and utilities need to be removed.

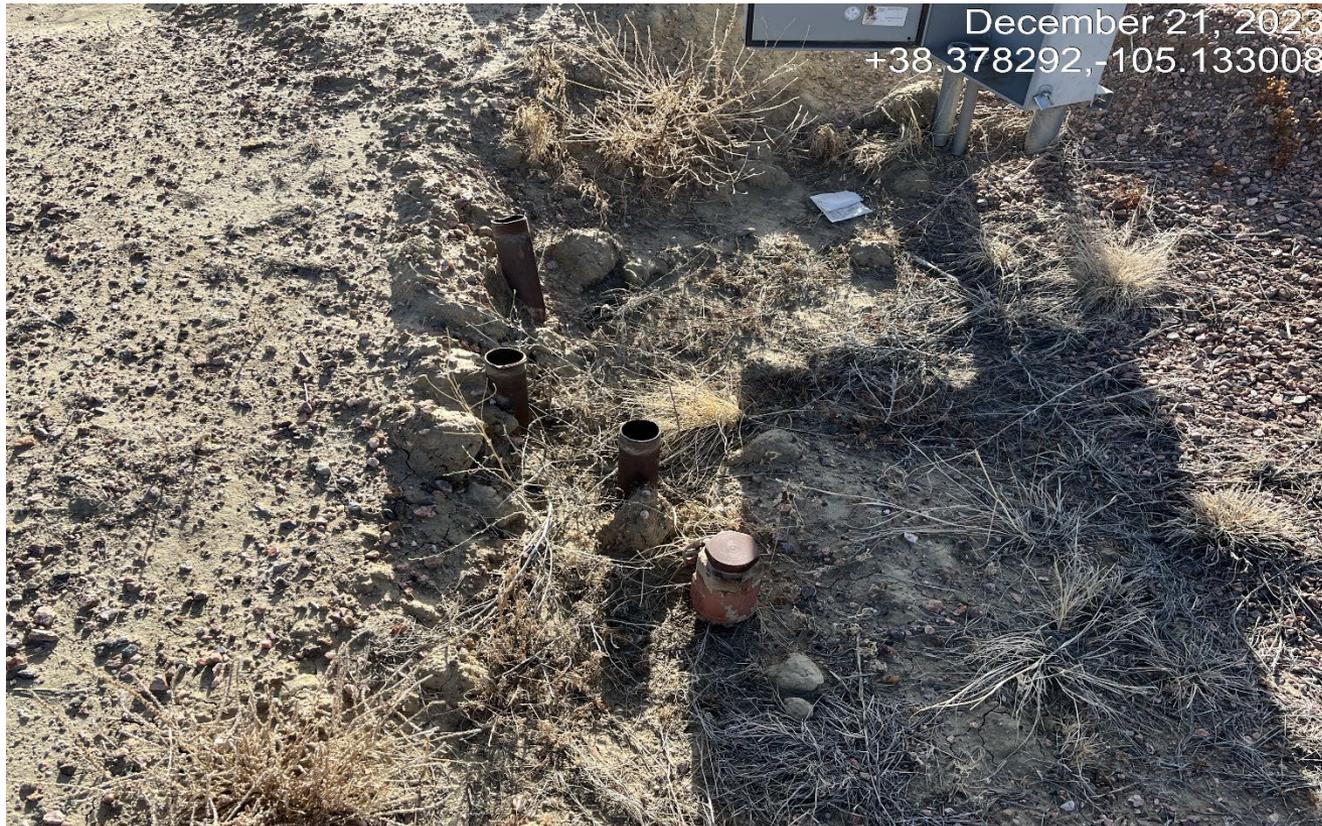
**Photo 5.** There are unused pipe risers that need to be abandoned and removed.

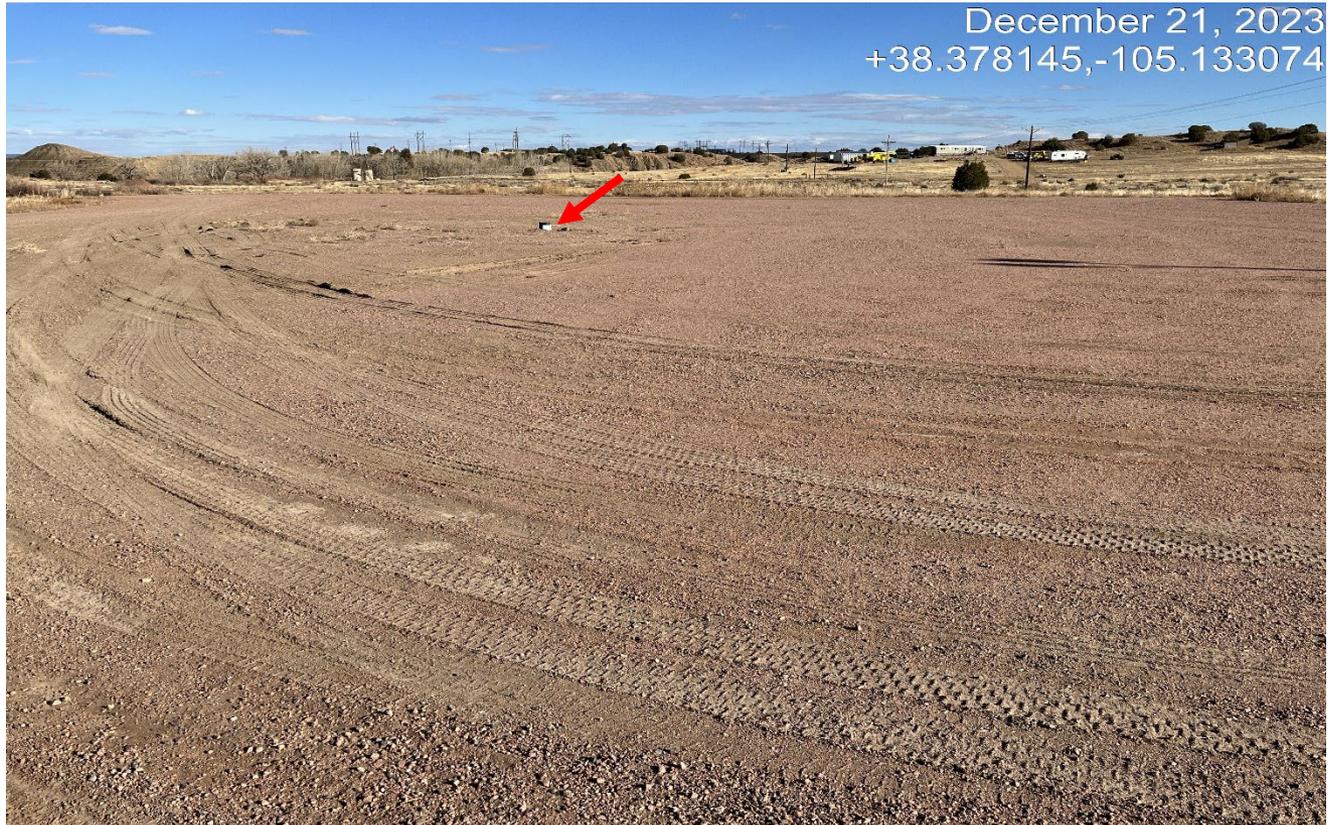
**Photo 6.** Facing back east at the location. There is a plastic bucket covering an open wellbore at red arrow.
