Inspection Photos

Loc: 322241

Operator: **INCREMENTAL OIL & GAS (FLORENCE) LLC**

Inspection Date: 12/21/2023

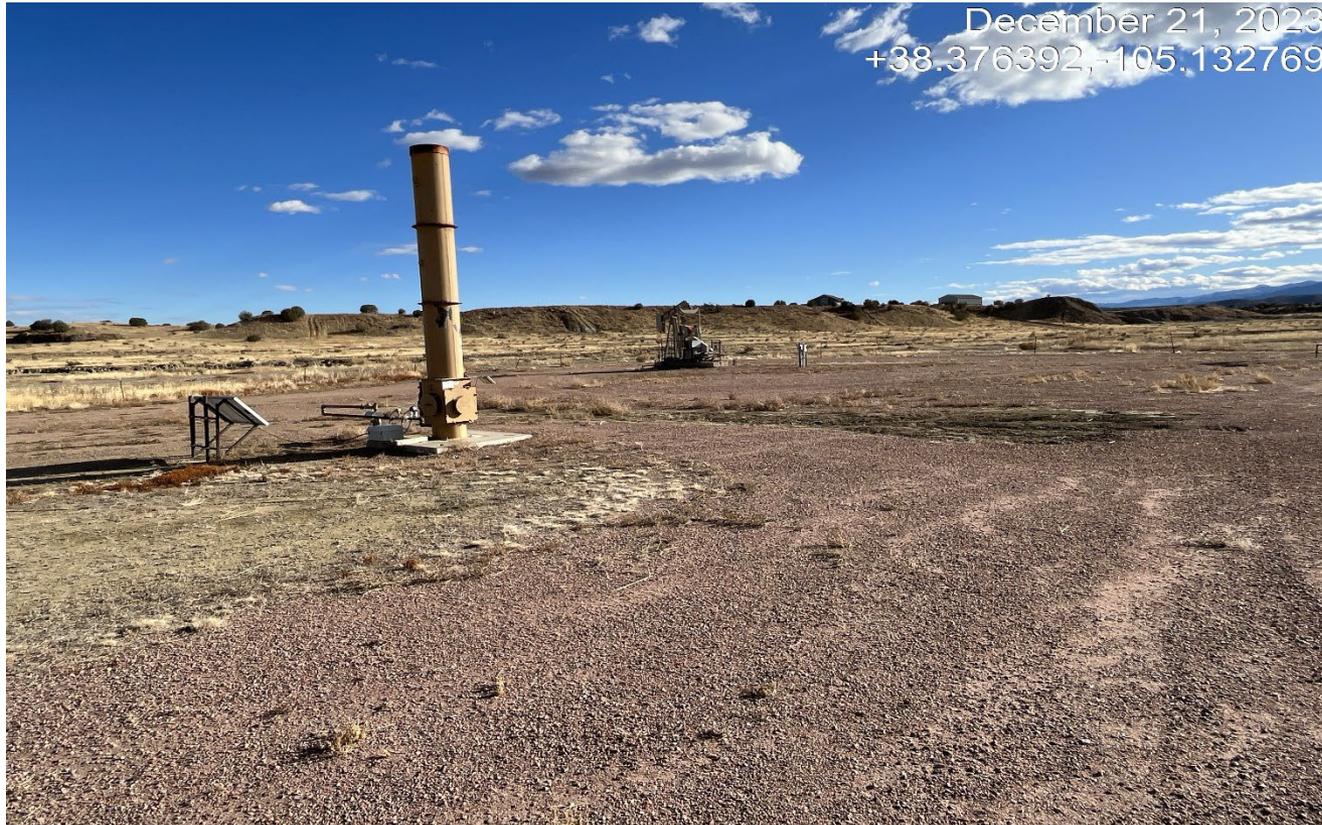
Photo 1. Facing southeast toward the wellsite location.

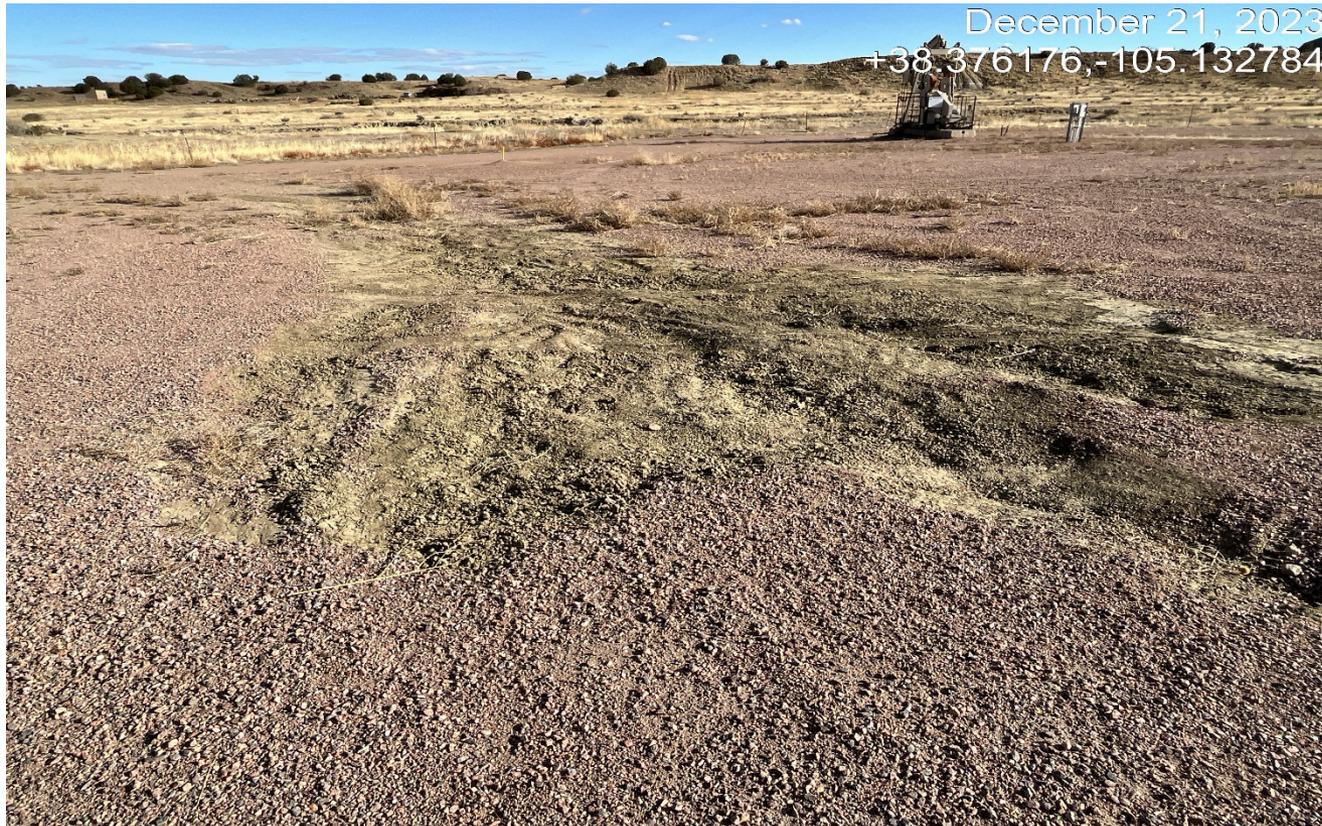
Photo 2. Facing east by the separator. There was an attempt to repair the erosion however this area needs to be properly stabilized.

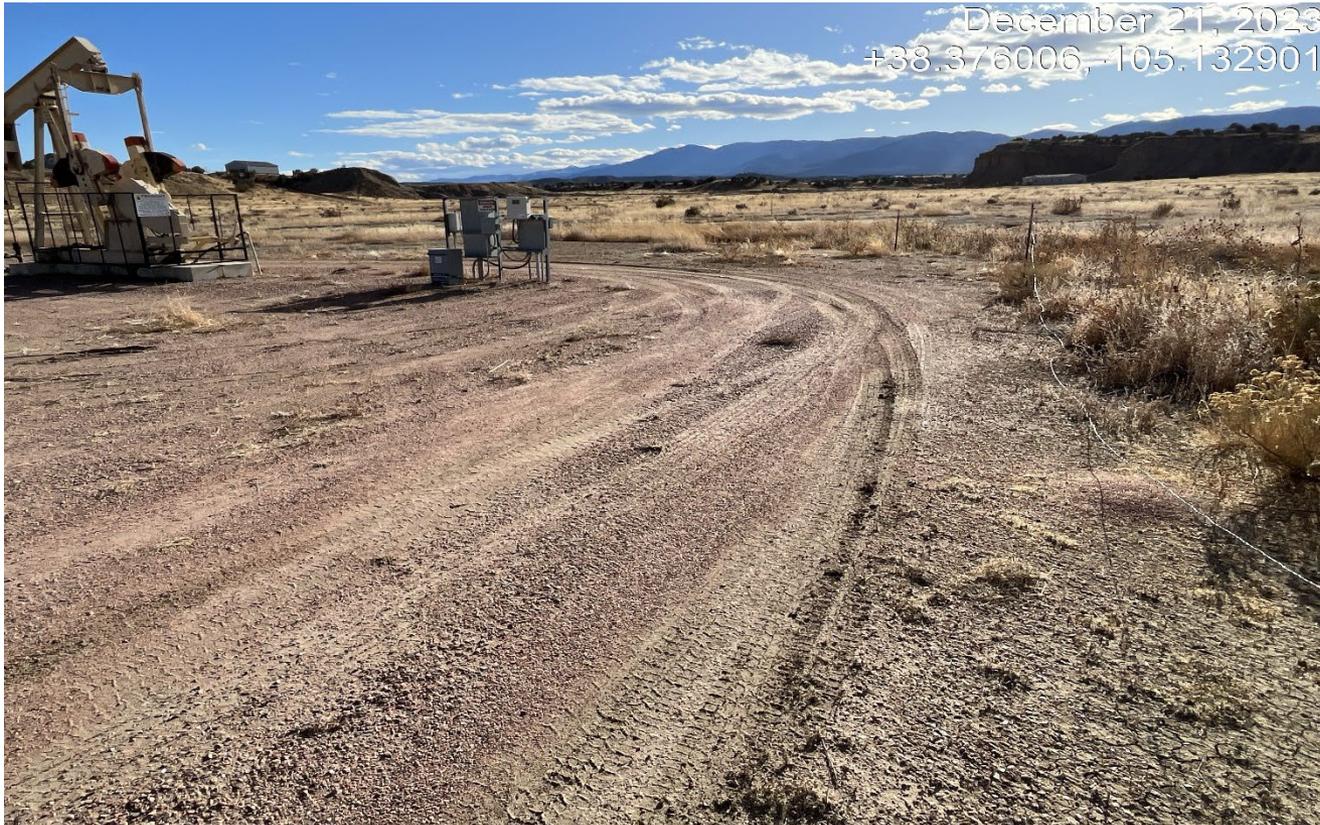
Photo 3. Facing southeast at west side of the location. The perimeter one wire fence is not maintained and needs to be removed or a proper fence installed.

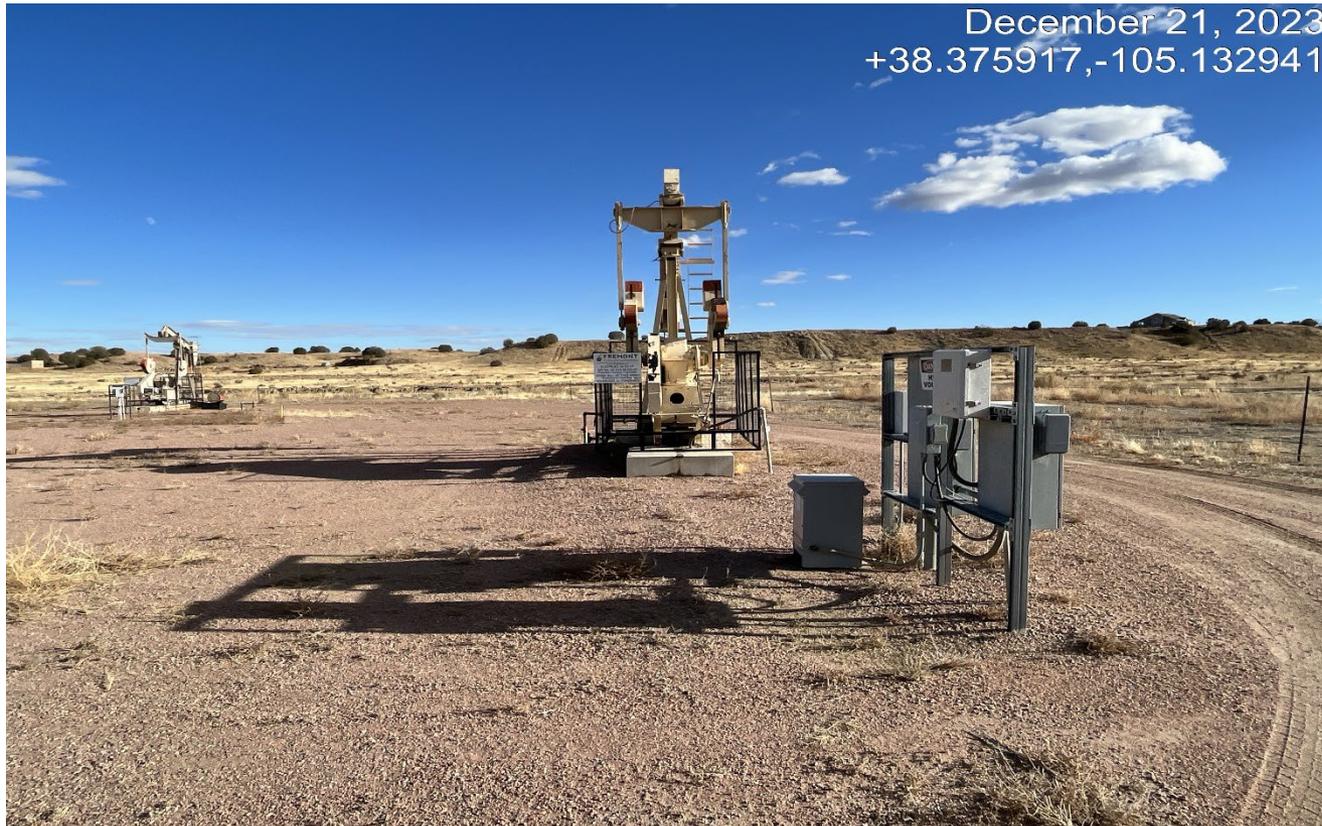
Photo 4. Facing east at the wellsite.

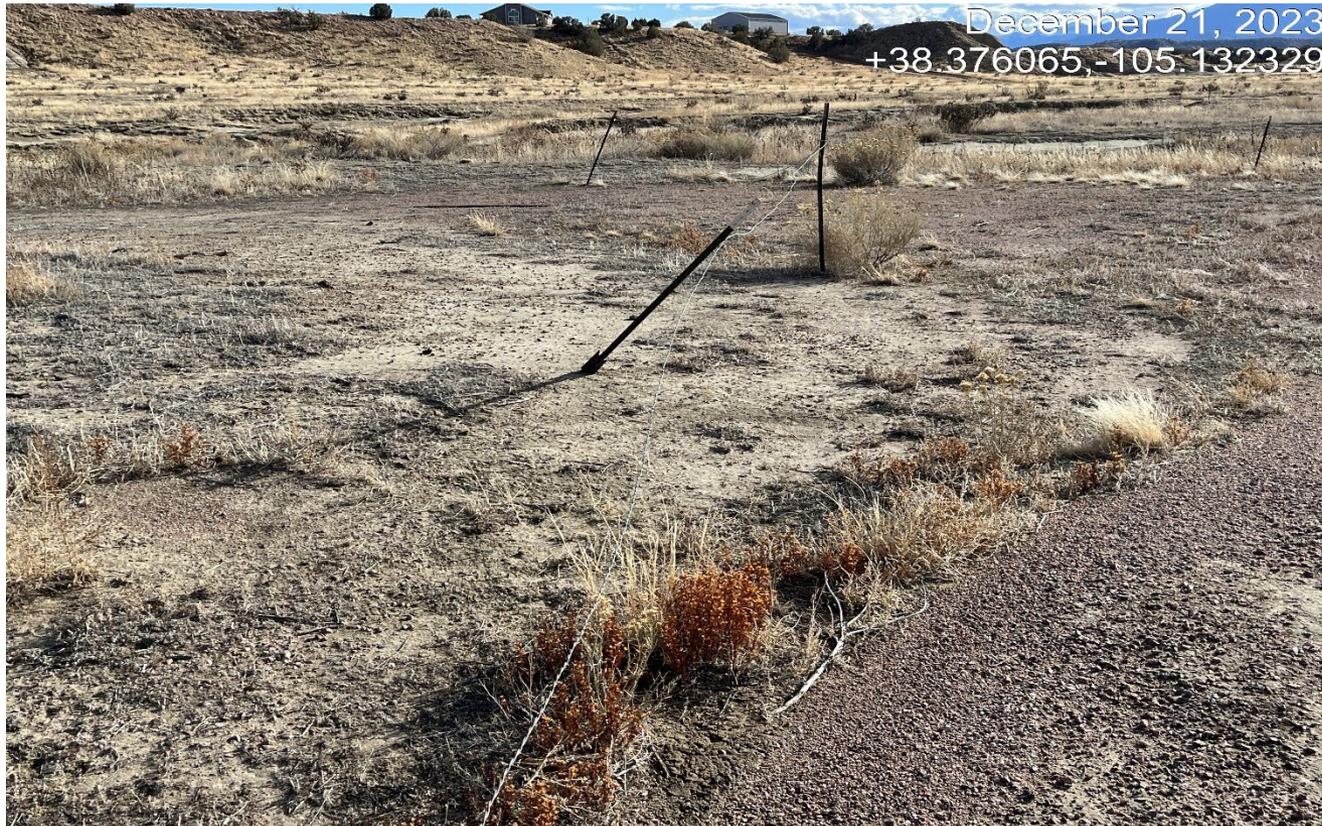
Photo 5. There is a one wire fence at the location which is not maintained and is not highly visible and could pose a collision hazard..
