Inspection Photos

Location Name: CAERUS PICEANCE LLC FEDERAL 11-13A (RM11) Pad

Location # 324422

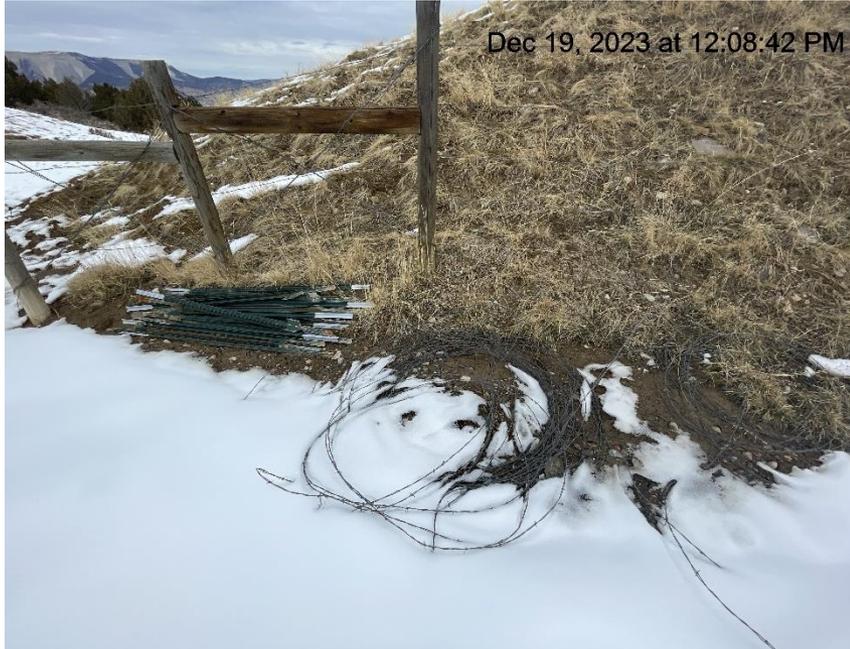
Photo # 196 Barbed wire on ground/wildlife hazard

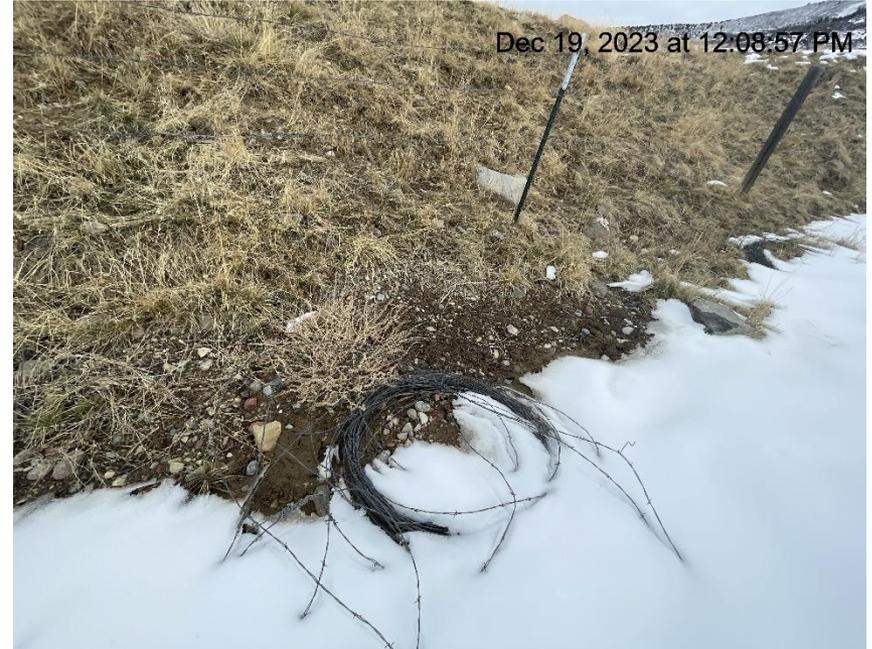
Photo # 197 Barbed wire on ground/wildlife hazard

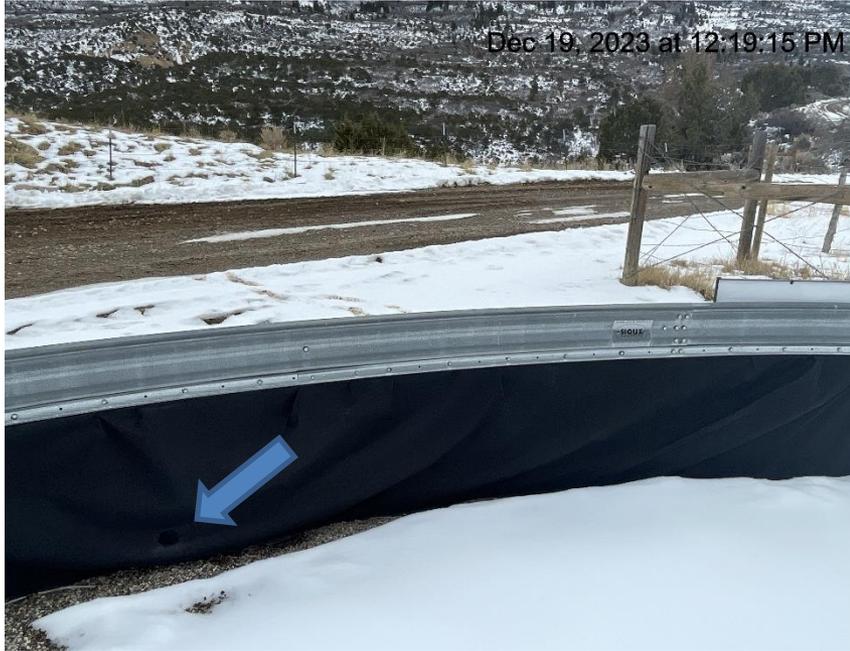
Photo # 198 Hole in liner/liner needs maintenance

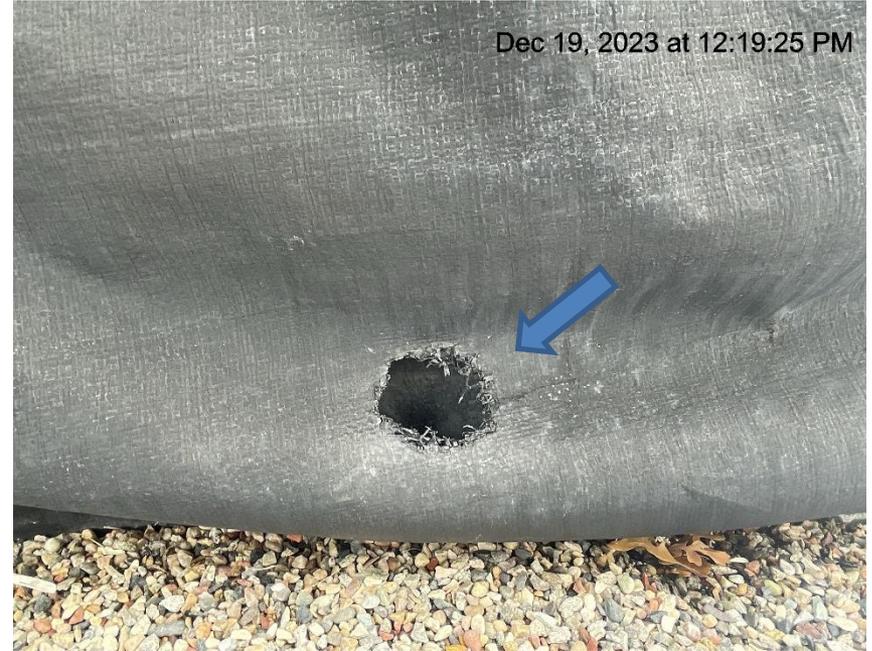
Photo # 199 Hole in liner/liner needs maintenance
