Storm Water Management and Erosion control
Location Name: CAERUS PICEANCE LLC FEDERAL 11-13A (RM11) Pad
Location # 324422

**Location Overview: Location is within High Priority/Black Bear
Habitat areas & in close proximity to Density Habitat area.
Location is approximately 260 yards from Porcupine Creek.
Section/Township/Range: 11 7S94W**

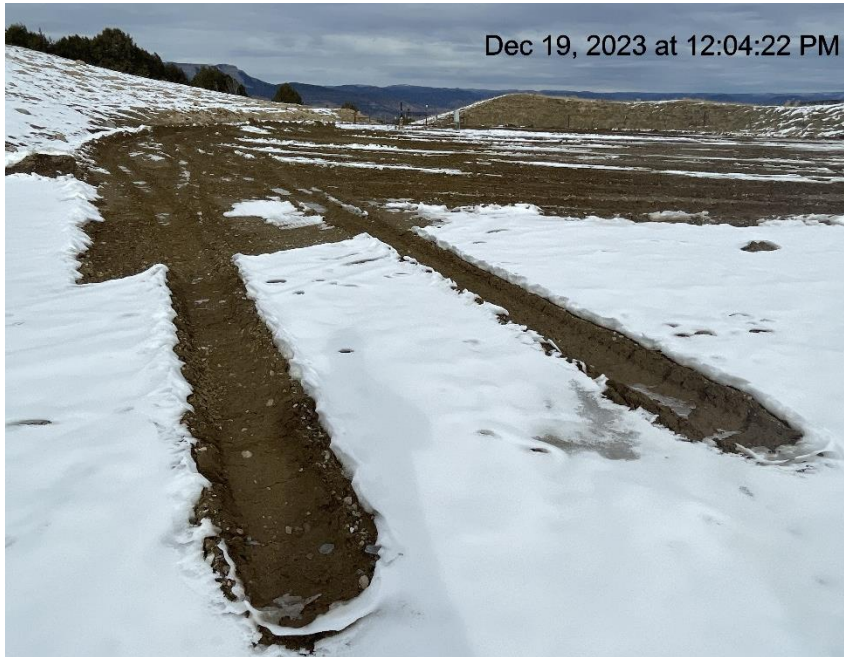
Photo # 200 Lack of stabilization/compaction/ insufficient BMP's

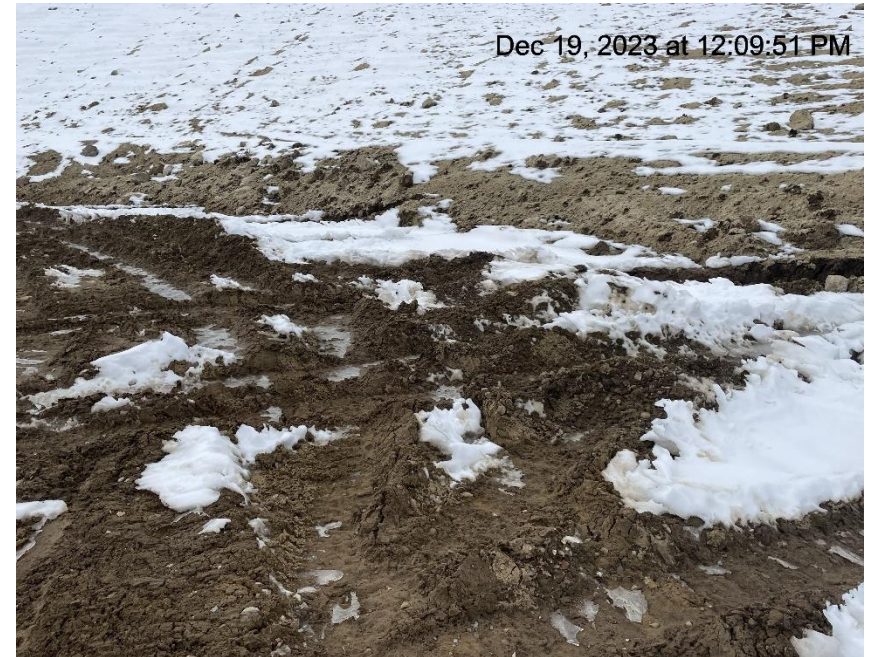
Photo # 201 Lack of stabilization/compaction/insufficient BMP's

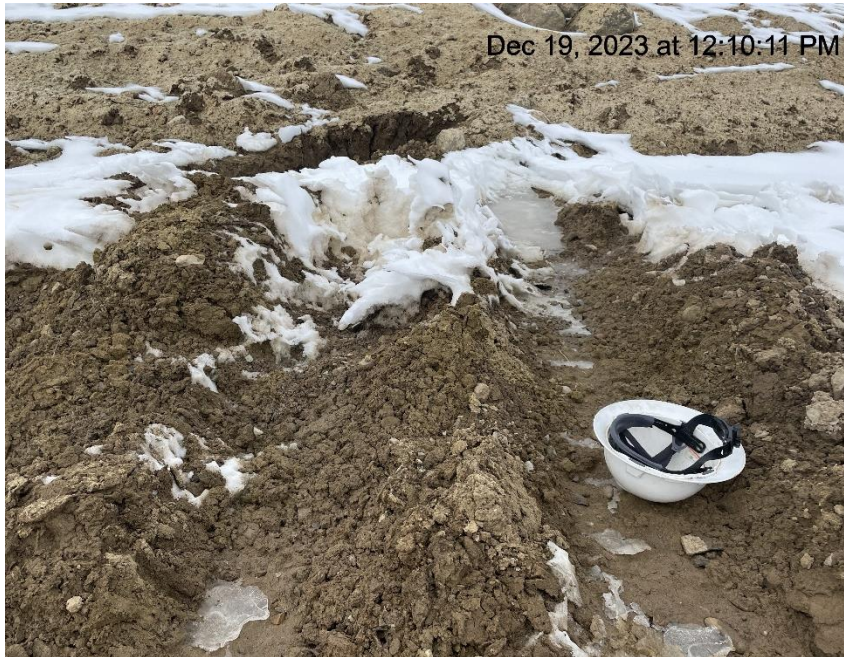
Photo # 202 Lack of stabilization/compaction/insufficient BMP's

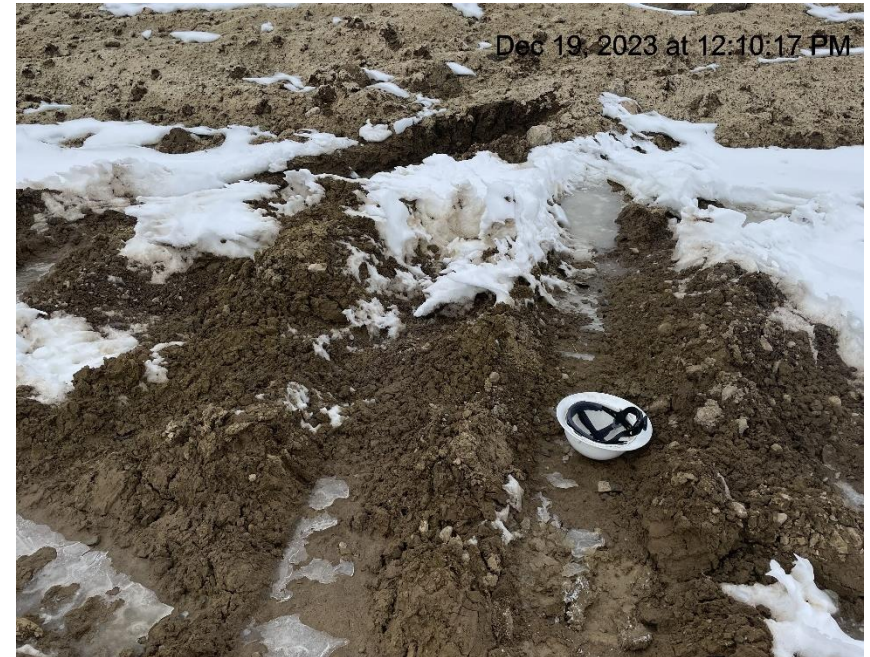
Photo # 203 Lack of stabilization/compaction/insufficient BMP's

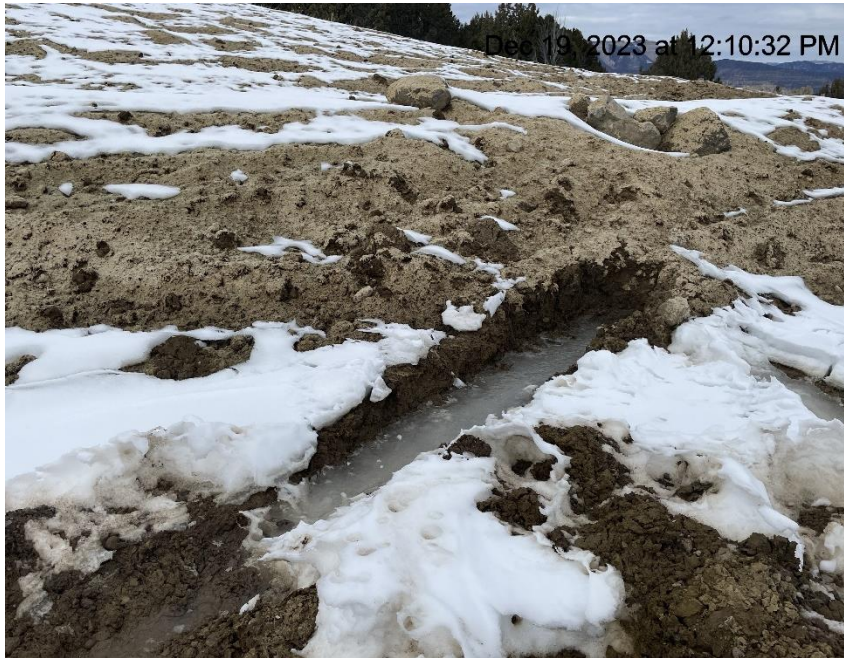
Photo # 204 Lack of stabilization/compaction/insufficient BMP's

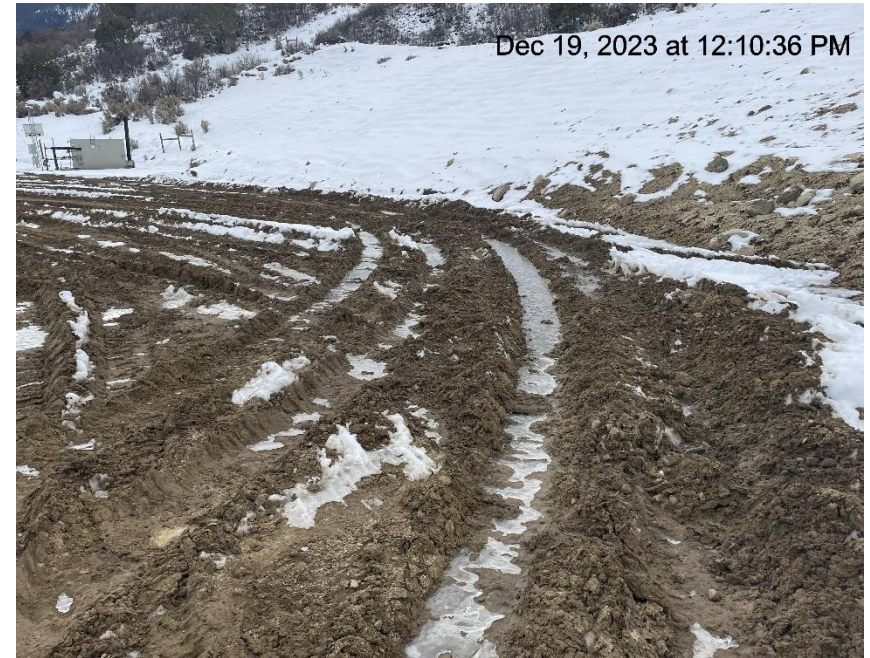
Photo # 205 Lack of stabilization/compaction/insufficient BMP's

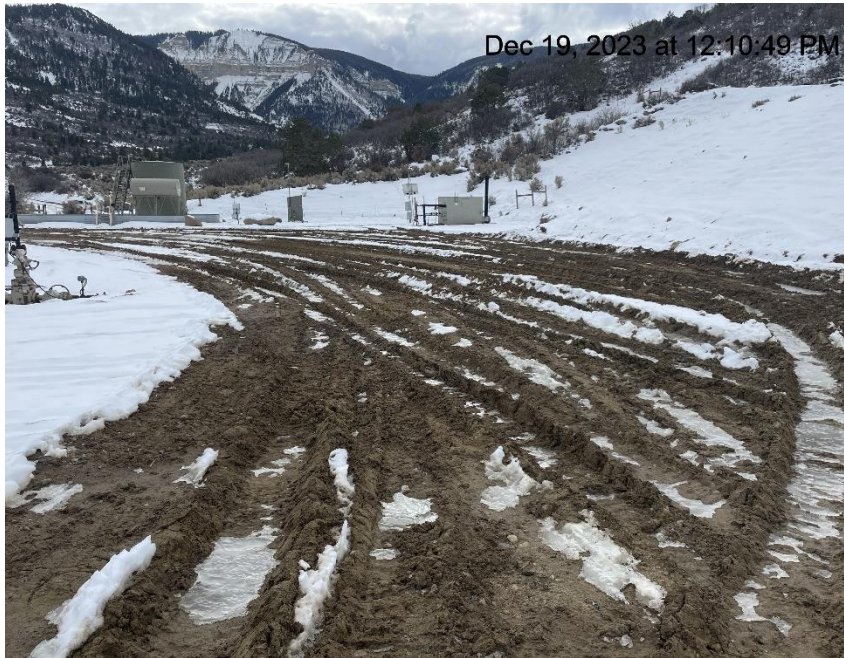
Photo # 206 Lack of stabilization/compaction/insufficient BMP's

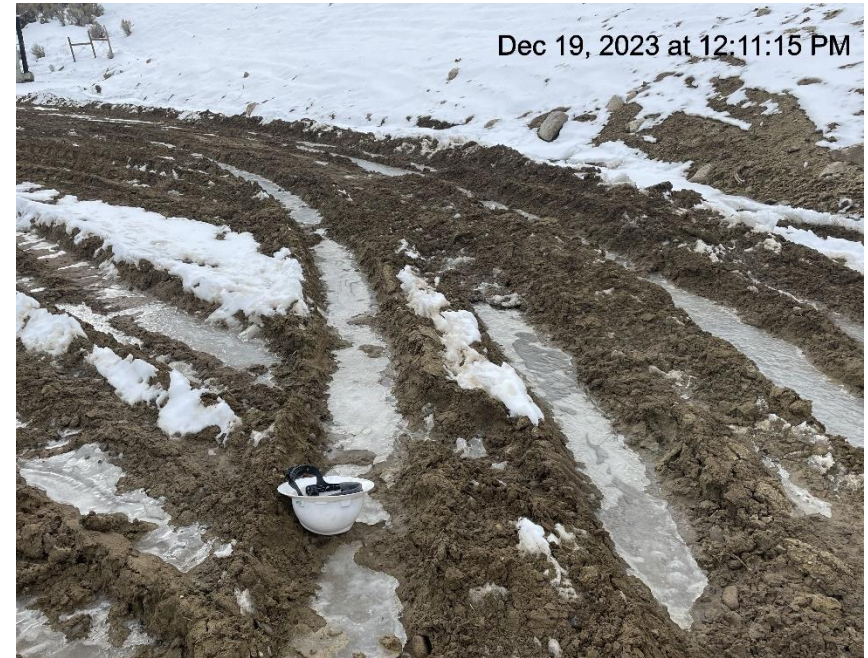
Photo # 207 Lack of stabilization/compaction/insufficient BMP's

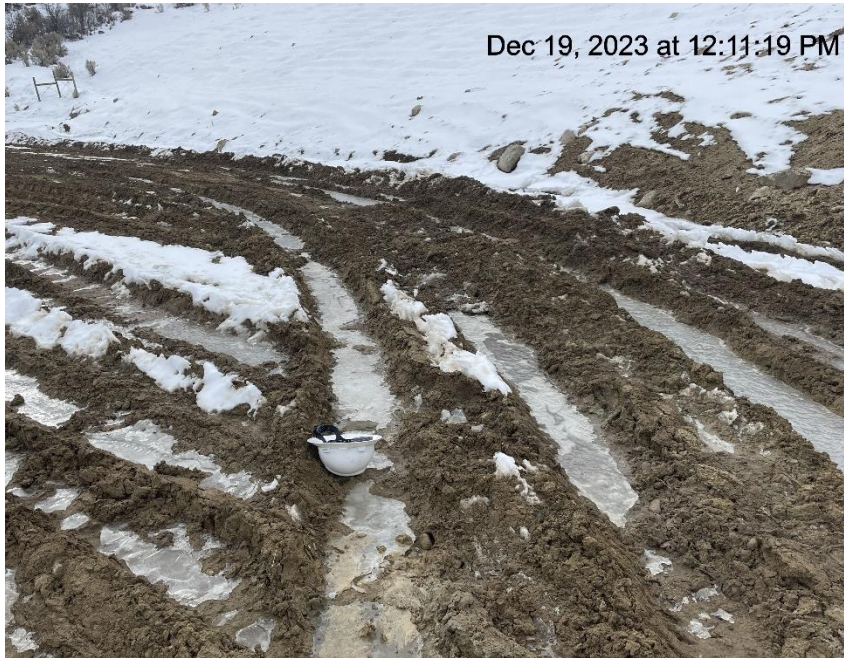
Photo # 208 Lack of stabilization/compaction/insufficient BMP's

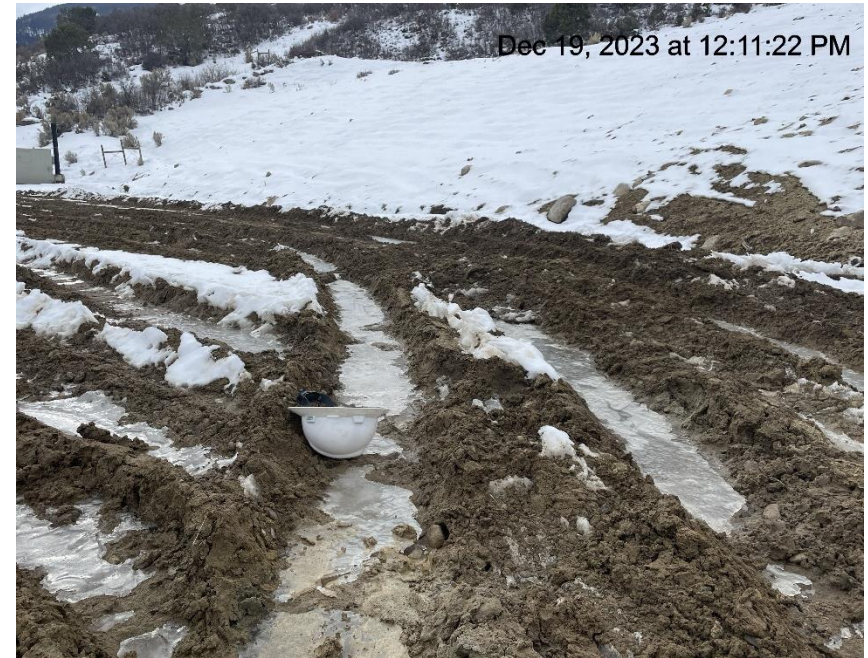
Photo # 209 Lack of stabilization/compaction/insufficient BMP's

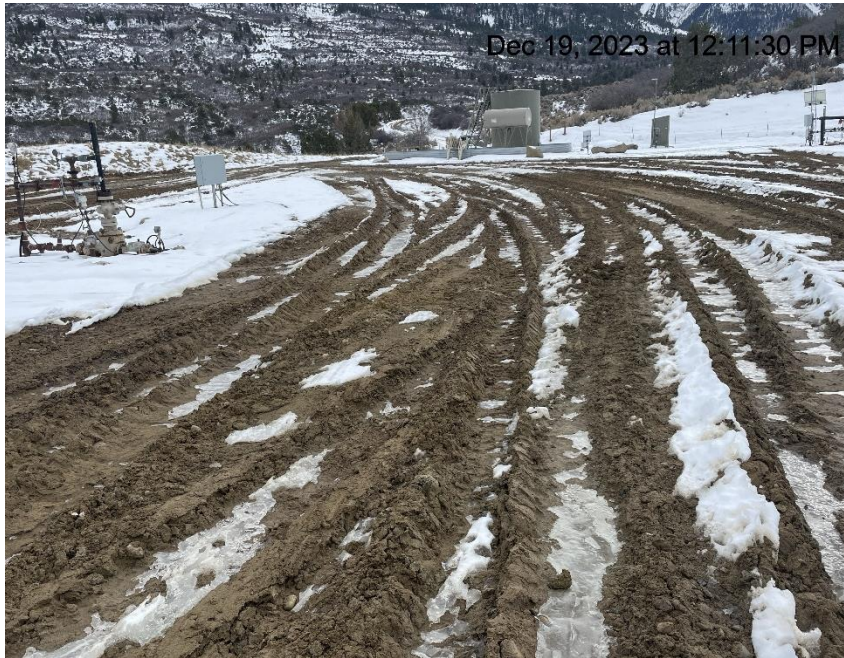
Photo # 210 Lack of stabilization/compaction/insufficient BMP's

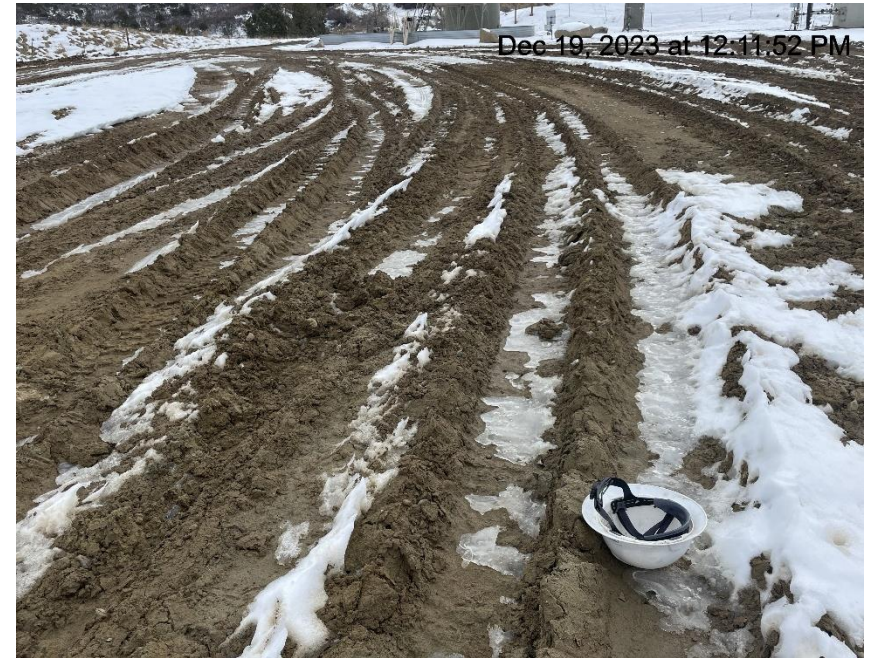
Photo # 211 Lack of stabilization/compaction/insufficient BMP's

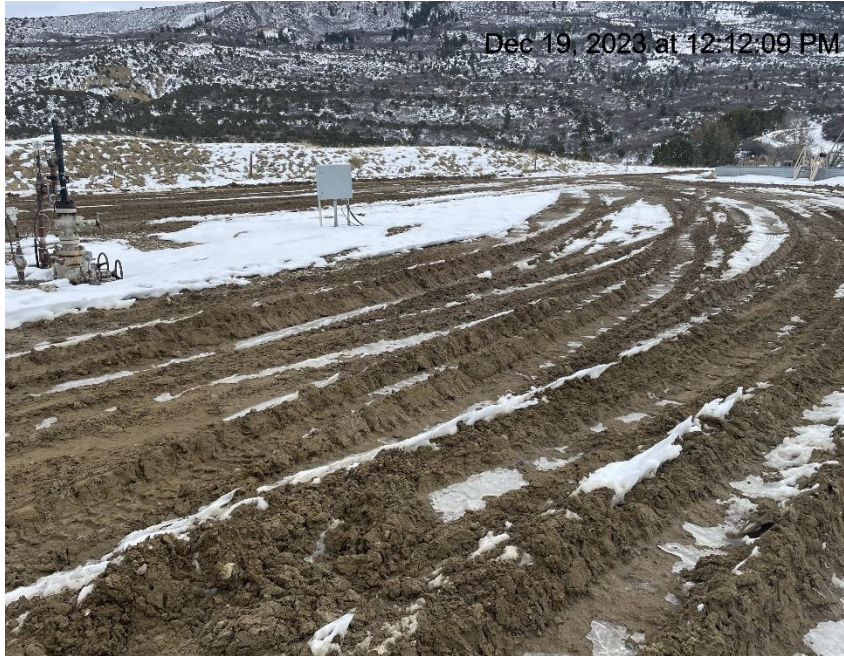
Photo # 212 Lack of stabilization/compaction/insufficient BMP's

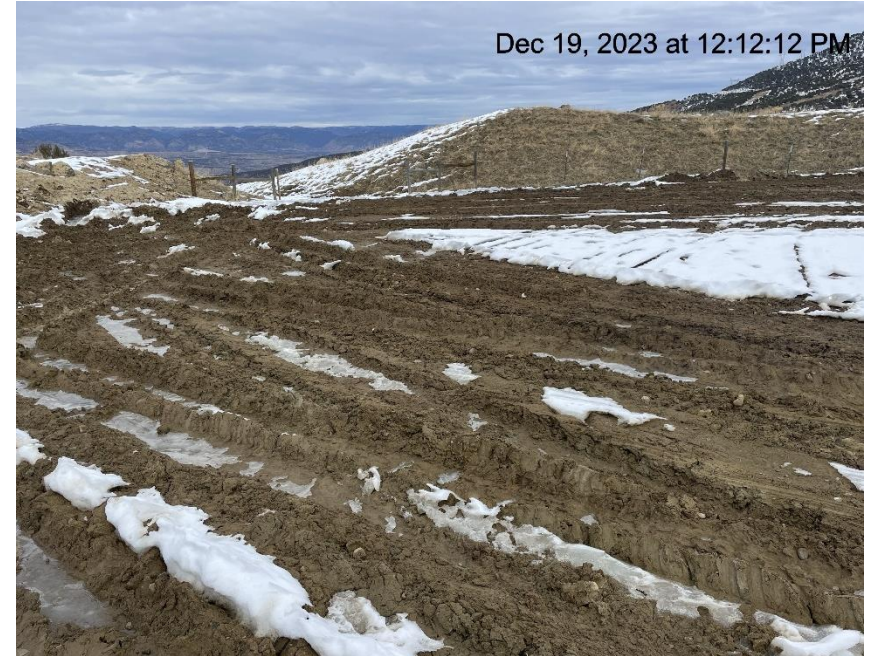
Photo # 213 Lack of stabilization/compaction/insufficient BMP's

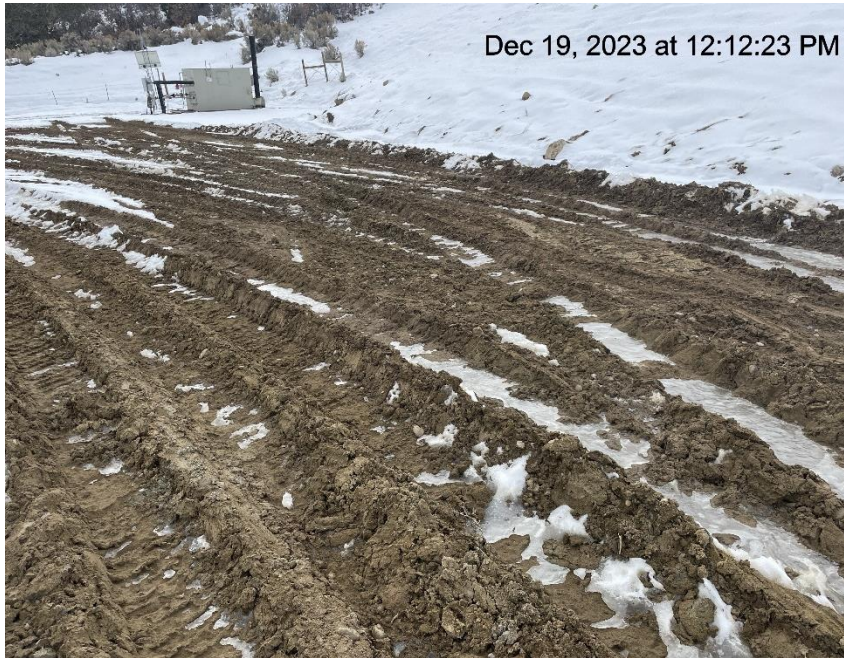
Photo # 214 Lack of stabilization/compaction/insufficient BMP's

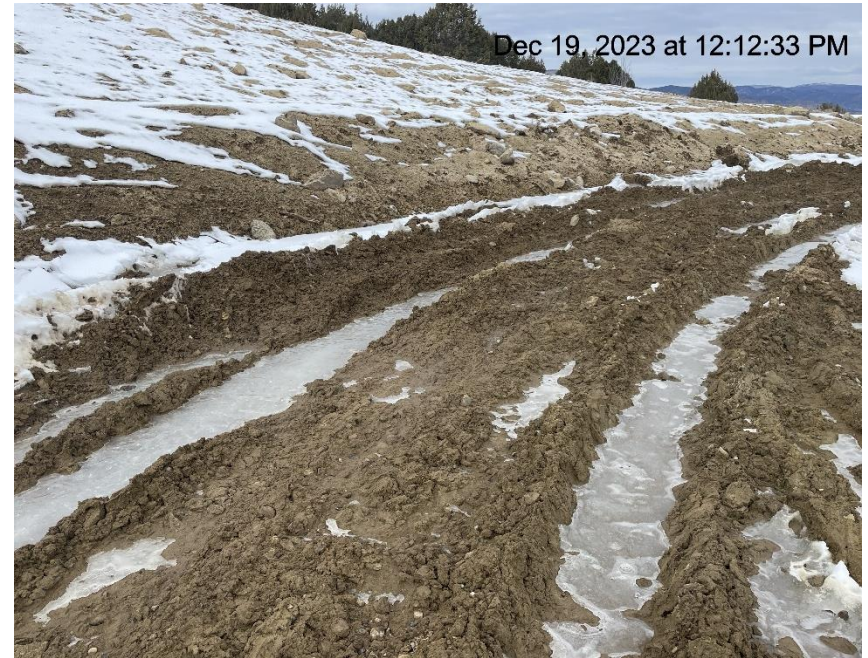
Photo # 215 Lack of stabilization/compaction/insufficient BMP's

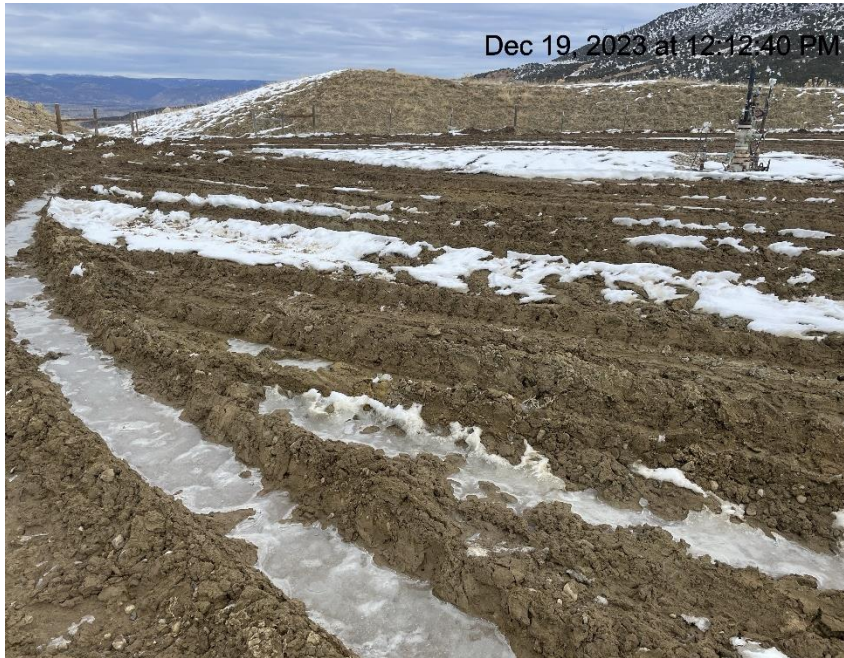
Photo # 216 Lack of stabilization/compaction/insufficient BMP's

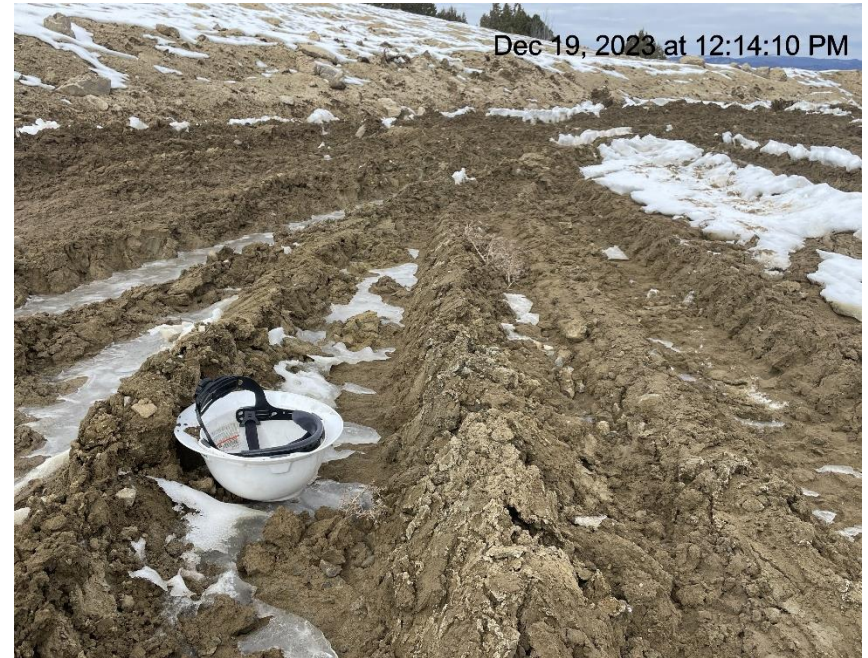
Photo # 217 Lack of stabilization/compaction/insufficient BMP's

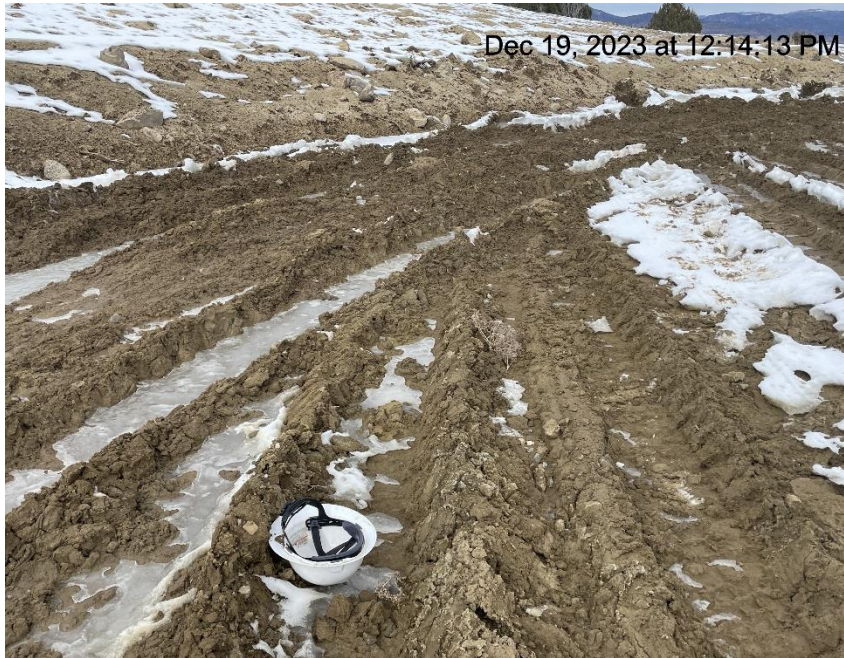
Photo # 218 Lack of stabilization/compaction/insufficient BMP's

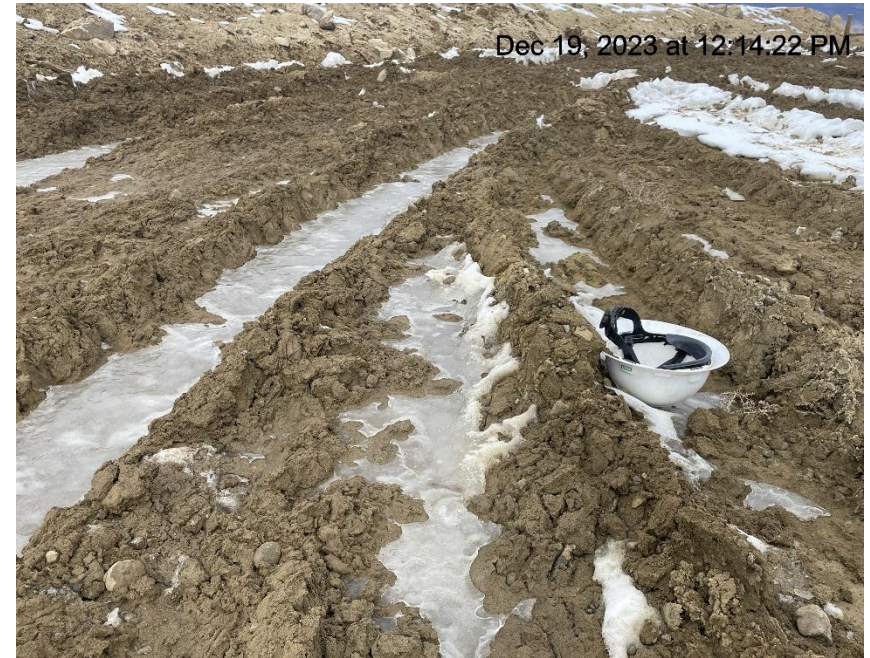
Photo # 219 Lack of stabilization/compaction/insufficient BMP's

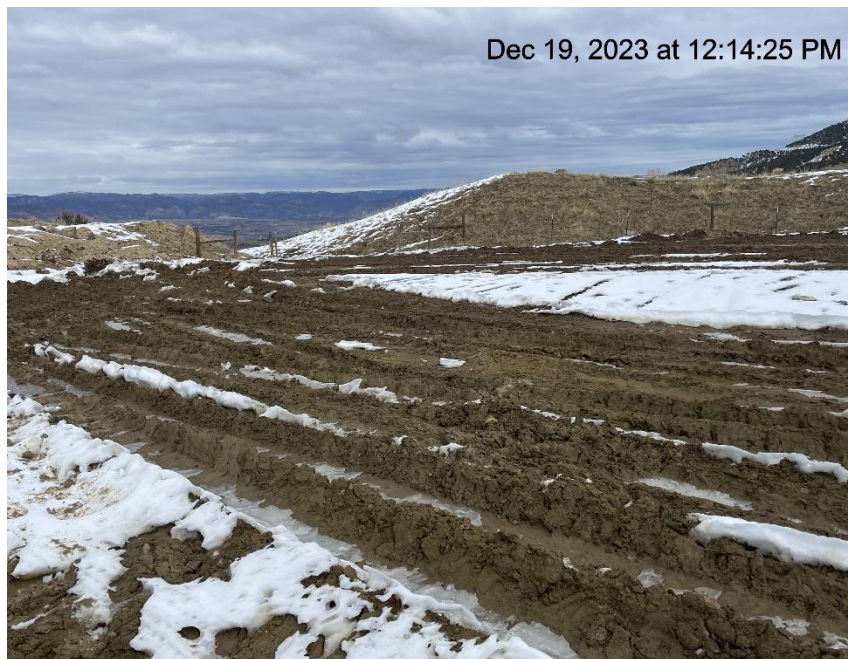
Photo # 220 Lack of stabilization/compaction/insufficient BMP's

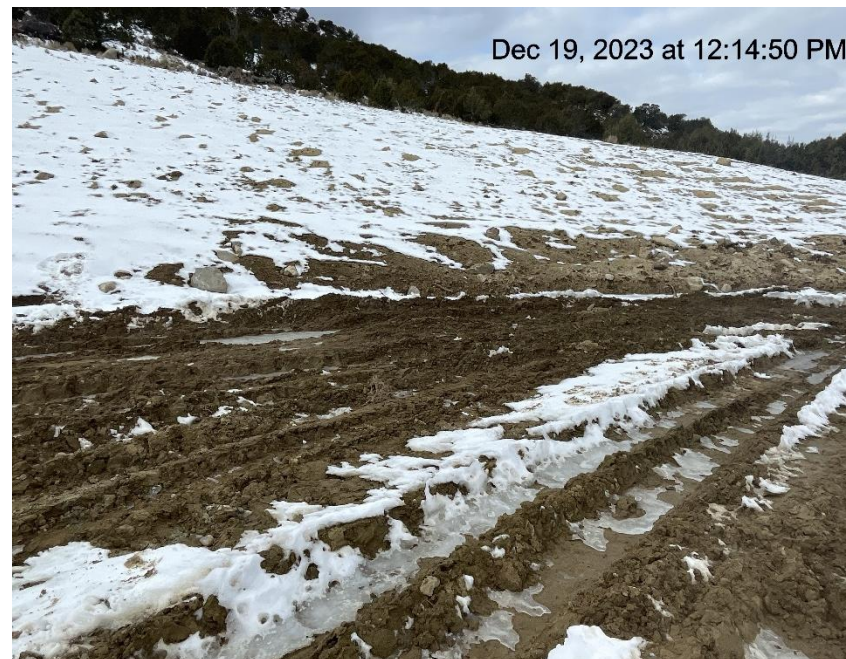
Photo # 221 Lack of stabilization/compaction/insufficient BMP's

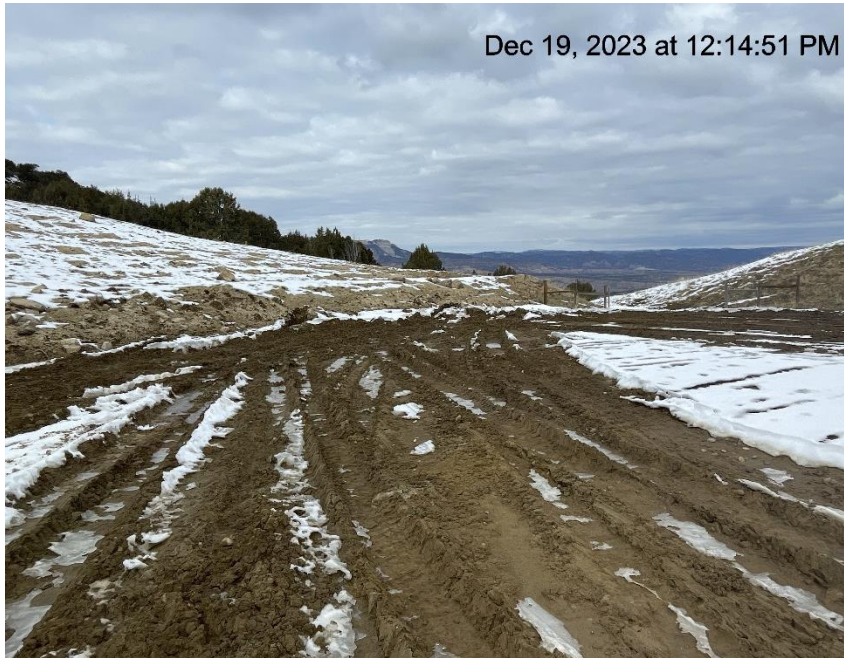
Photo # 222 Lack of stabilization/compaction/insufficient BMP's

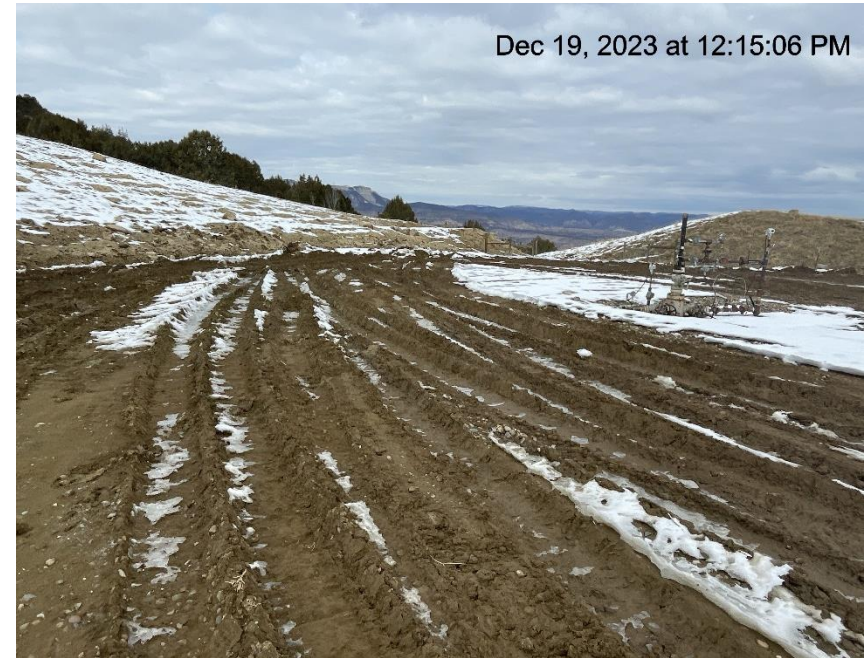
Photo # 223 Lack of stabilization/compaction/insufficient BMP's

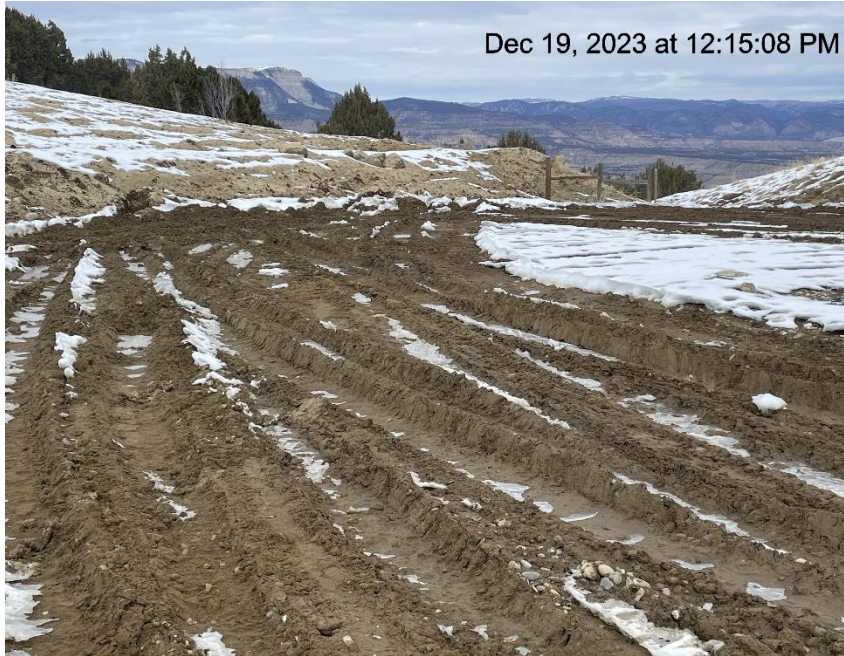
Photo # 224 Lack of stabilization/compaction/insufficient BMP's

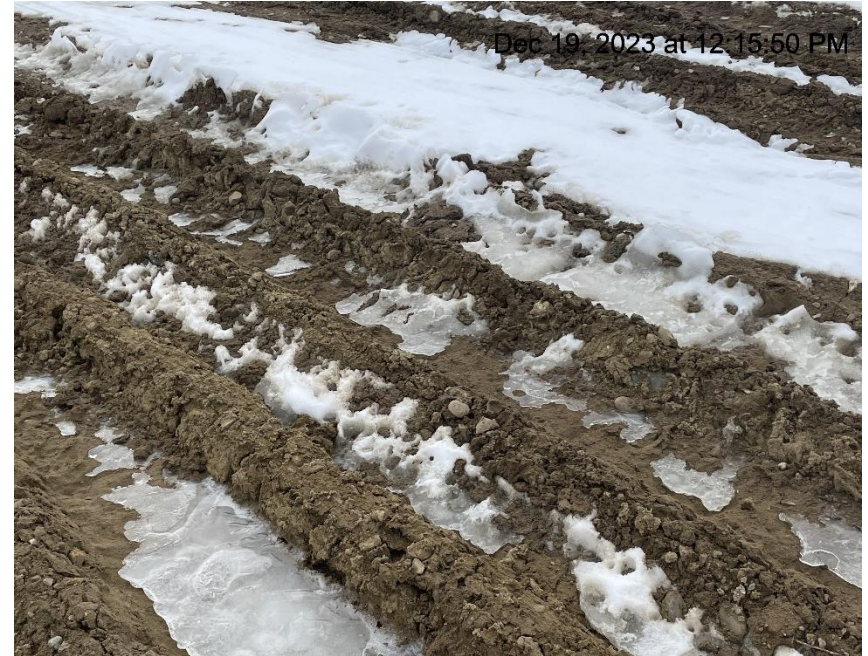
Photo # 225 Lack of stabilization/compaction/insufficient BMP's
