Interim Reclamation and Stormwater Inspection

Operator: NOBLE ENERGY INC - 100322

Location ID: 421062

Inspection Photos
Location Name: State 8-60 16-1H
Location ID: 421062

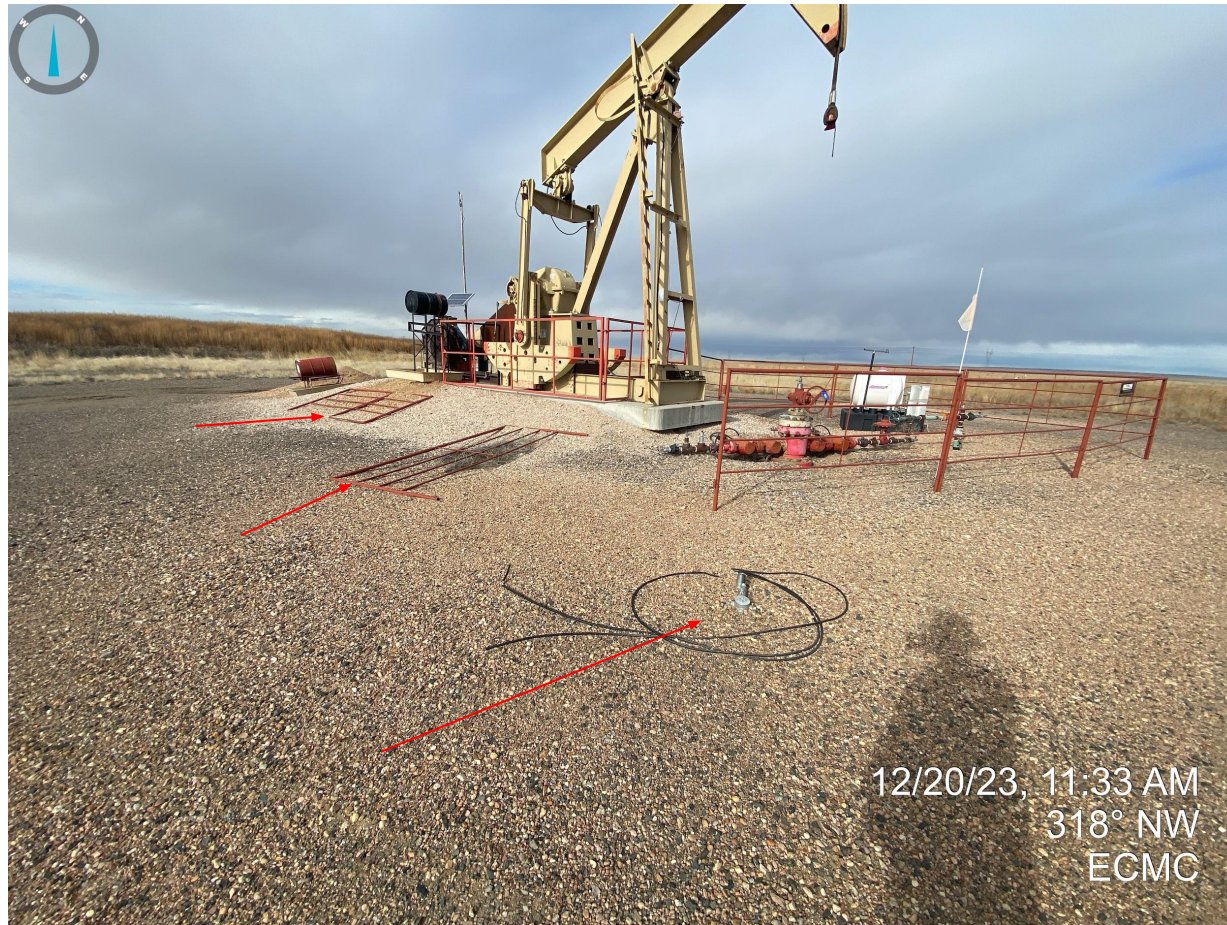
Photo 1. Cattle panels and wire/cable do not appear to be in use.

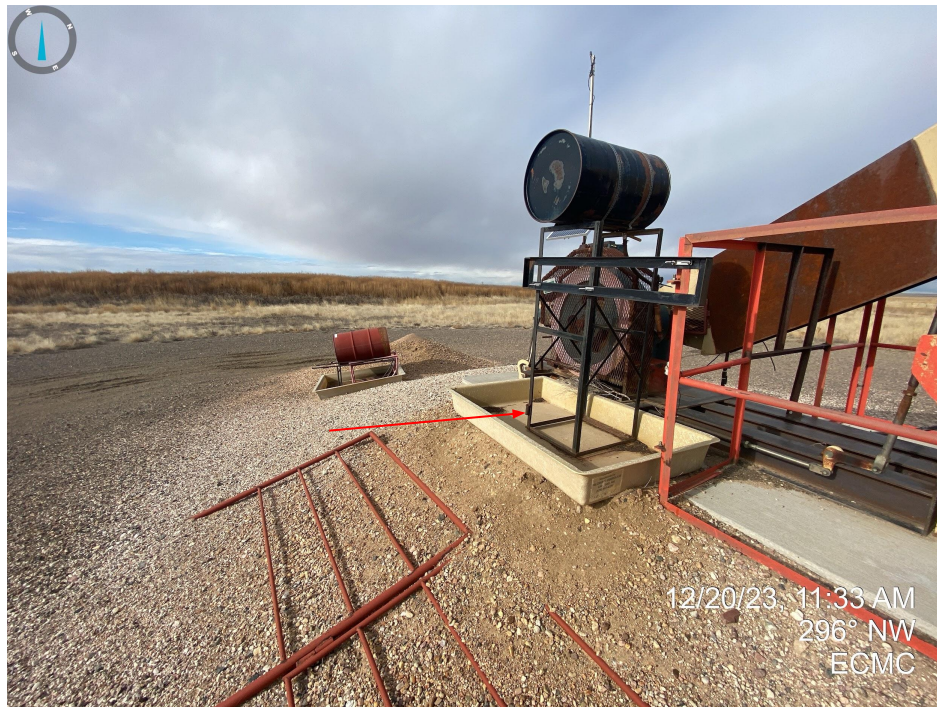
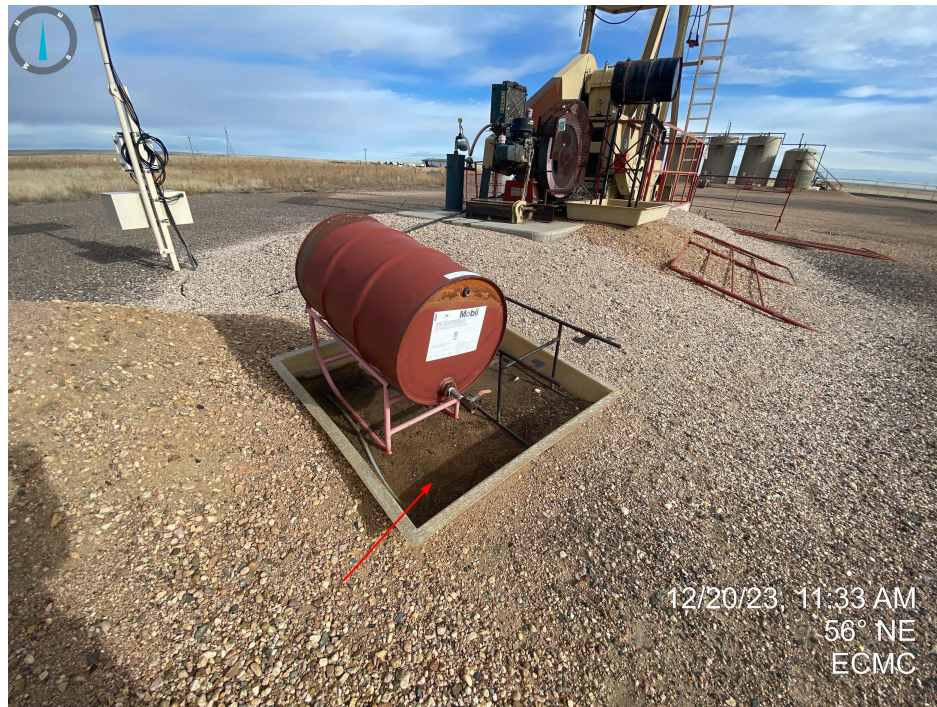
Photos 2 & 3. Day tank secondary containment units at wellhead do not have adequate wildlife protection equipment (e.g. netting).

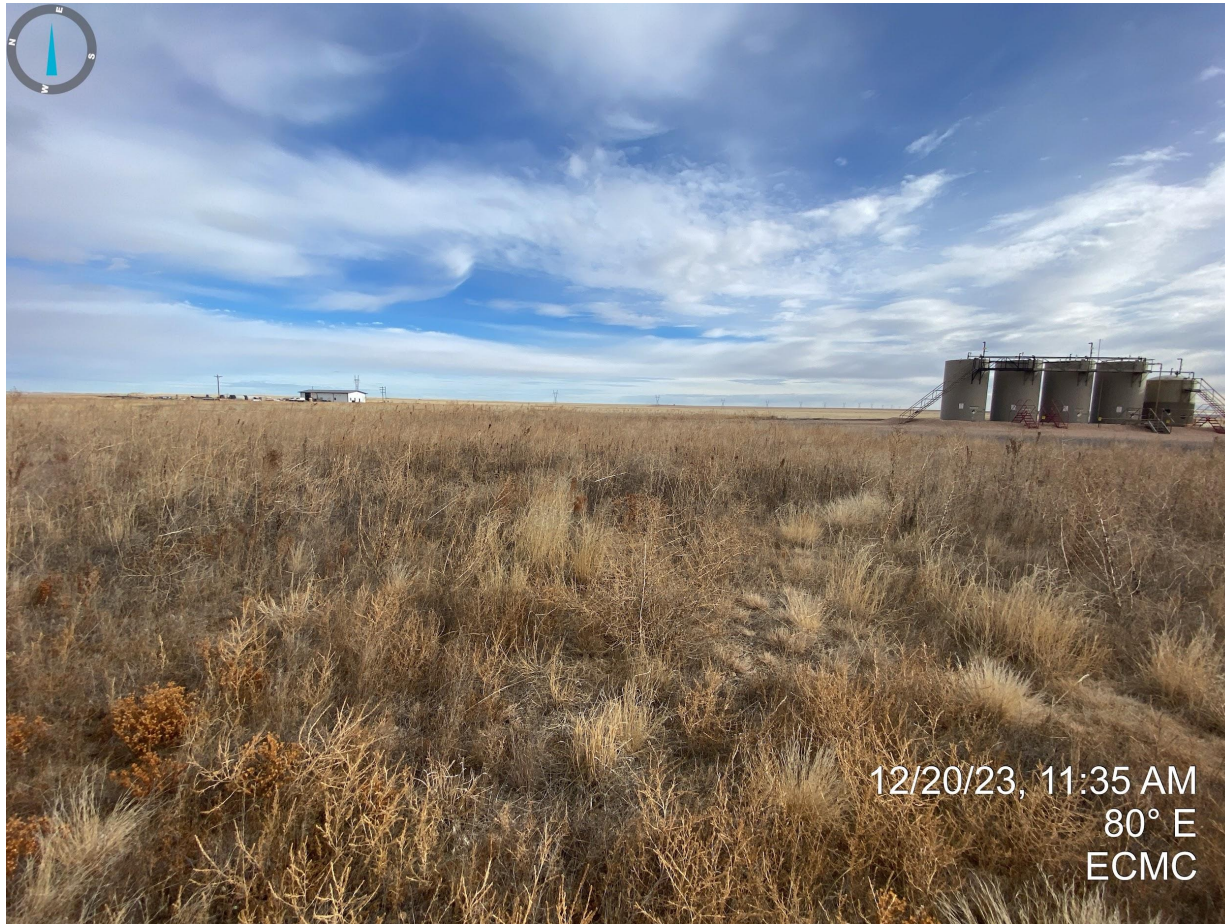
Photo 4. Northern interim areas appear to be progressing towards Rule 1003 standards and regulations with the presence of desirable species observed. A follow-up inspection will be conducted at a later date during the active growing season to verify vegetation compliance with Rule 1003.

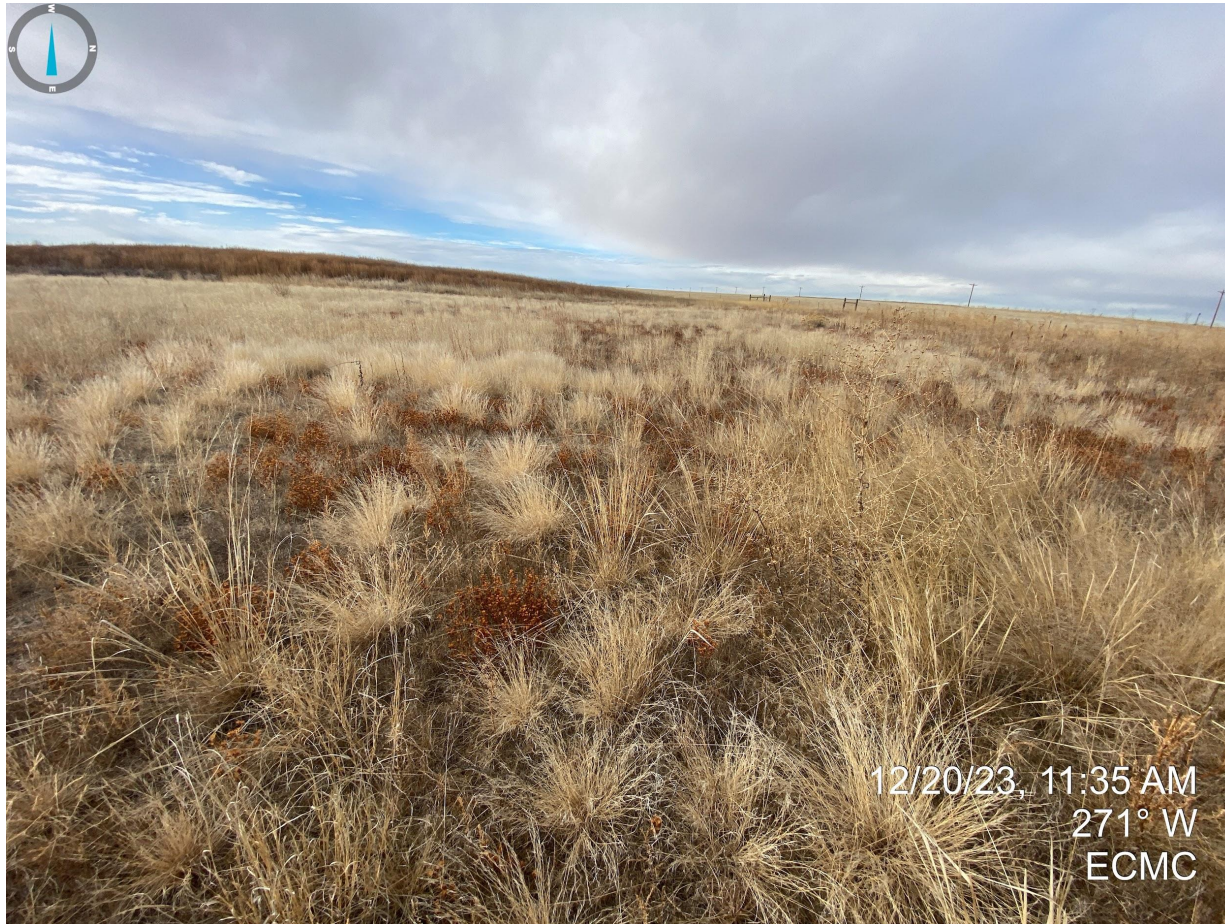
Photo 5. Northern interim areas, facing west. See comments in Photo 4.

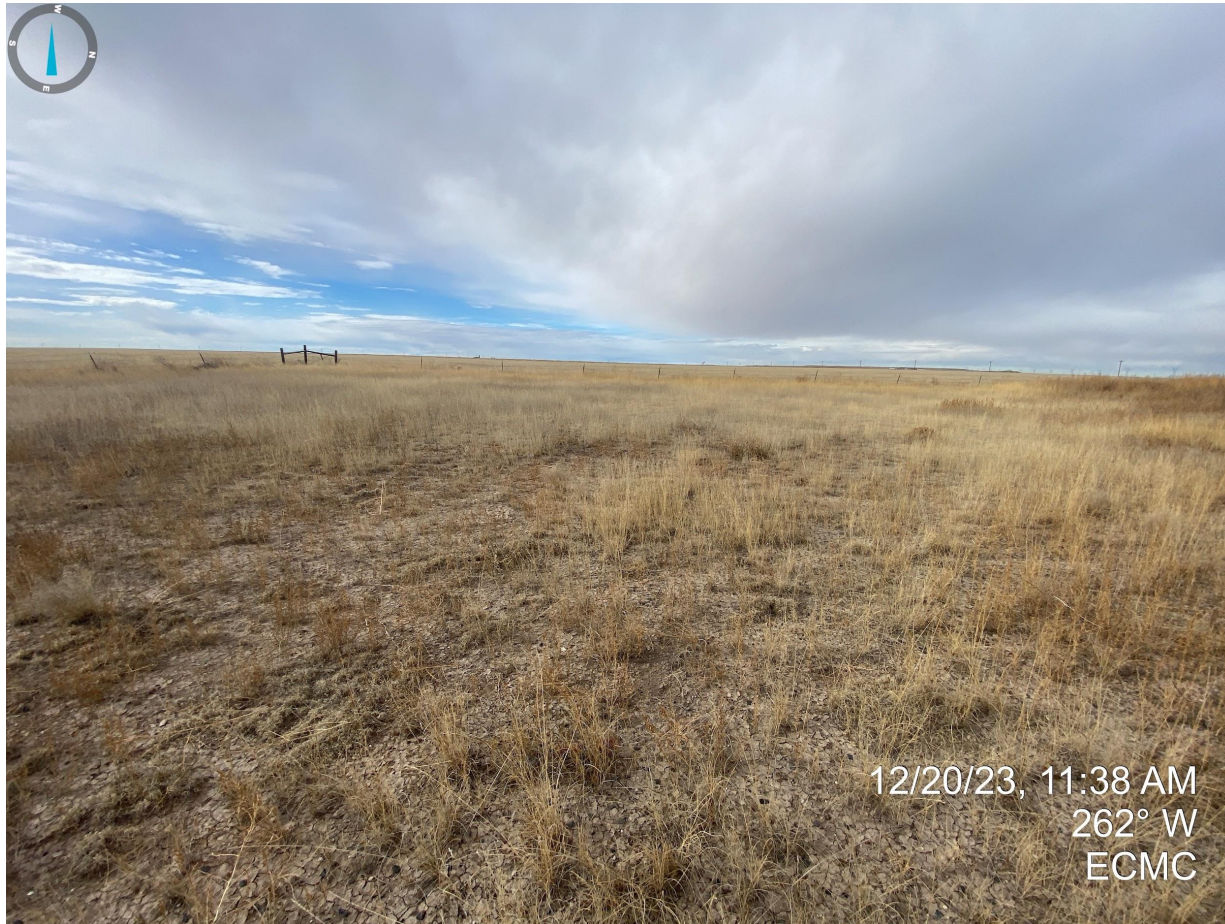
Photo 6. Southern interim areas, facing west. See comments in Photo 4.

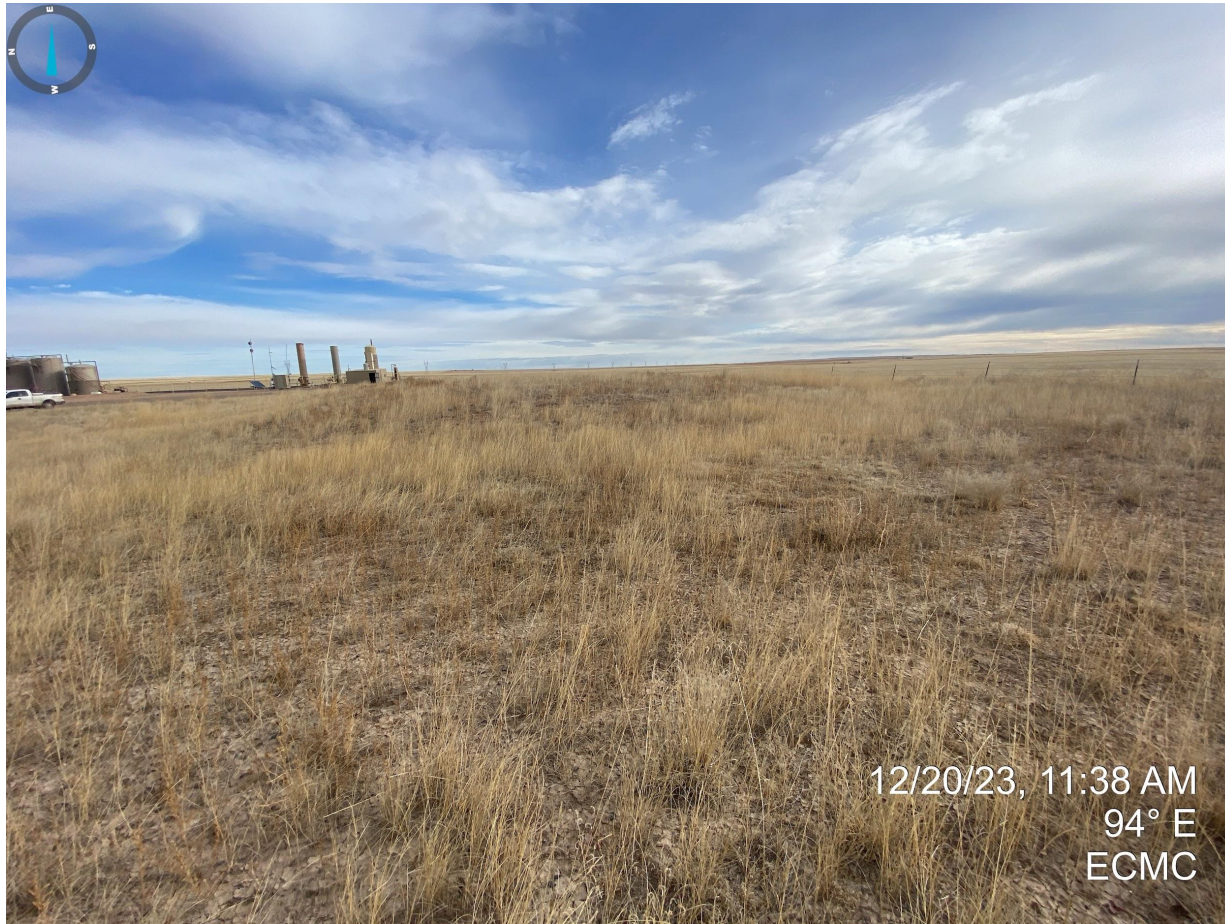
Photo 7. Southern interim areas, facing east. See comments in Photo 4.

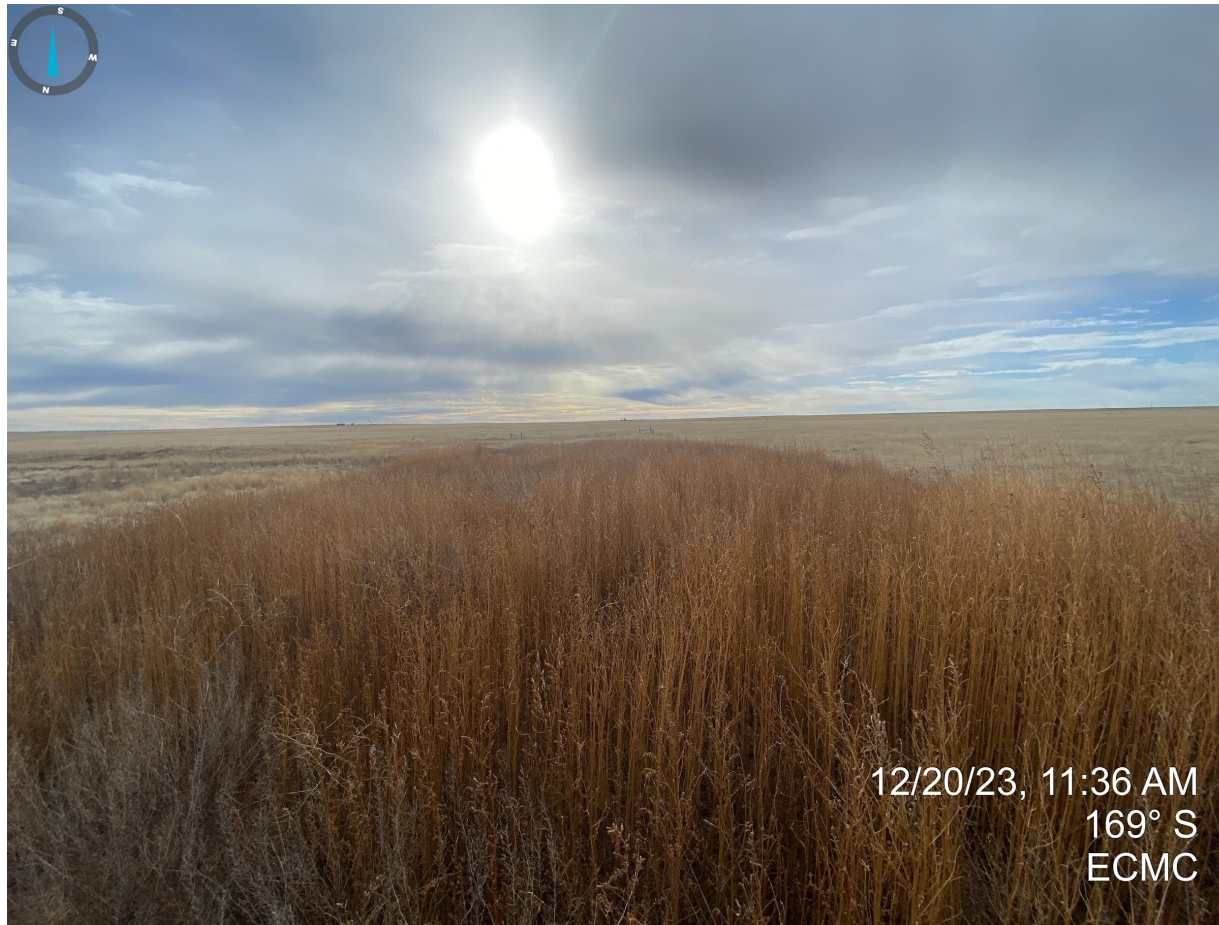
Photo 8. Taken from the top of the topsoil stockpile, facing south. Photo illustrates that the topsoil stockpile is predominantly undesirable vegetation (e.g. kochia and russian thistle). Additional weed management and/or reseeding activities are required in order to comply with Rule 1002.c.

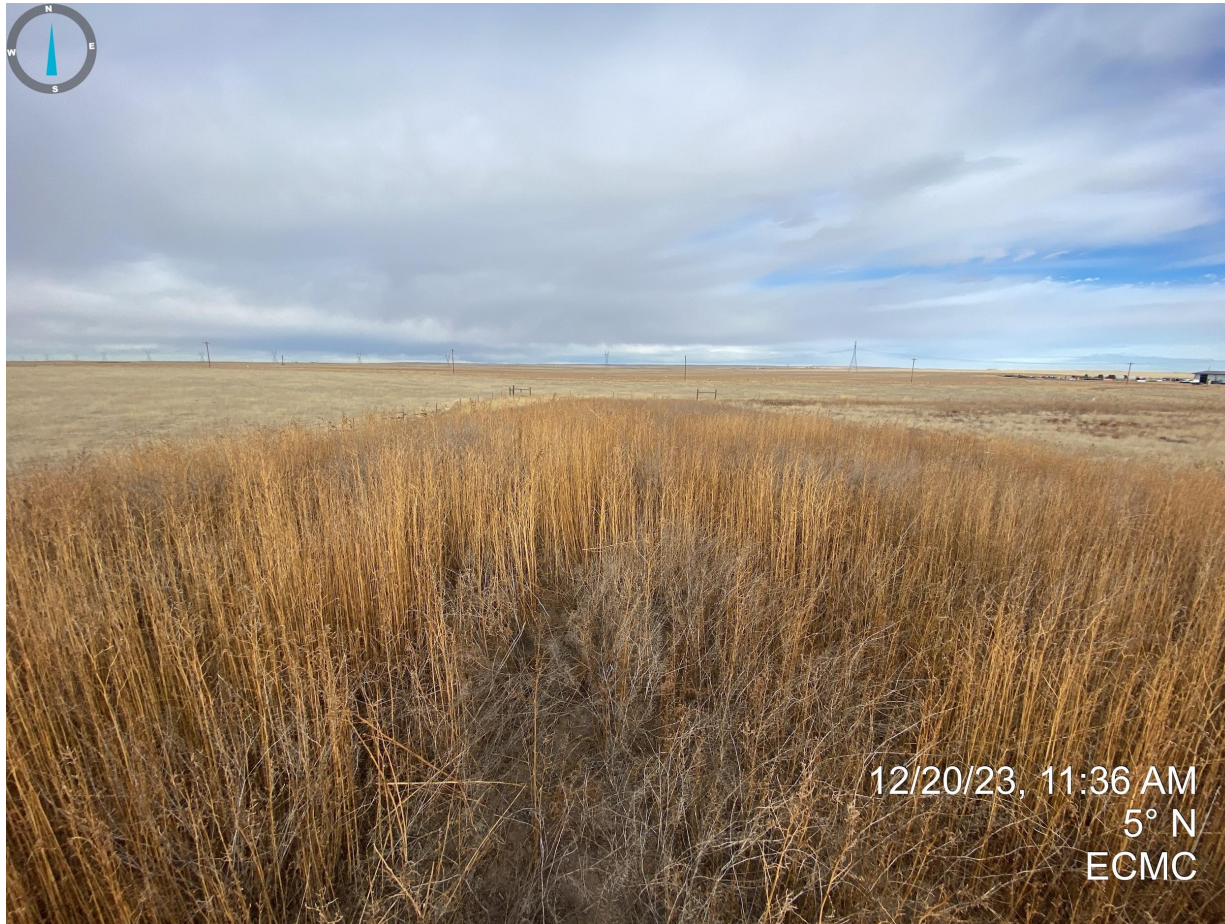
Photo 9. Topsoil stockpile, facing north. See comments in Photo 8.
