Inspection Photos

Location Name: CAERUS PICEANCE LLC N. PARACHUTE C29 Pad

Location #: 335692

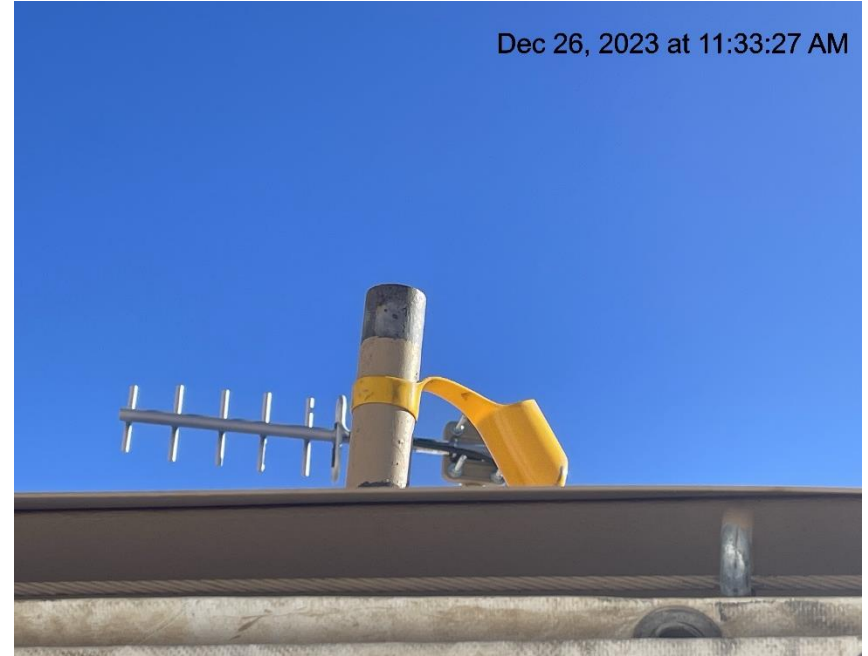
Photo # 758 Cap not covering PRV vent line on test separator

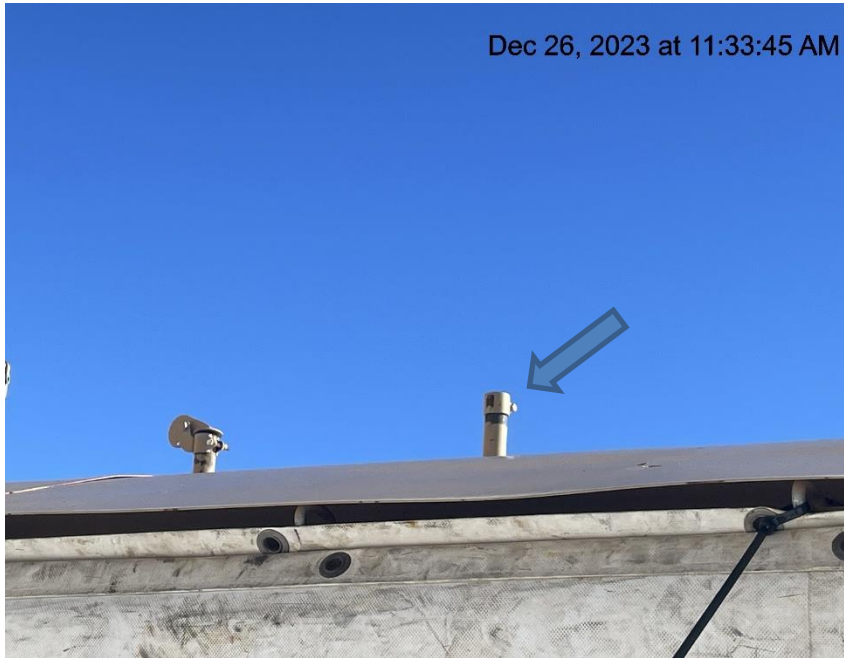
Photo # 759 PRV vent line on test separator lacks cap

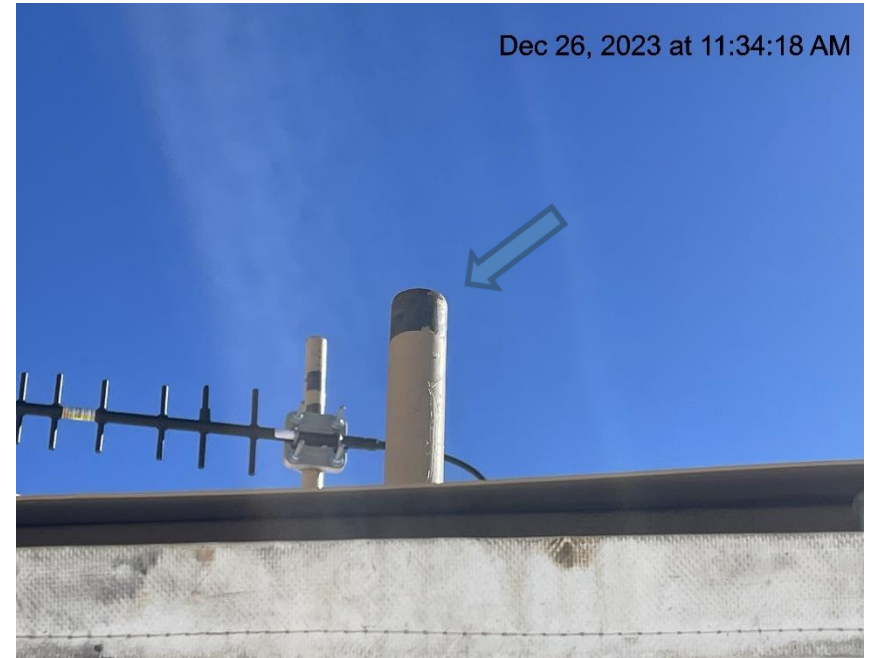
Photo # 760 PRV vent line on test separator lacks cap

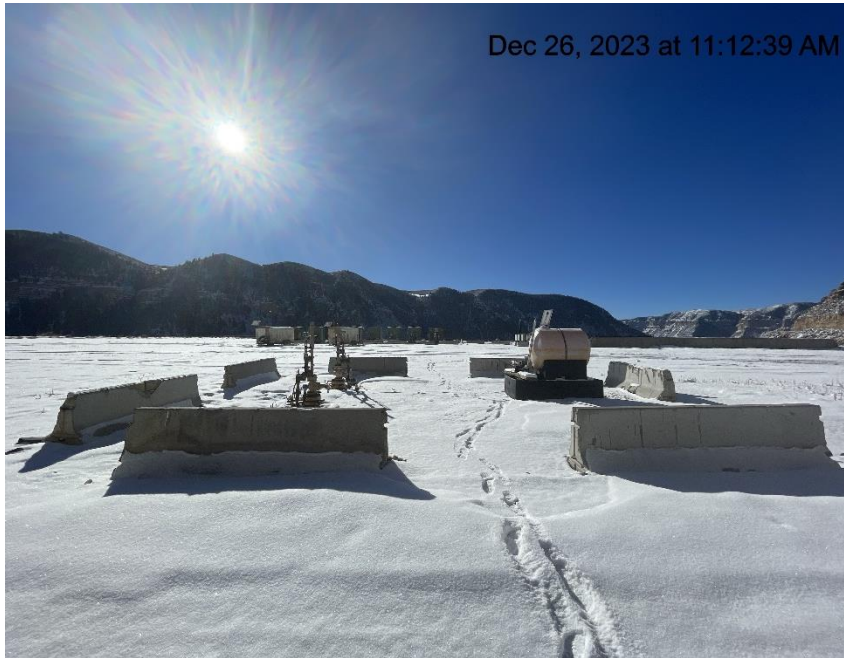
Photo # 761 Wellheads lack required signage

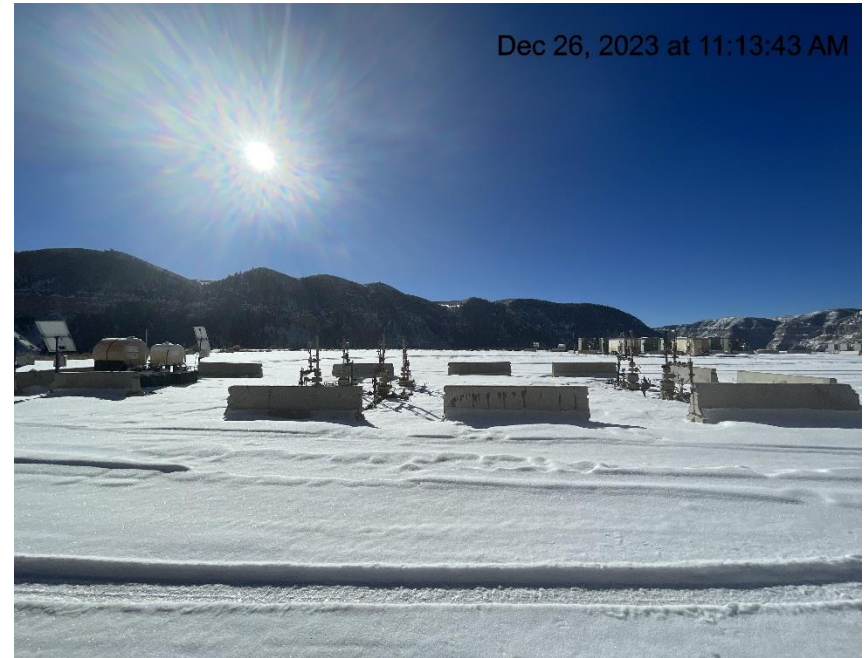
Photo # 762 Wellheads lack required signage

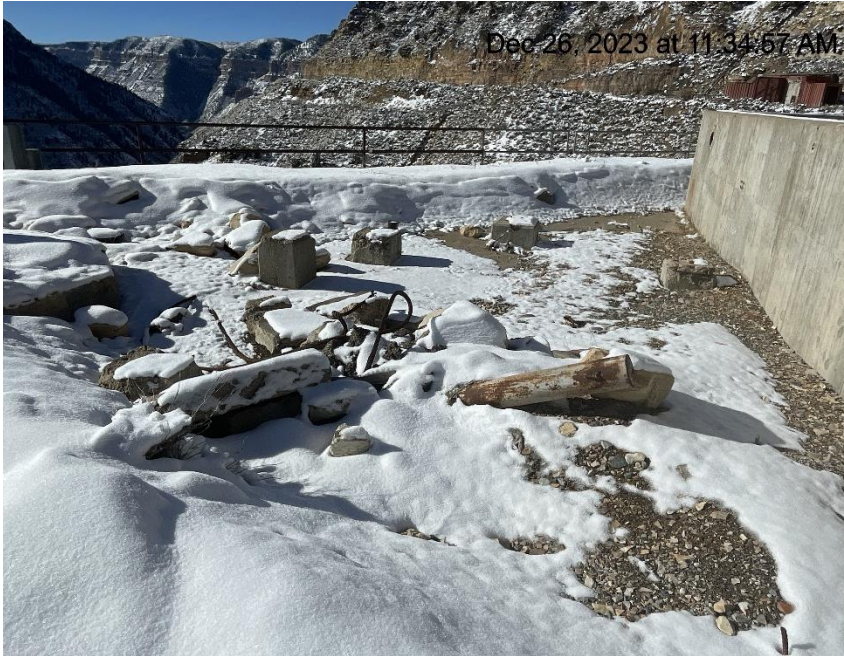
Photo # 763 Debris
