Interim Reclamation and Stormwater Inspection

Operator: Bonanza Creek Energy Operating
Company LLC - 8960

Location ID: 470863

Inspection Document #: 713900191

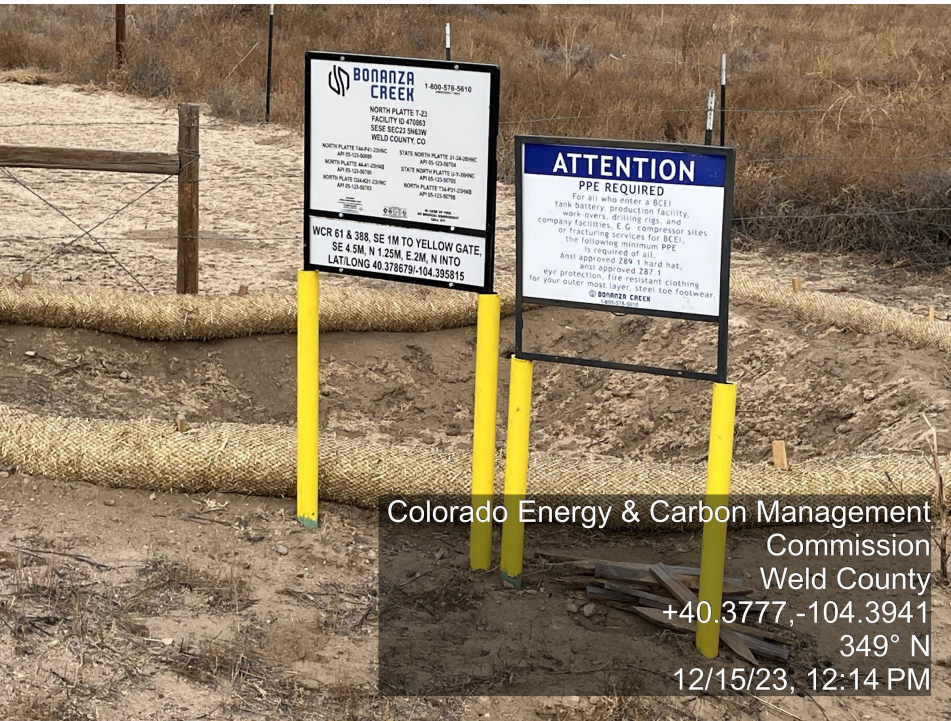
Photo 1. The photo was taken at the well location entrance facing North. The photo illustrates the operator location sign.

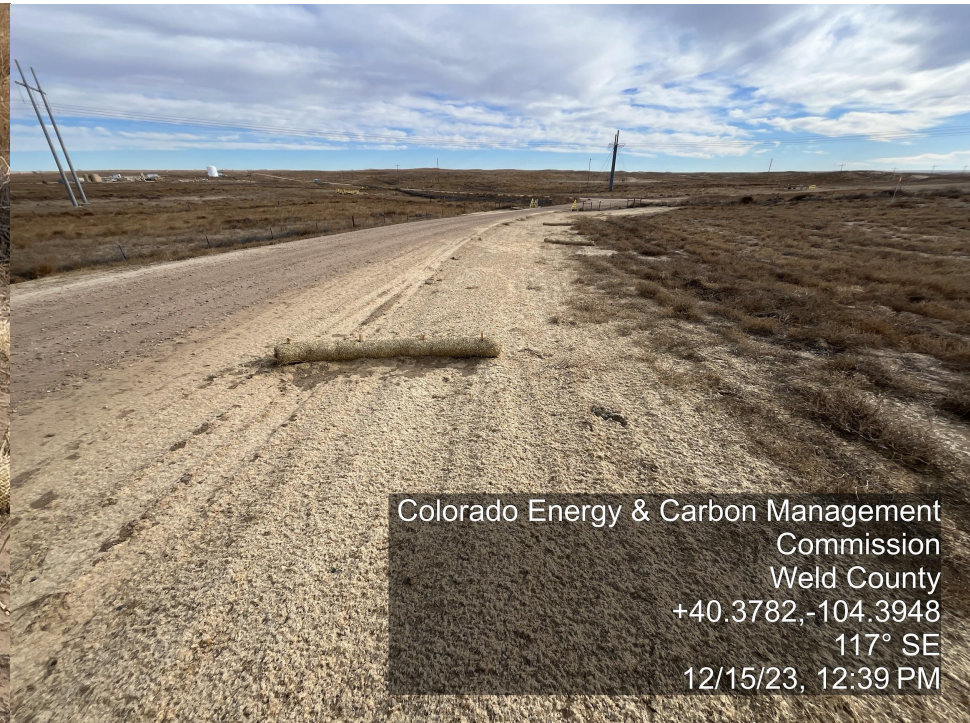
Photo 2. The photo was taken at the well location entrance facing Southeast. The photo illustrates 3 straw wattle check dams and mulch on the sloped road sides.

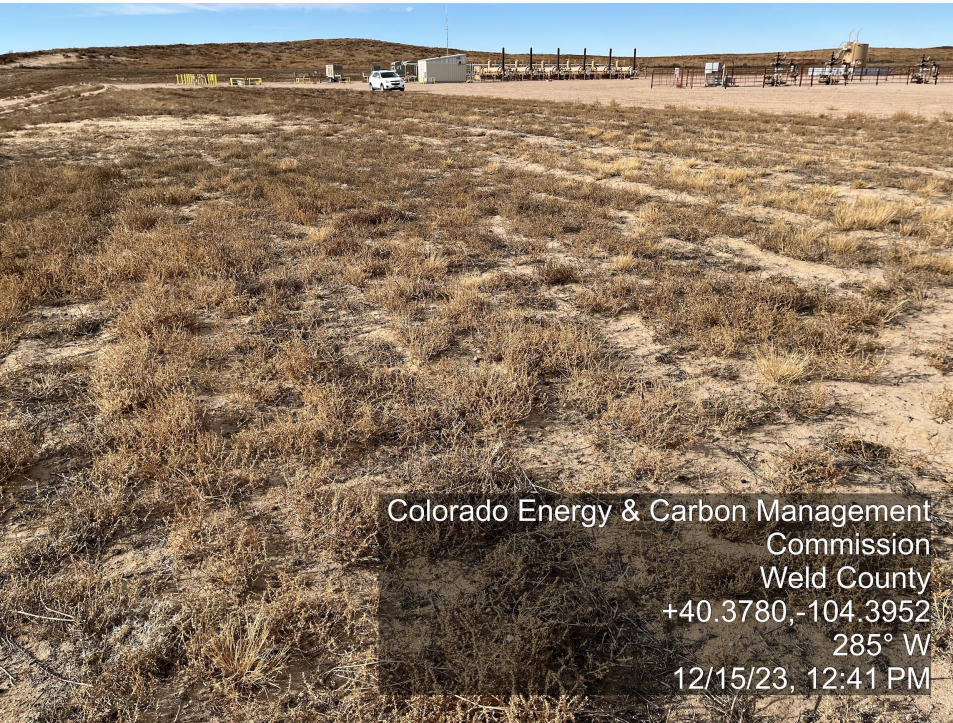
Photo 3. The photo was taken at the South side of the well location facing West. The photo illustrates the interim areas are dominated by russian thistle and bare soil.

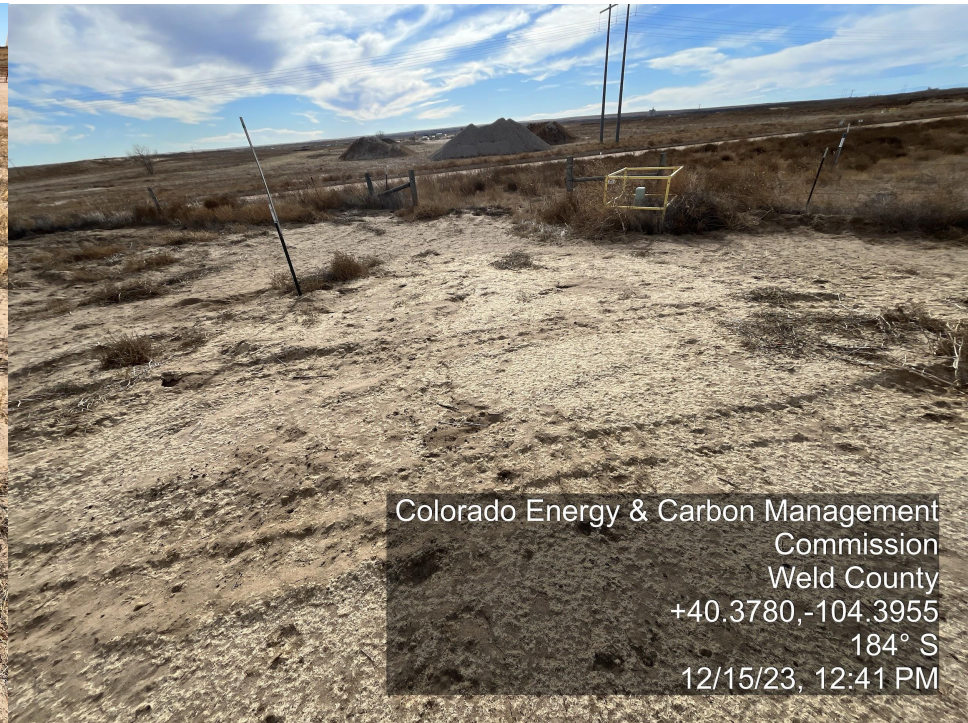
Photo 4. The photo was taken at the South side of the well location facing South. Refer to the comment for photo 3.

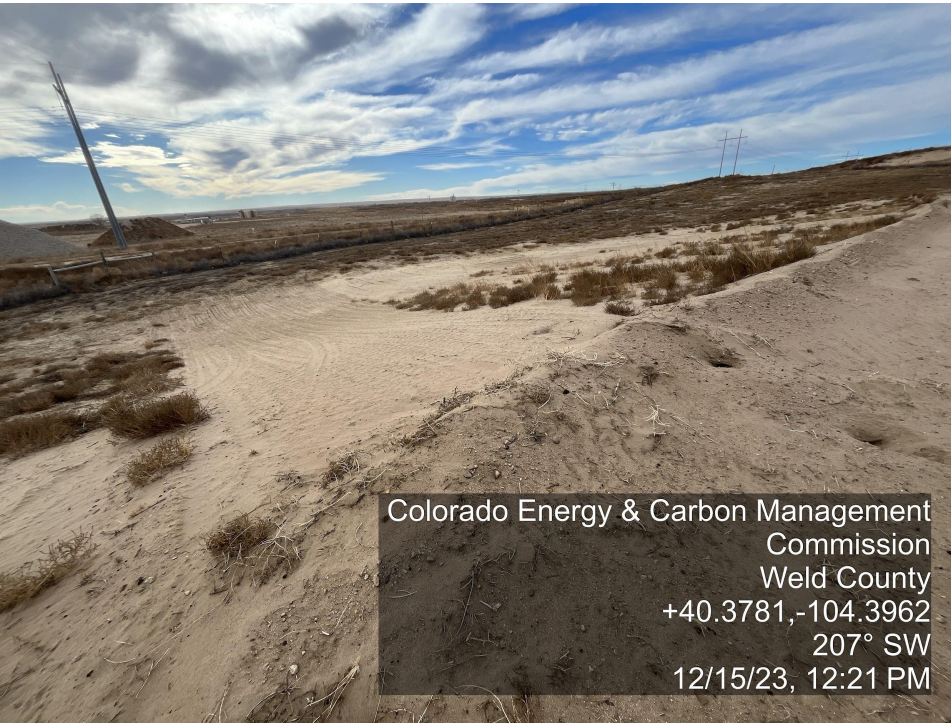
Photo 5. The photo was taken at the South side of the well location facing Southwest. Refer to the comment for photo 3. The photo also illustrates a large area of bare soil with no vegetation growth or stormwater BMP's.

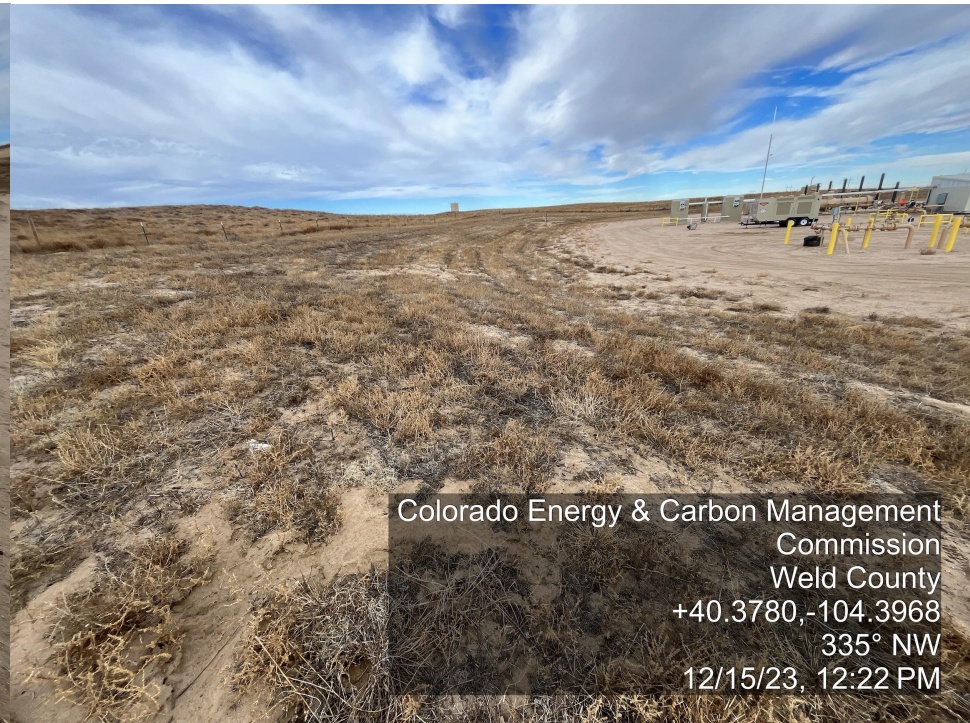
Photo 6. The photo was taken at the West side of the well location facing Northwest. Refer to the comment for photo 3.

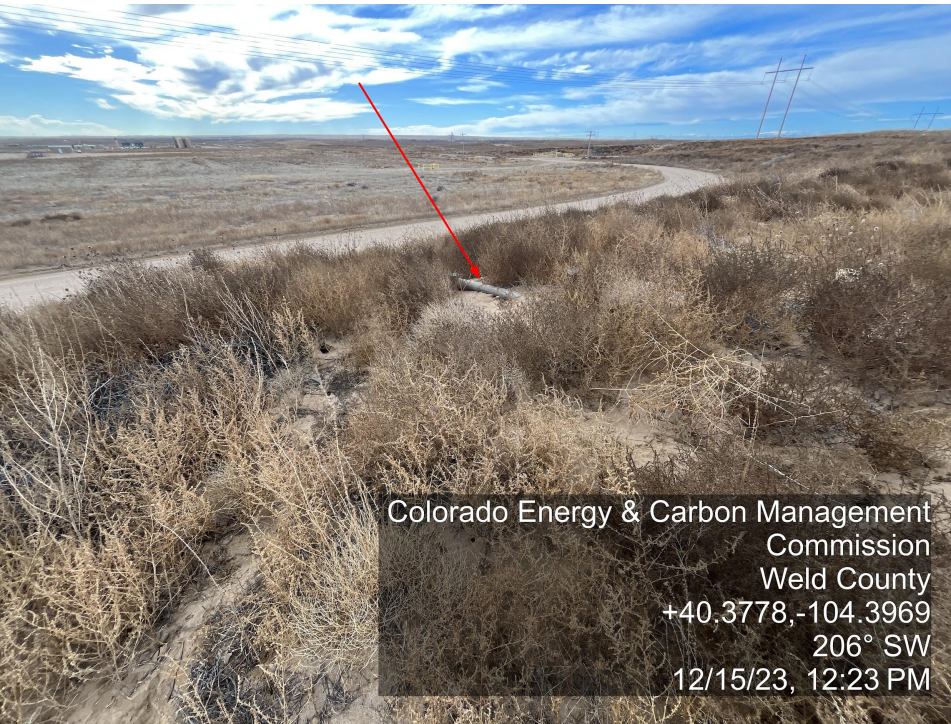
Photo 7. The photo was taken at the South side of the well location facing Southwest. The photo illustrates the corner fencing has been buried by sedimentation from the slope above..

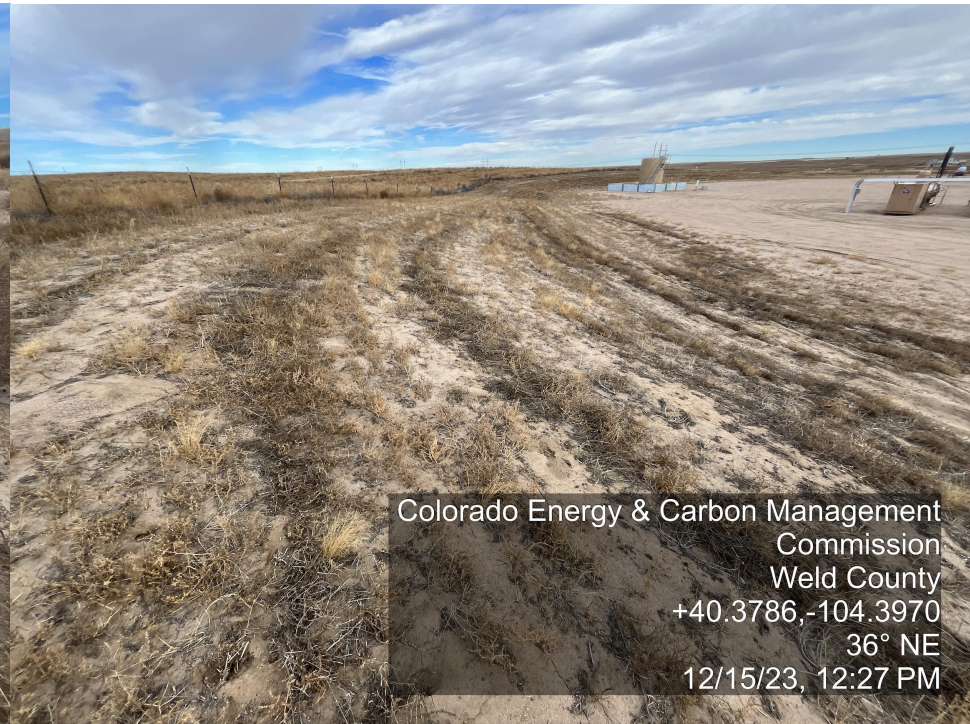
Photo 8. The photo was taken at the Northwest side of the well location facing Northeast. Refer to the comment for photo 3.

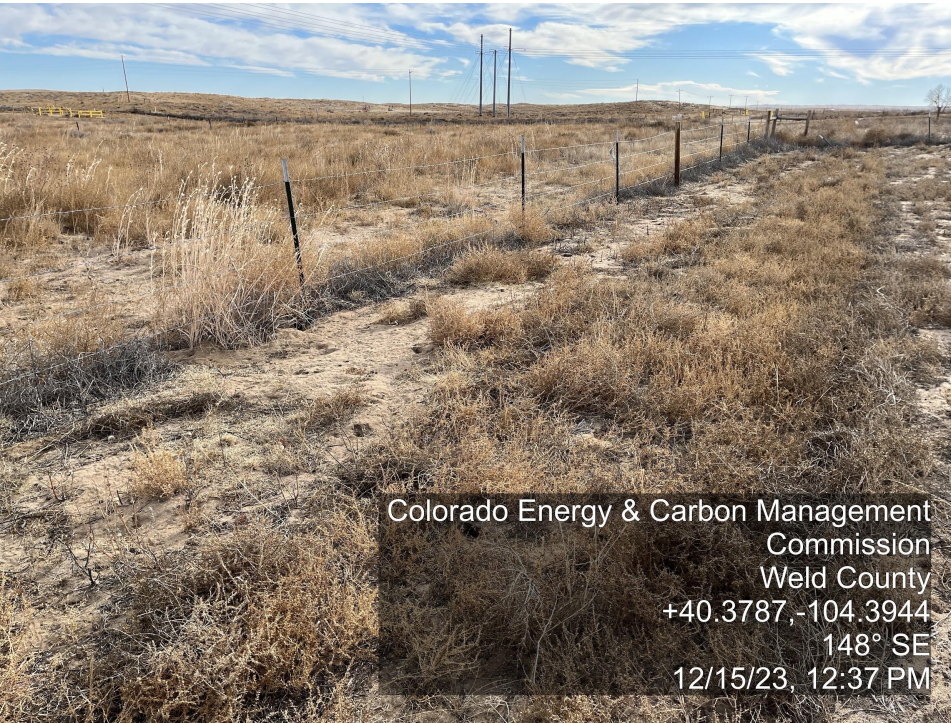
Photo 9. The photo was taken from the East side of the well location facing Southeast. The photo illustrates the differences between the interim area and outside of the perimeter fence. The interim is dominated by russian thistle and outside has more perennial diversity.

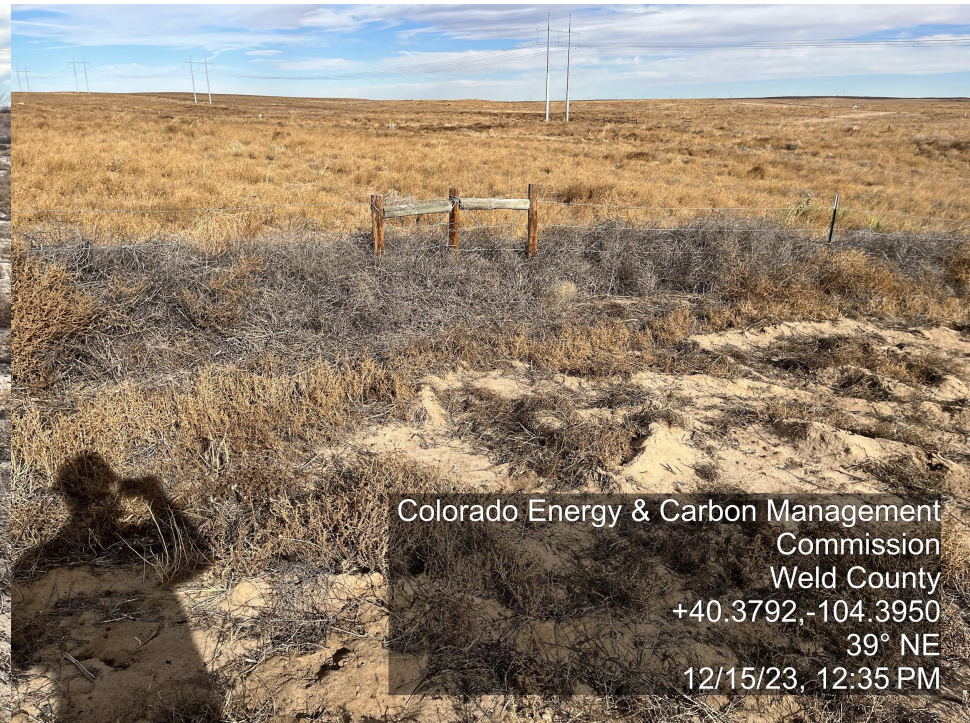
Photo 10. The photo was taken at the Northeast side of the well location facing Northeast. The photo illustrates large amounts of tumbleweeds stuck on either side of the perimeter fencing..

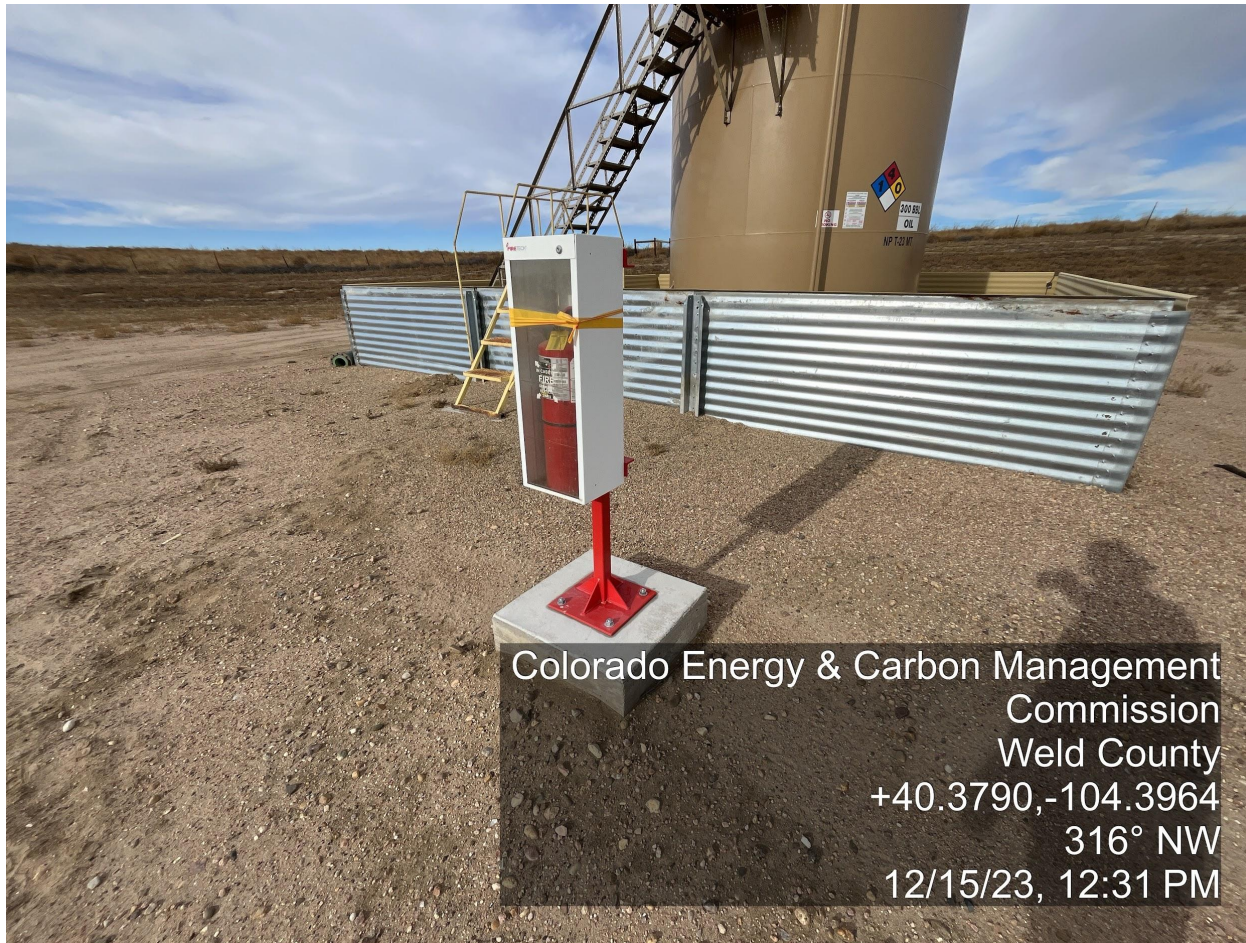
Photo 11. The photo was taken at the North side of the well location facing Northwest. The photo illustrates an oil tank that is not noted in the location paperwork.
