Inspection Photos

Location Name: CAERUS PICEANCE LLC N.PARACHUTE EF07B A28 595 Pad

Location #: 335804

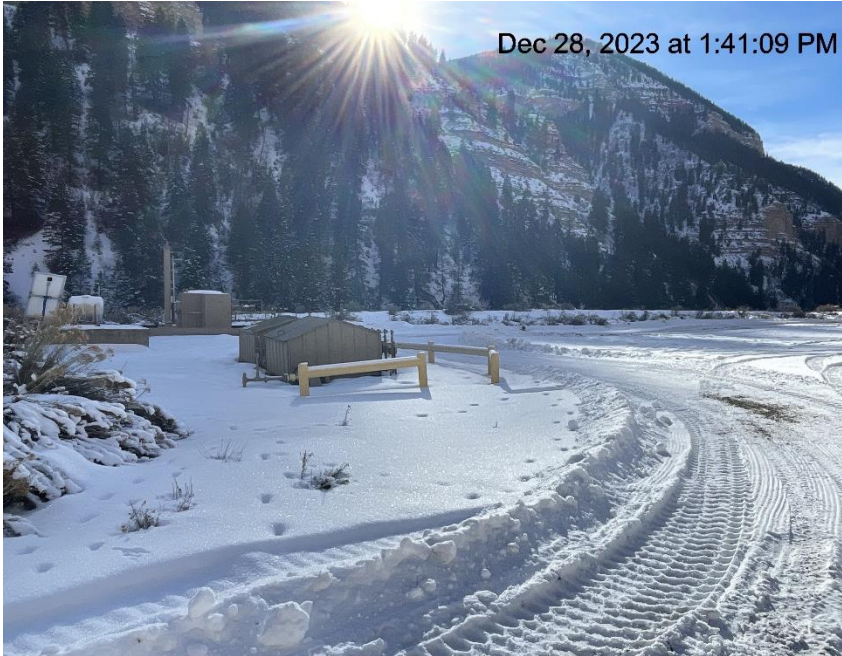
Photo # 1318 From entrance to location

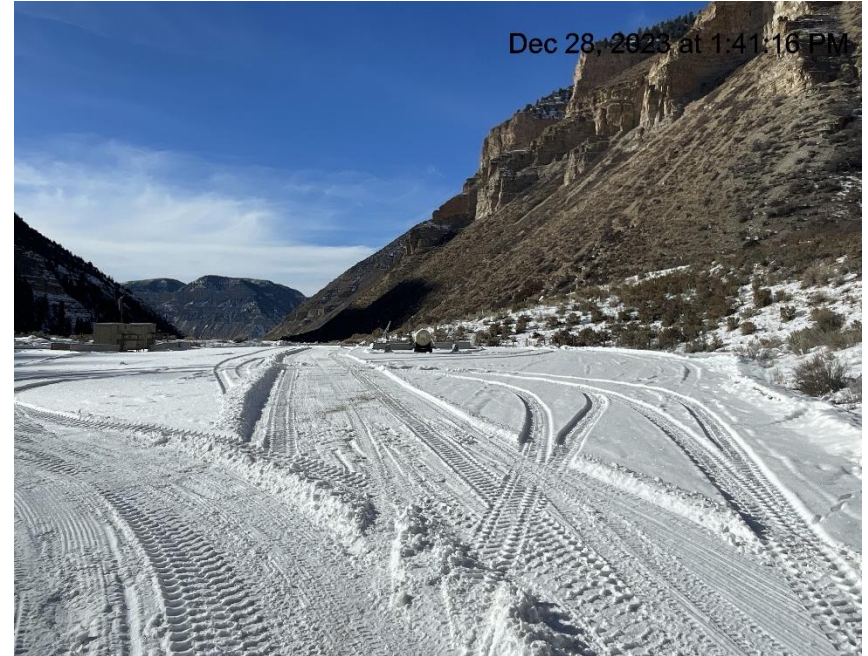
Photo # 1319 From entrance to location

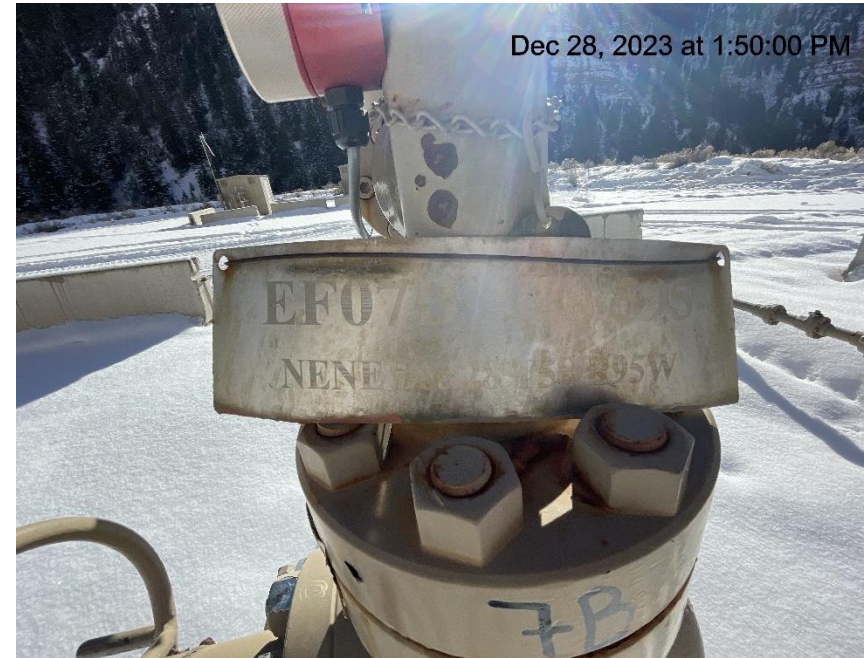
Photo # 1327 Wellhead sign lacks required info

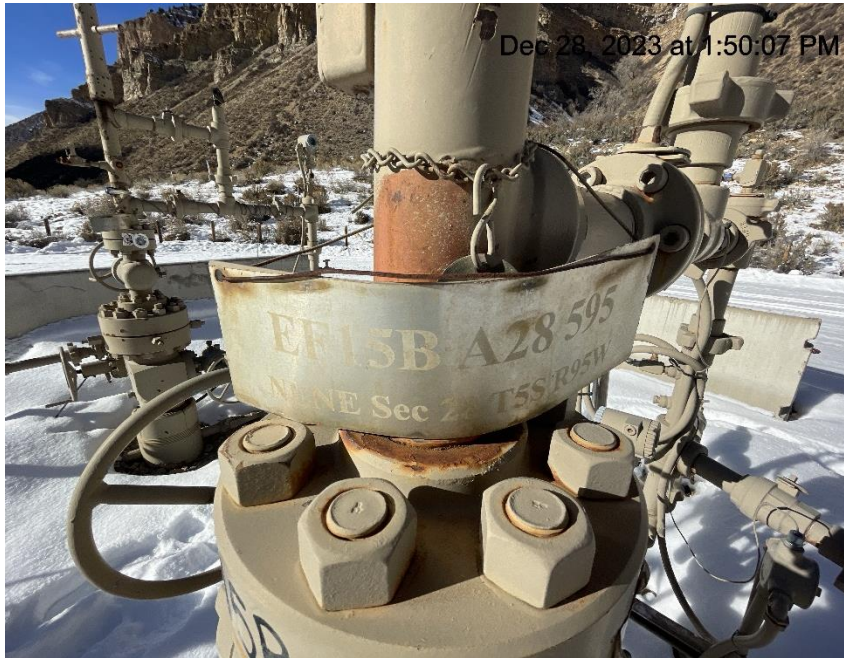
Photo # 1328 Wellhead sign lacks required info

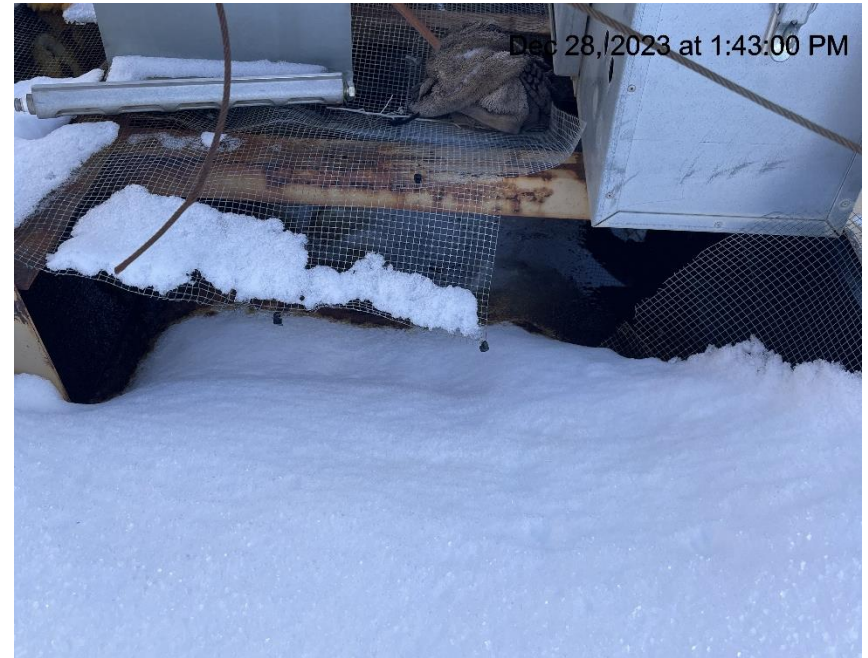
Photo # 1329 Wildlife protection on chemical tank containment needs maintenance

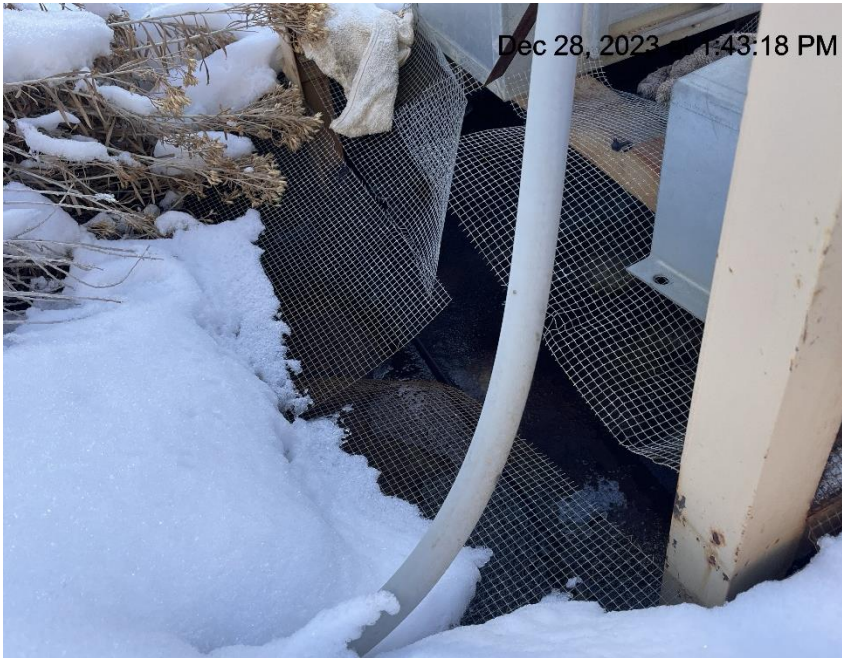
**Photo # 1330 Wildlife protection on chemical tank
containment needs maintenance**
