Inspection Photos

Location Name: CAERUS PICEANCE LLC N.PARACHUTE EFO6B I30A 595 Pad

Location #: 335807

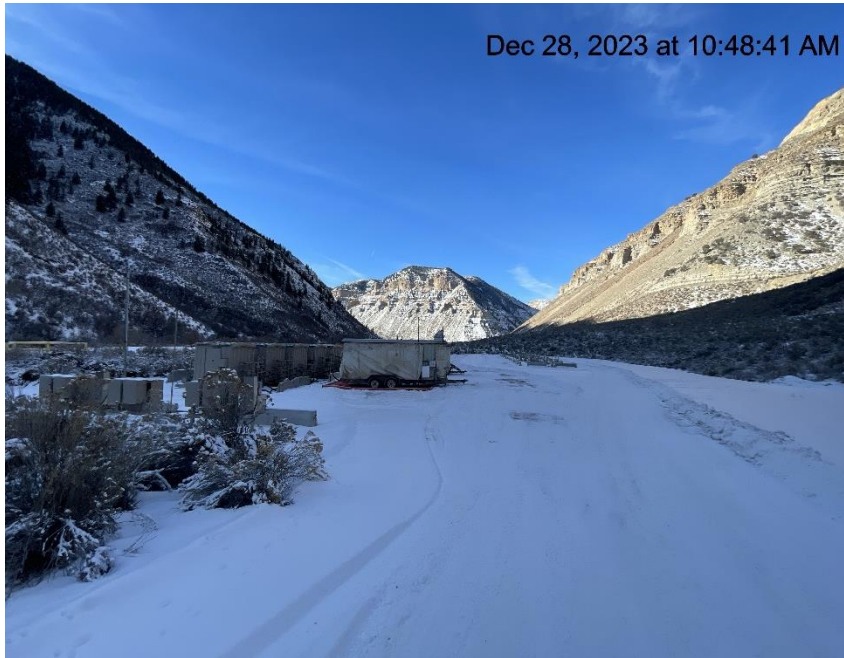
Photo # 1052 From entrance to location

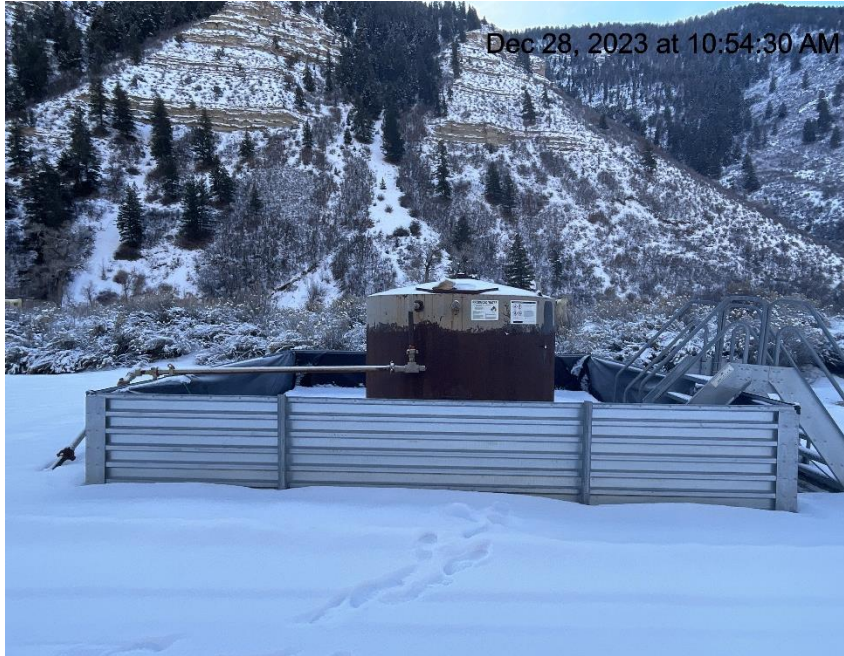
Photo # 1056 Location/blowdown tank

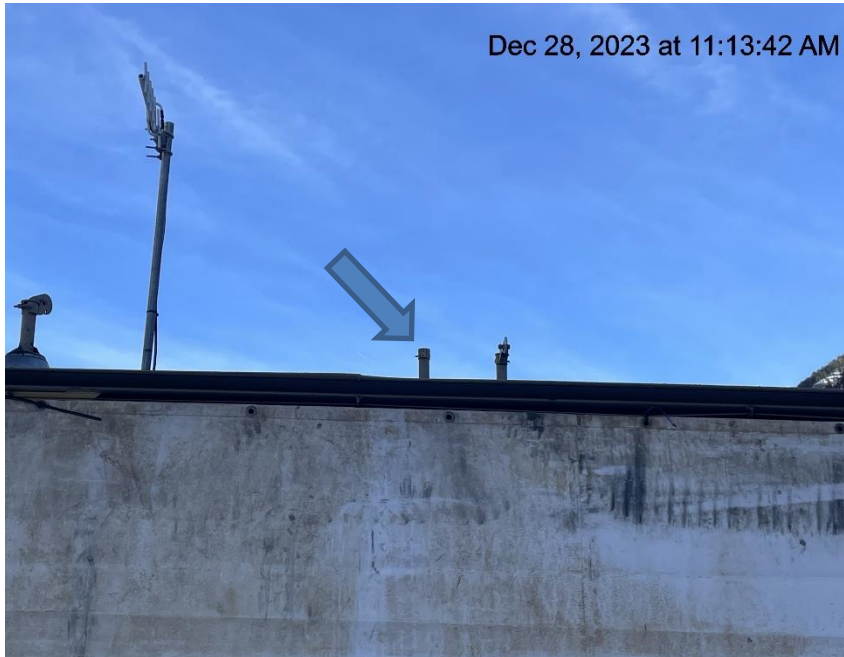
Photo # 1064 PRV vent line on test separator lacks cap

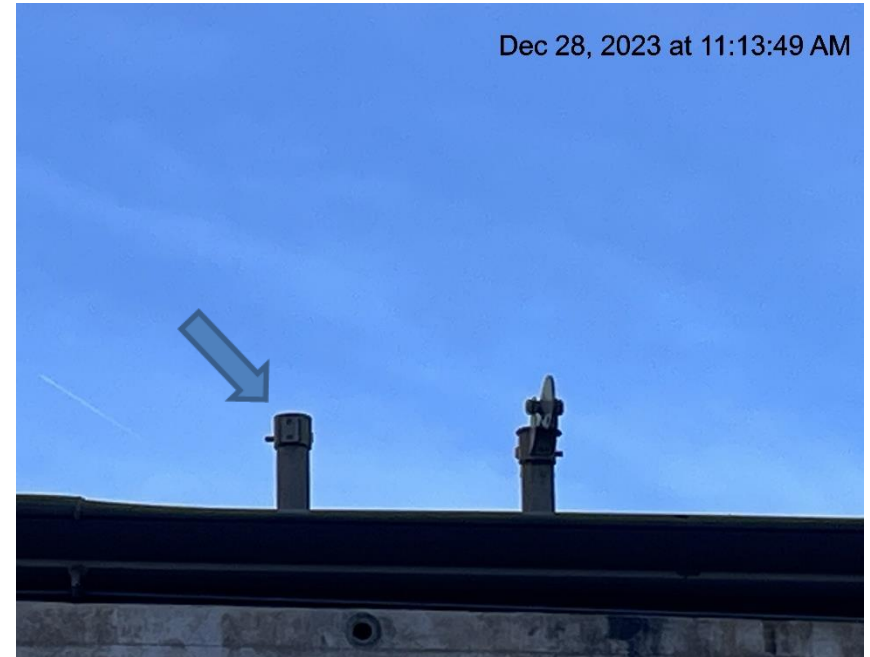
Photo # 1065 PRV vent line on test separator lacks cap

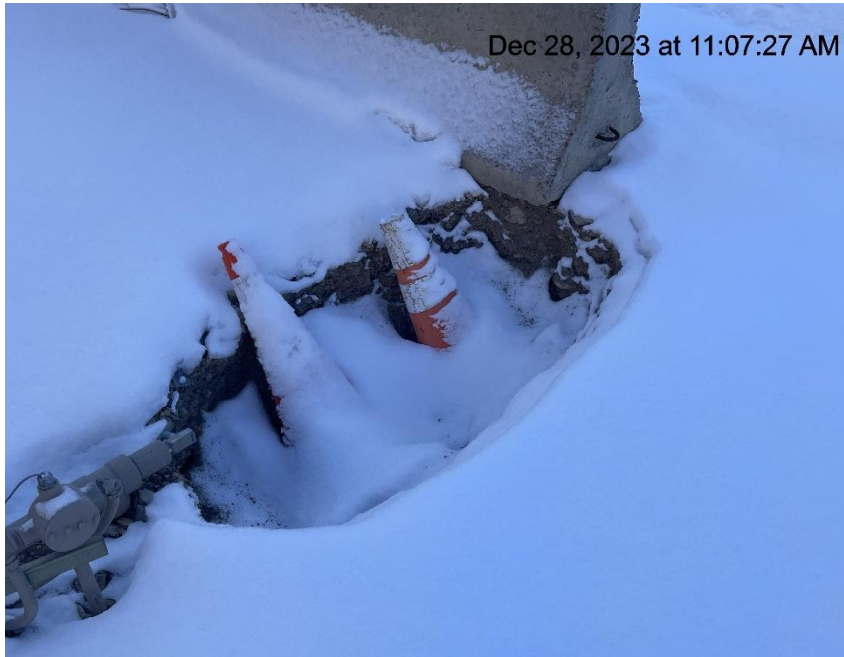
Photo # 1066 Hole in ground near wellheads/wildlife & personnel protection insufficient

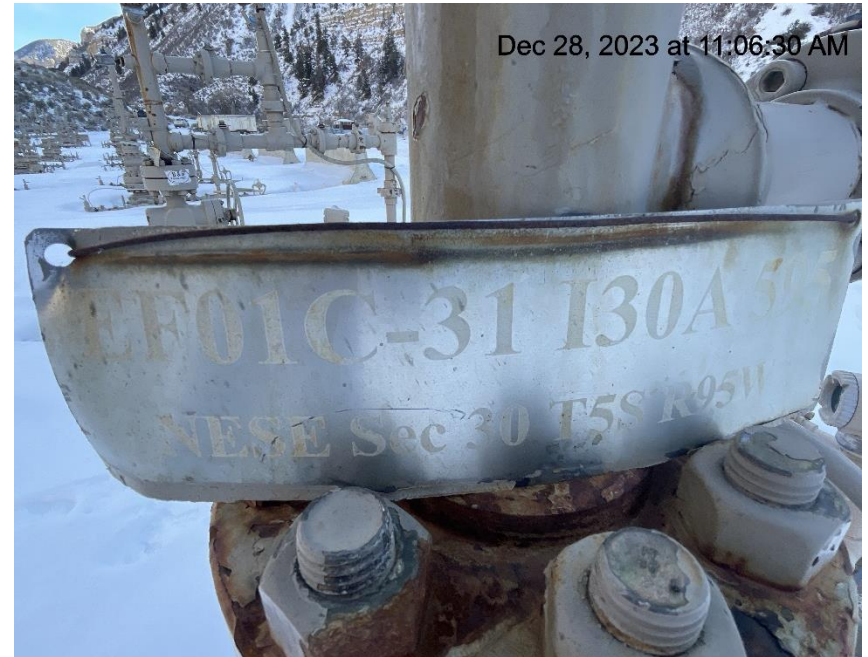
Photo # 1067 Wellhead signs lack required information

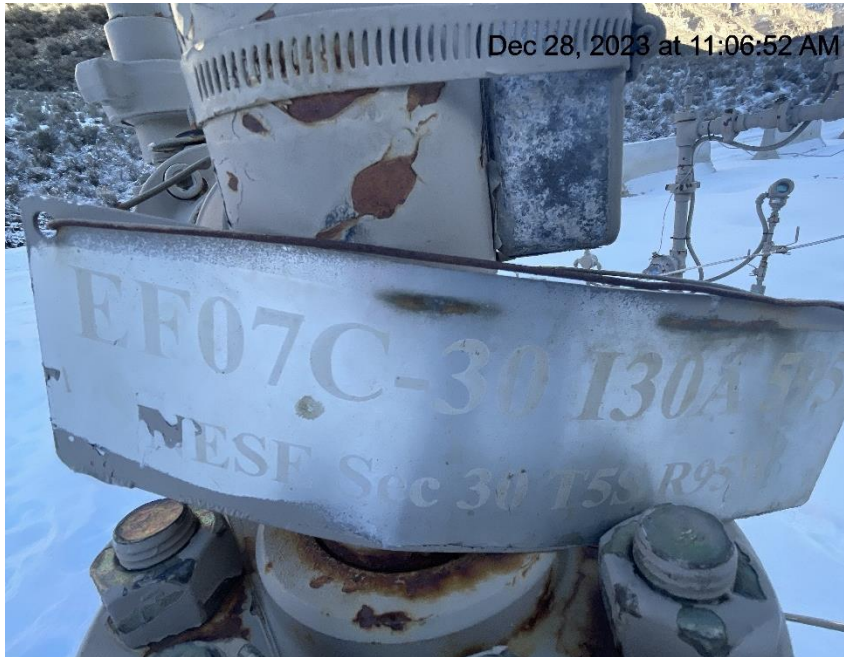
Photo # 1068 Wellhead signs lack required information

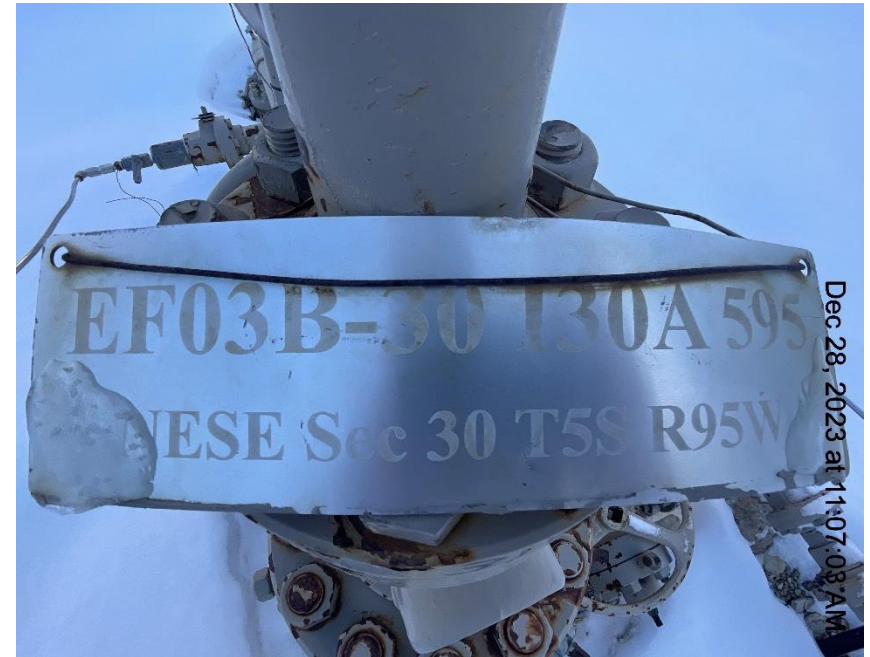
Photo # 1069 Wellhead signs lack required information

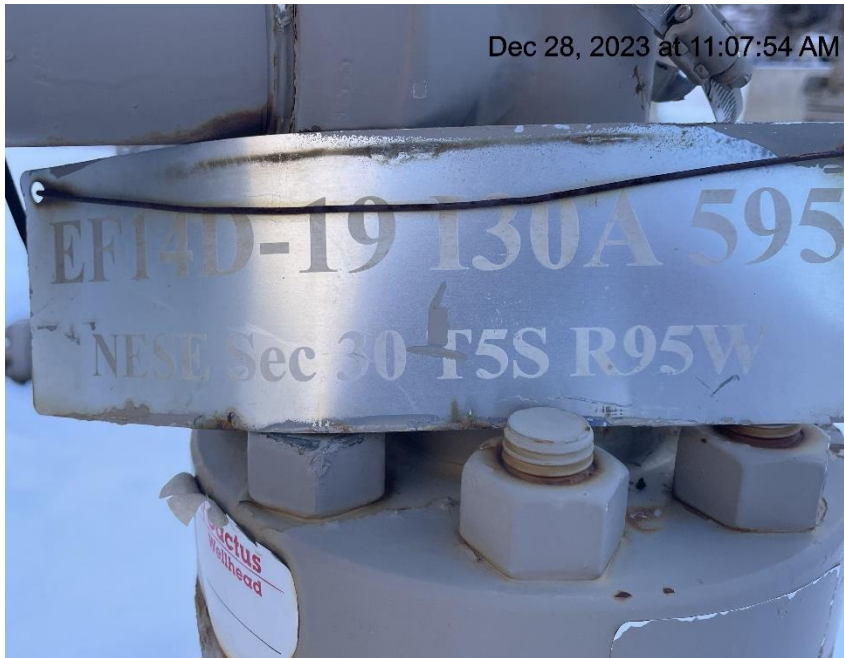
Photo # 1070 Wellhead signs lack required information

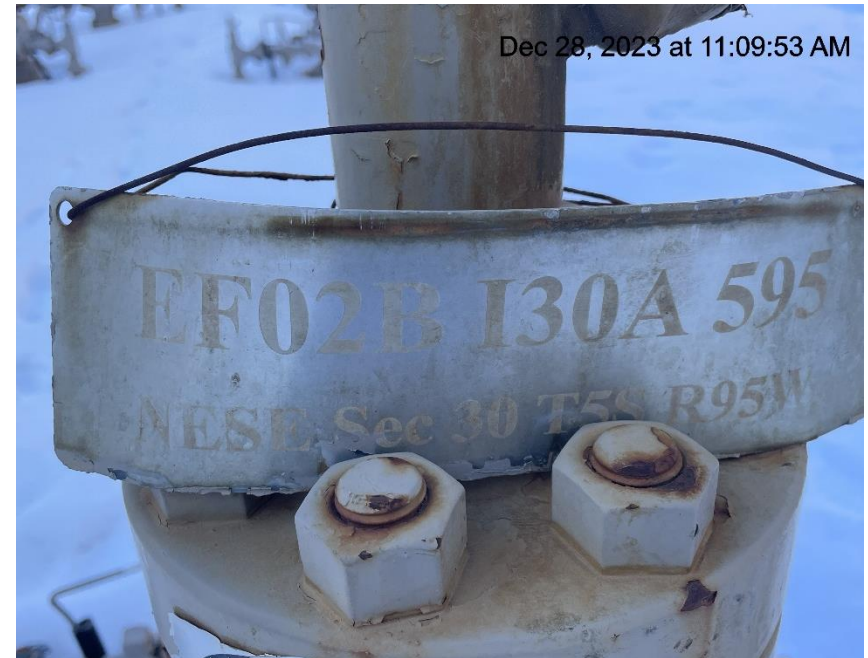
Photo # 1071 Wellhead signs lack required information

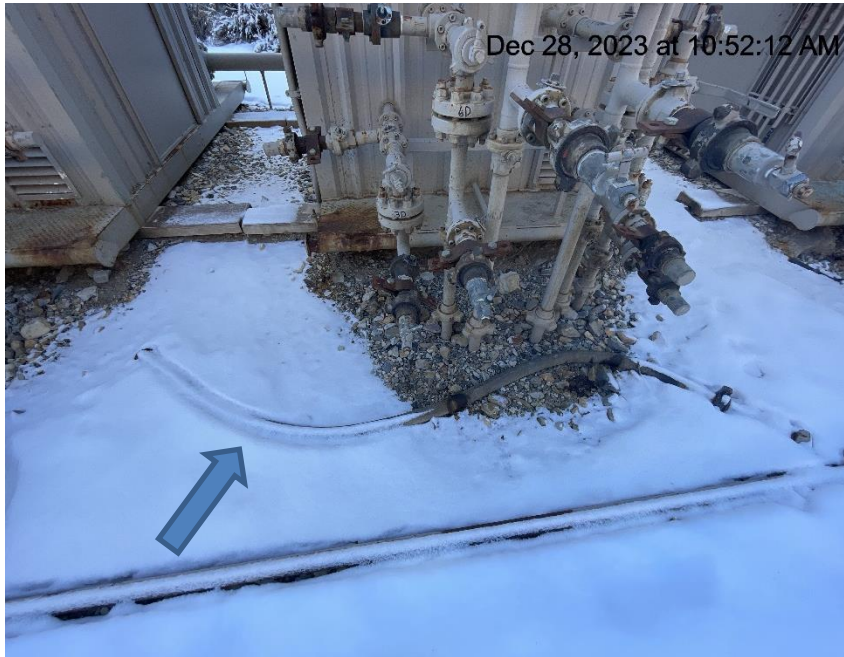
Photo # 1072 Debris

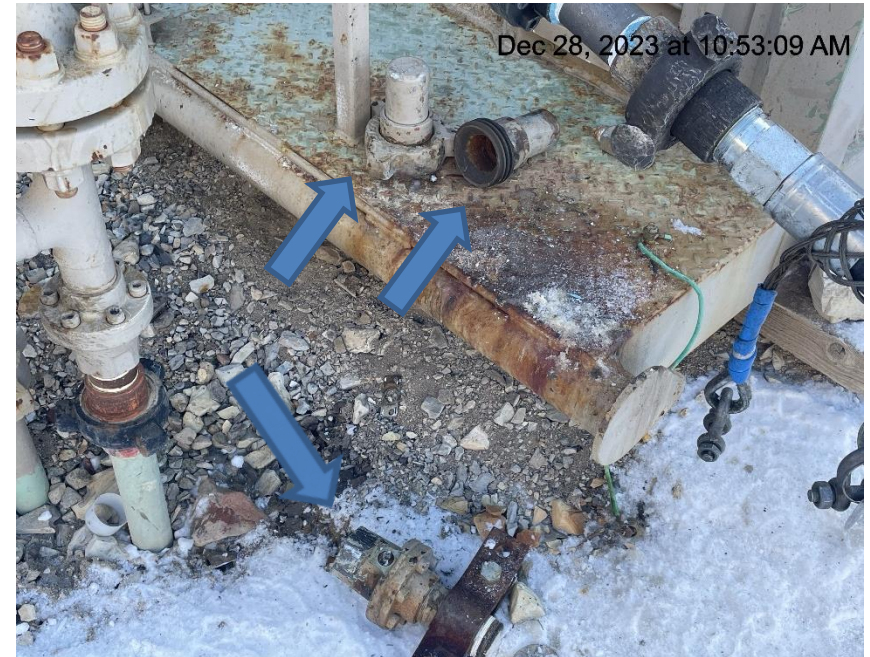
Photo # 1073 Debris

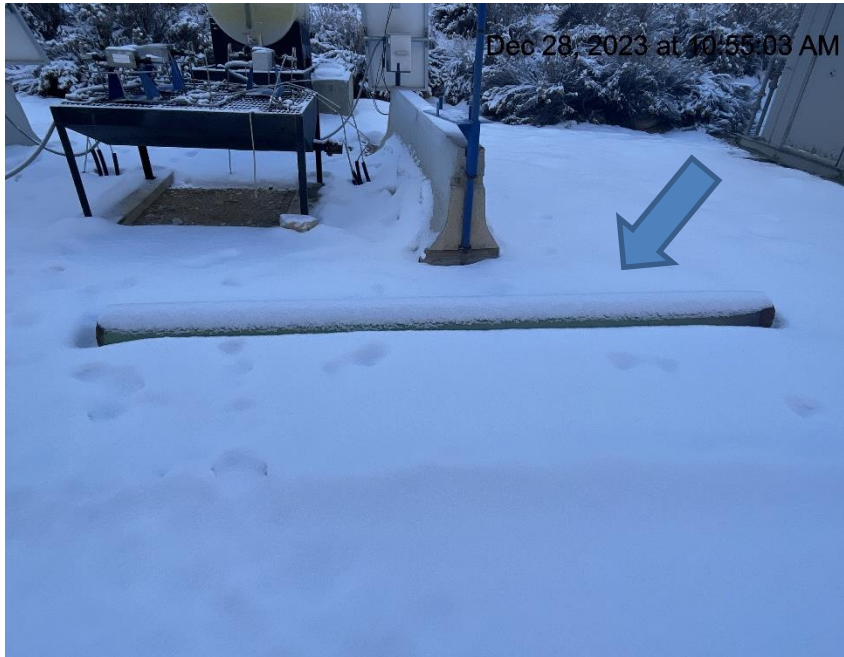
Photo # 1074 Debris

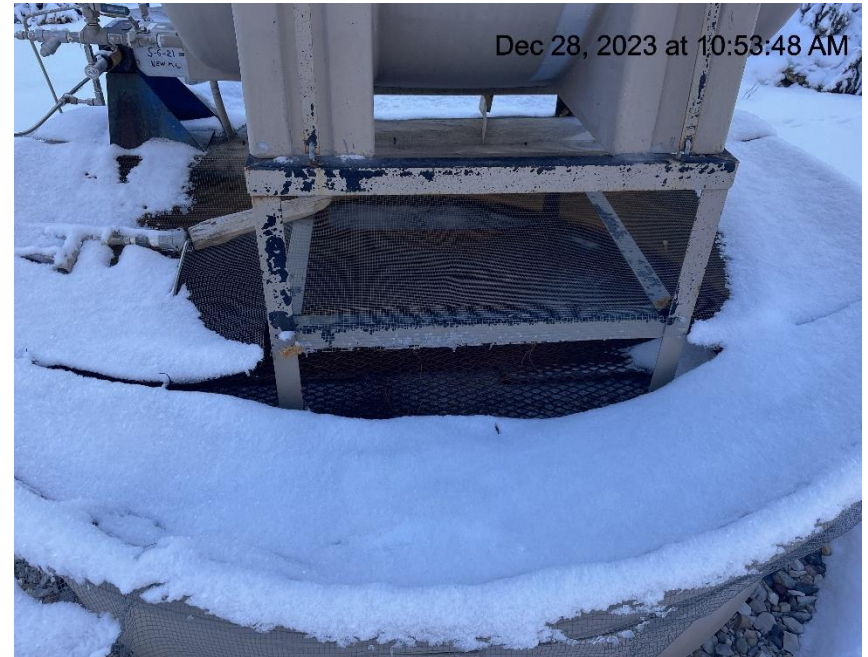
Photo # 1075 Wildlife protection on chemical tank containment needs maintenance

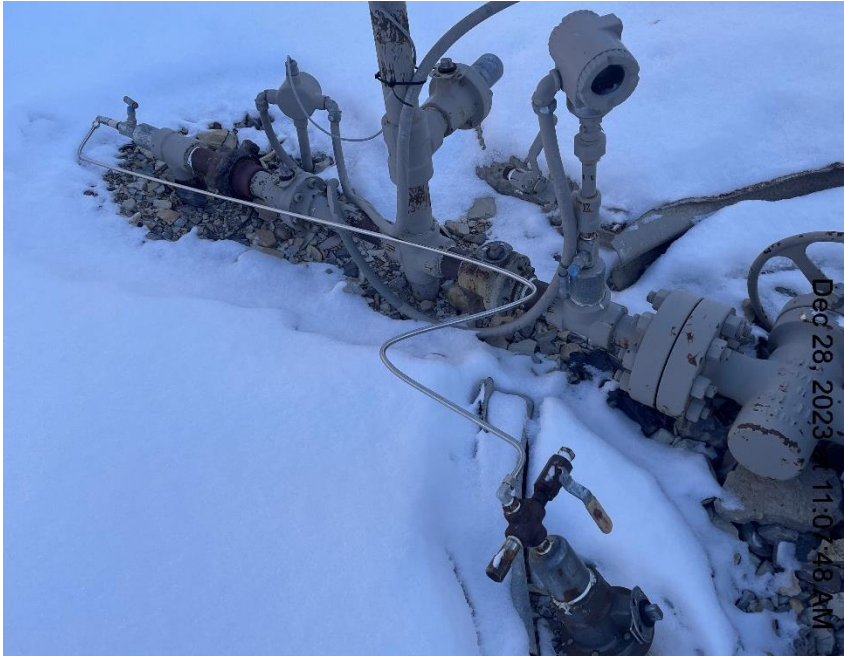
Photo # 1076 EF14D-19 well bradenhead line connected to flowline/no FORM 4 Sundry
