Construction and Stormwater Inspection

Date: 12/28/2023

Operator: BISON IV OPERATING LLC - 10670

Location ID: 485658

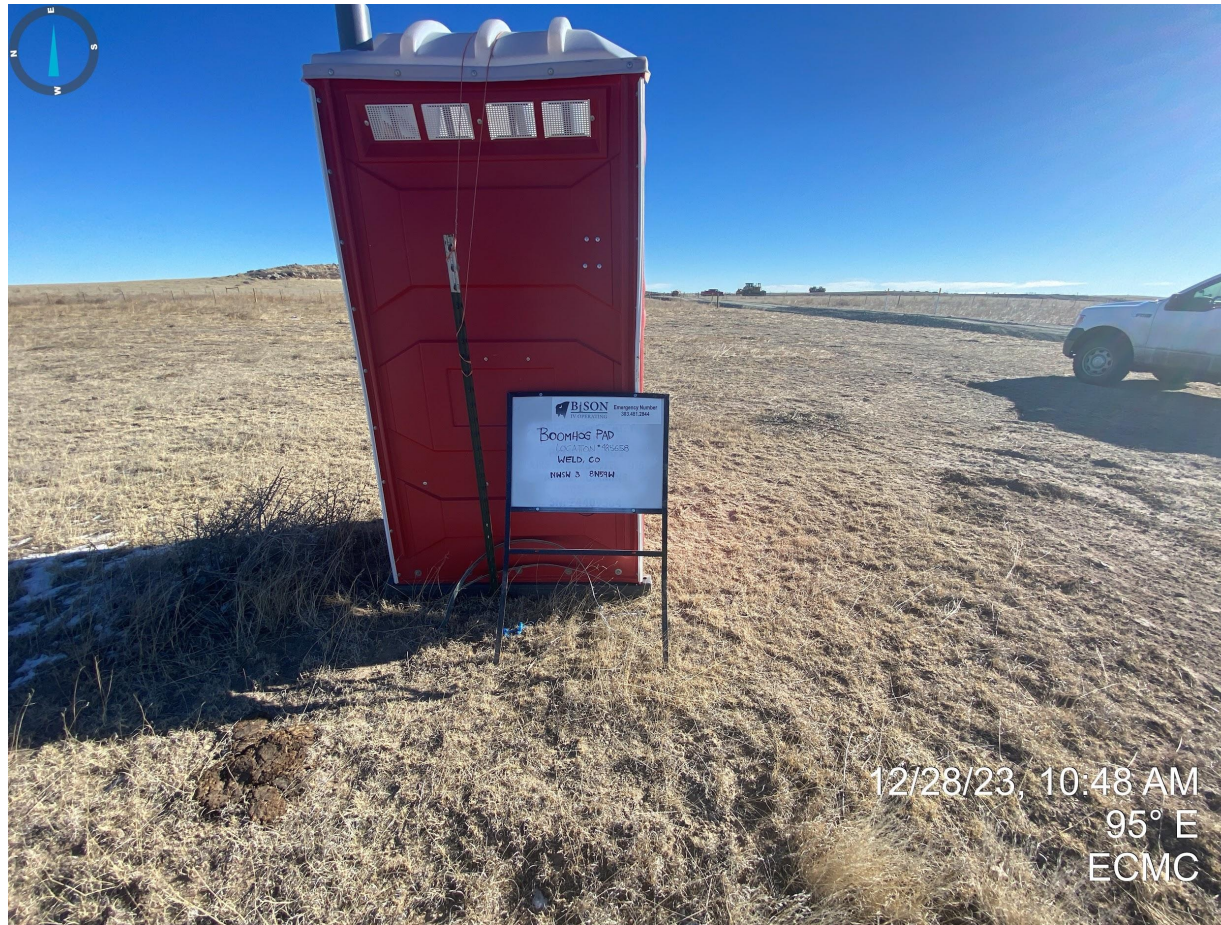
Photo 1. Location sign has been posted at the intersection of the access road and adjacent county road, in compliance with Rule 605.a.

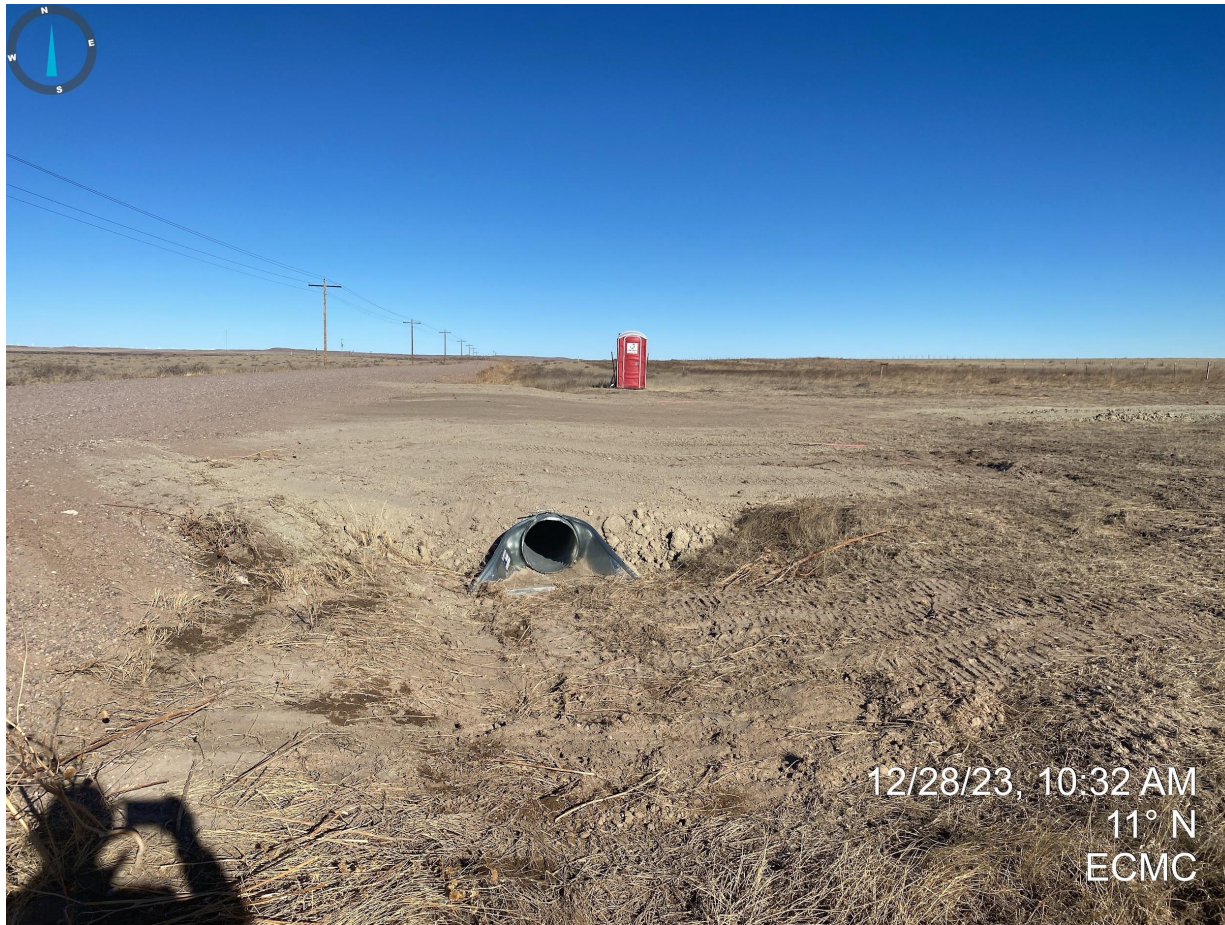
Photo 2. Taken from the county road near the location entrance. A culvert has been installed in the bar ditch.

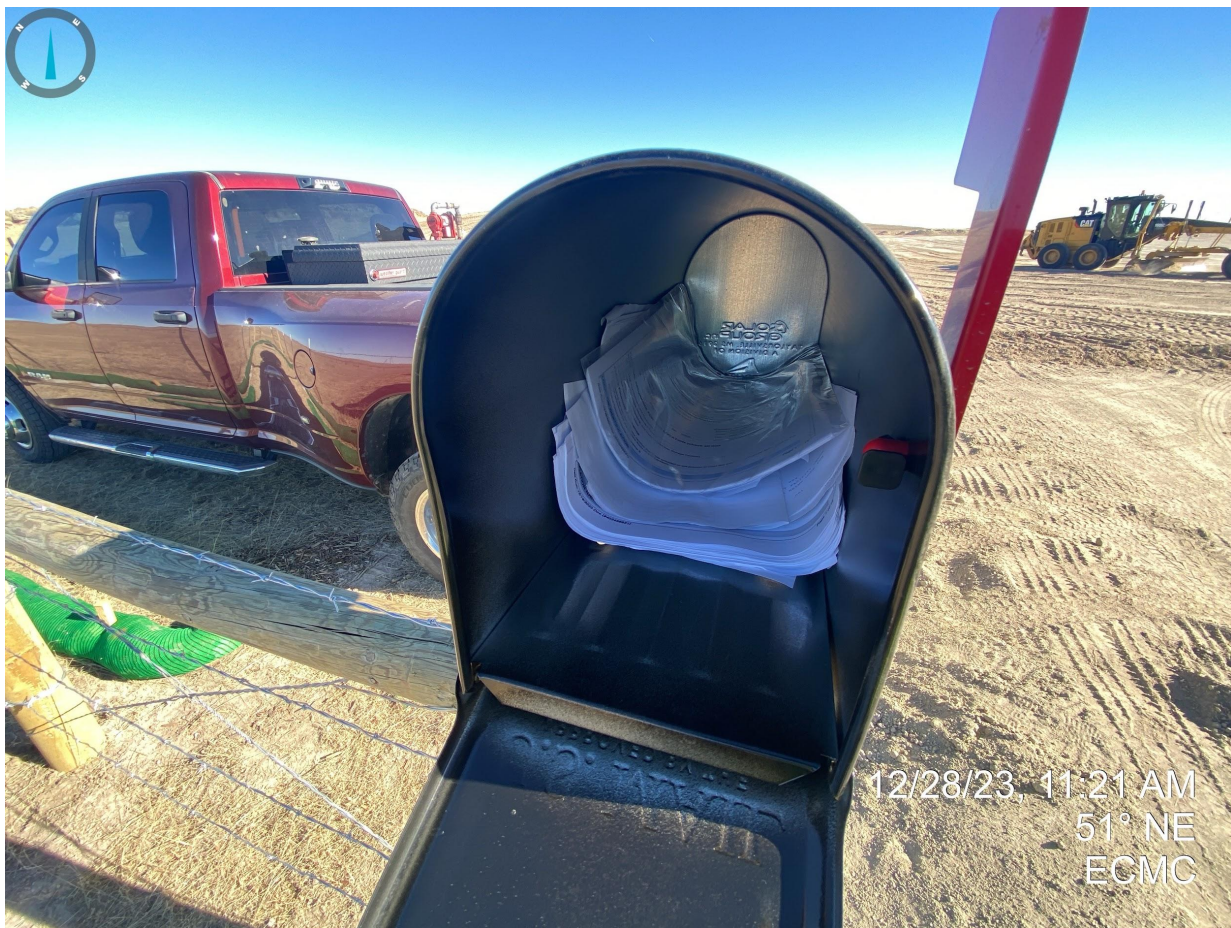
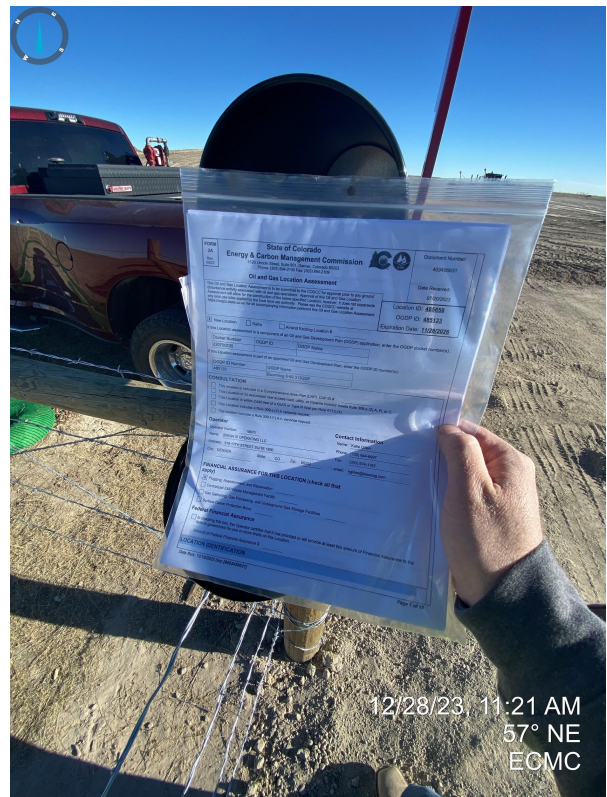
Photo 3. A copy of the approved Form 2A was posted on the location at the time of this inspection.

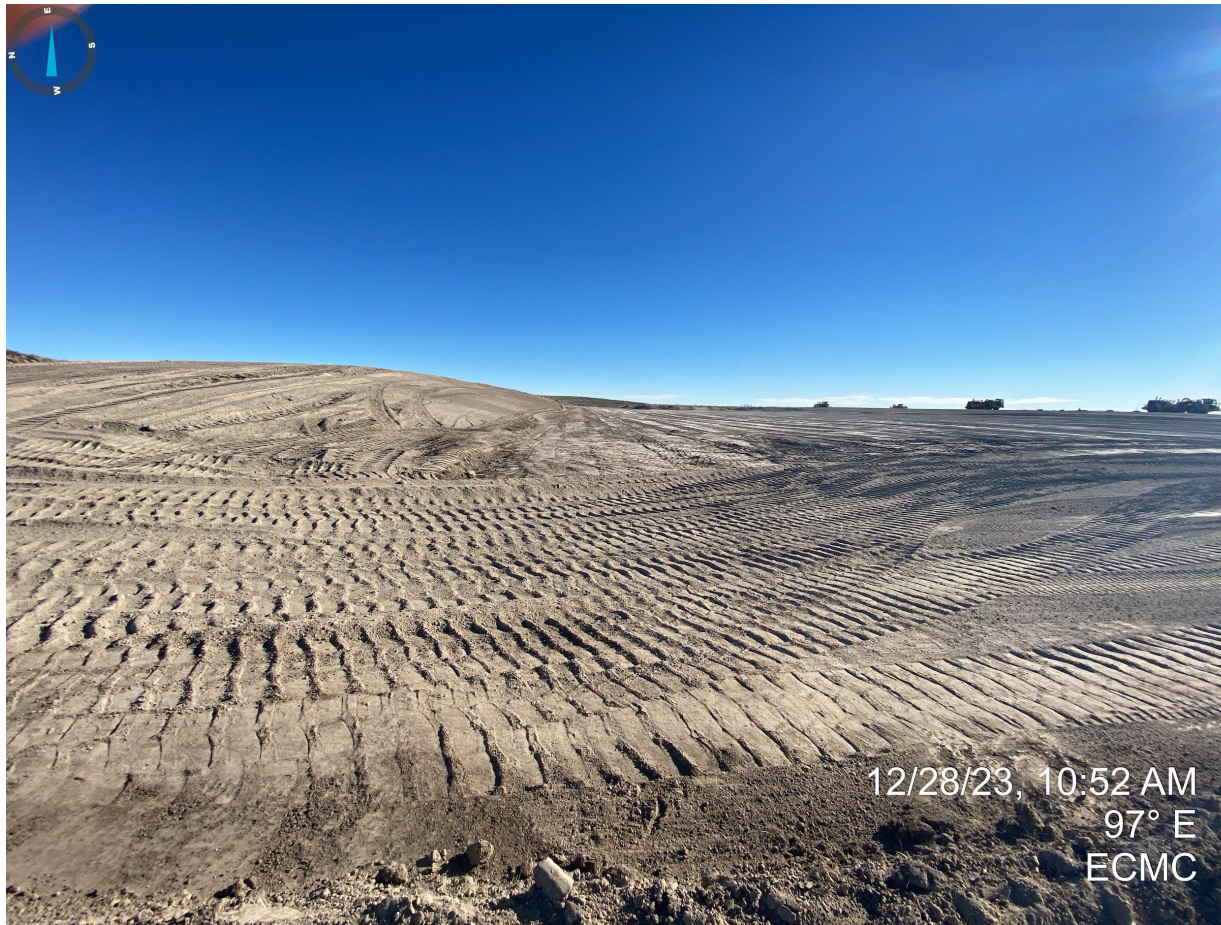
Photo 4. Taken near the northwest corner of the location. During this inspection, topsoil salvage operations were still ongoing, in addition to cut and fill activities. Topsoil stockpile pictured on left side of the picture.

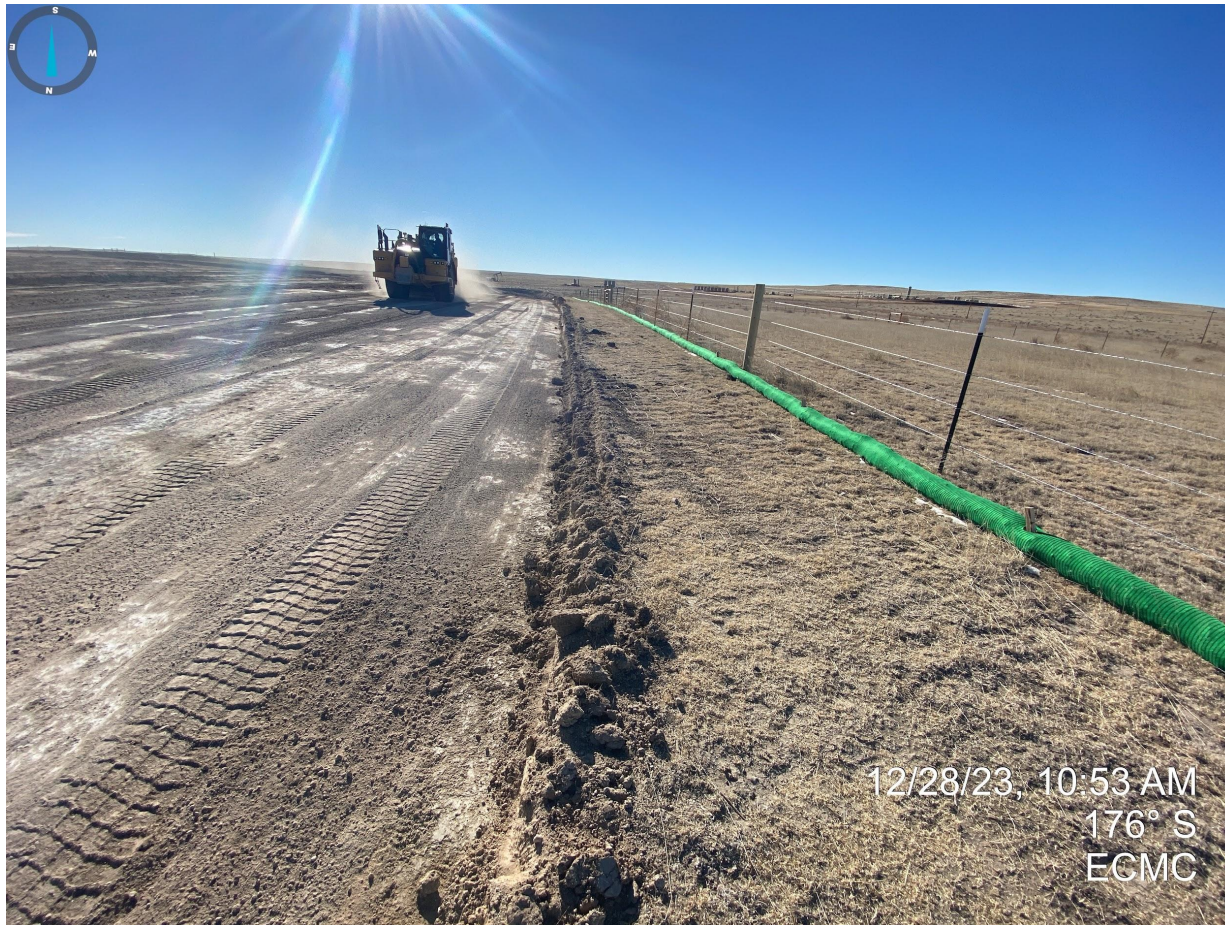
Photo 5. West side of location. Photo illustrates topsoil salvage activities are still ongoing at the time of this inspection.

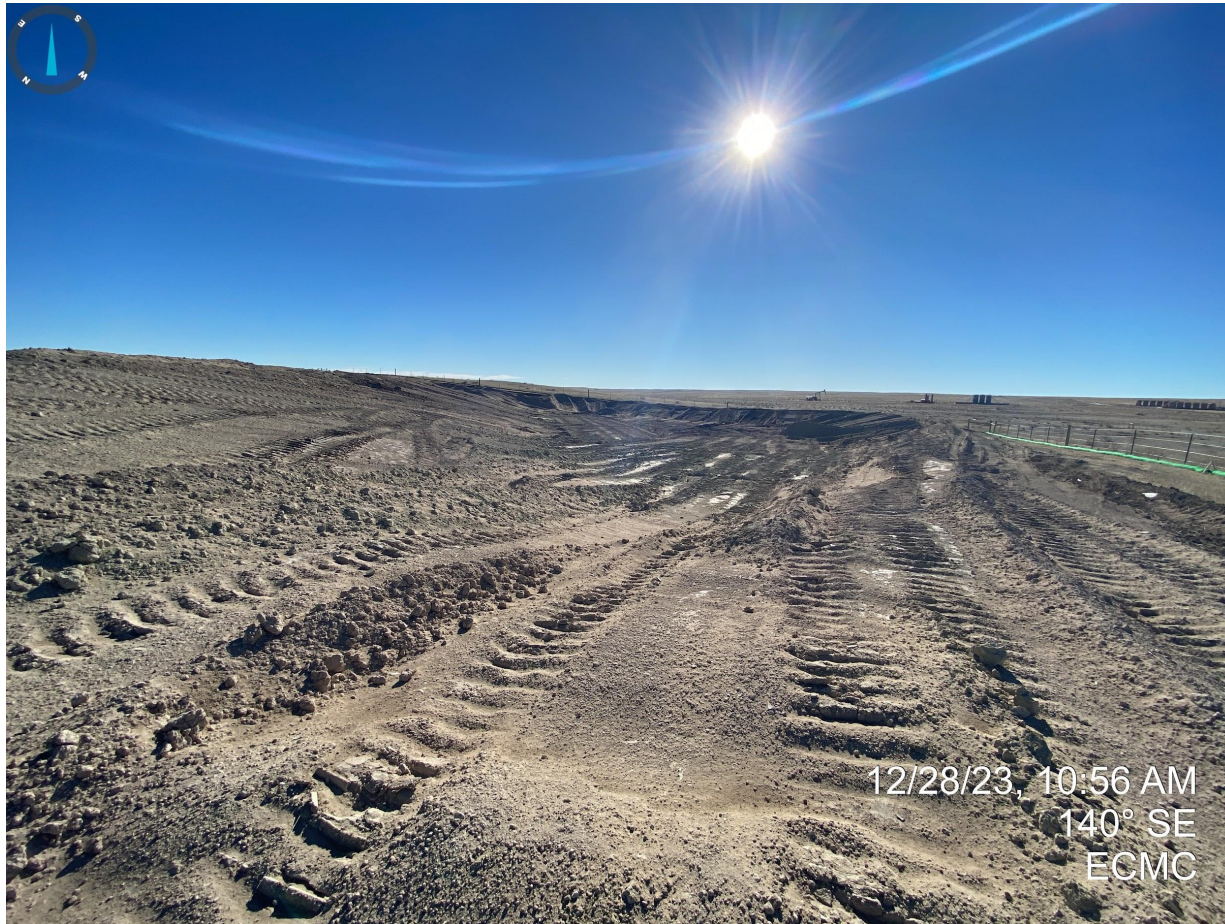
Photo 6. Taken from the southwest corner of the location. The sediment detention area is still in the process of being constructed.

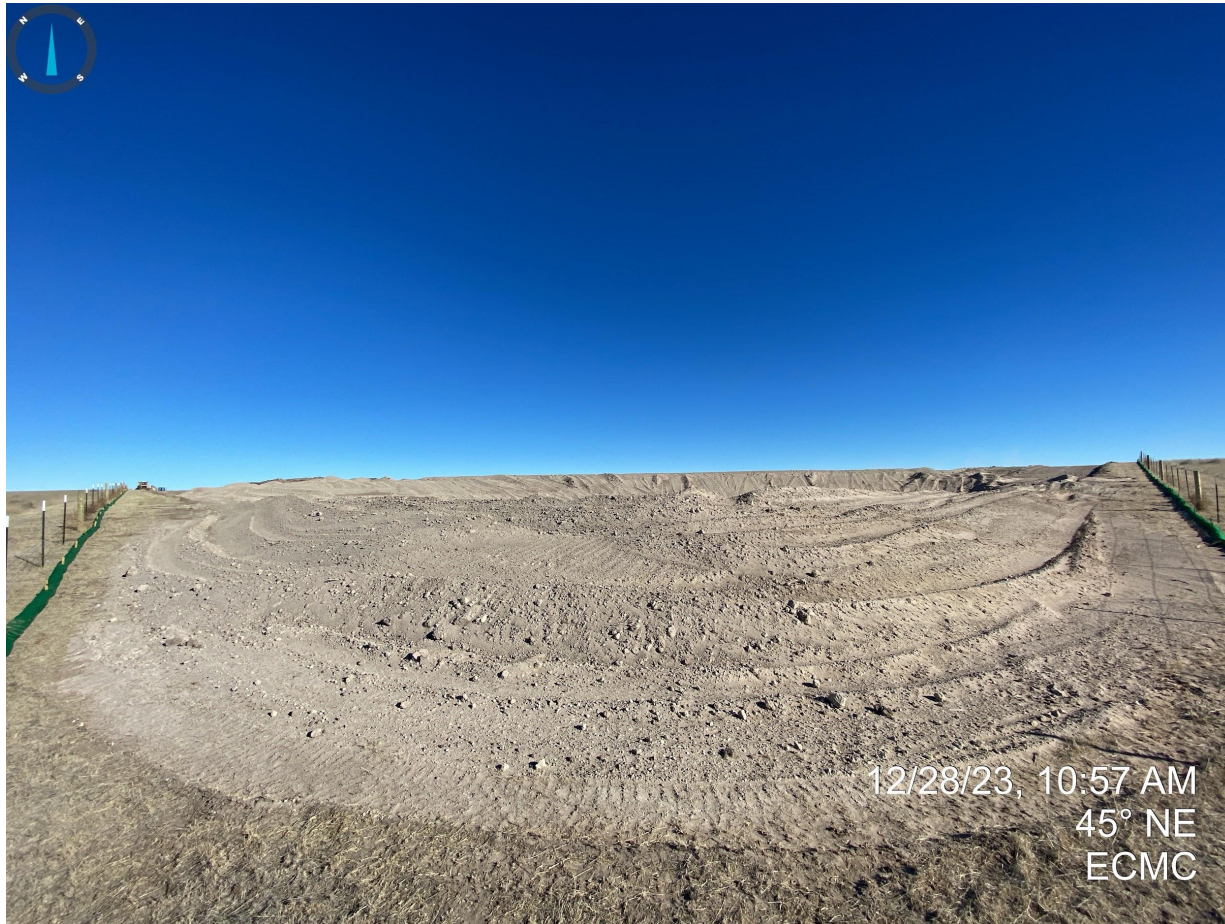
Photo 7. Taken from the southwest corner, looking towards the sediment detention area. See comments in Photo 6.

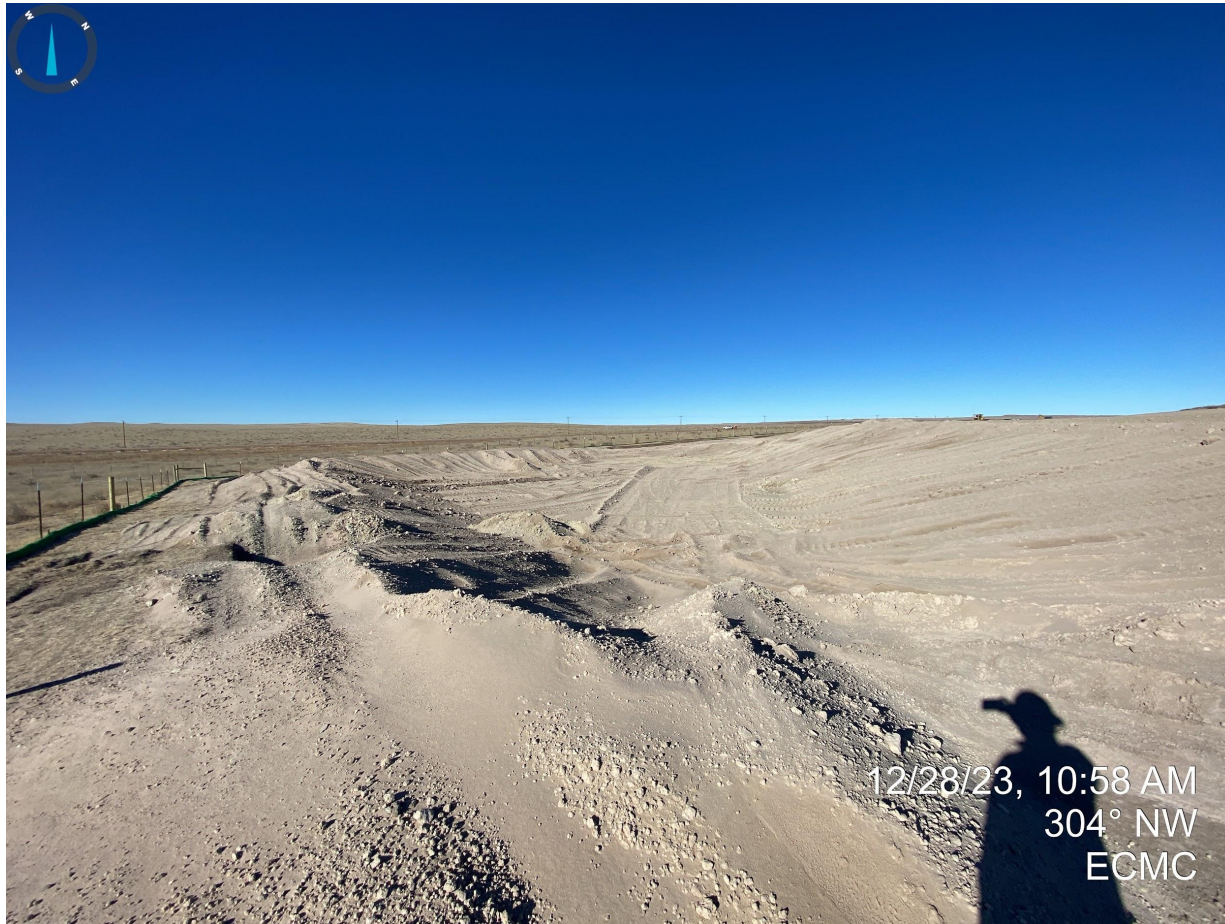
Photo 8. Taken near the southwest sediment detention area. See comments in Photo 6.

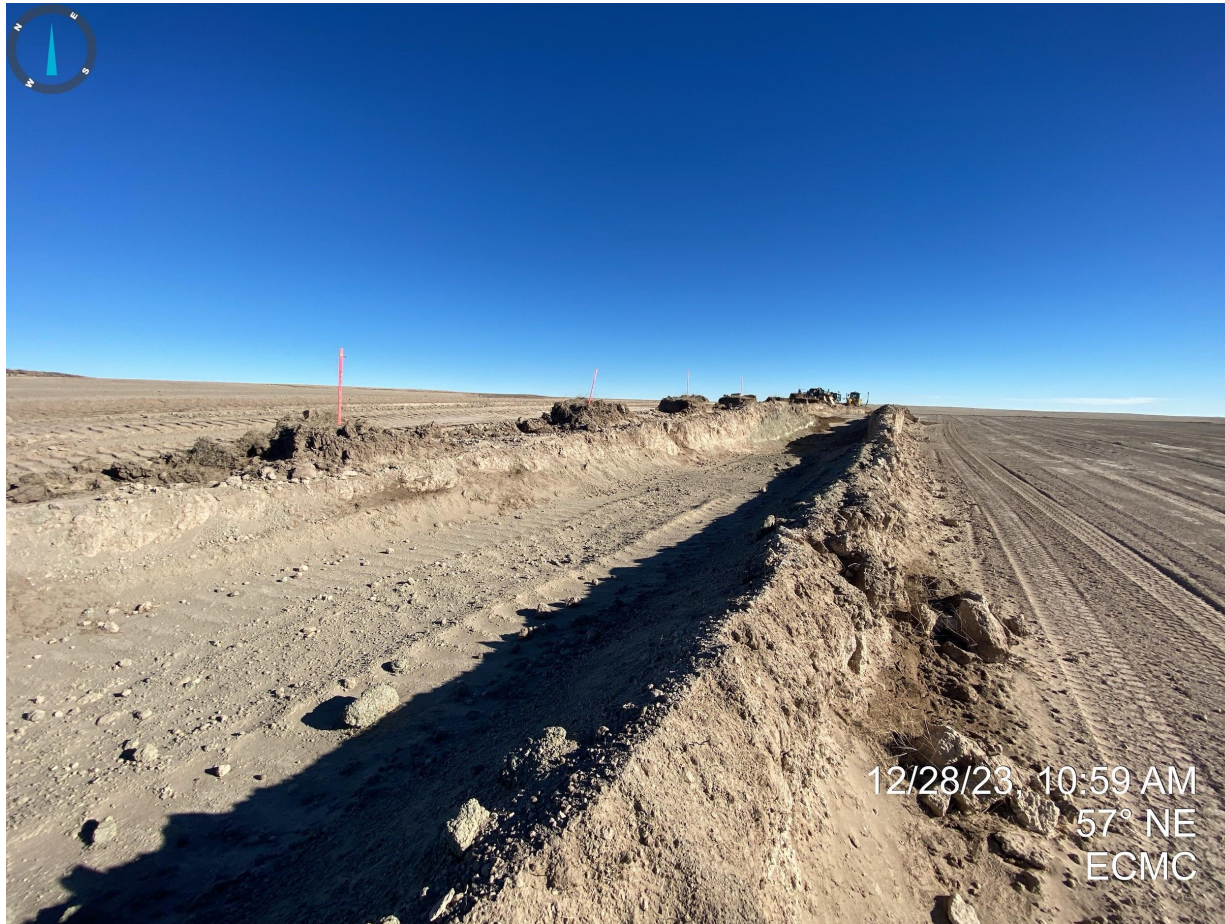
Photo 9. Taken from the center portion of the location; facing northeast. Photo illustrates cut and fill activities occurring near the proposed well locations.

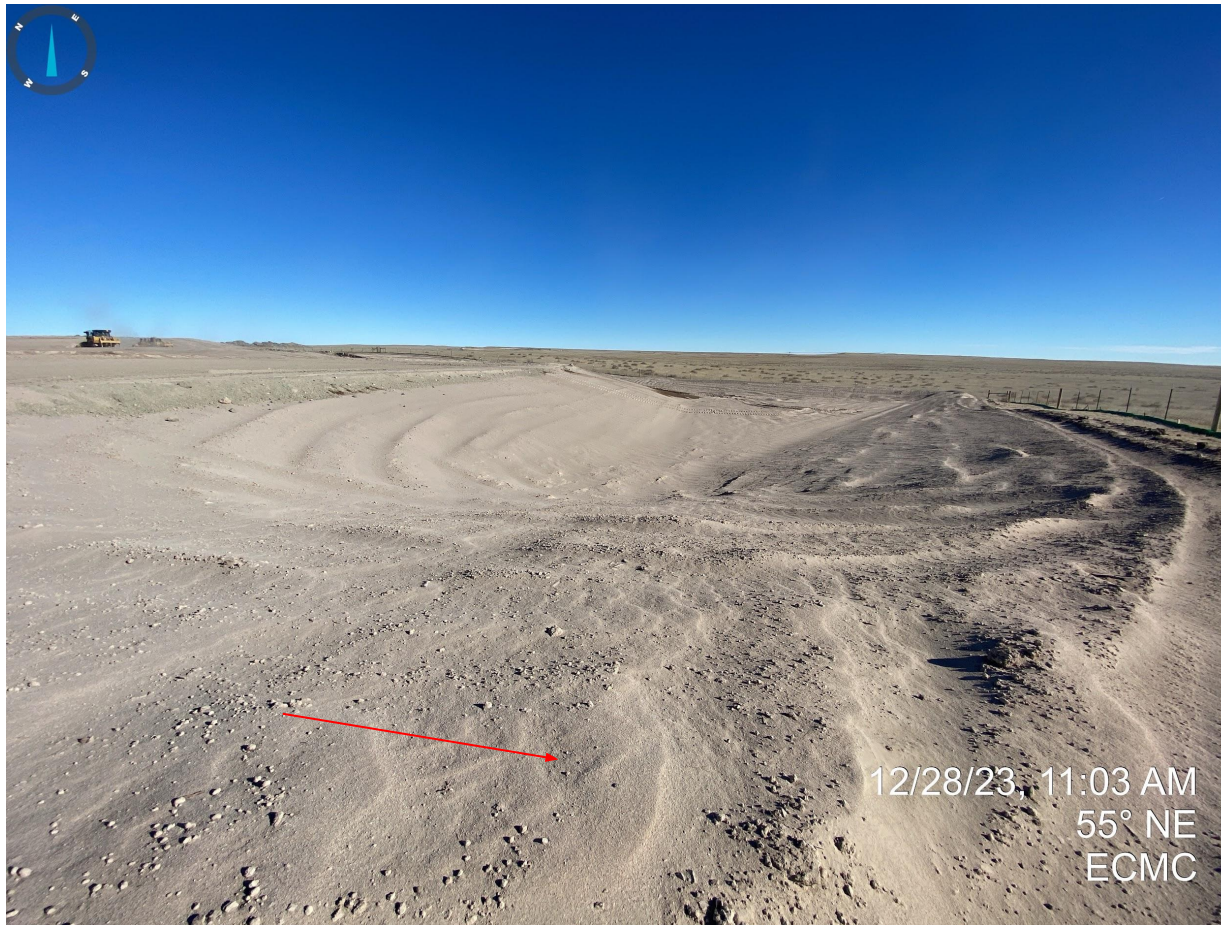
Photo 10. Taken near the southeast corner of the location, at the sediment detention area. Photo illustrates that the soils do not appear to be properly stabilized with no apparent temporary BMPs to prevent wind and water erosion. Arrow indicates evidence of wind blown sediment deposition.

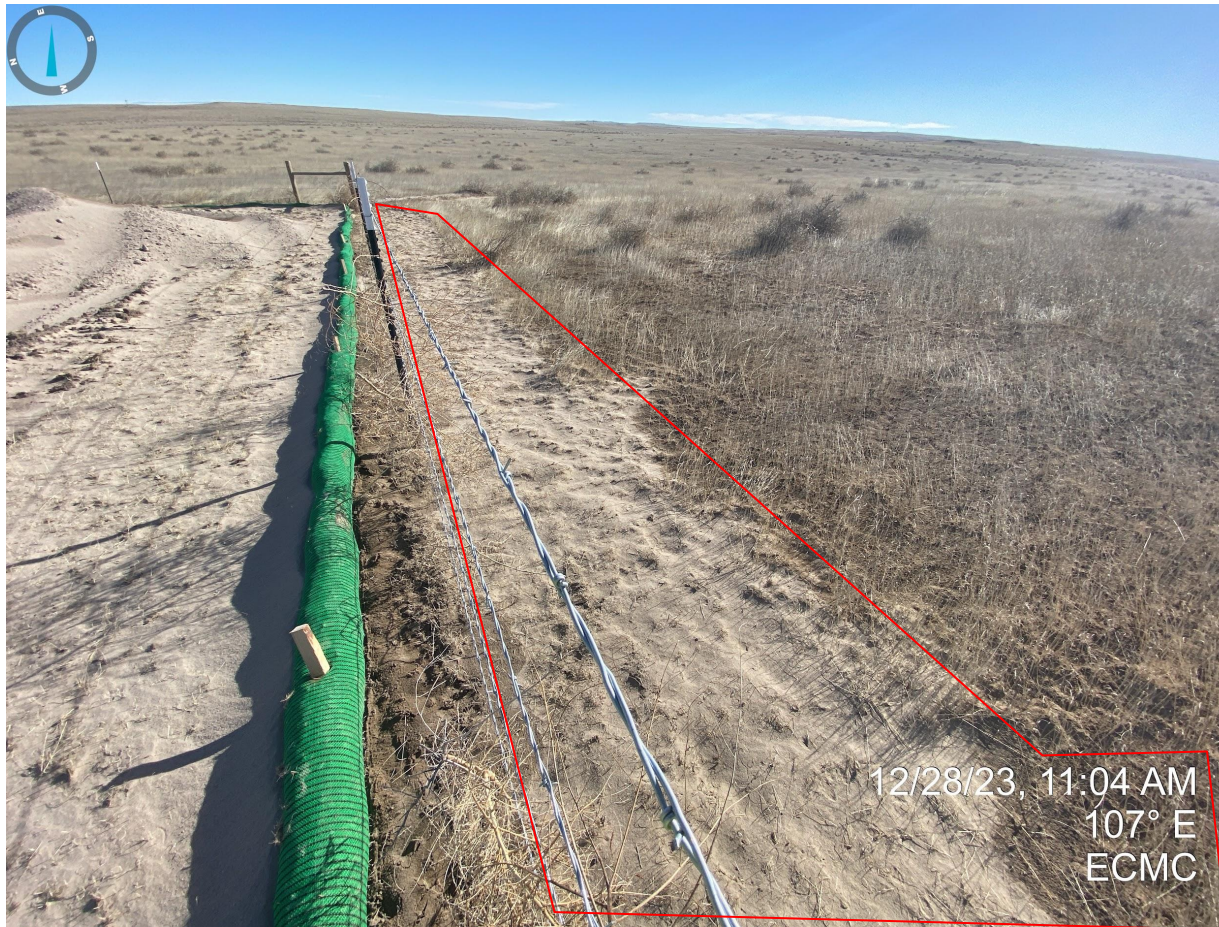
Photo 11. Taken near the southeast corner of the location, near the sediment detention area. Photo illustrates evidence of blow sand occurring outside of the fenced disturbance area, indicating that soils are not properly stabilized.

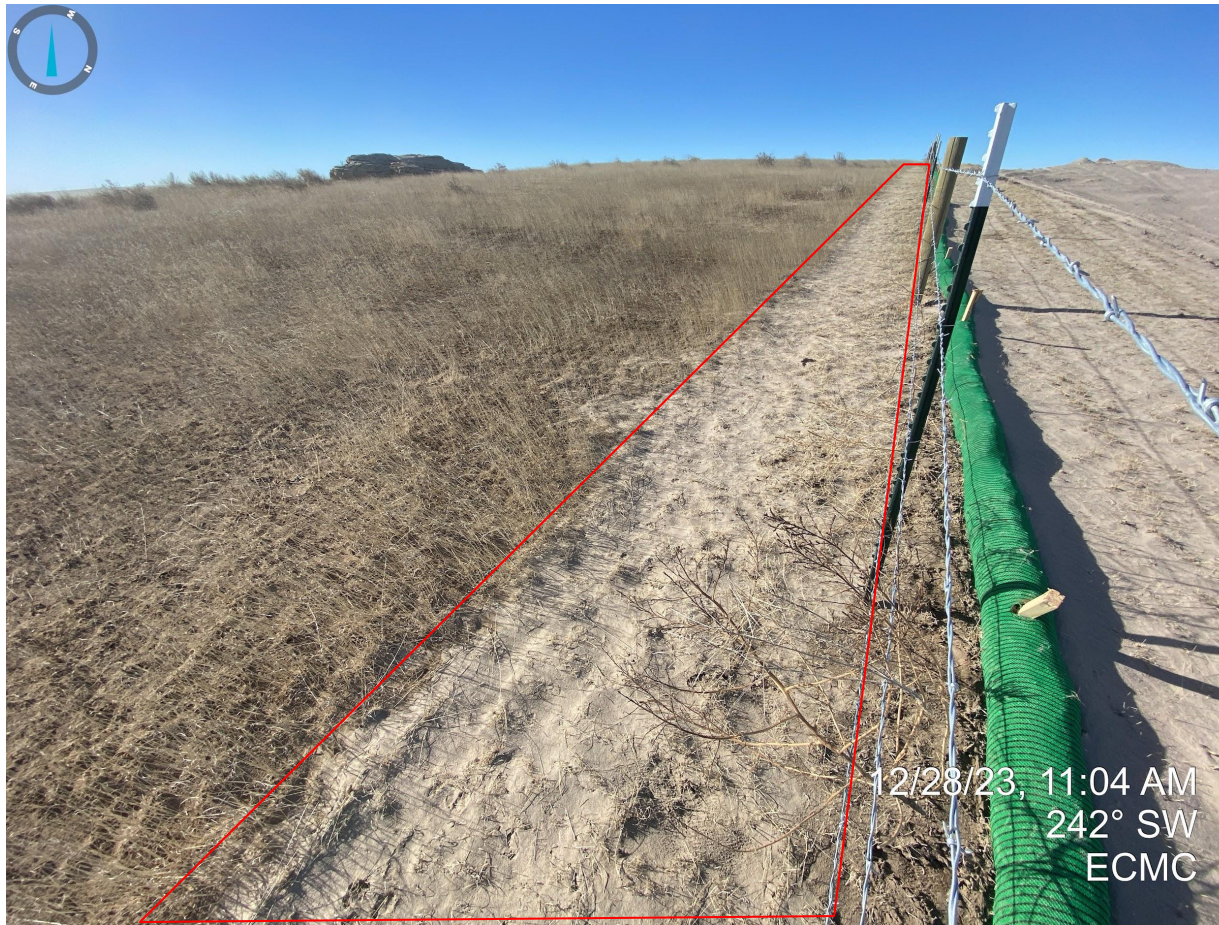
Photo 12. Facing southwest; see comments in Photo 11.

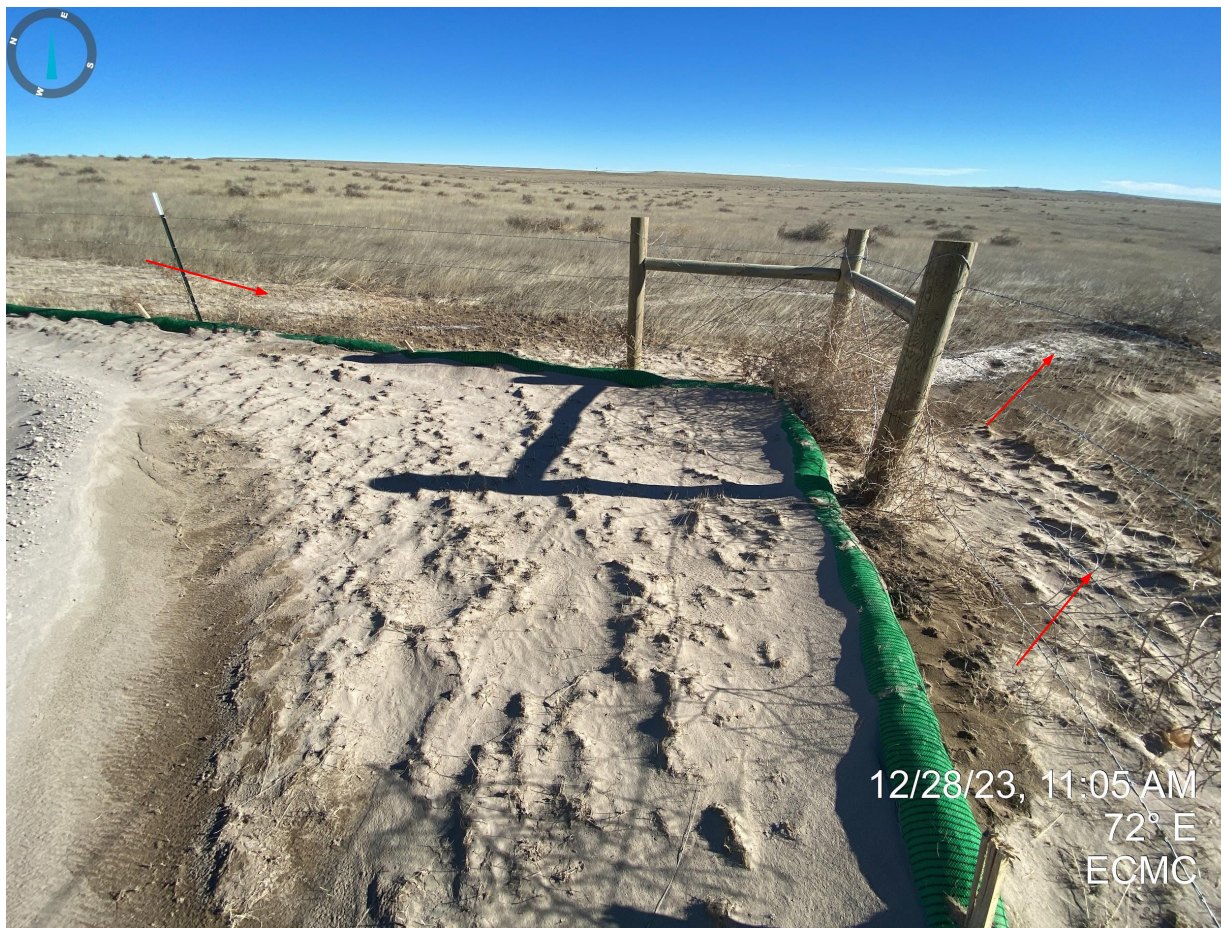
Photo 13. Facing the southeast corner of the location. Temporary stormwater control measures (e.g. filtrexx) are beginning to fill with sediment and require maintenance. Also pictured, blown sand outside of the disturbance area (red arrows).

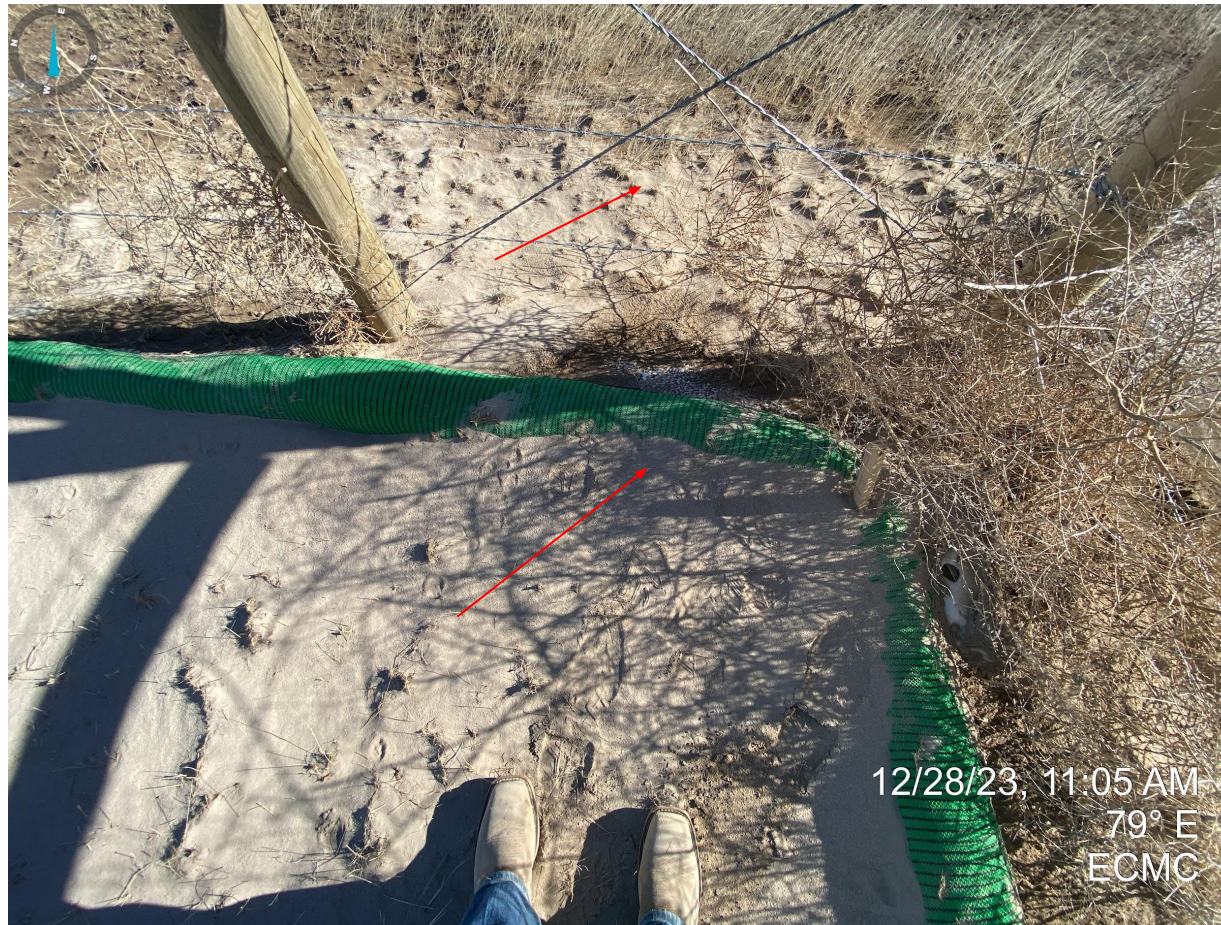
Photo 14. See comments in Photo 13.

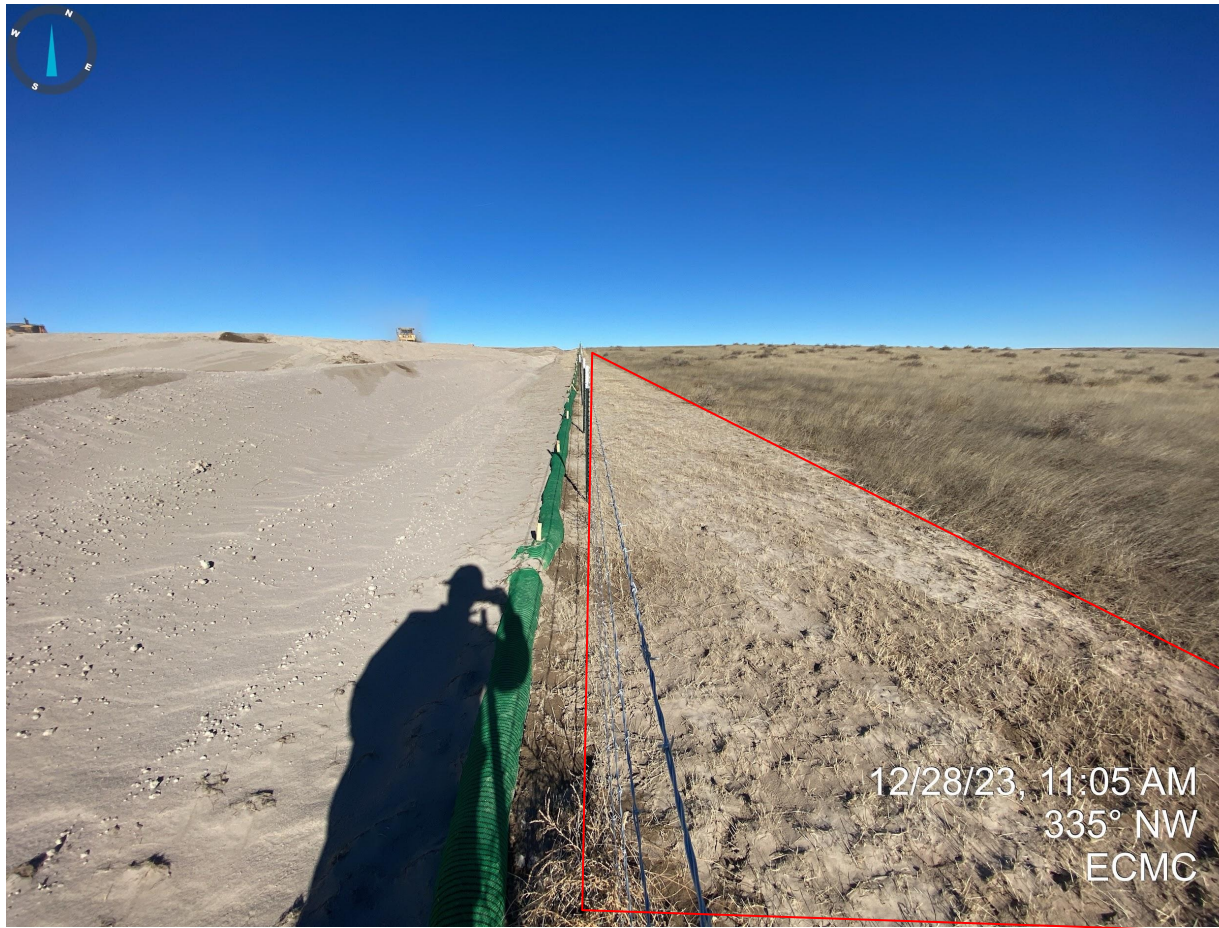
Photo 15. Taken from the southeast corner, facing northwest. Photo illustrates blow sand originating from the unstabilized soils of the construction area.

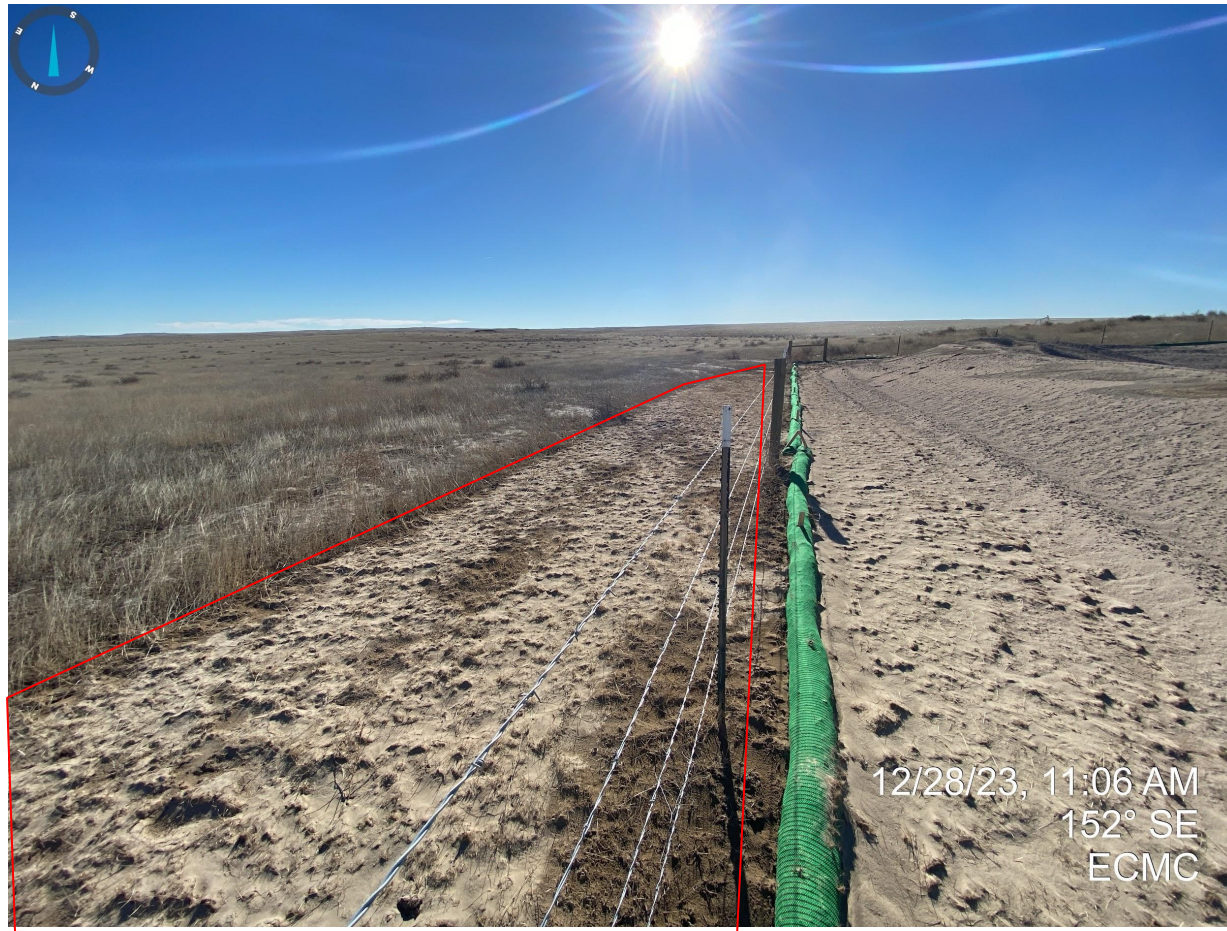
Photo 16. Continued from Photo 15, facing southeast.

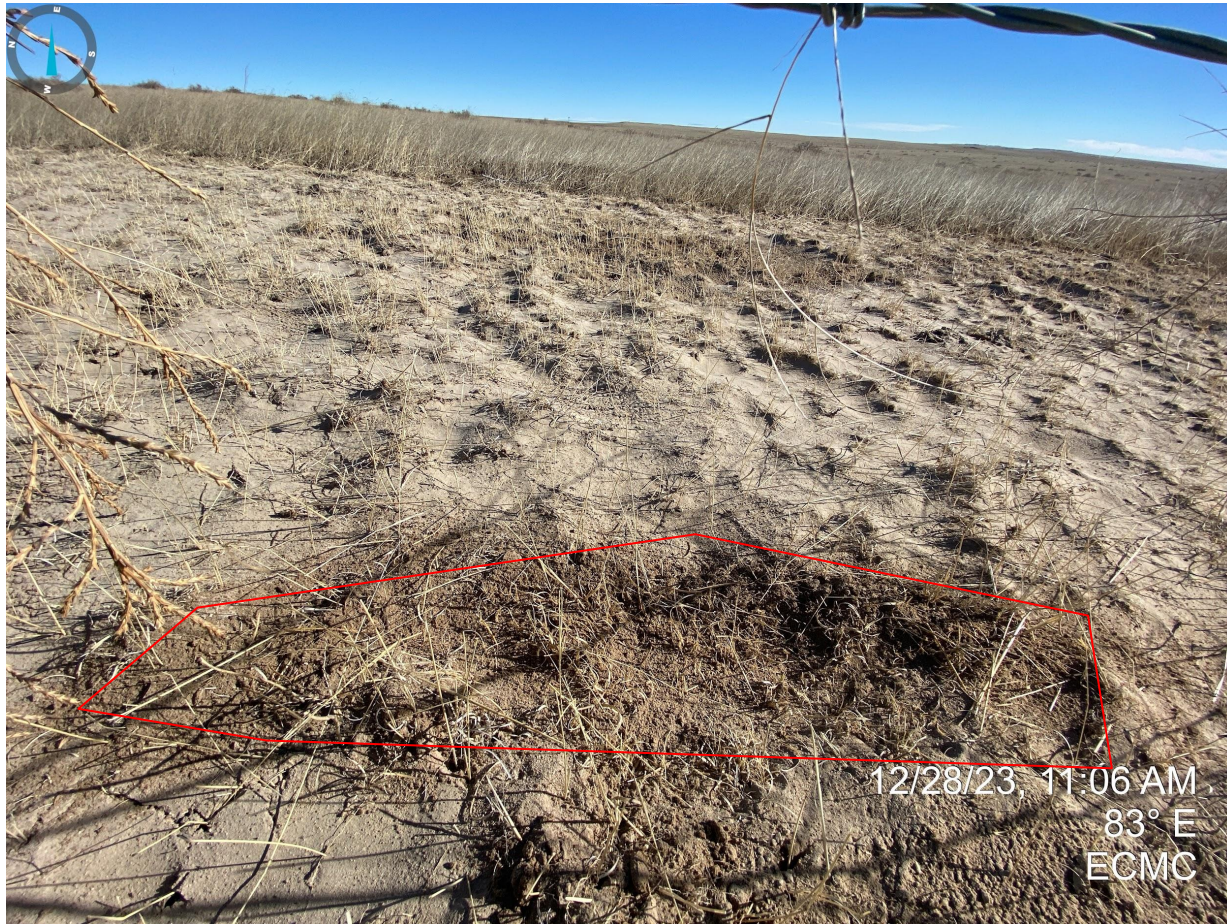
Photo 17. Close up photo of blow sand deposition outside of the disturbance area. Area outlined in red was uncovered to show undisturbed vegetation covered by blow sand.

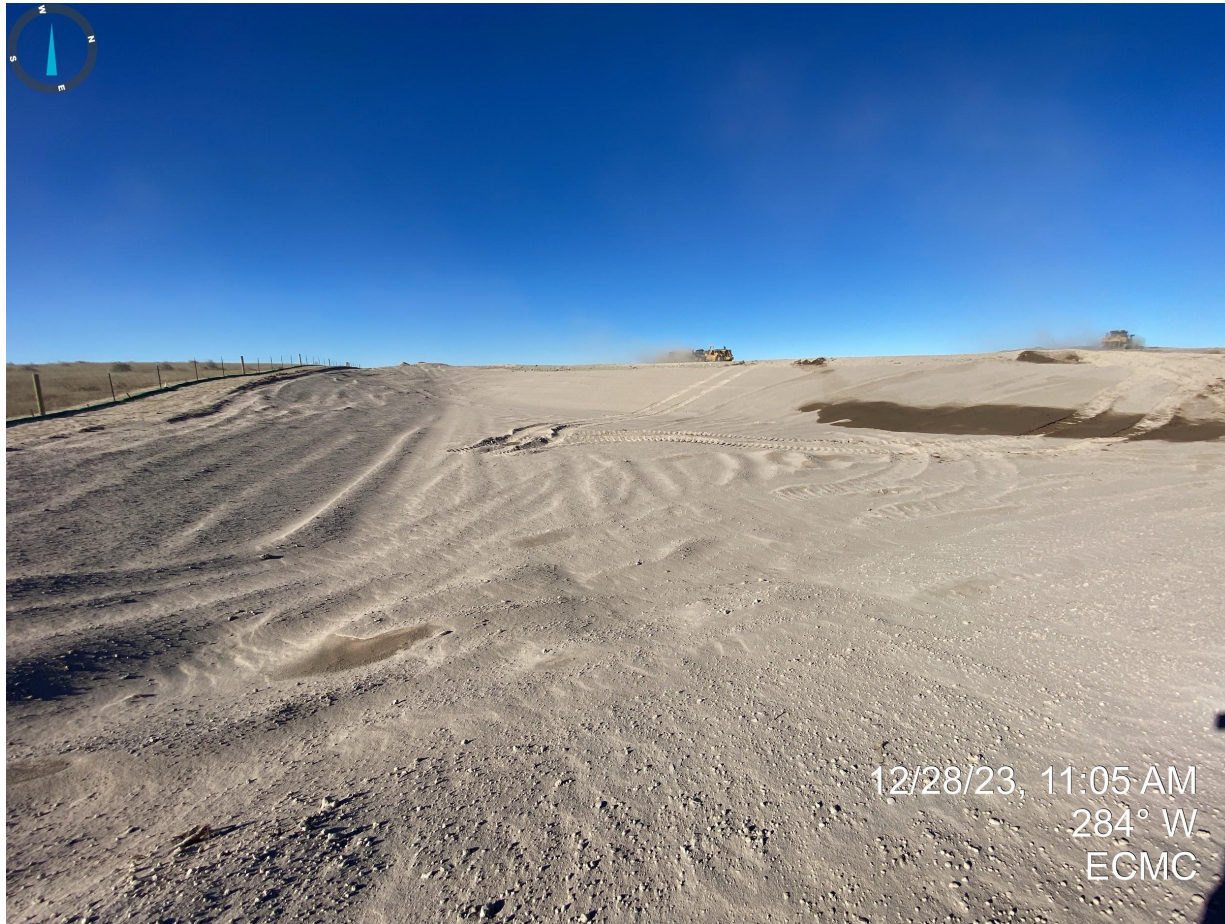
Photo 18. Taken from the southeast corner, looking towards the sediment detention area.

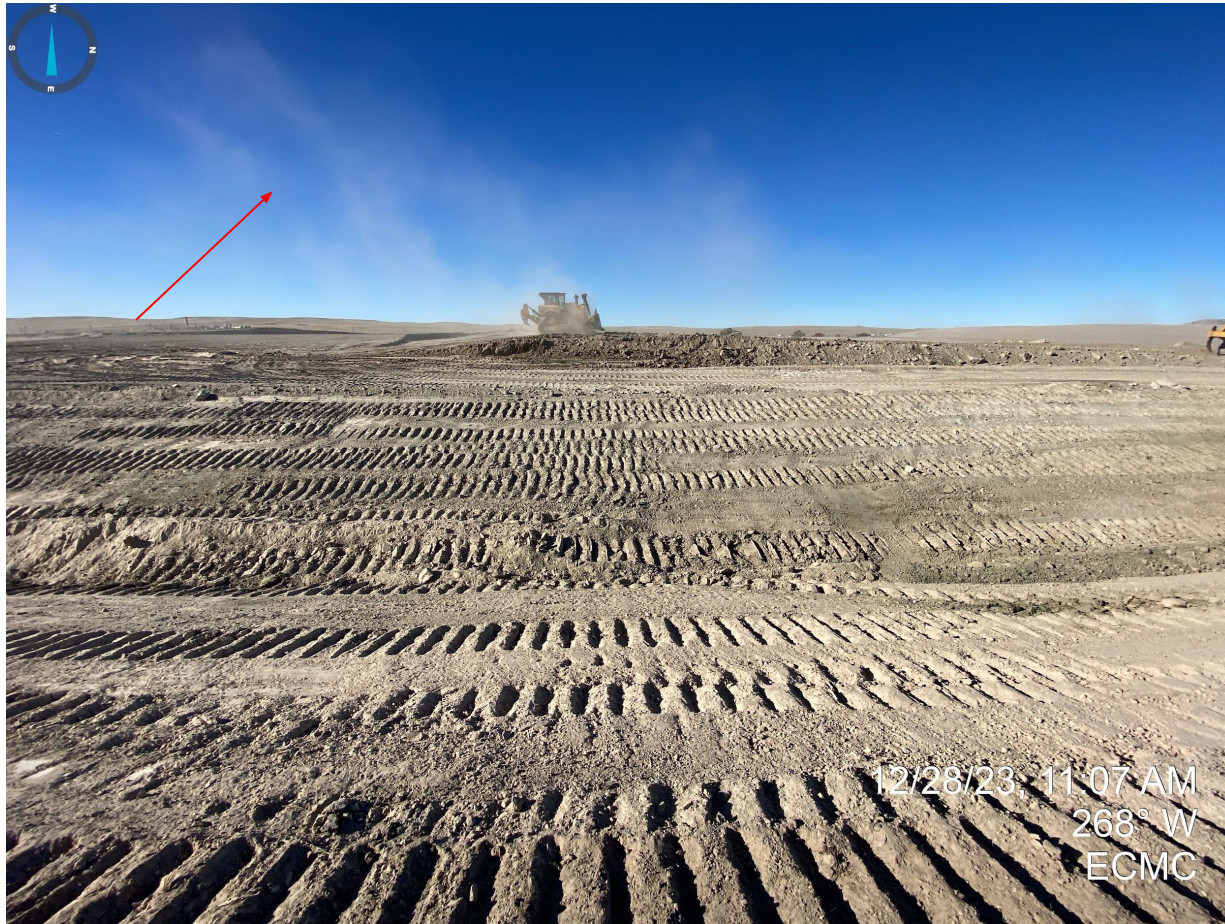
Photo 19. Photo illustrates fugitive dust occurring from dirt work activities. There were no dust suppression BMPs observed during this inspection.
