Construction and Stormwater Inspection

Date: 12/28/2023

Operator: BISON IV OPERATING LLC - 10670

Location ID: 485658

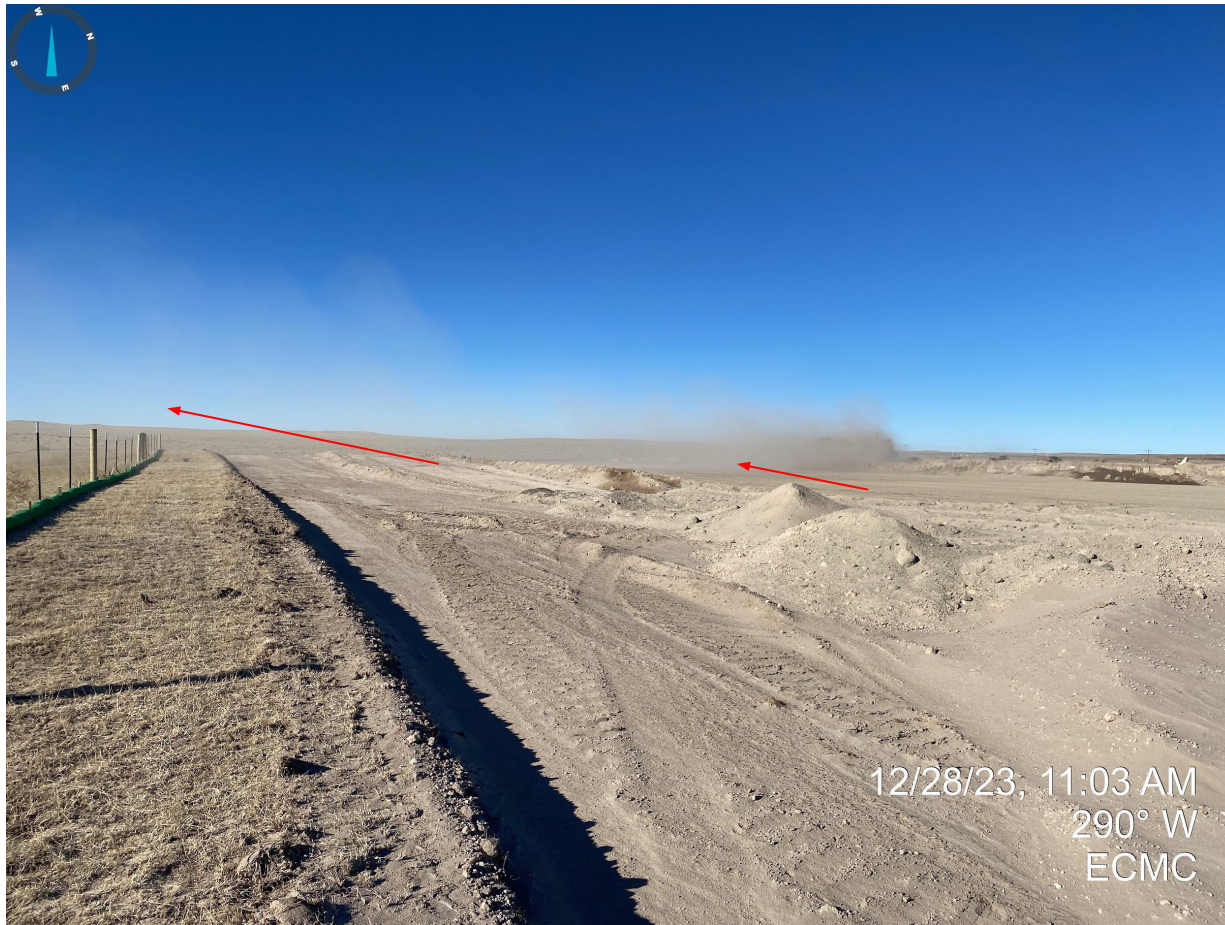
Photo 19. Photo illustrates fugitive dust occurring from dirt work activities. There were no dust suppression BMPs observed during this inspection.

Photo 20. Taken from the southern portion of the construction area; fugitive dust was observed to be blowing off location. See also, comments in Photo 19.

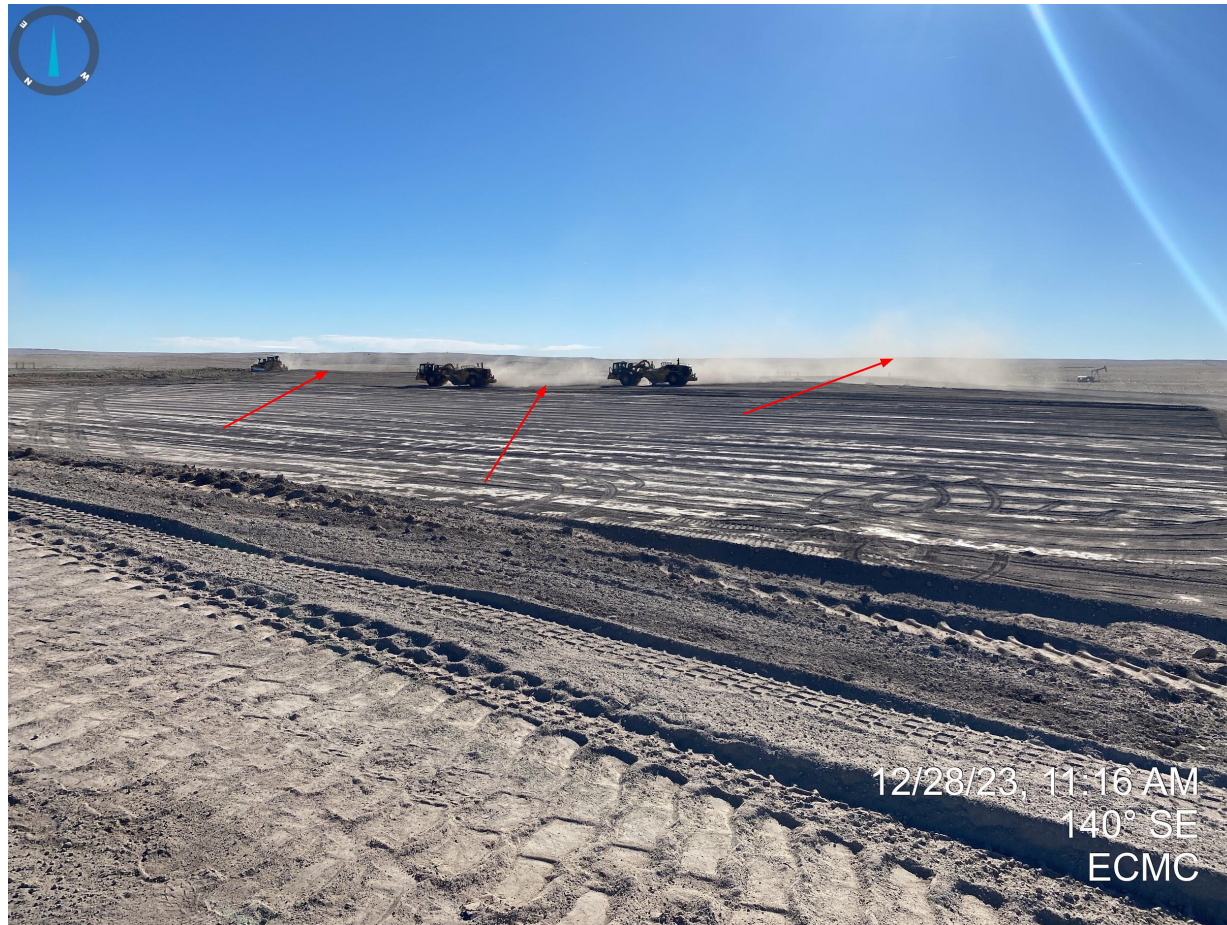
Photo 21. Taken from the northern portion of the location. See comments in Photo 19.

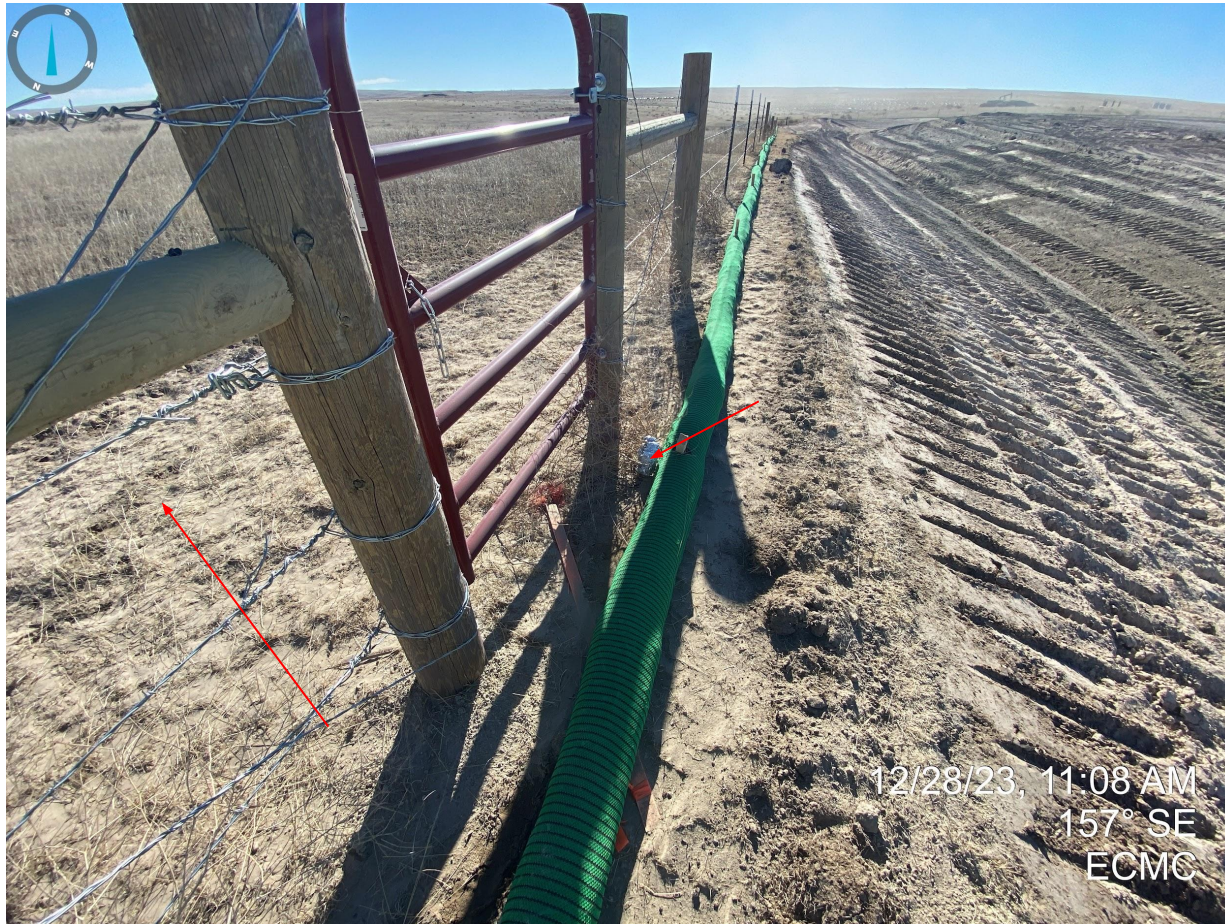
Photo 22. Taken from the eastern side of the construction area. Trash and blown sand illustrated by red arrows.

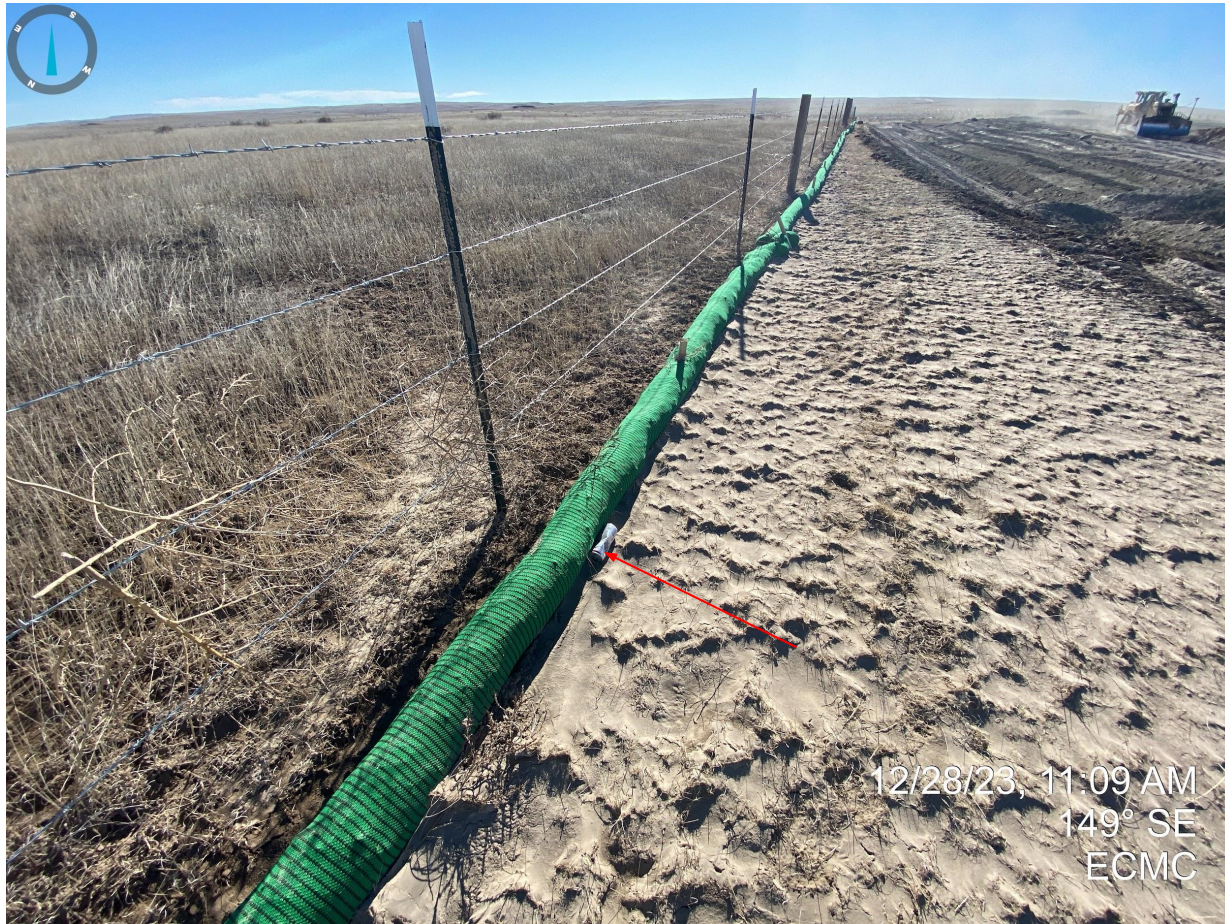
Photo 23. Example of trash on the eastern side of the construction area.

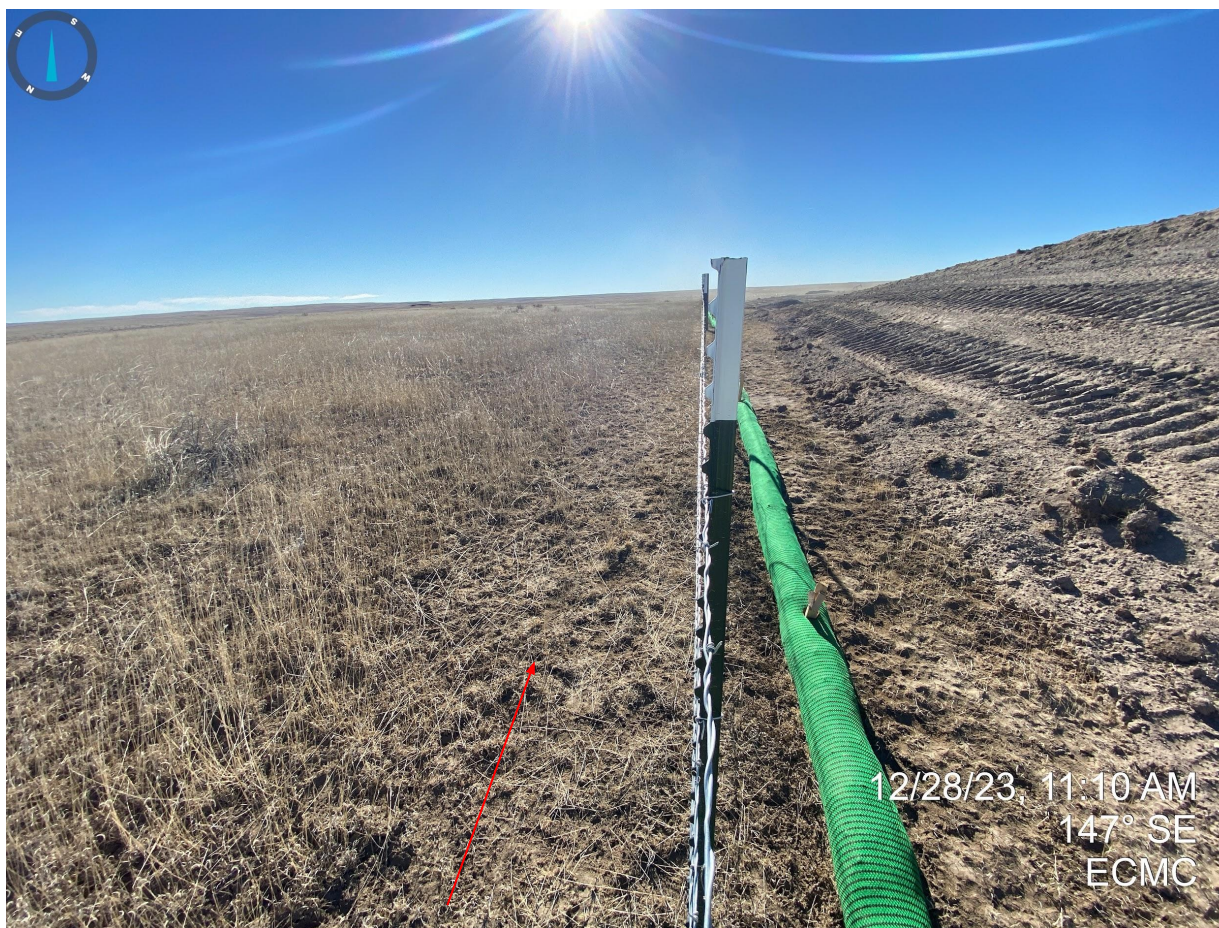
Photo 24. Taken near the northeast corner of the location, near the topsoil stockpile. Photo illustrates that this portion of the construction area is not experiencing evidence of blow sand.

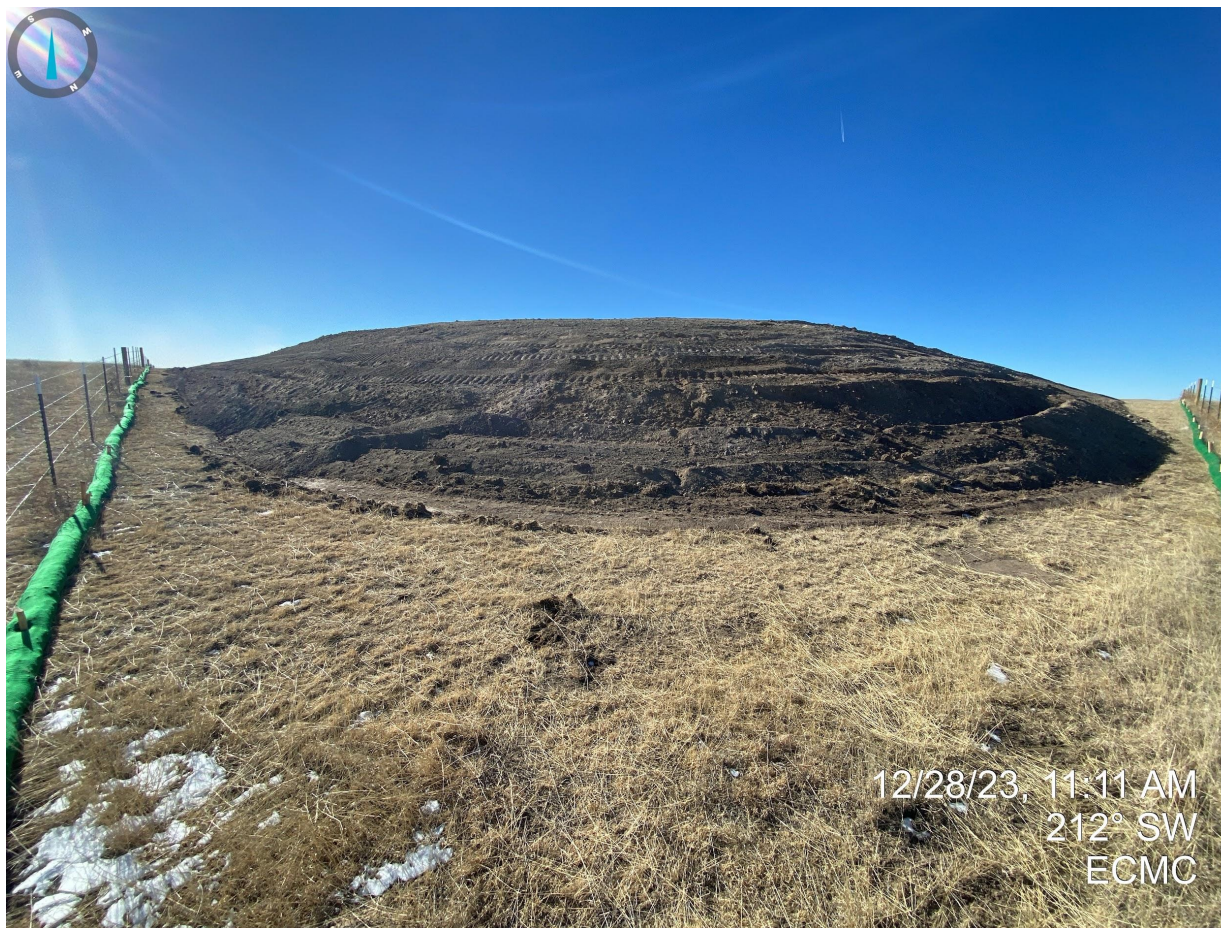
Photo 25. Taken from the northeast corner; facing the topsoil stockpile. Topsoil salvage operations were still ongoing at the time of this inspection; the Operator shall ensure that all stockpile soils are stabilized per Rule 1002.c.

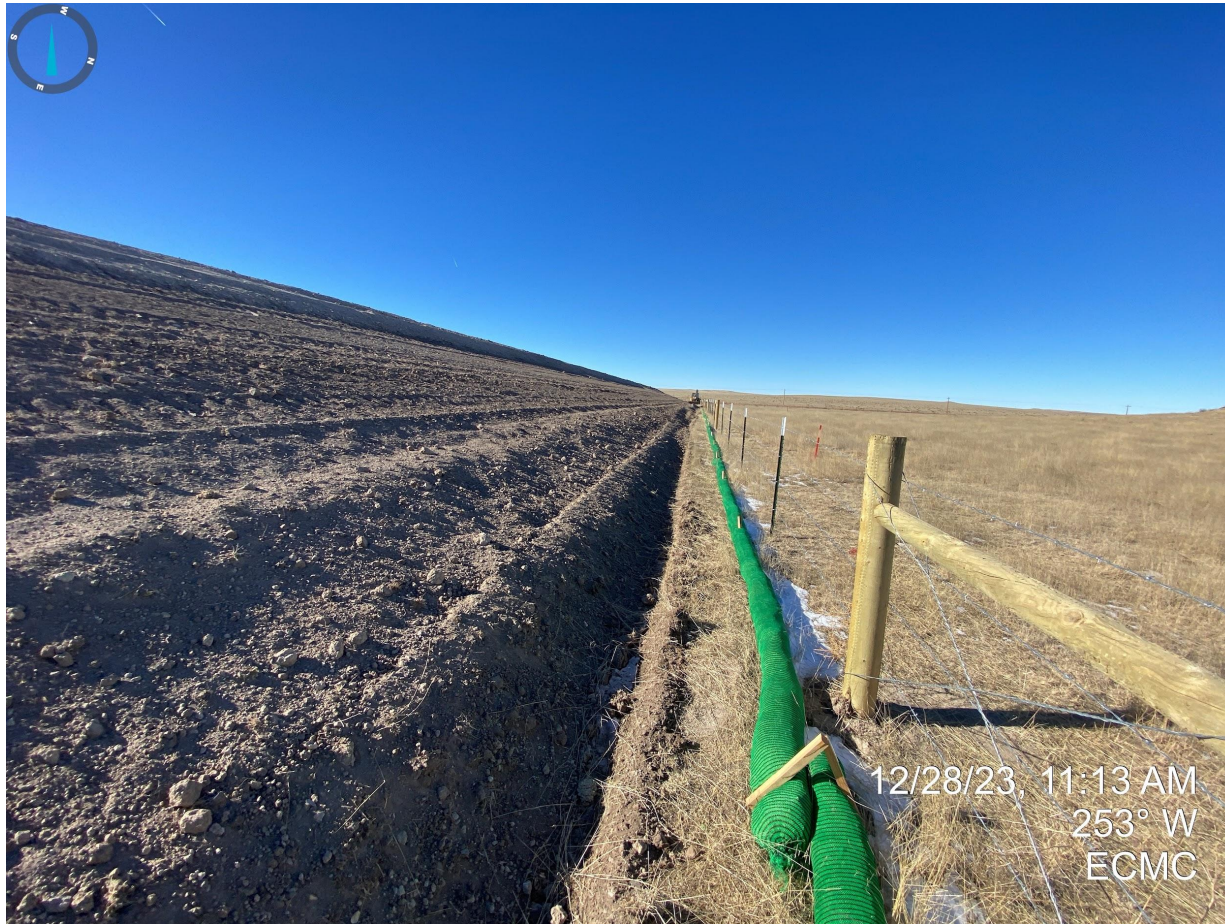
Photo 26. Taken from the center/northern portion of the location. See comments in Photo 25.

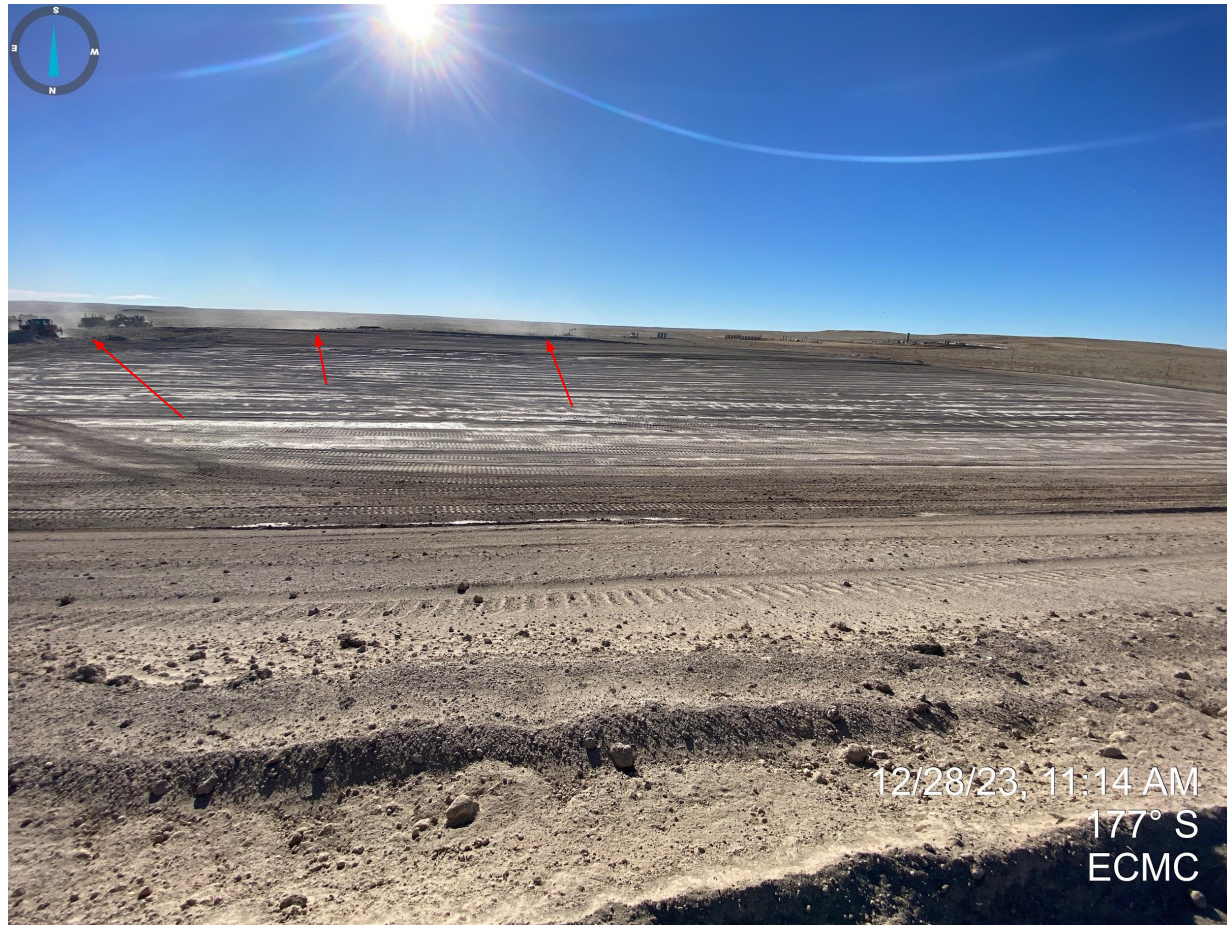
Photo 27. Taken from the topsoil stockpile, facing south over the construction area. Fugitive dust observed during the dirt work activities.
