Interim Reclamation and Stormwater Inspection

Operator: NOBLE ENERGY INC - 100322

Location ID: 457009

Inspection Photos
Location Name: LG 04-15 Multi
Location ID: 457009

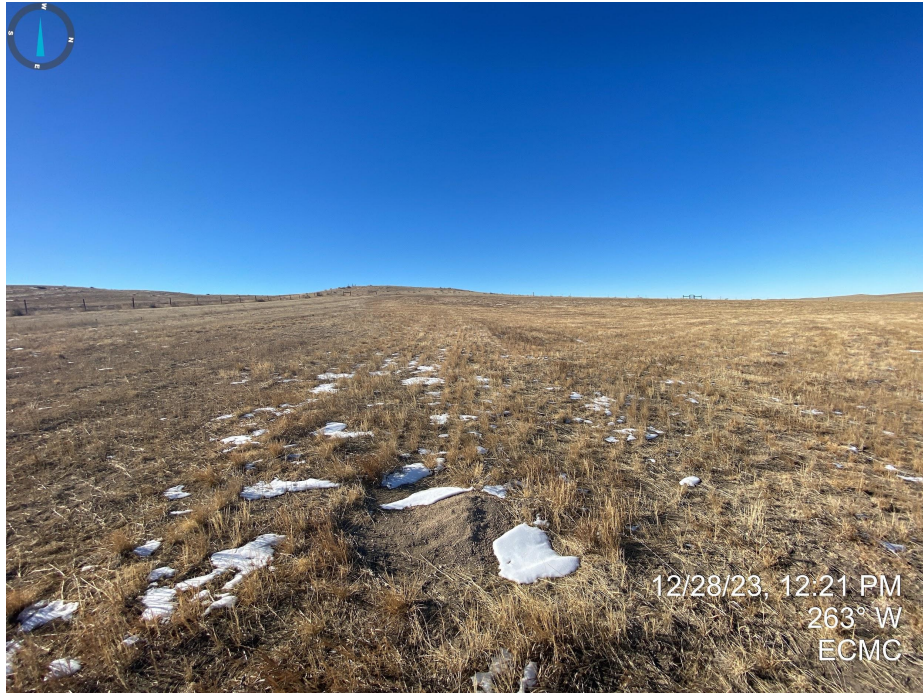
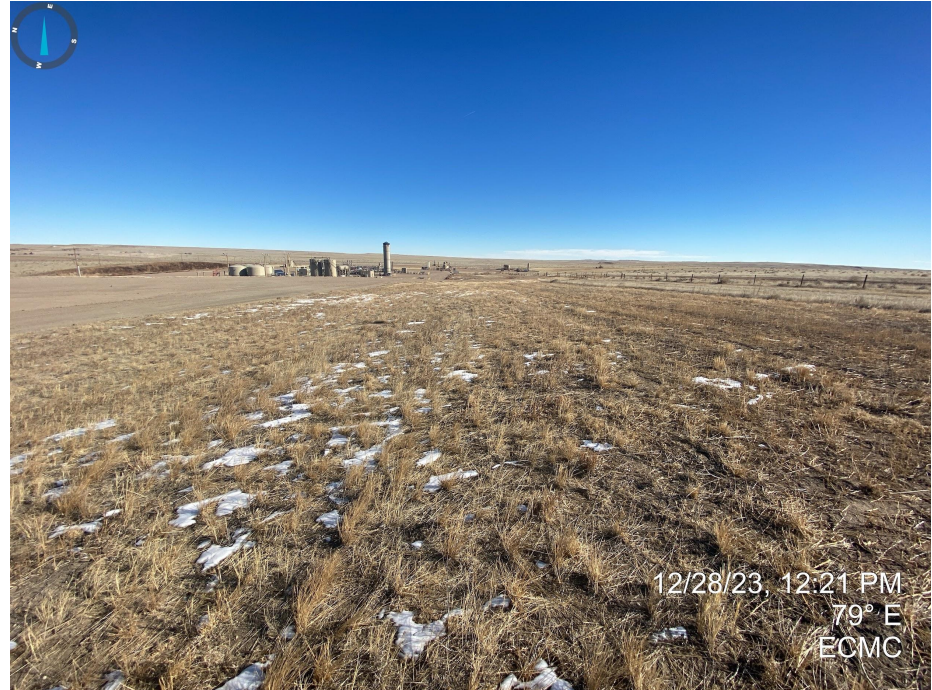
Photos 1 & 2. Southern interim areas appear to be progressing towards Rule 1003 regulations and standards with evidence of desirable perennial vegetation observed. The interim areas also appear to have been recently mowed, therefore, a follow-up inspection will be conducted at a later date to verify vegetative compliance during the next growing season.

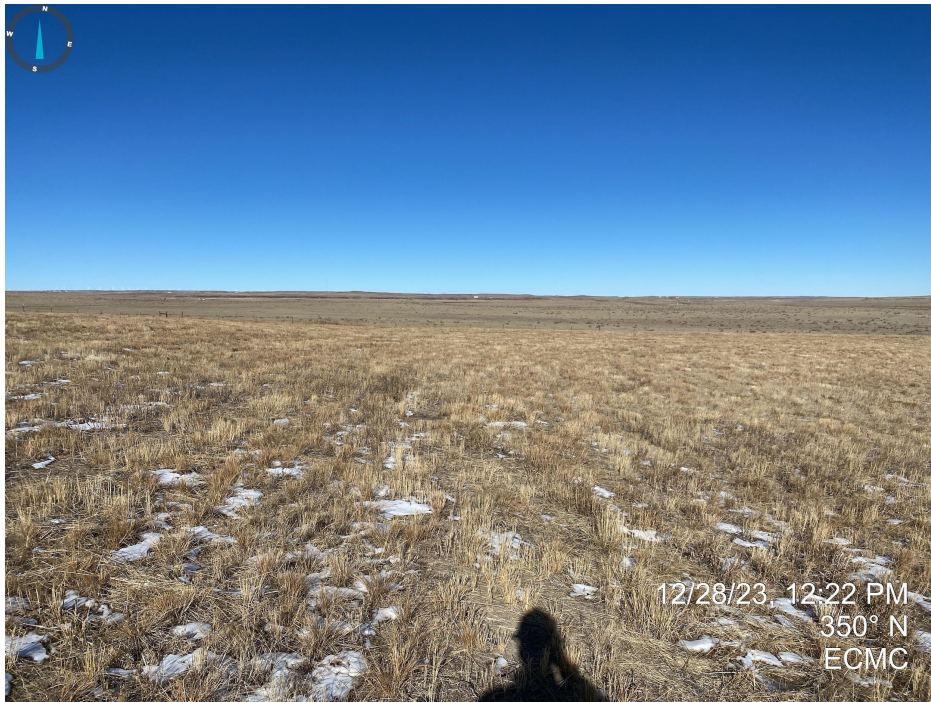
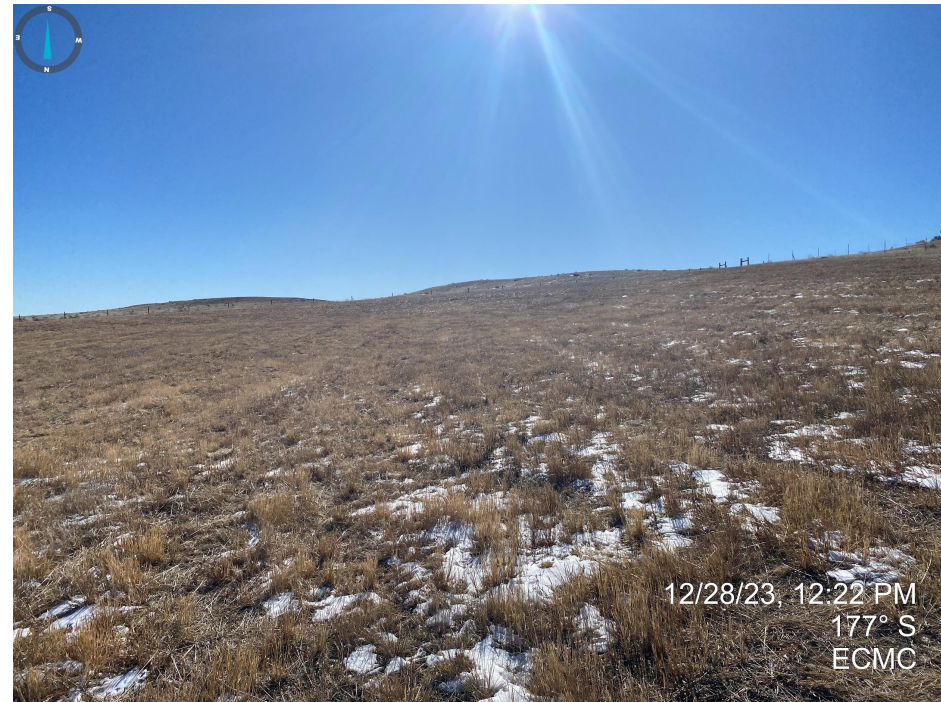
Photos 3 & 4. Western interim areas; see comments in Photos 1 & 2.

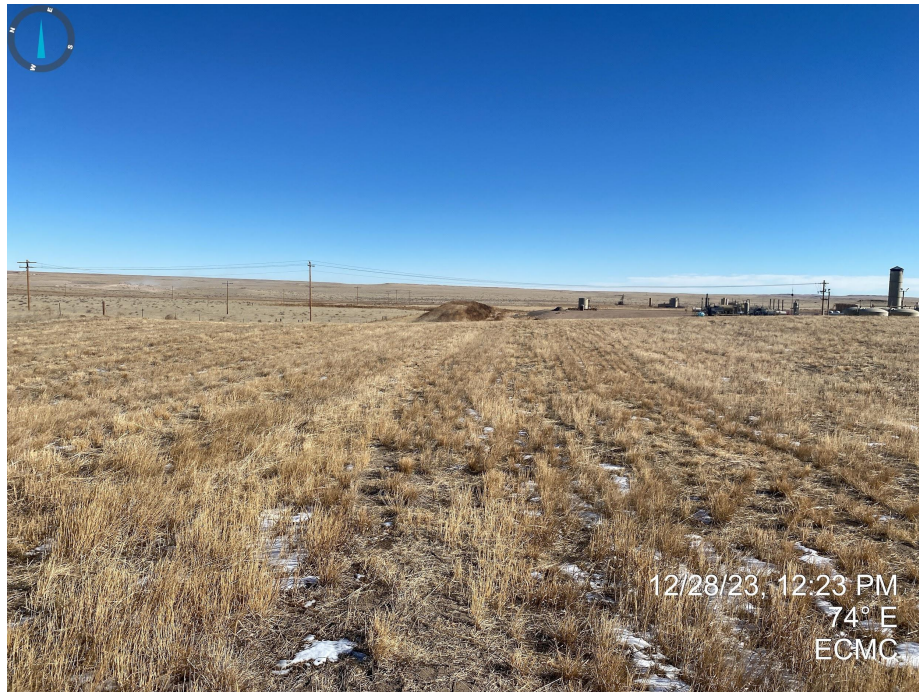
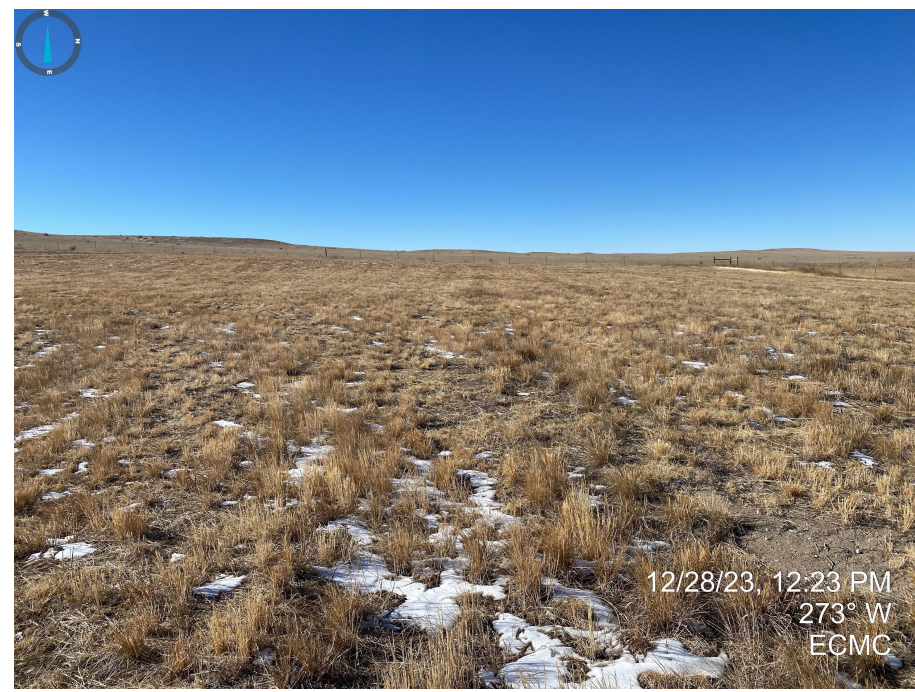
Photos 5 & 6. Northern interim areas; see comments in Photos 1 & 2.

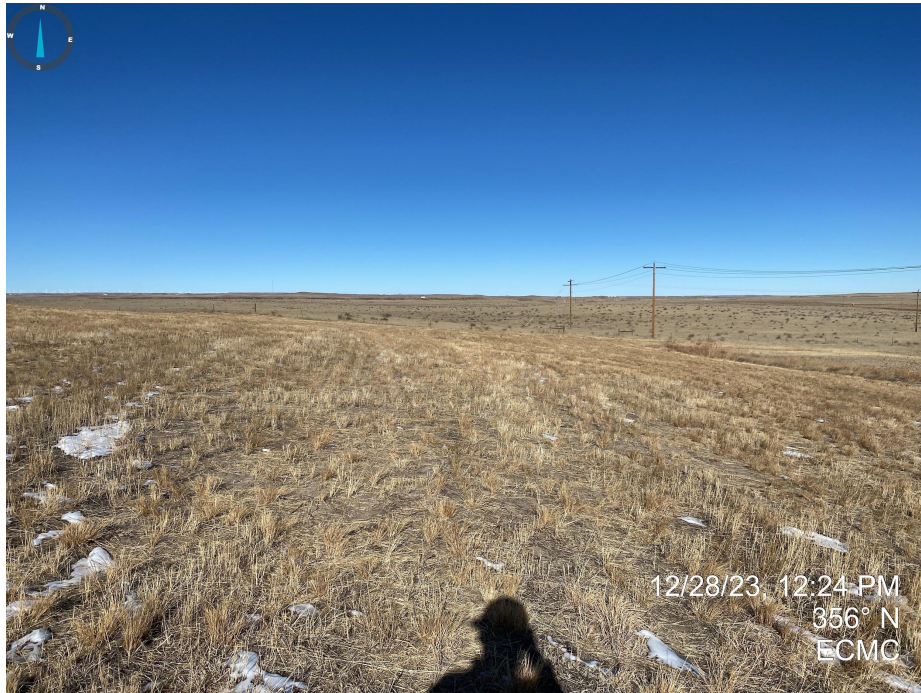
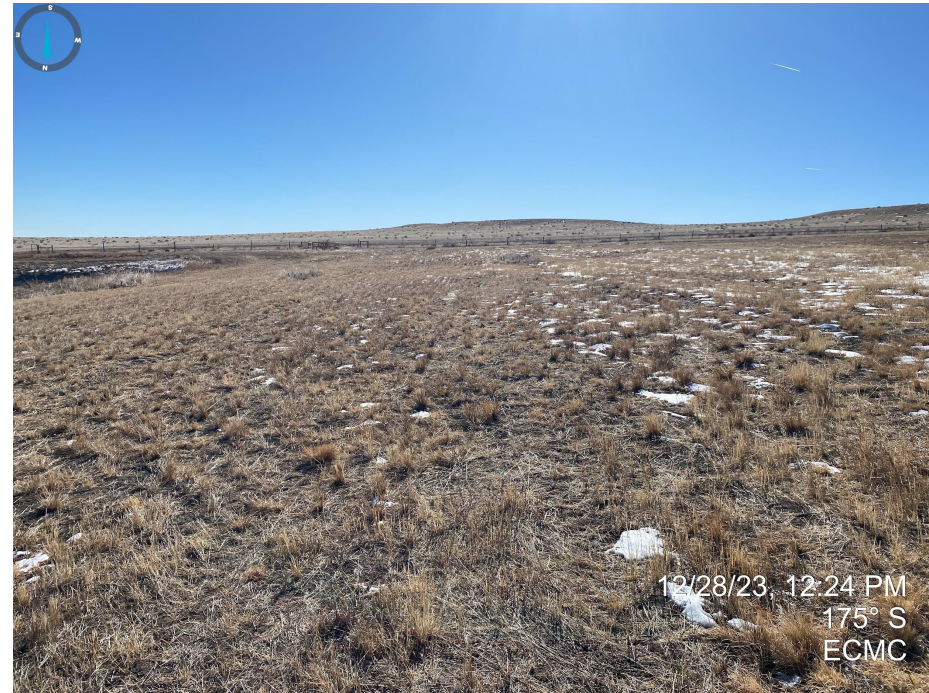
Photos 7 & 8. Eastern interim areas; see comments in Photos 1 & 2.

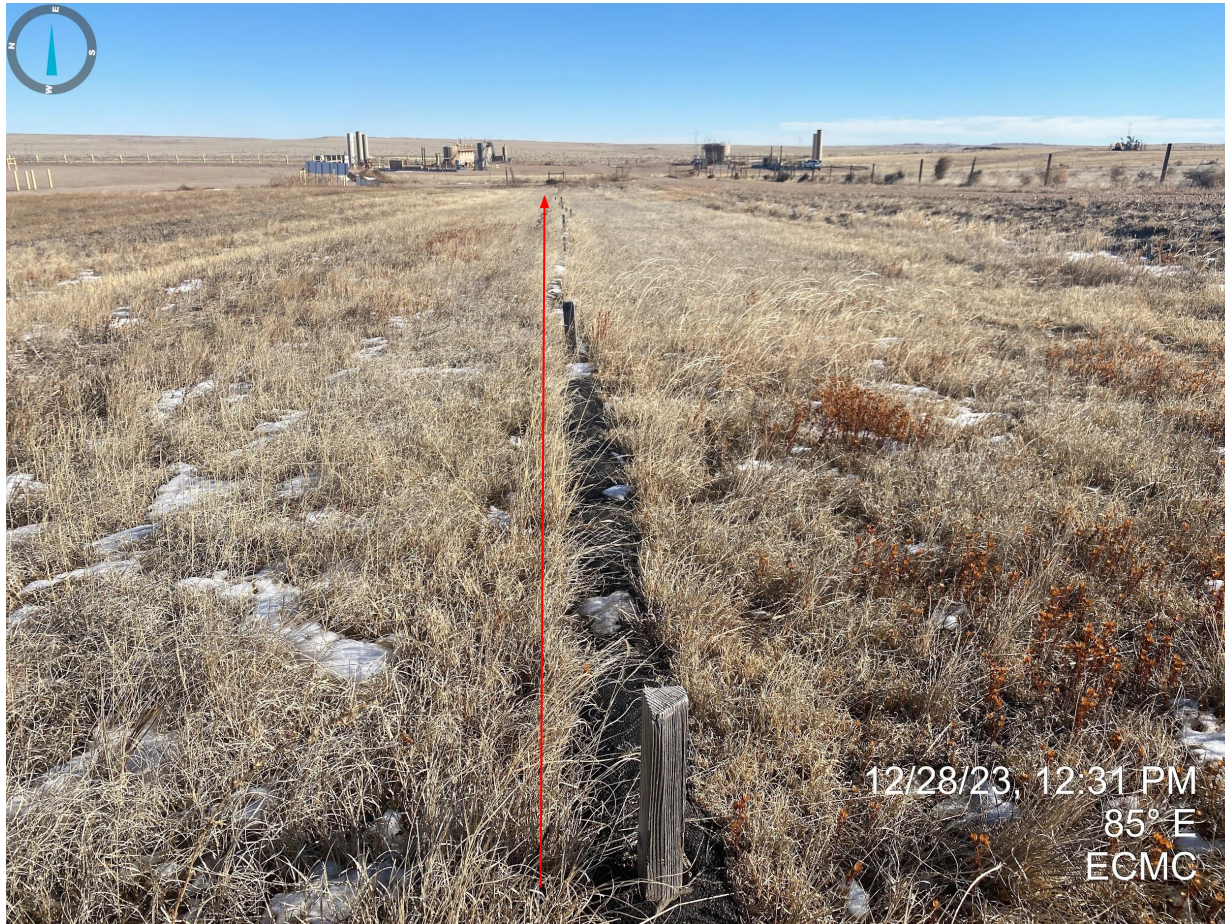
Photo 9. Buried/degraded straw wattles located within the southern interim areas, south of the production facility, are now considered debris as they are no longer a properly functioning control measure/BMP.

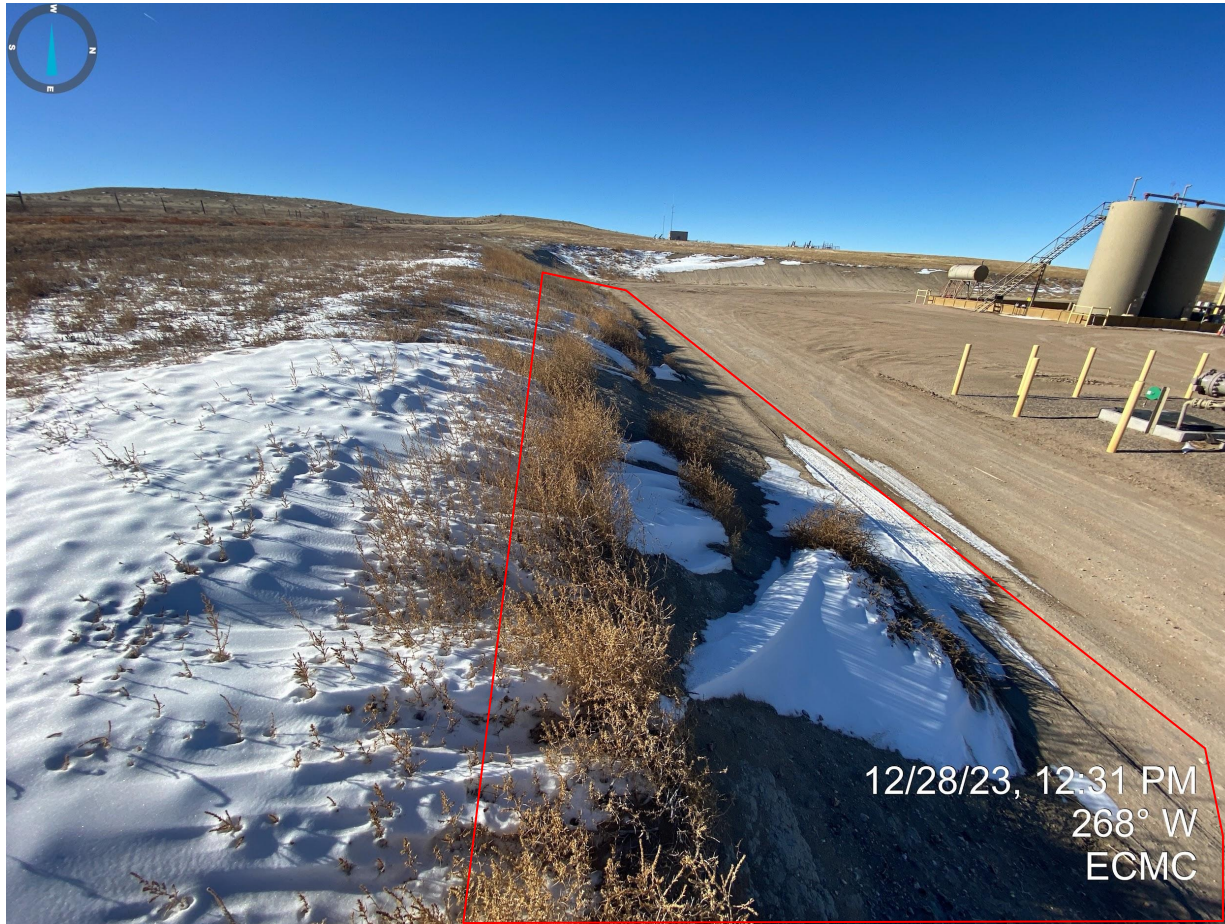
Photo 10. Weedy debris and bare/exposed cut banks along the southern portion of the production areas.

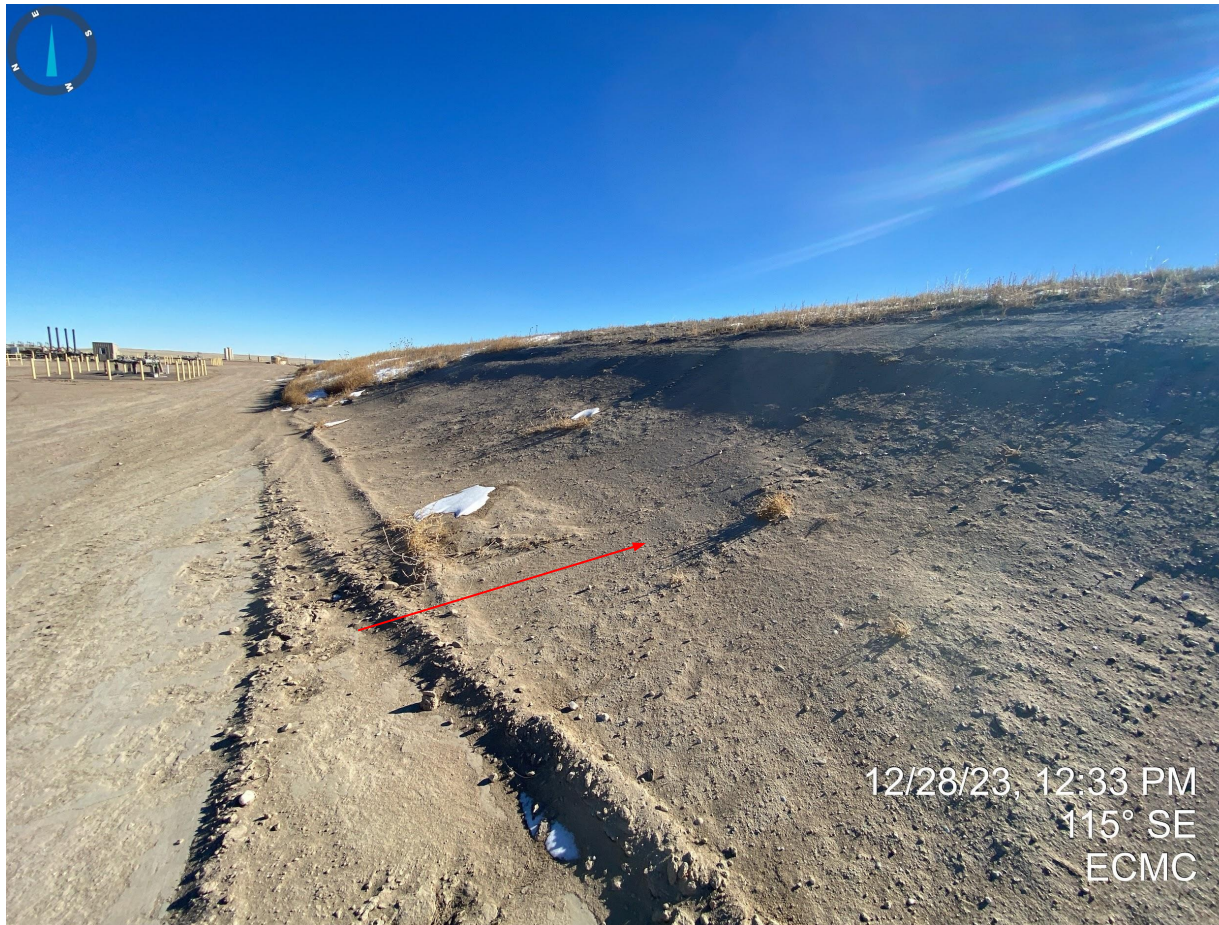
Photo 11. Bare and exposed cuts banks along the southern portion of the production facility are not properly stabilized against wind and water erosion degradation. Additional stabilization measures/BMPs are required.

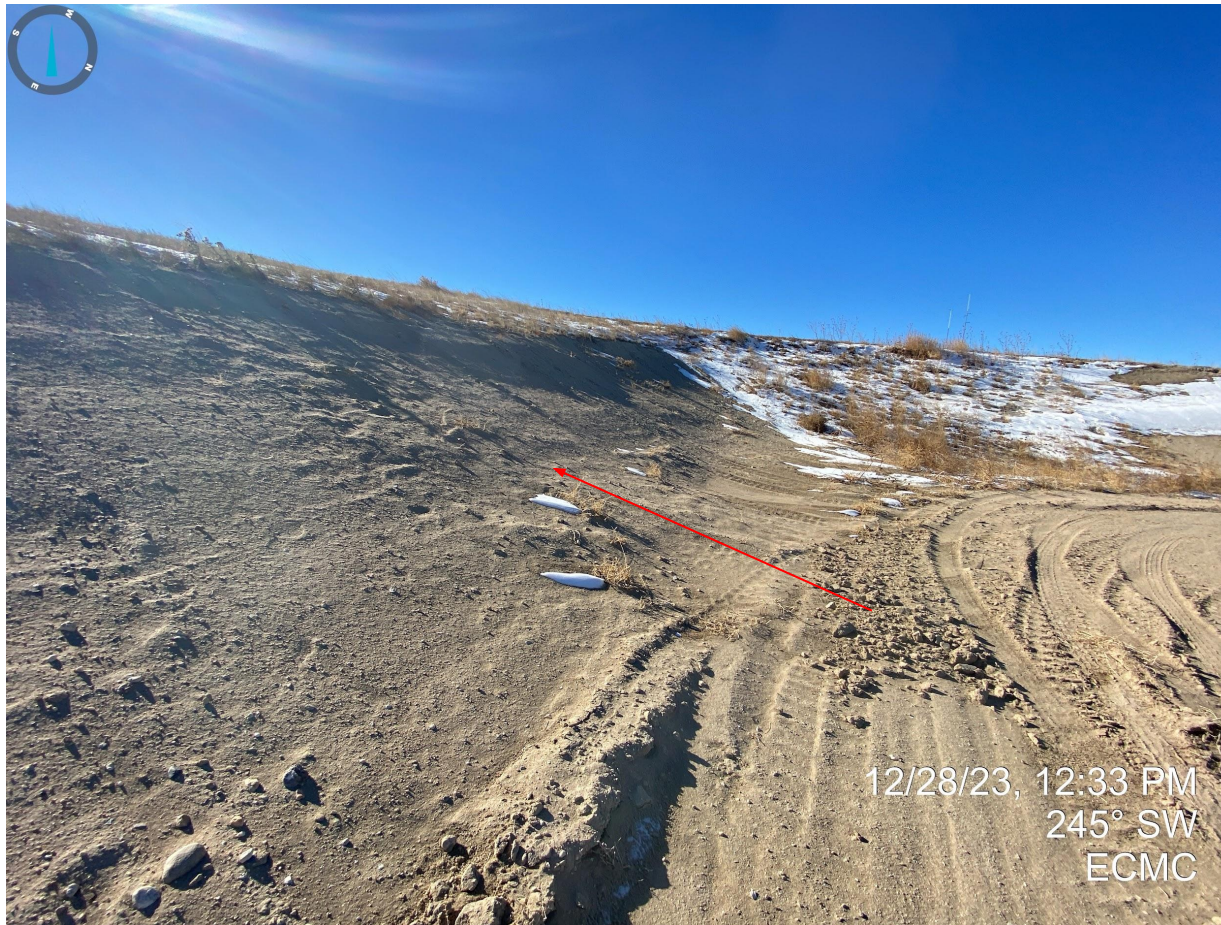
Photo 12. Bare and exposed cuts banks along the southern/southwestern portion of the production facility are not properly stabilized against wind and water erosion degradation. Additional stabilization measures/BMPs are required.

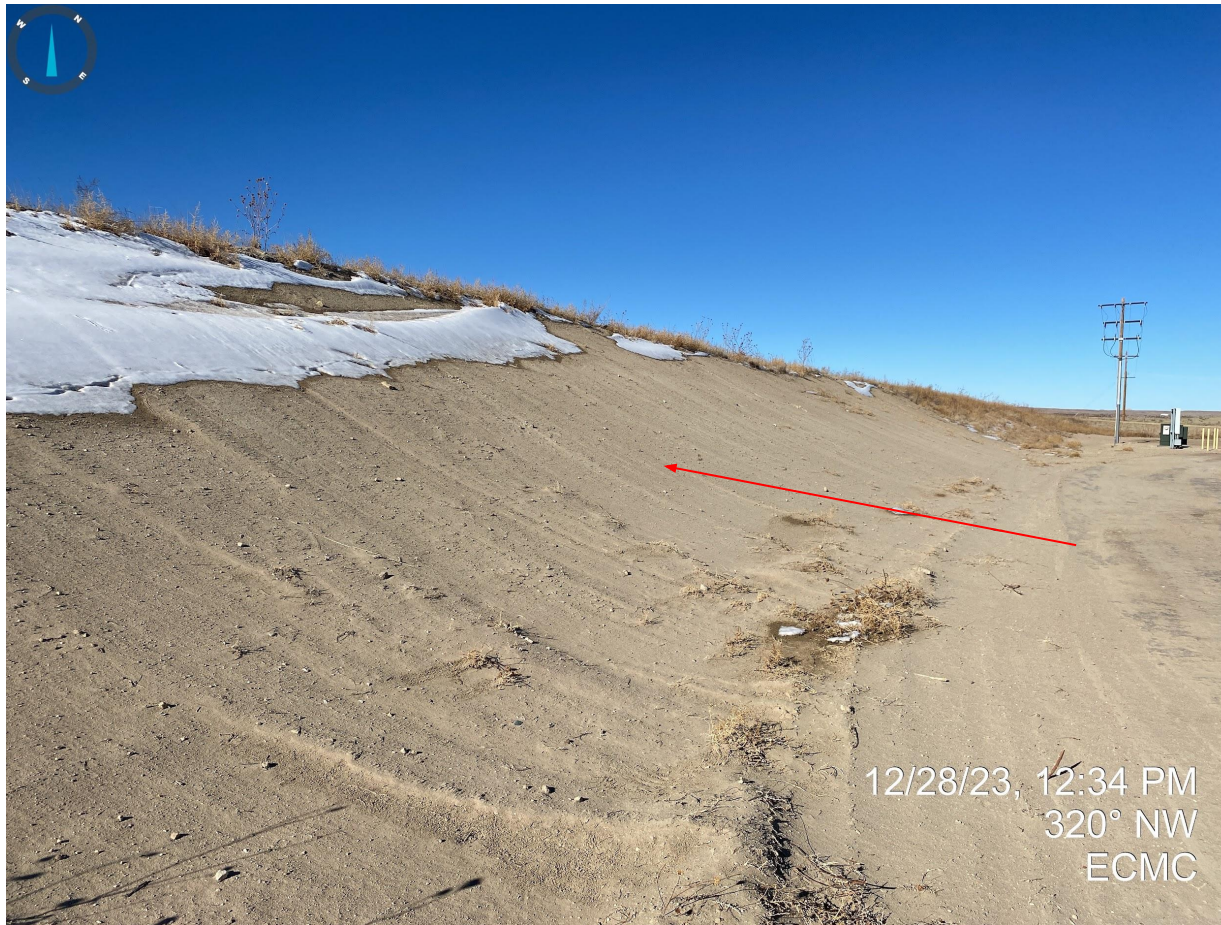
Photo 13. Bare and exposed cuts banks along the western/southwestern portion of the production facility are not properly stabilized against wind and water erosion degradation. Additional stabilization measures/BMPs are required.

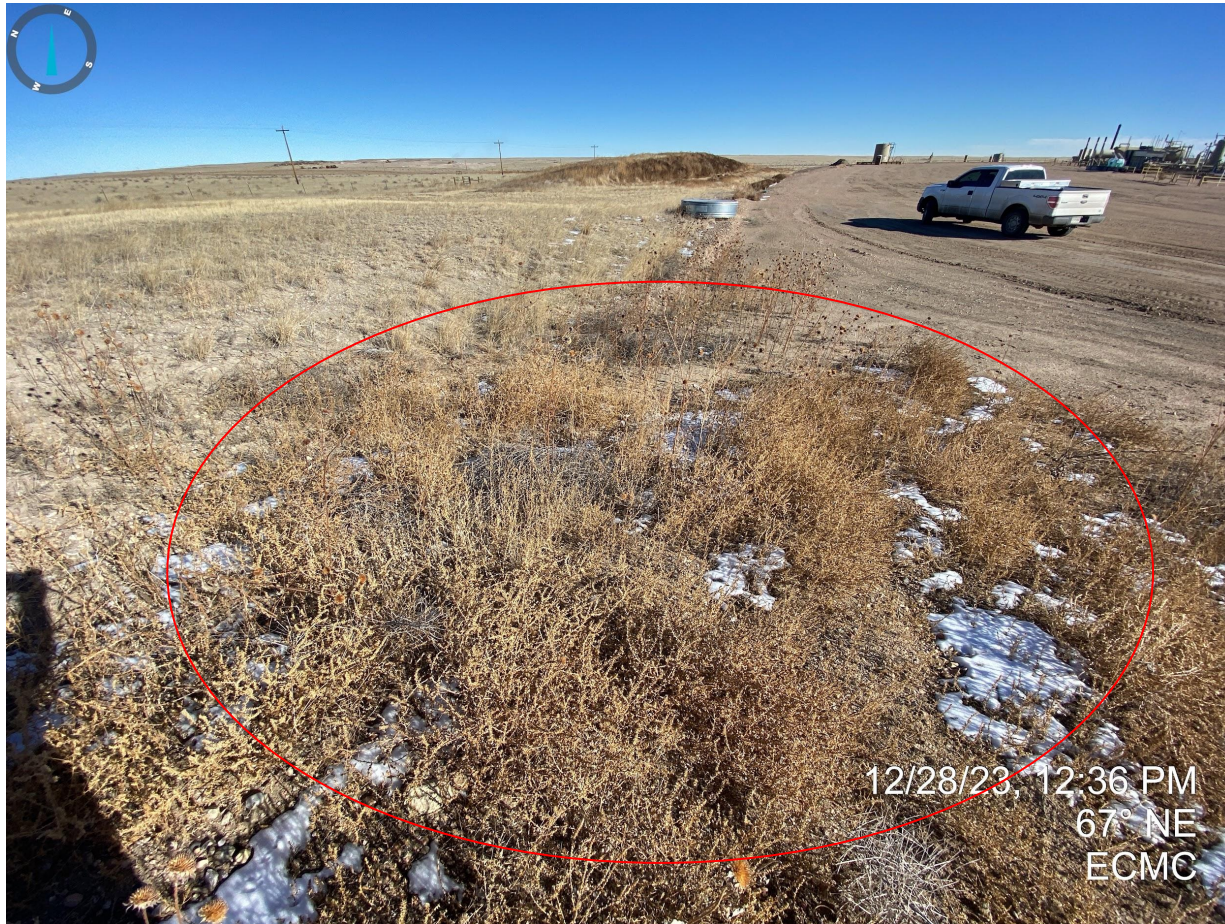
Photo 14. Weedy debris observed along the northwest corner of the production facility.

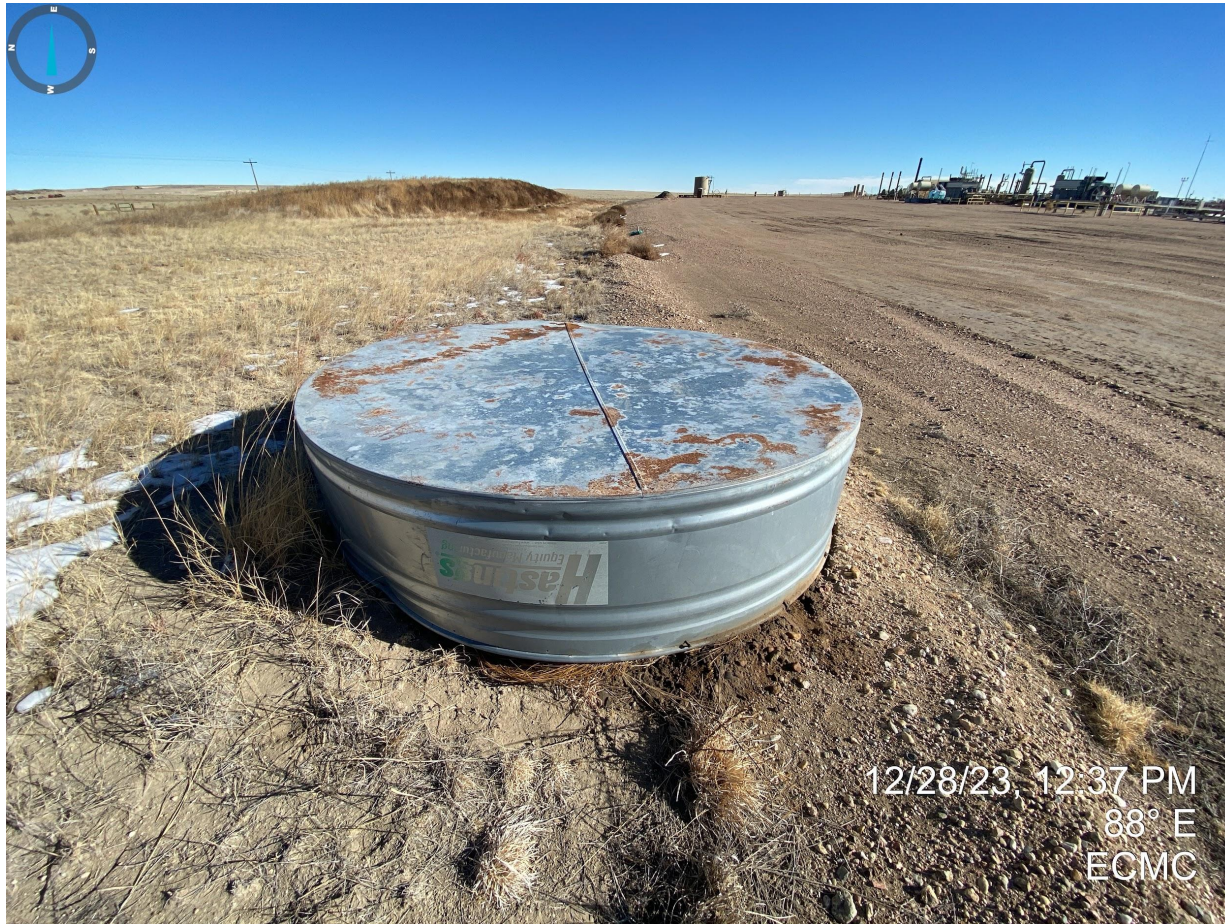
Photo 15. Stock tank/secondary containment does not appear to be in use and needs to be removed or returned to service.

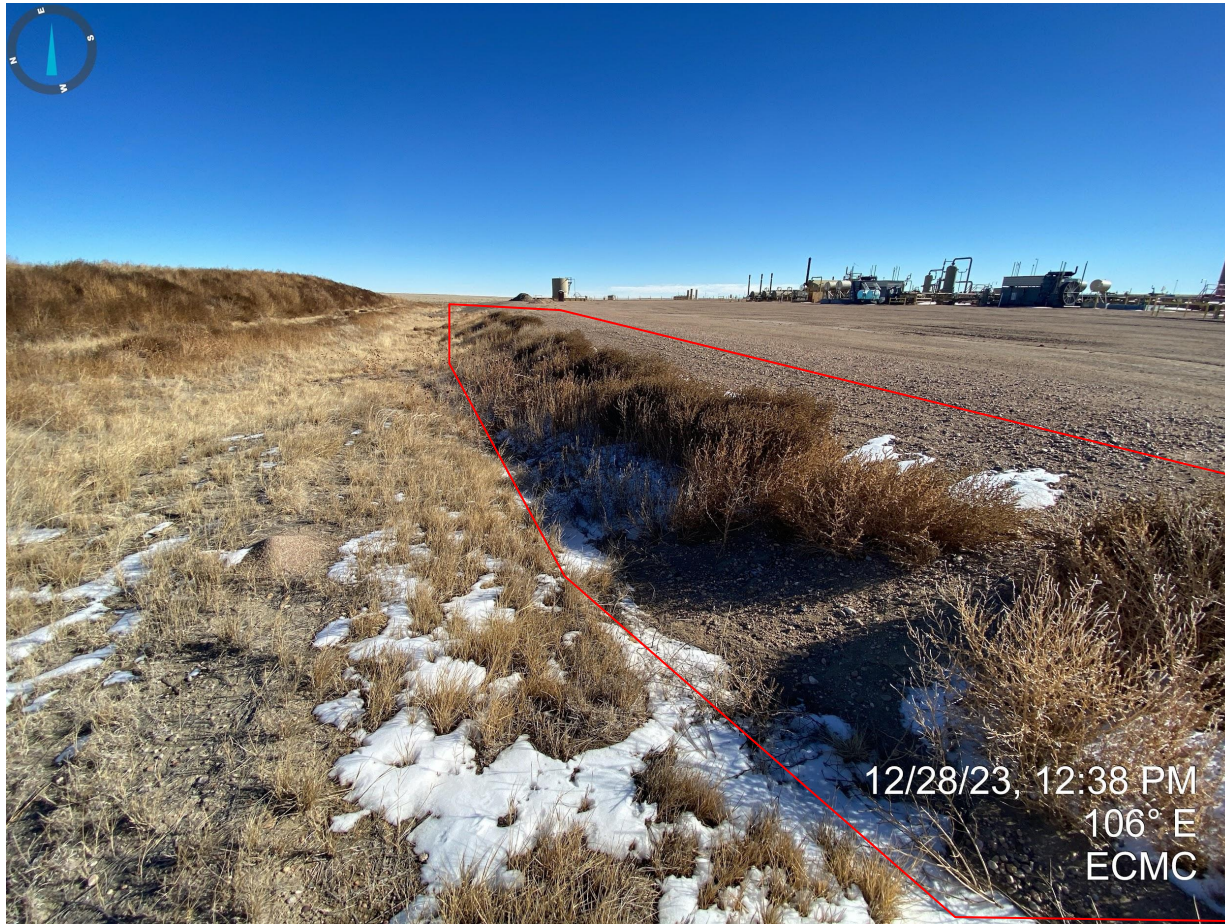
Photo 16. Weedy debris observed around the northern portion of the production areas.

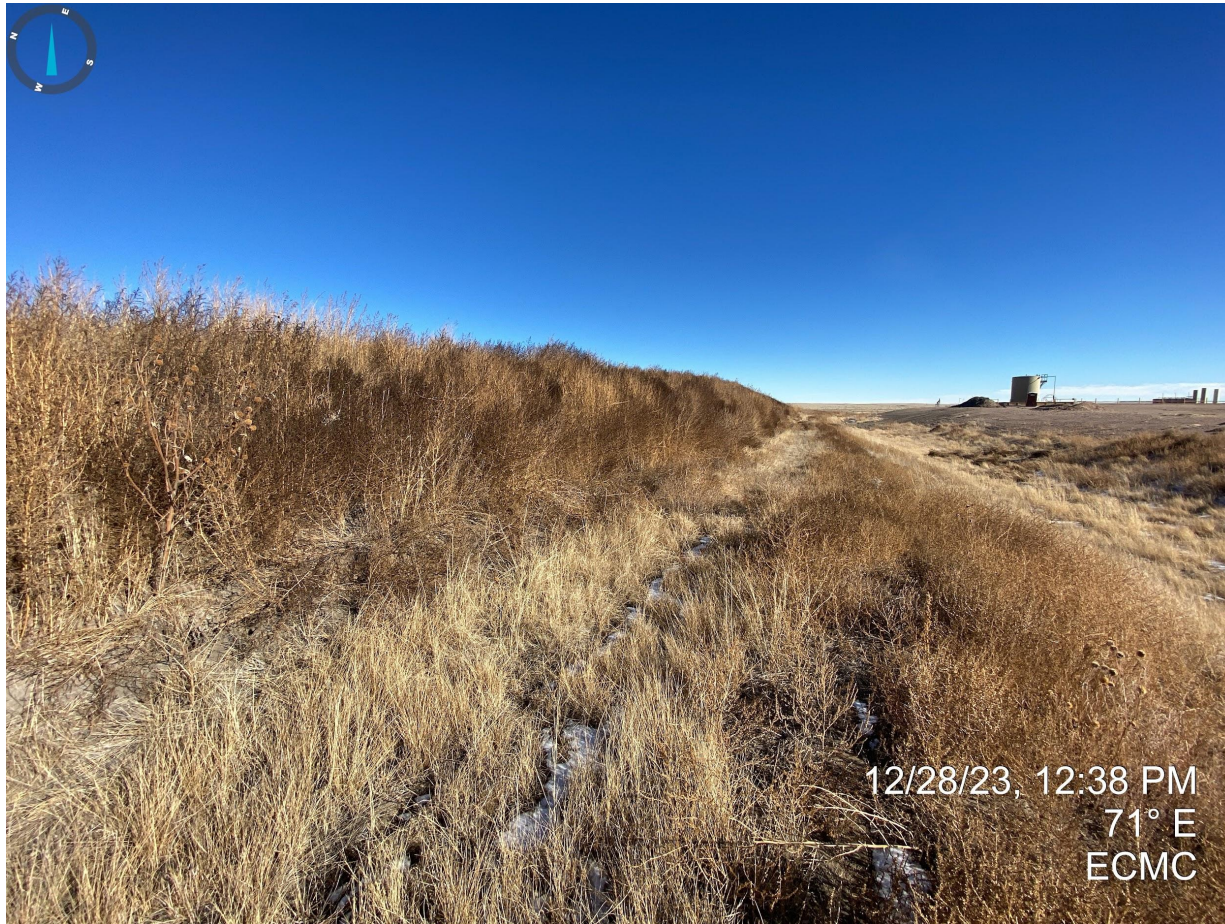
Photo 17. The topsoil stockpile has significant weed cover- russian thistle and kochia- with no perennial vegetation that would compete with the weedy vegetation and generally work to decrease weed growth.

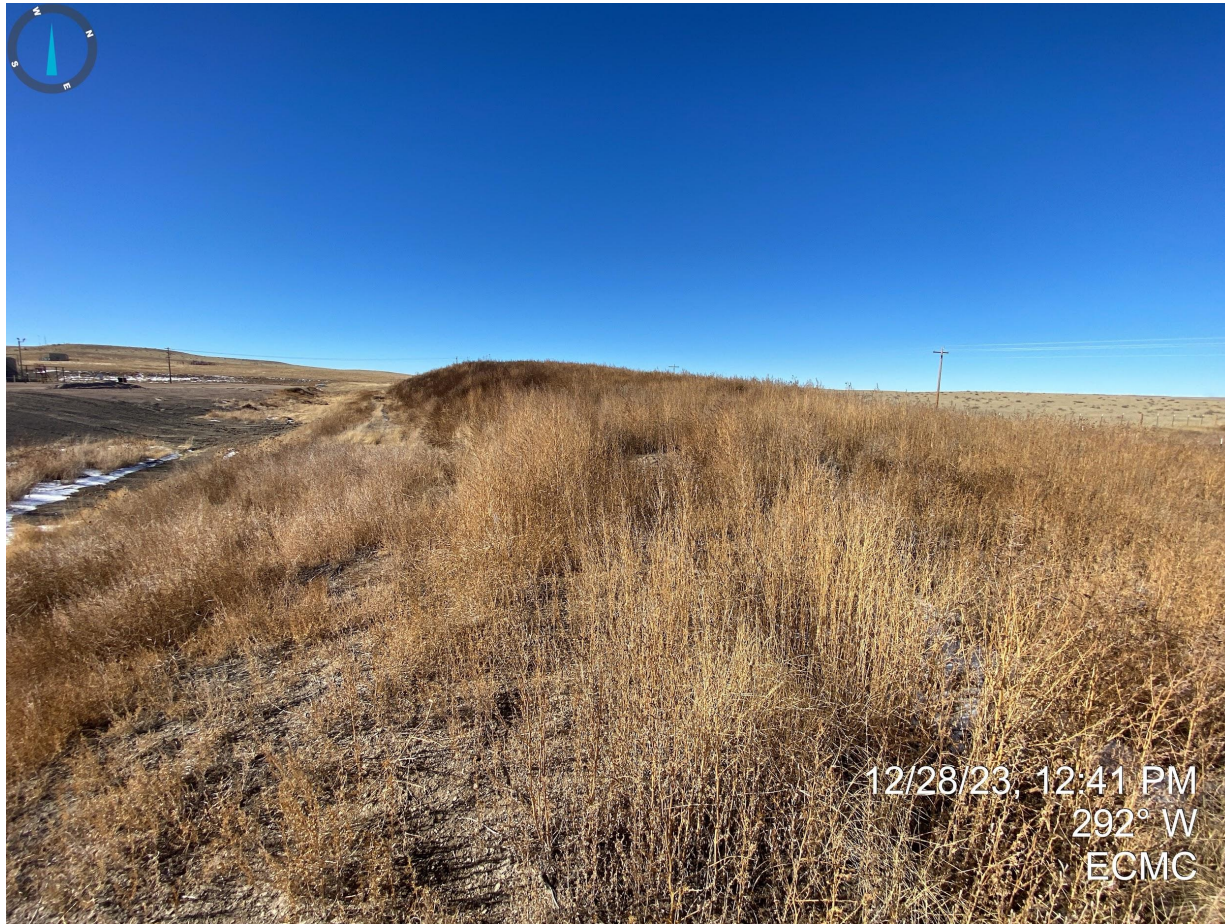
Photo 18. Topsoil stockpile, facing west. See comments in Photo 17.

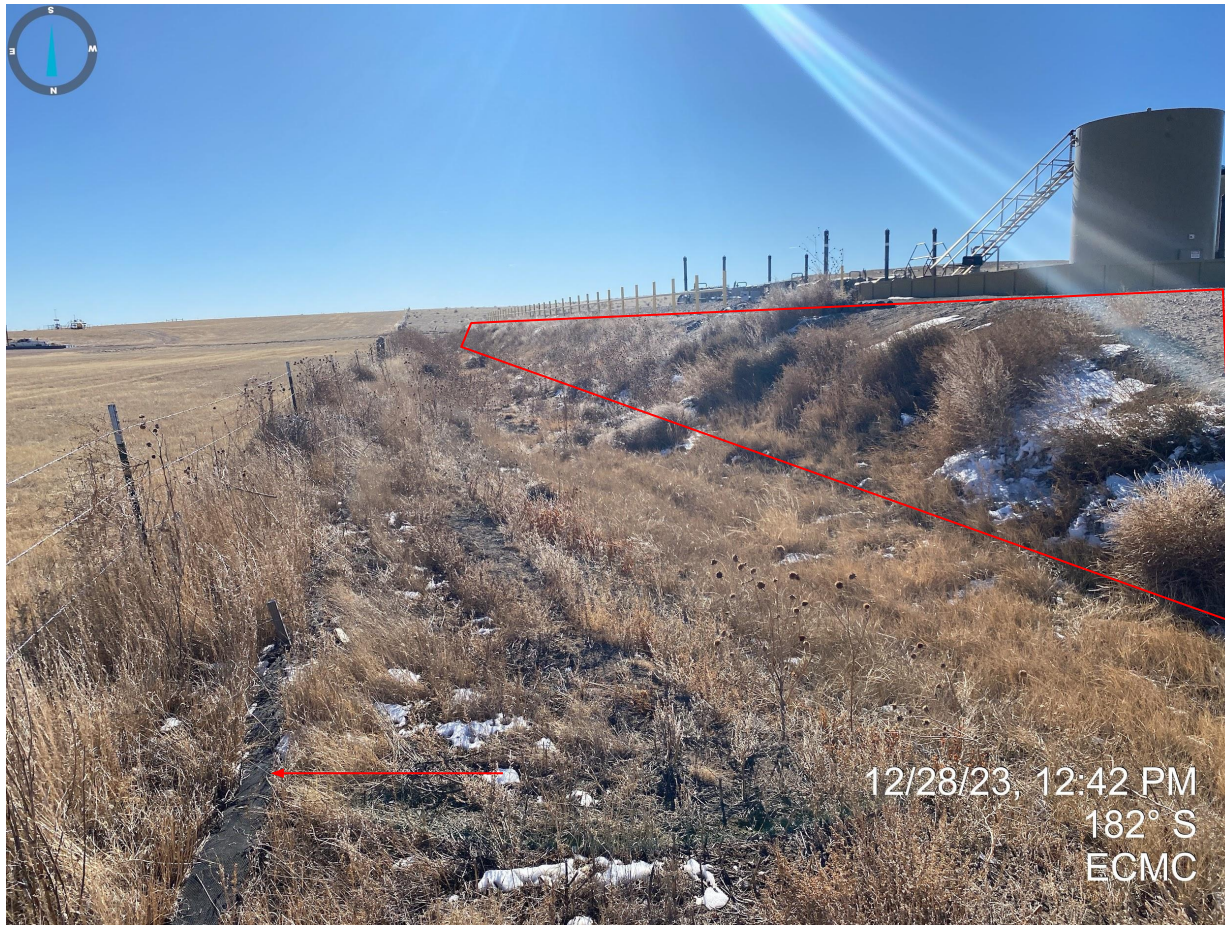
Photo 19. Weedy debris observed around the eastern portion of the production areas. Also pictured, buried/degraded straw wattles that are now considered debris.

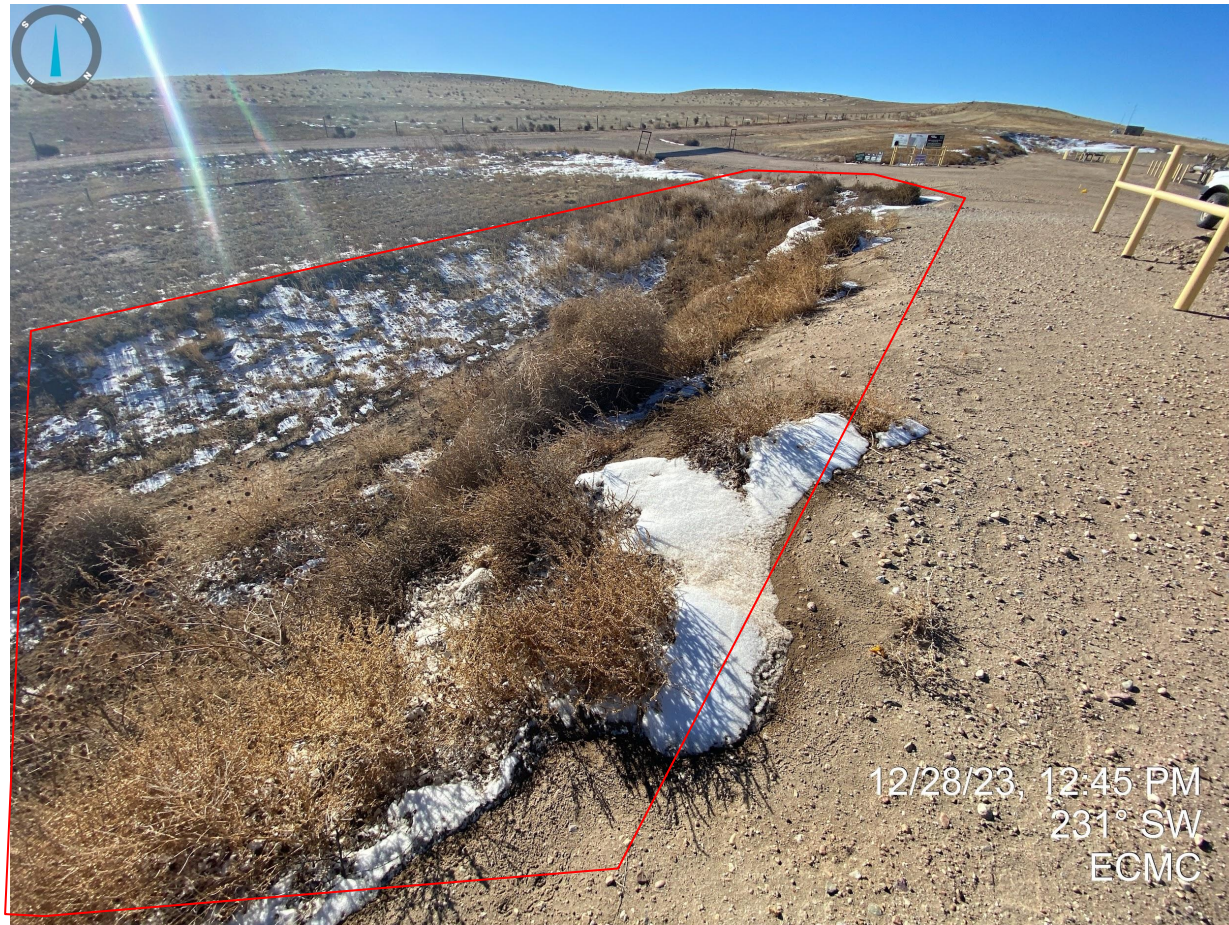
Photo 20. Weedy debris observed around the southern portion of the production areas.
