Inspection Photos

Location Name: AMIGO-66N64W/17NWNE

Location ID: 330135

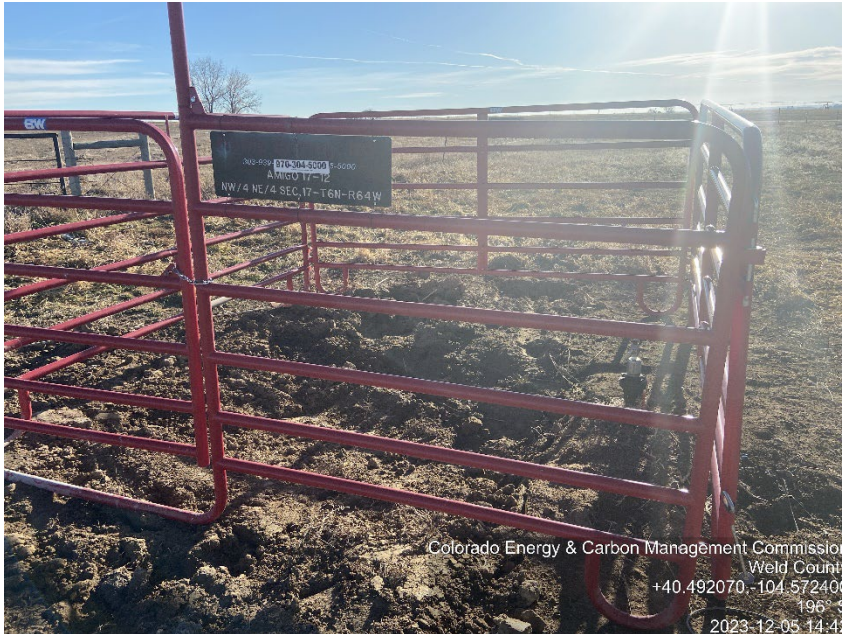
Photo #1

Amigo 17-12 (123-18484) Wellsite

Plugged & Abandoned | PA

Cut / Capped

Flowline is Locked-Out, Tagged-Out | LOTO ; OOSLAT

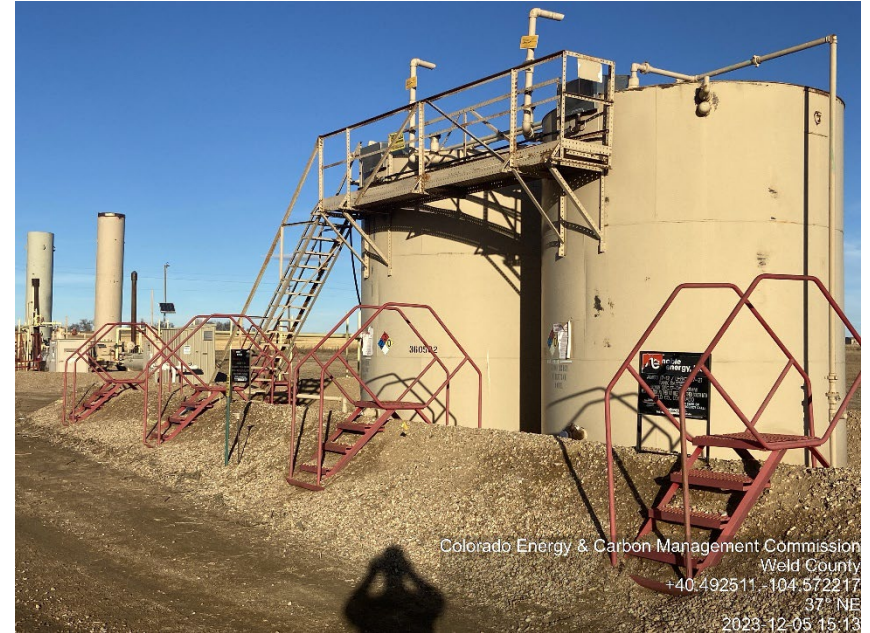
Photo #2

Amigo 17-12 Battery site

Inactive | Shut-down

Formerly served:

Amigo 17-12, Gulley 17-15, Uhrich 17-21 ;

Plugged & Abandoned | PA

Equipment Documented; Loc ID: 330135

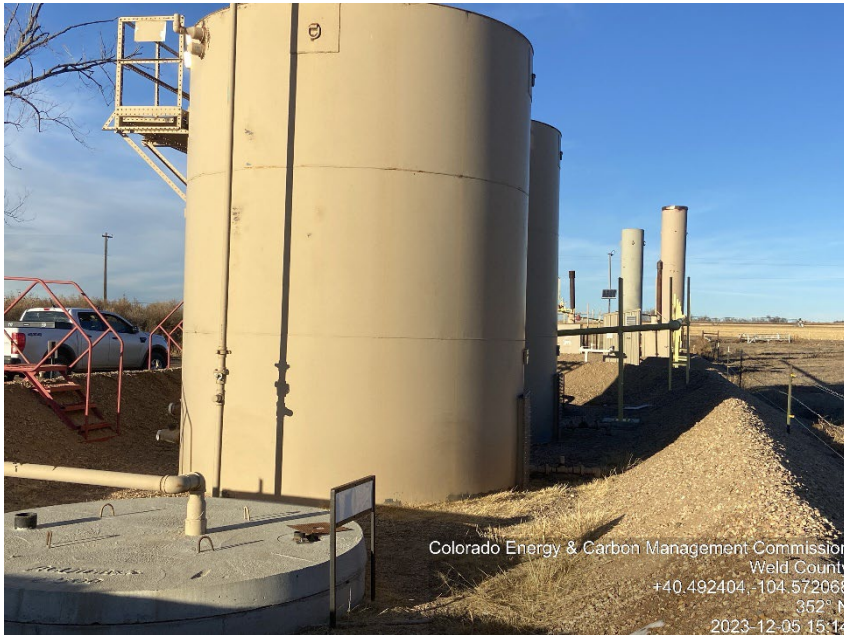
Photo #3

Amigo 17-12 Battery site

Inactive | Shut-down

Tank(s): SE corner

All wells have been PA'd; Remove Equipment

Form 27-I Remediation Workplan on file.

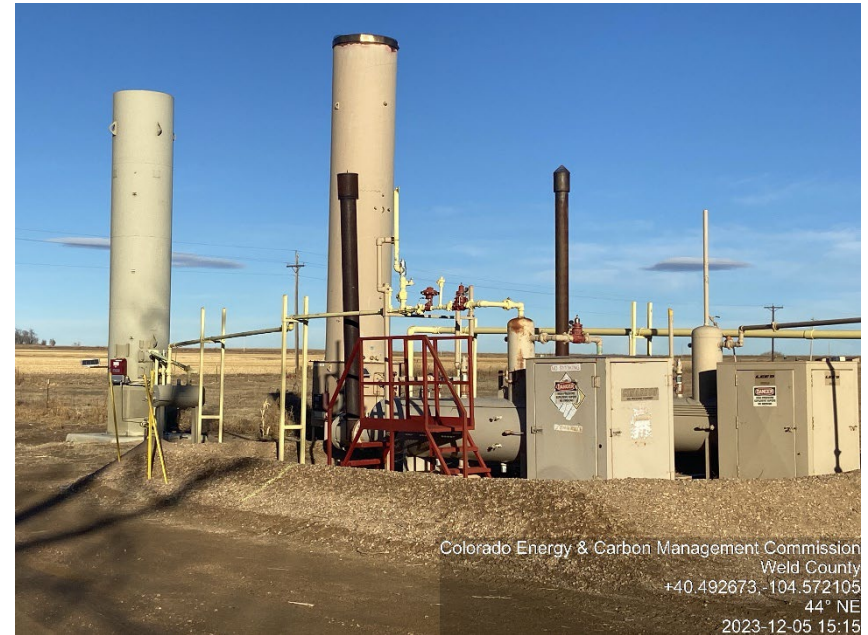
Photo #4

Amigo 17-12 Battery site

Inactive | Shut-down

ECD(s), Separator(s)

All wells have been PA'd; Remove Equipment

Form 27-I Remediation Workplan on file.

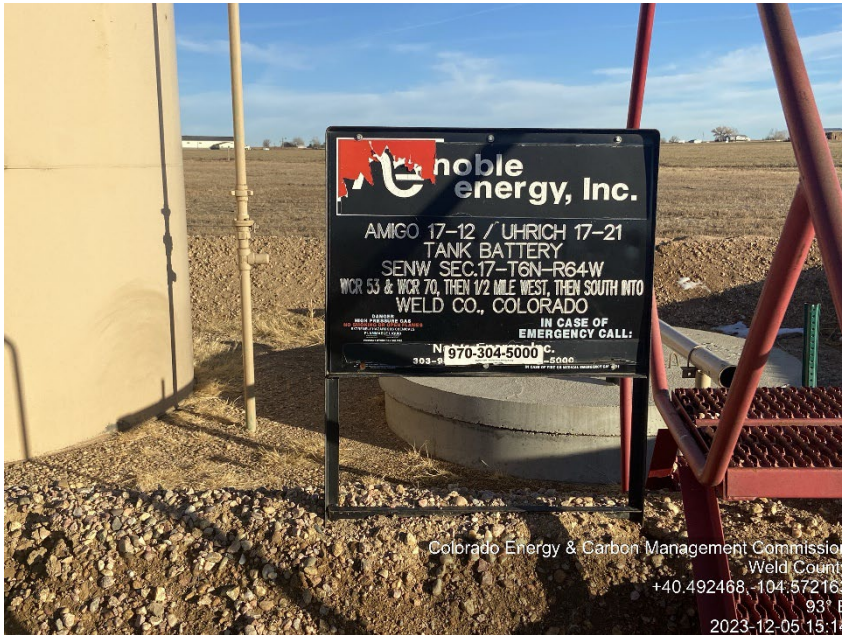
Photo #5

Amigo 17-12 Battery site

Inactive | Shut-down

Battery sign

All wells have been PA'd; Remove Equipment

Form 27-I Remediation Workplan on file.
