Storm Water Management and Erosion control
Location Name: TEP Rocky Mountain LLC FEDERAL RMV 60-17 Pad
Location # 324076

**Location Overview: Location is within High Priority/Density
Habitat areas & in close proximity to NSO Habitat area.
Location is approximately 138 yards from a creek/drainage
that contributes to the Colorado River.
Section/Township/Range: 17 6S94W**

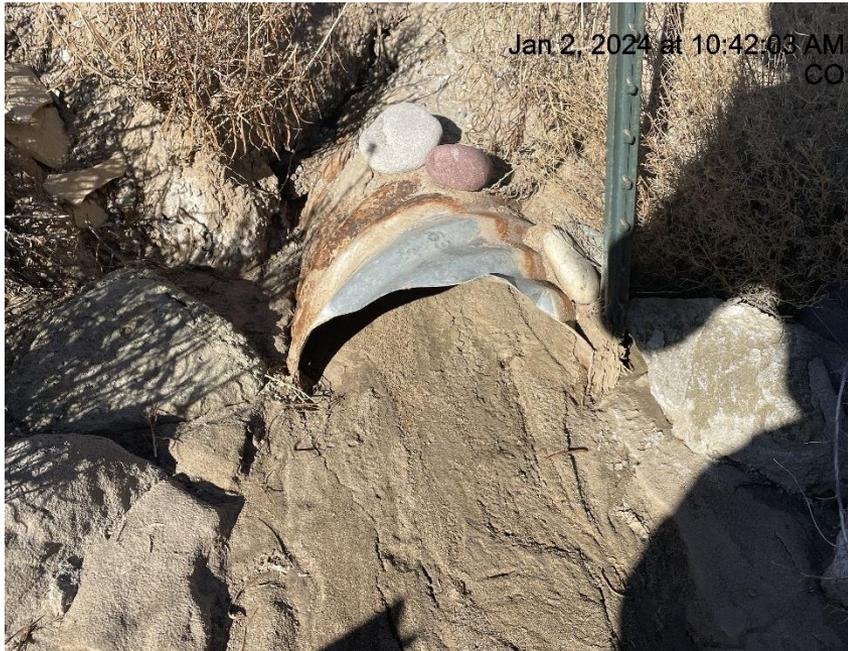
Photo # 1389 Culvert at entrance to location needs maintenance

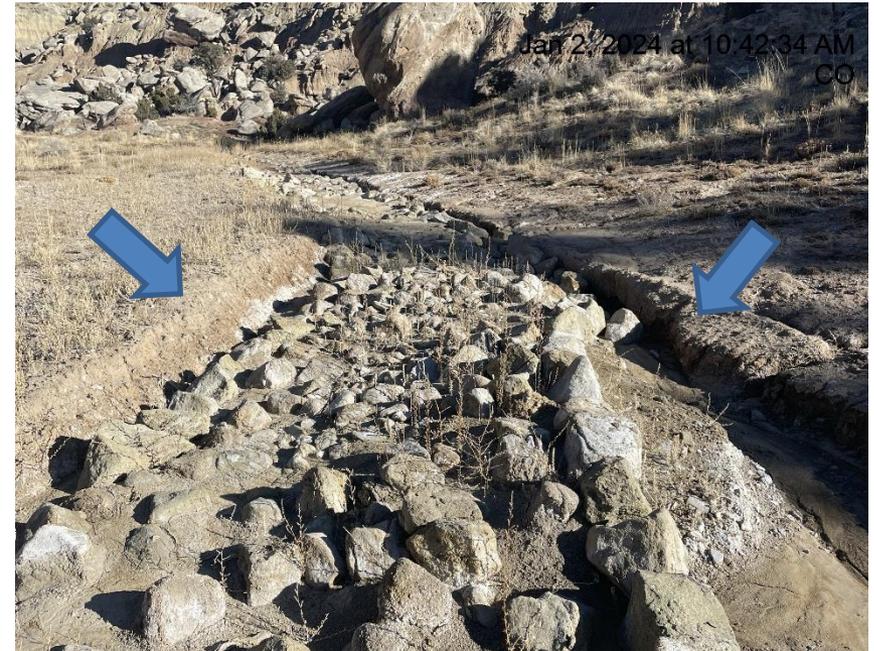
Photo # 1390 Rip Rap Run needs maintenance, stormwater has eroded around both sides of BMP & there's sediment buildup in some areas of BMP (eastern side of location)

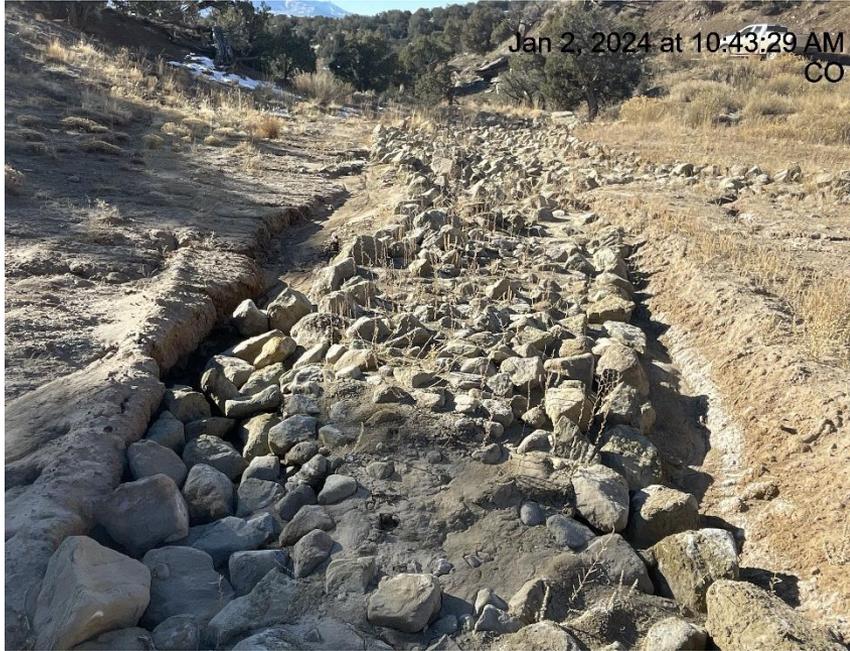
Photo # 1391 Rip Rap Run needs maintenance, stormwater has eroded around both sides of BMP (eastern side of location)

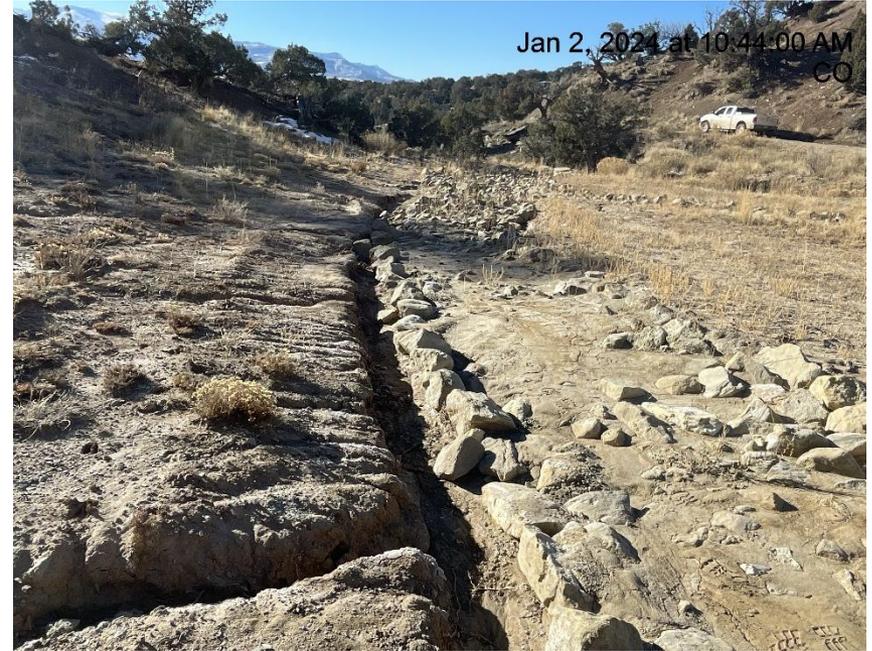
Photo # 1392 Rip Rap Run needs maintenance (eastern side of location)

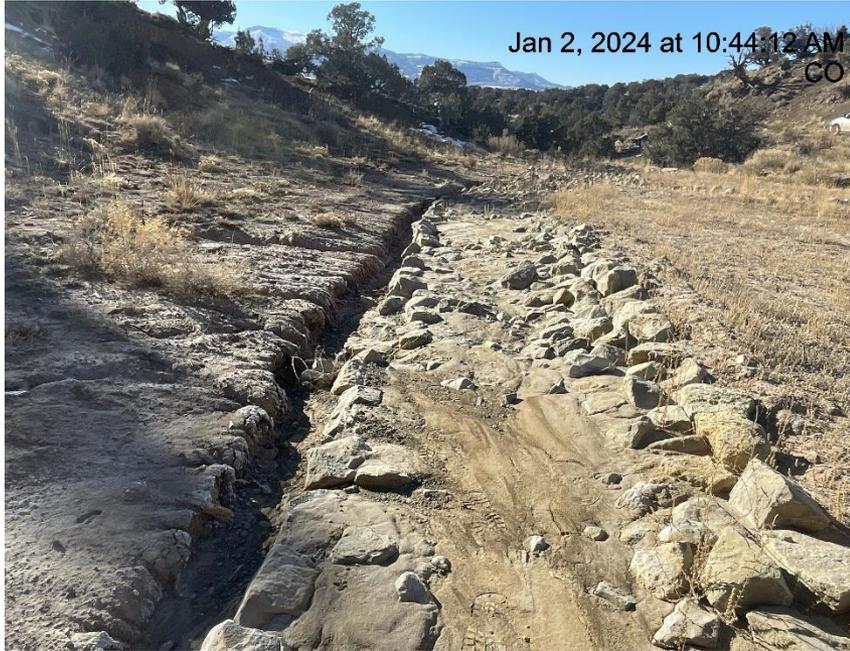
Photo # 1393 Rip Rap Run needs maintenance (eastern side of location)

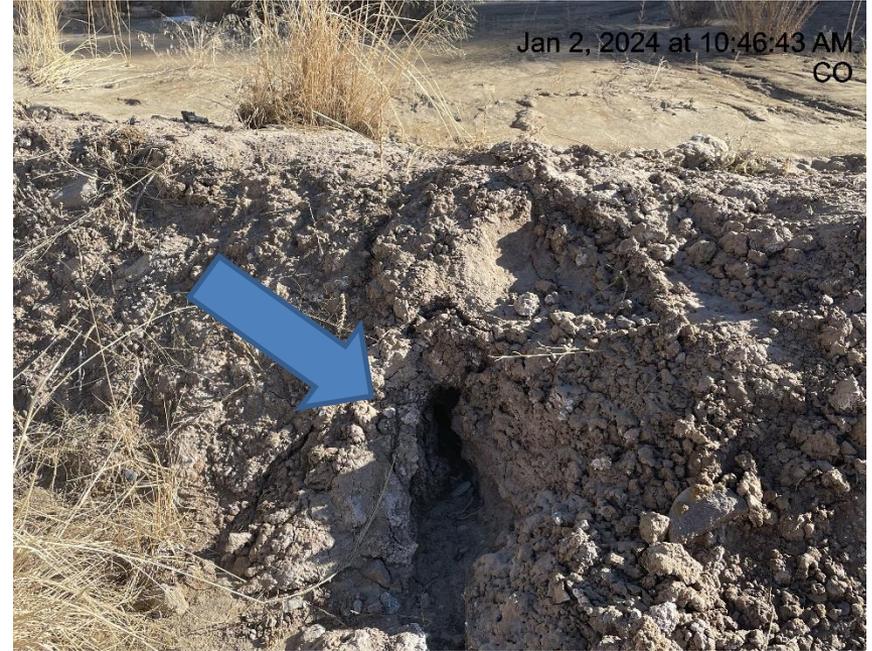
Photo # 1394 Berm needs maintenance/tunnel erosion & transport of sediment through berm & onto location (North area of location)

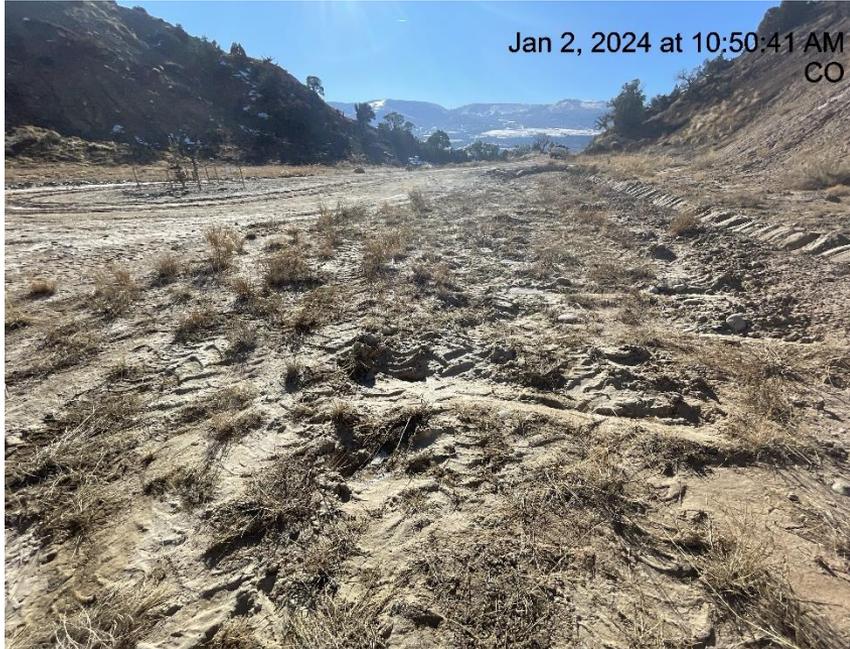
Photo # 1395 Vehicle tracks observed traveling off the working pad area & into the interim area.

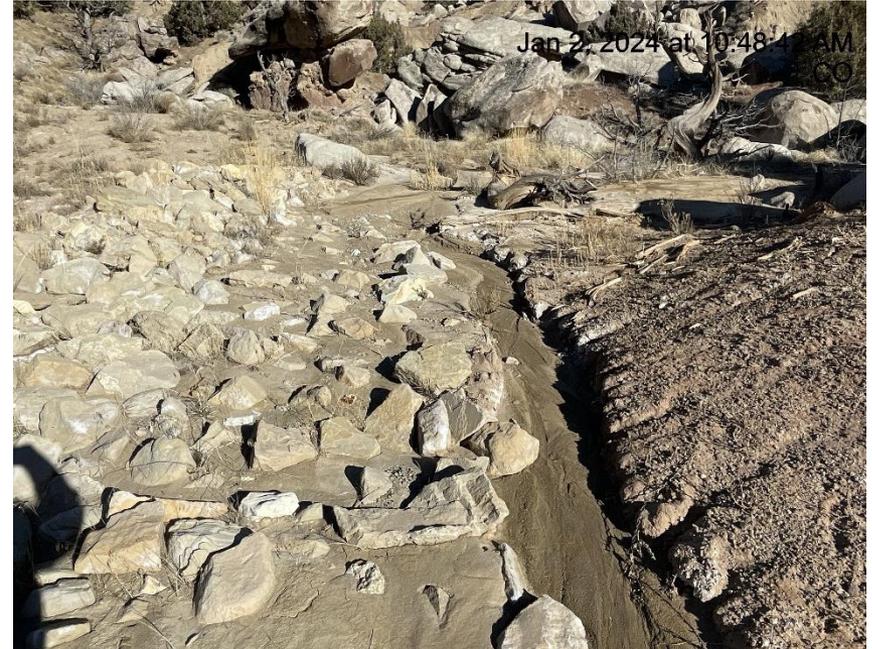
Photo # 1396 Rip Rap Run/BMP needs maintenance (N/NW area of location)

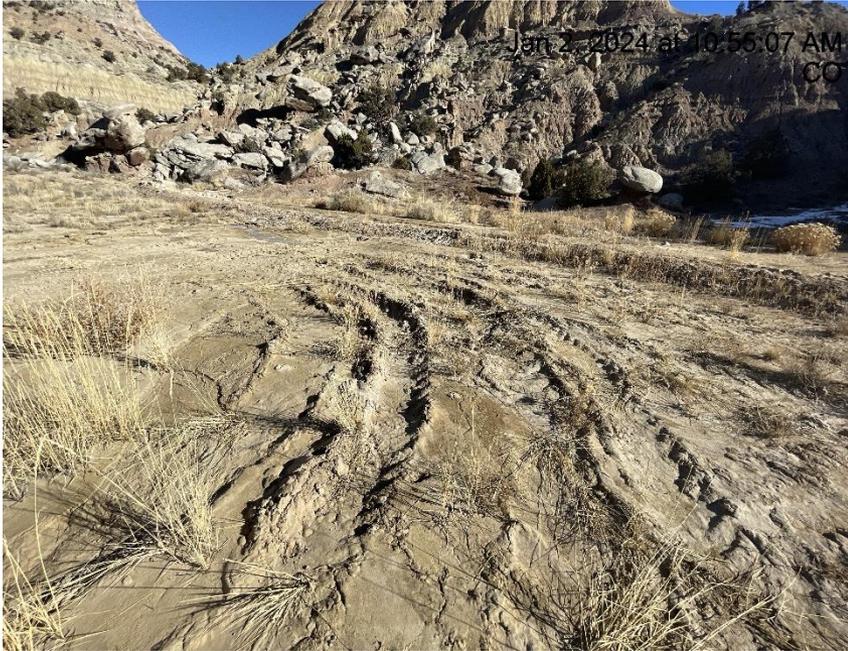
Photo # 1397 Vehicle tracks observed traveling off the working pad area & into the interim area.

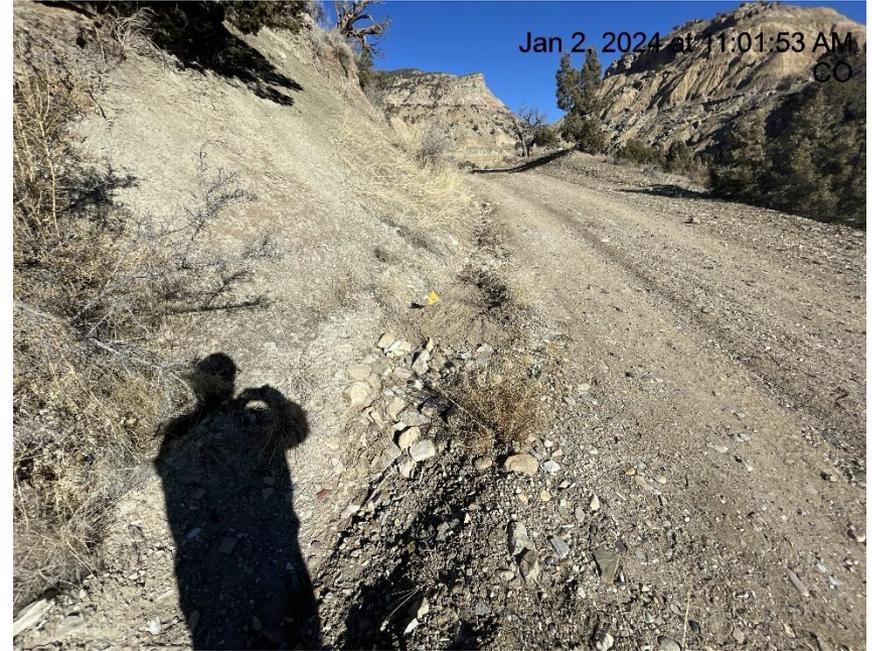
Photo # 1398 Stormwater BMP's along lease road need maintenance (Approximately 70-75 yards from entrance to location)

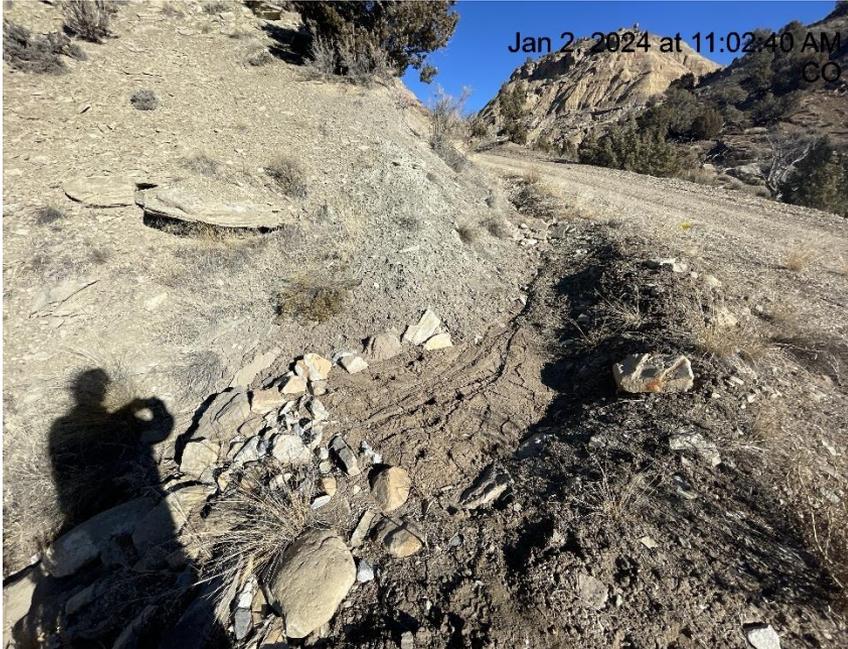
Photo # 1399 Stormwater BMP's along lease road need maintenance (Approximately 75-80 yards from entrance to location)

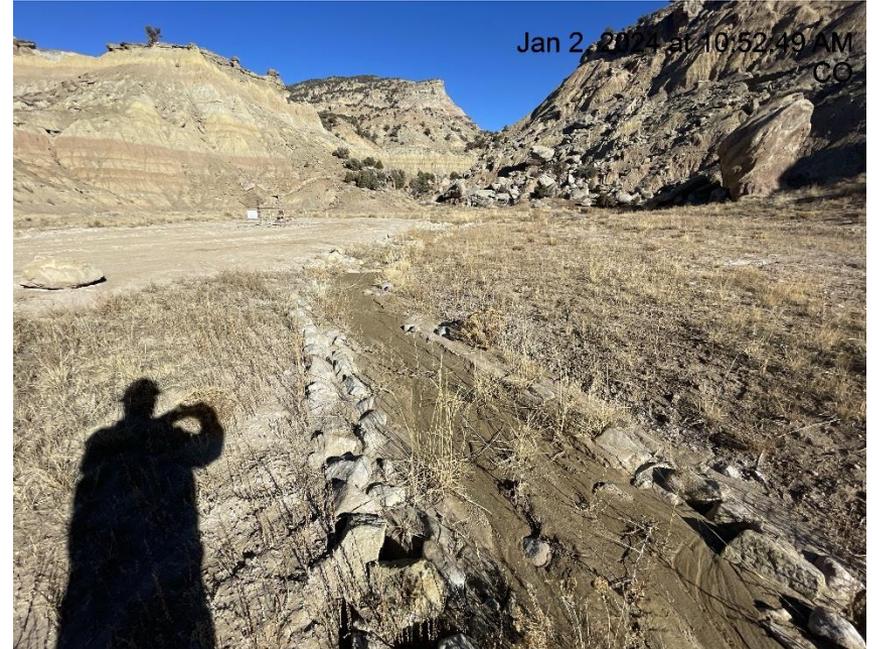
Photo # 1400 Rip Rap Run/BMP needs maintenance (S/SE area of location)
