# Inspection Photos

Loc: 307766

Operator: WAPITI OPERATING LLC

Inspection Date: 1/2/2024

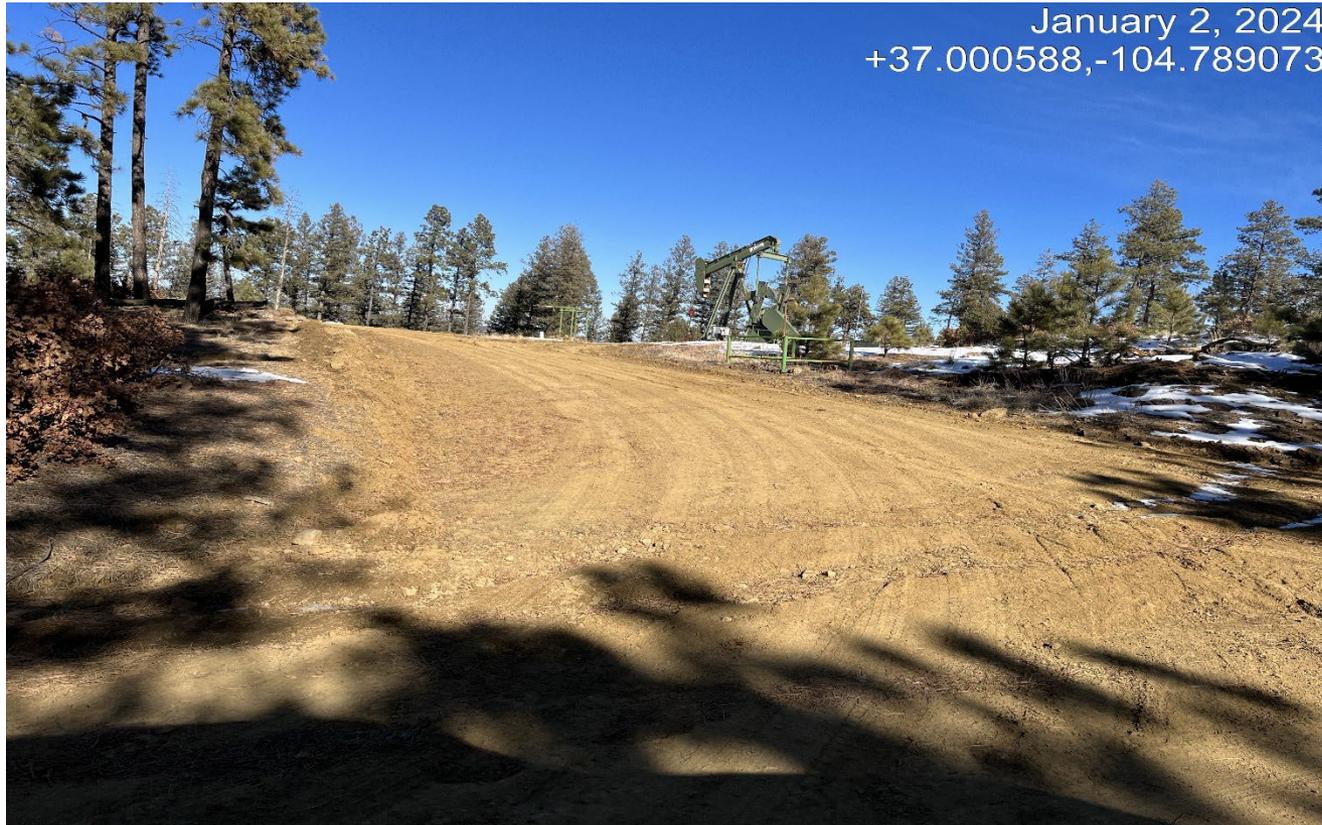
**Photo 1.** Facing northeast toward the access road and wellsite.

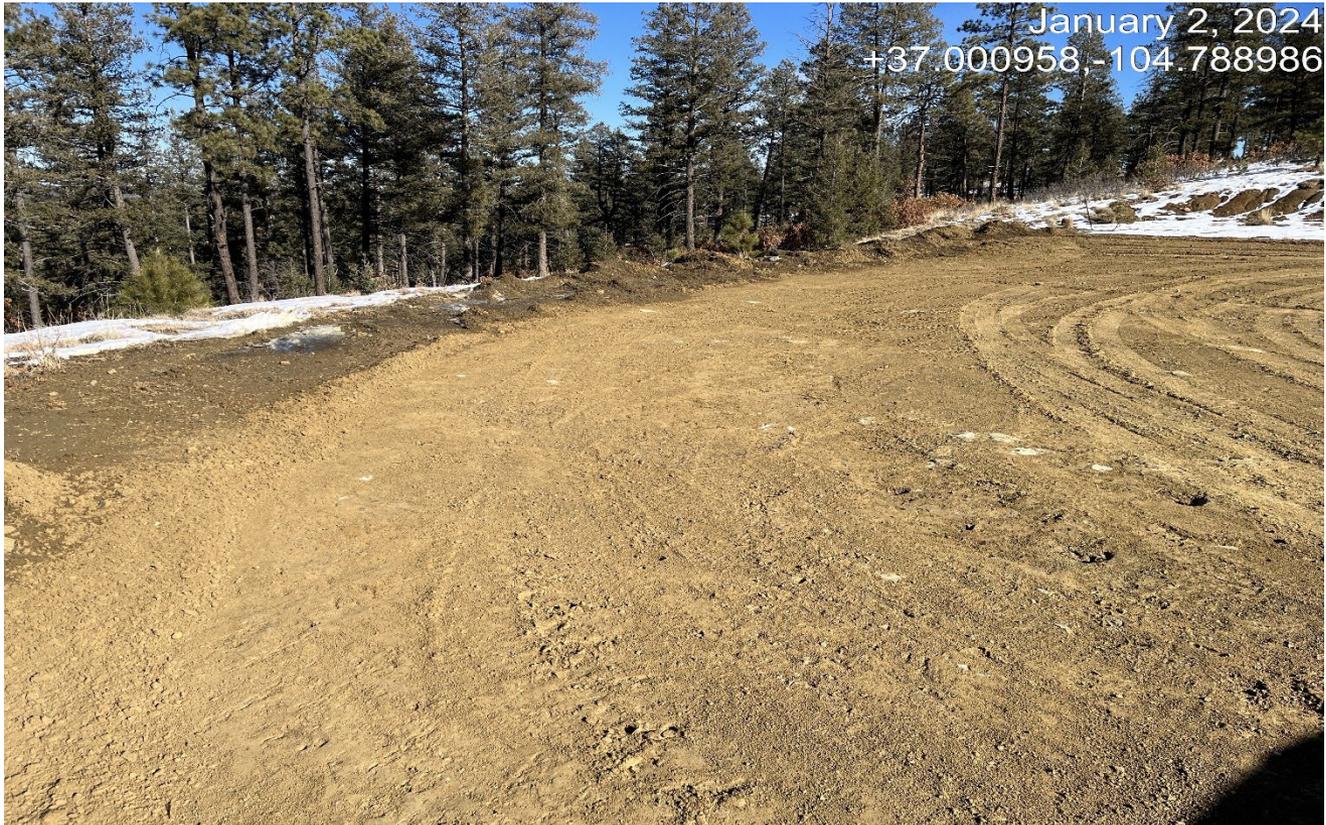
**Photo 2.** Facing toward north side of the location. This area has been graded and soil is pushed out to the edge. This interim area will need to be reclaimed.

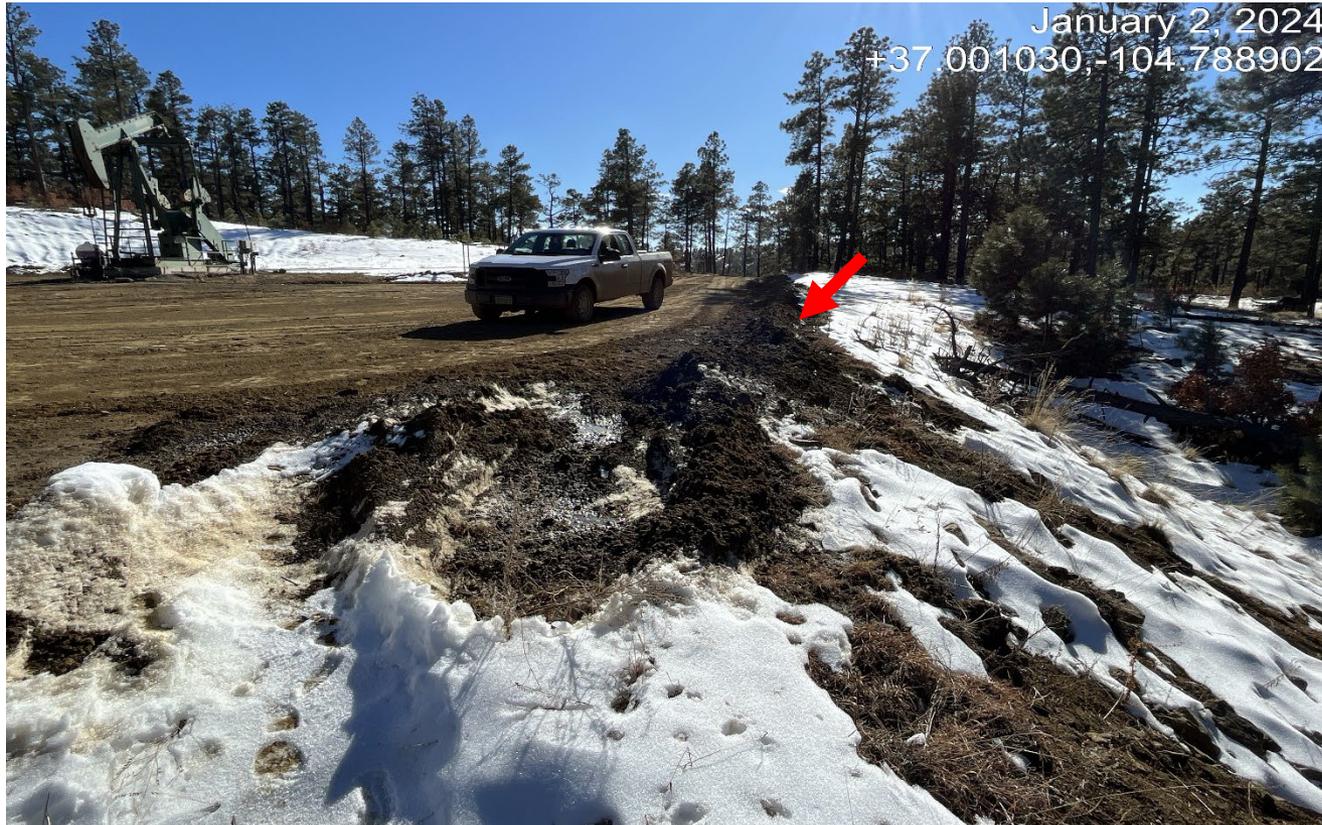
**Photo 3.** Facing south at the west side of the location. Soil has been pushed out along the edge and will need to be pulled back..

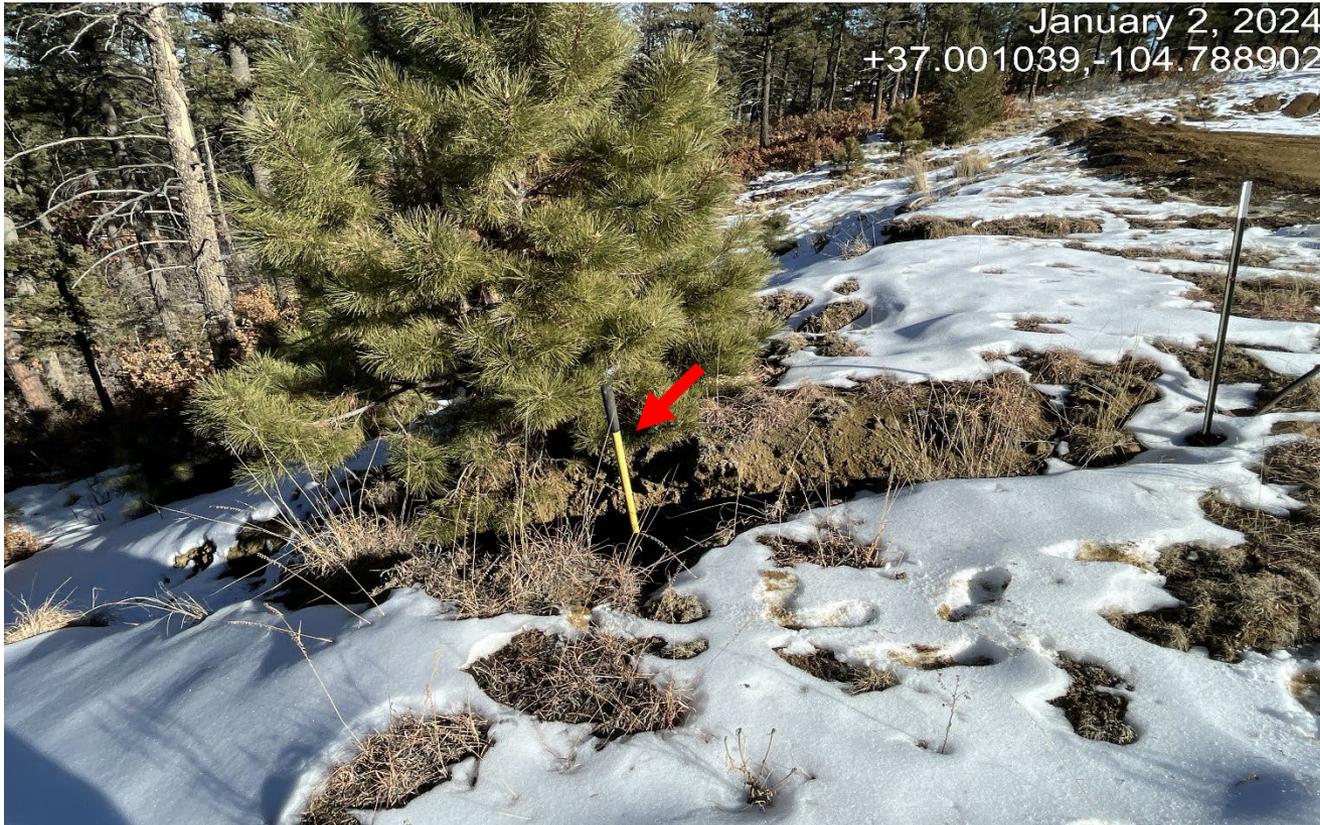
**Photo 4.** There is an erosion channel at the northwest side of the location that needs to be repaired. Arrow points to 4.5 ft. shovel.

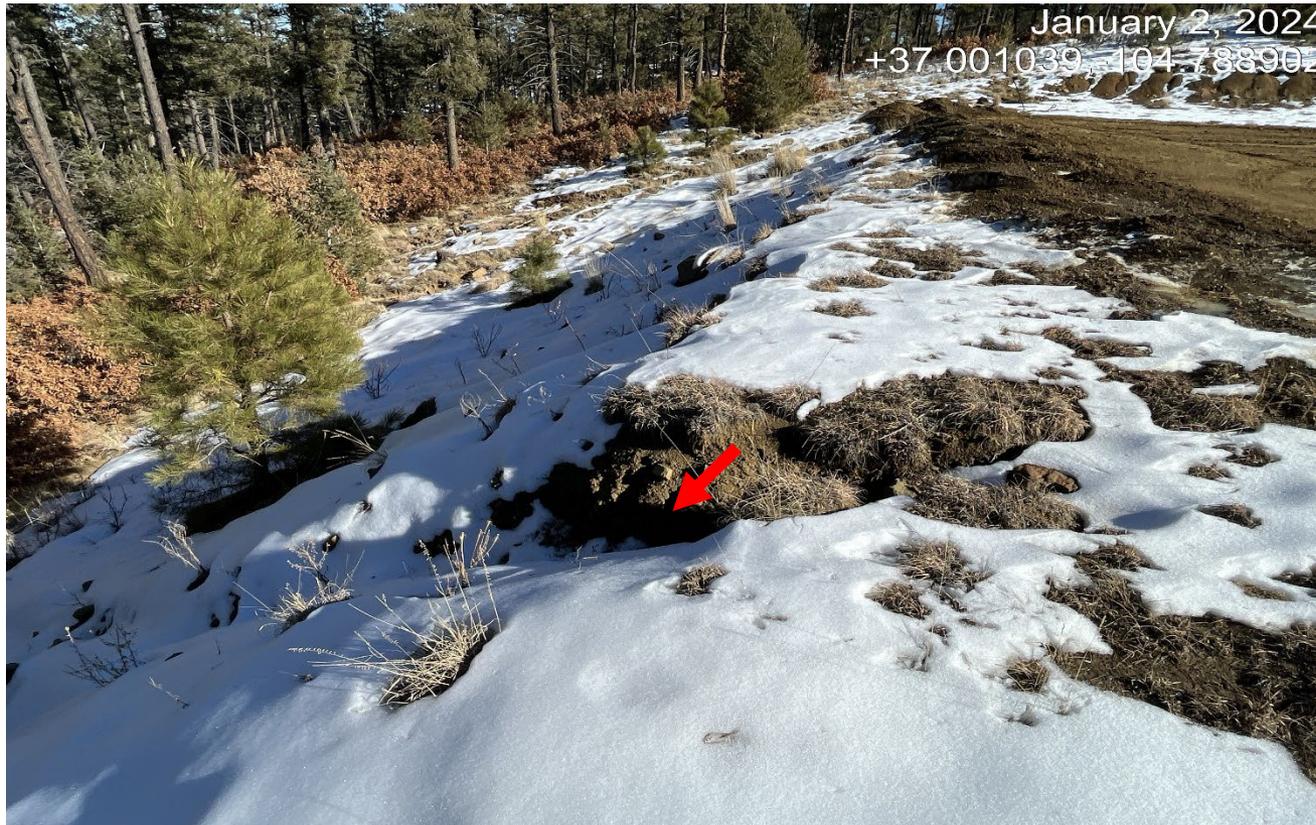
**Photo 5.** There are other erosion channel along the cut slope which have snow cover..

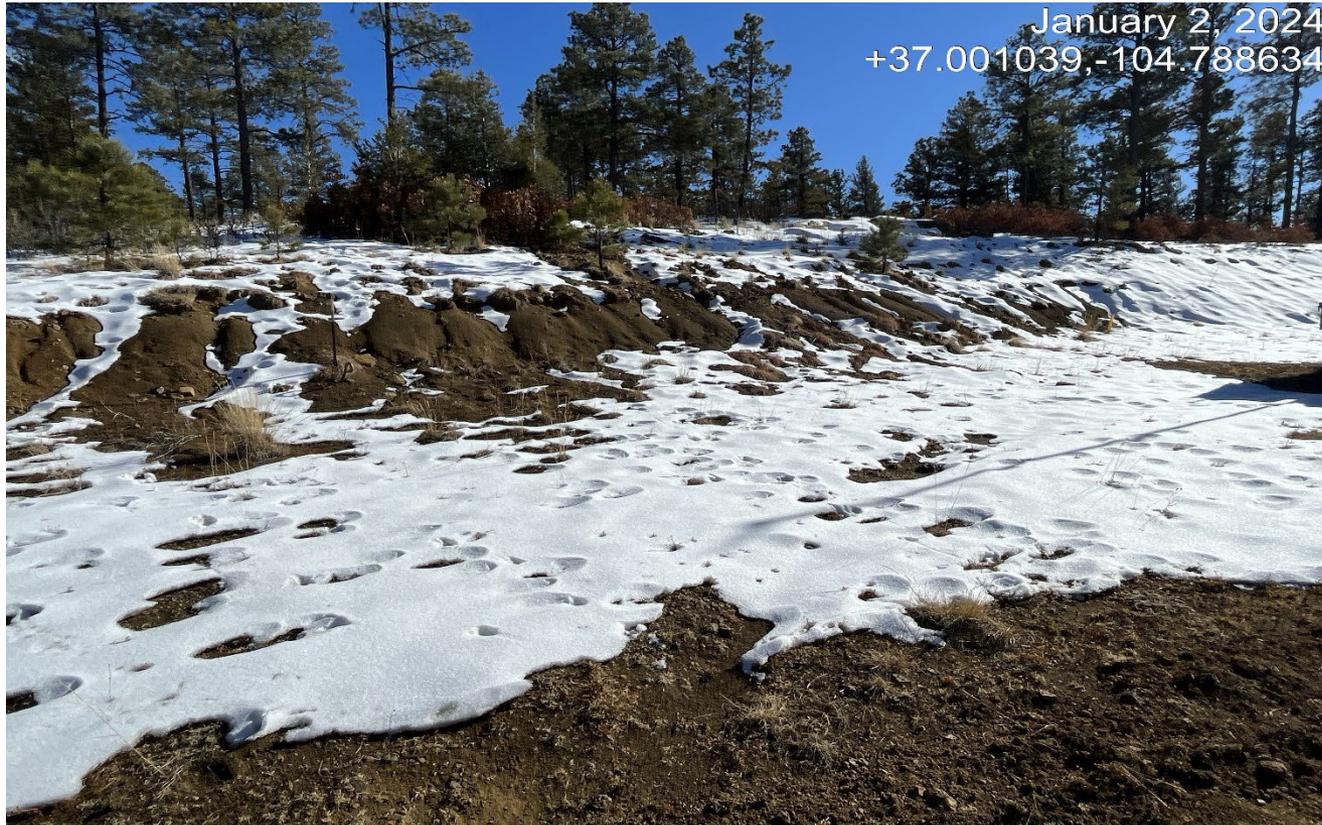
**Photo 6.** Facing toward the cut slope which has sign of erosion that need to be repaired..

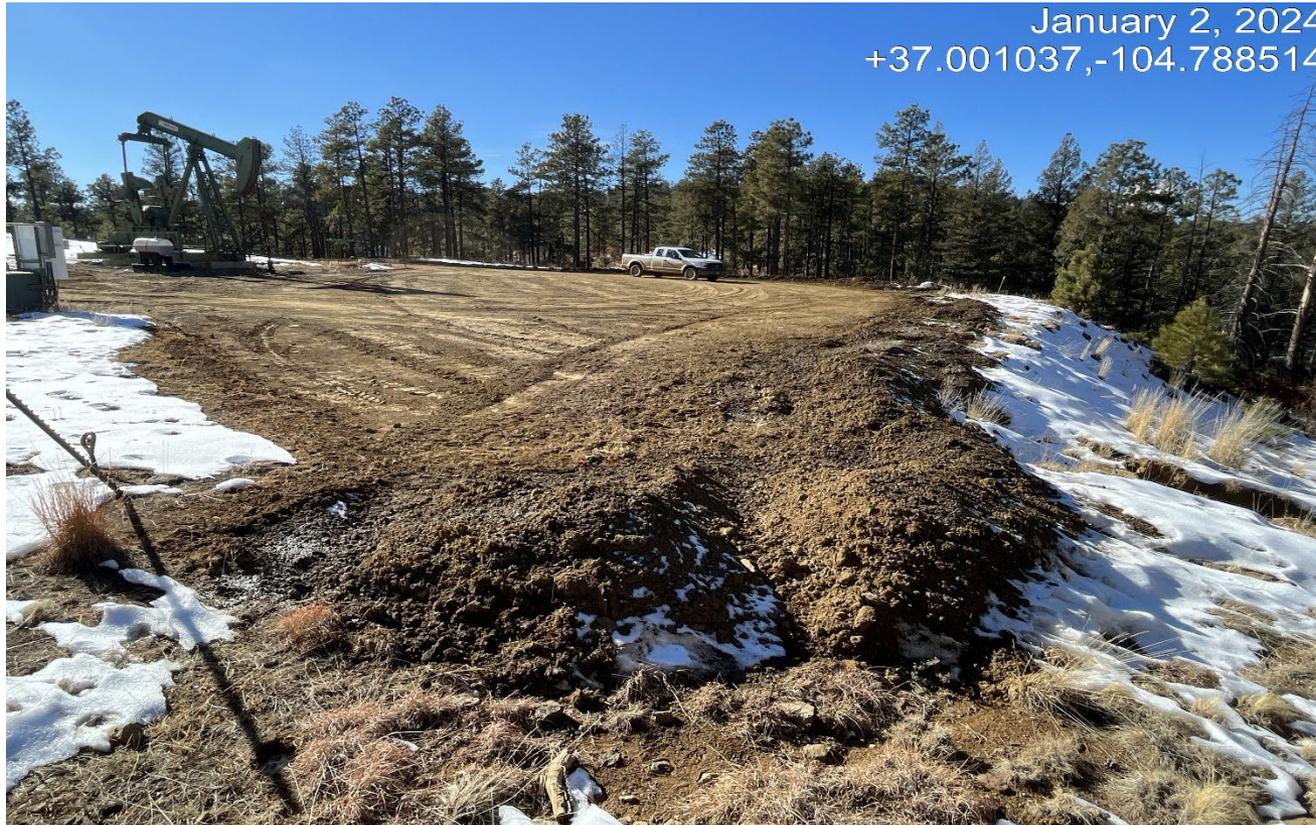
**Photo 7.** Northeast corner of the location. Soil has been pushed out from snow removal and will need to be replaced. Disturbance area will need to be reclaimed.

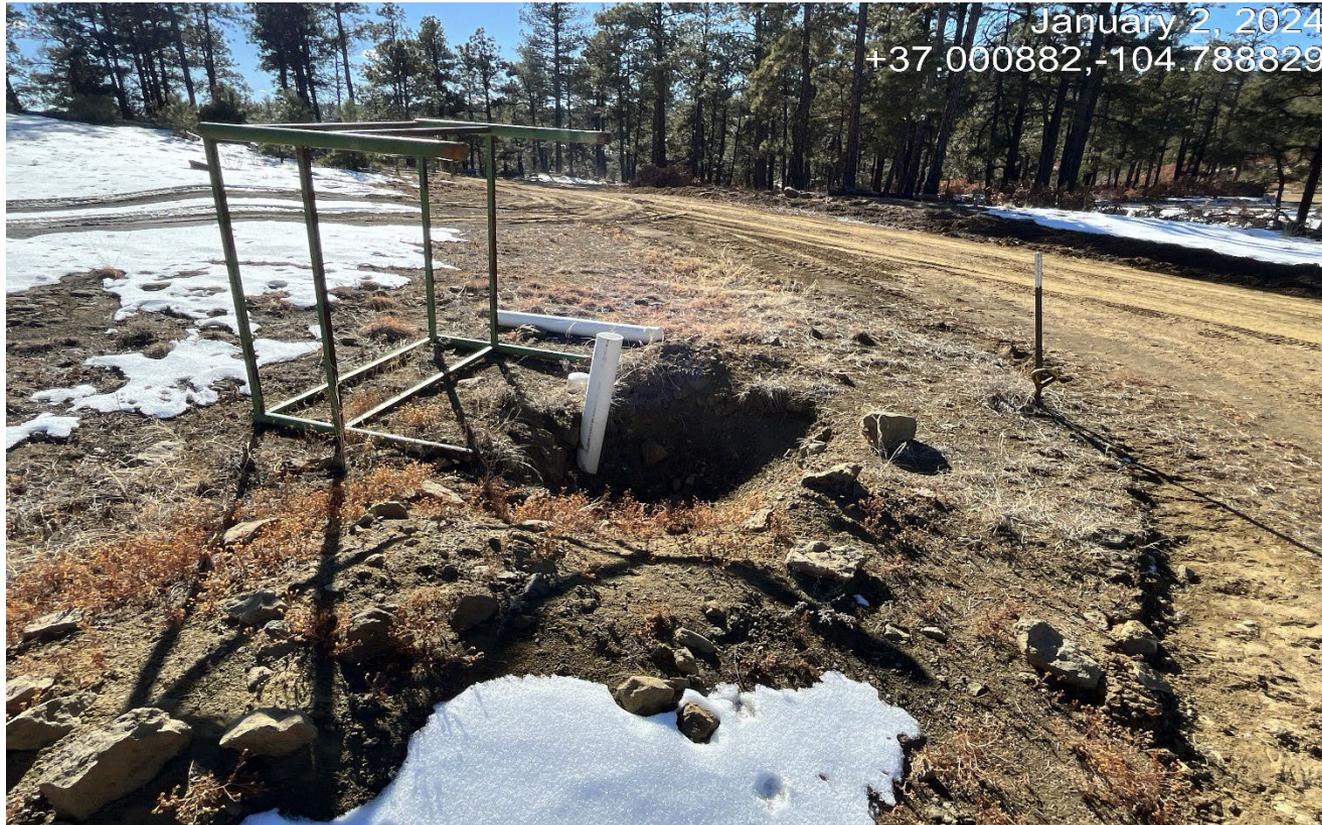
**Photo 8.** The plastic pipe has been excavated and pipe fence guard is not in place. .
