Operator: HIGHPOINT OPERATING CORPORATION

Location Name: Park 4-63-4 NE

Loc ID: 459857

Inspection: 699107965

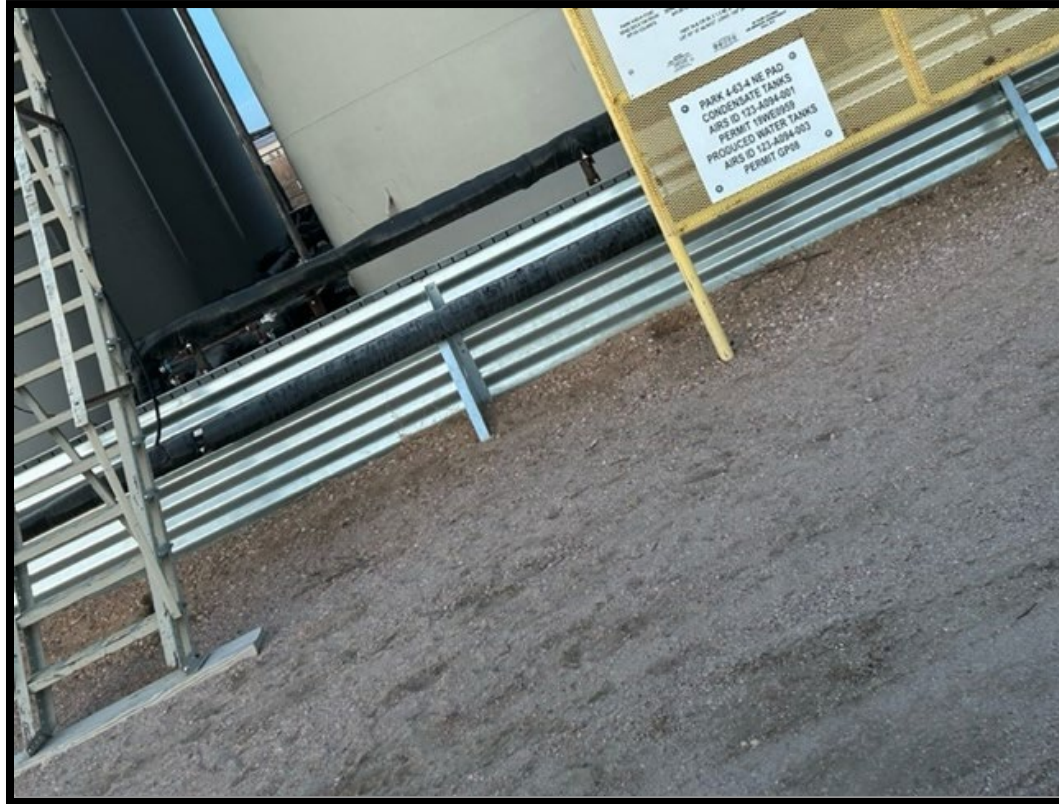
Exhibit A

CA: Stained soil under appears to be leaking valve next to the tank needs to be removed. See attached photo. "Properly dispose of oily waste in accordance with 905.e."

CA Resolution: Operator has appropriately addressed and cleared identified stained soil to comply with Rule 905.e.

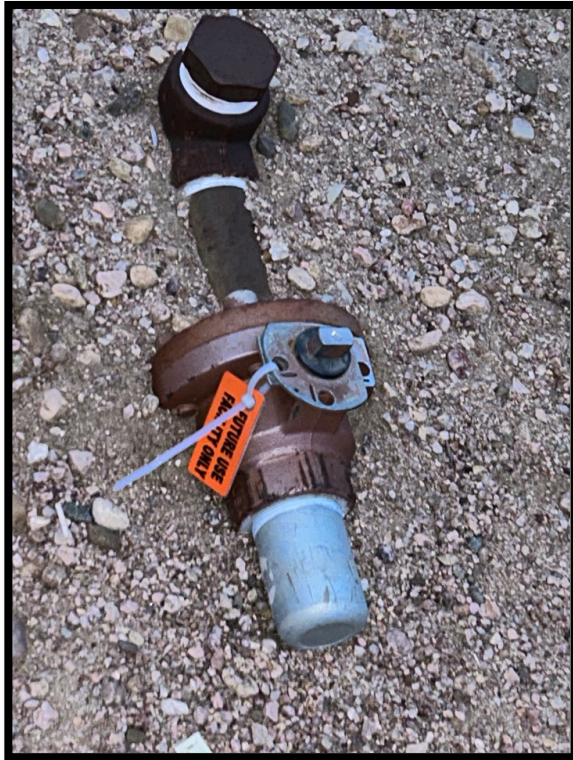
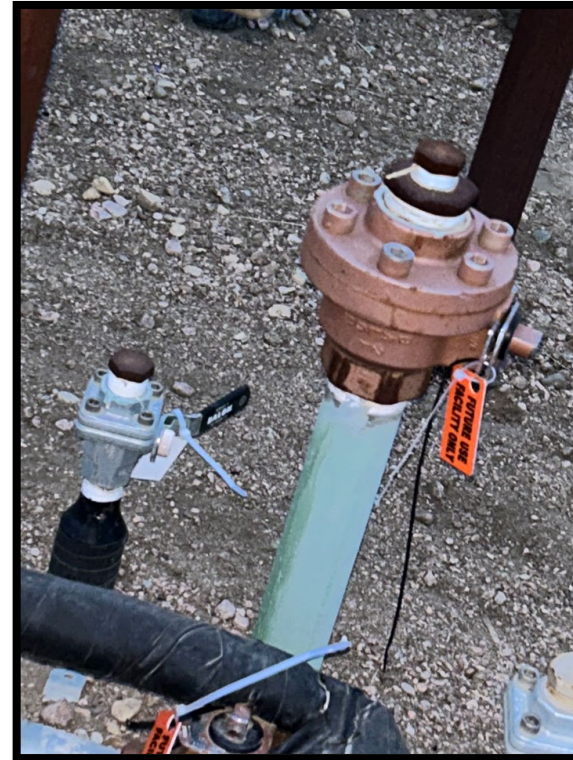
Exhibit B

CA: Unmarked risers in multiple spots need to be marked with OOSLAT tags and Locked out/ Tagged out. See attached photos. Comply with the 1100 rules.

CA Resolution: Operator has appropriately marked identified Risers to comply with the Rule 1100 series.

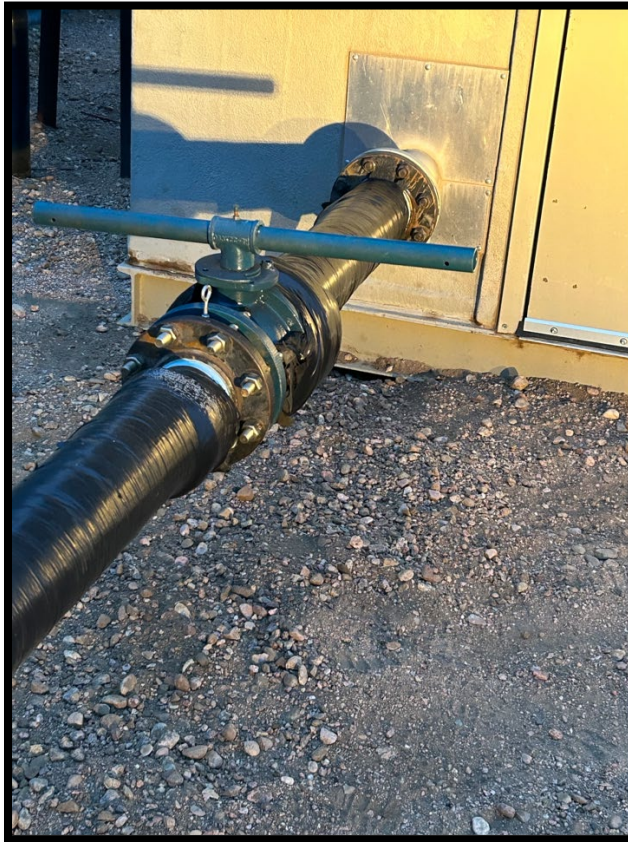
Exhibit A

CA: Stained soil under appears to be leaking valve next to the lact needs to be removed. See attached photo. "Properly dispose of oily waste in accordance with 905.e."

CA: Valve next to the lact appears to be leaking and needs to be fixed or replaced. See attached photo. Securely fasten all valves, pipes, fittings, and Production Facilities to ensure good mechanical condition, inspect at regular intervals and maintain in good mechanical condition per Rule 608.e.

CA Resolution: Operator has appropriately addressed and cleared identified stained soil to comply with Rule 905.e.

CA Resolution: Operator has appropriately addressed the identified valve issue to comply with Rule 608.e.
