Inspection Photos
Location Name: ROUSE-USX A-66N64W/5NWNW
Location #: 306456

Rouse-USX A 5-19 (123-24697) Wellsite
Plugged & Abandoned | PA
Plugging Ops; Cementing: Initial plug(s)

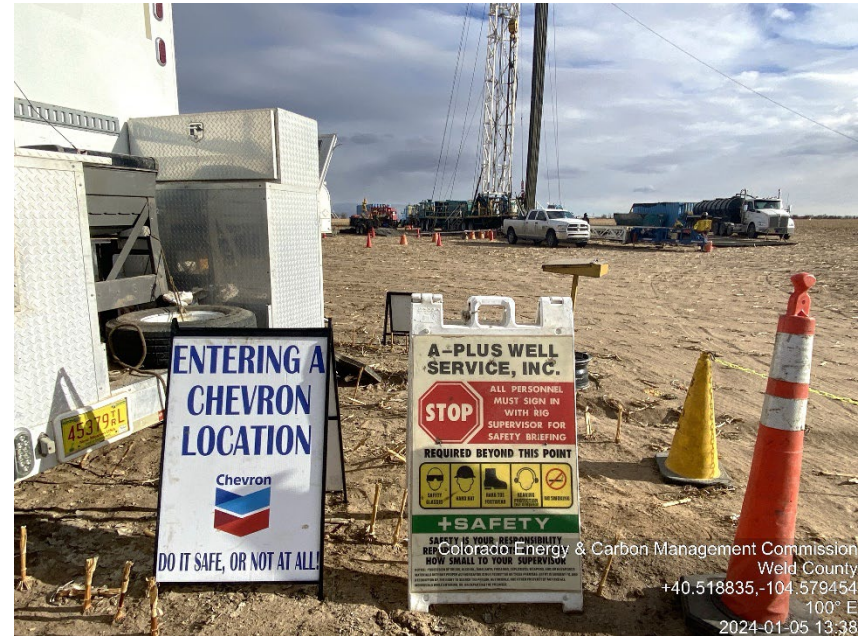
Photo #2

Rouse-USX A 5-19 Wellsite
Plugged & Abandoned | PA
Plugging Ops; Cementing: Initial plug(s)
Site safety signage

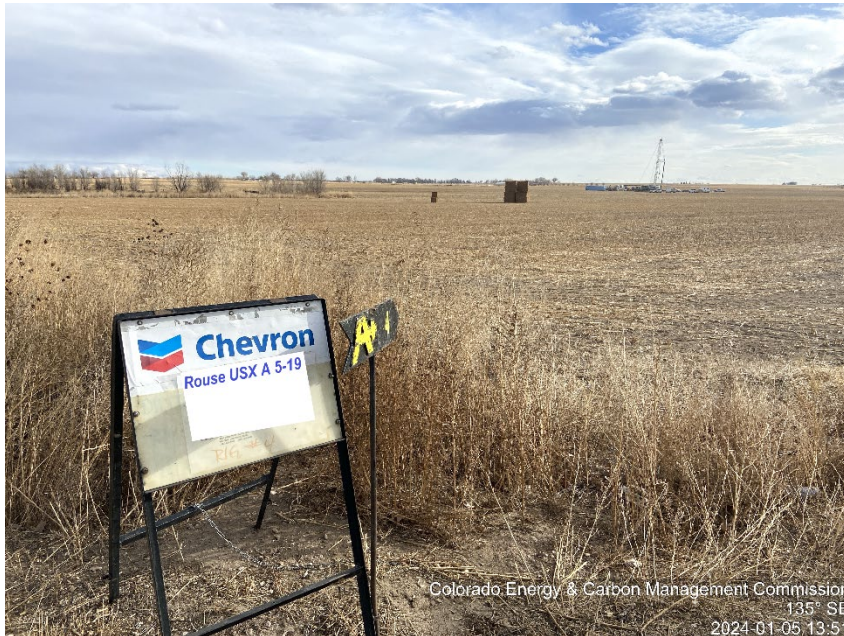
Photo #3
Rouse-USX A 5-19 Wellsite
Plugged & Abandoned | PA
Plugging Ops; Cementing: Initial plug(s)
Wellsite entrance

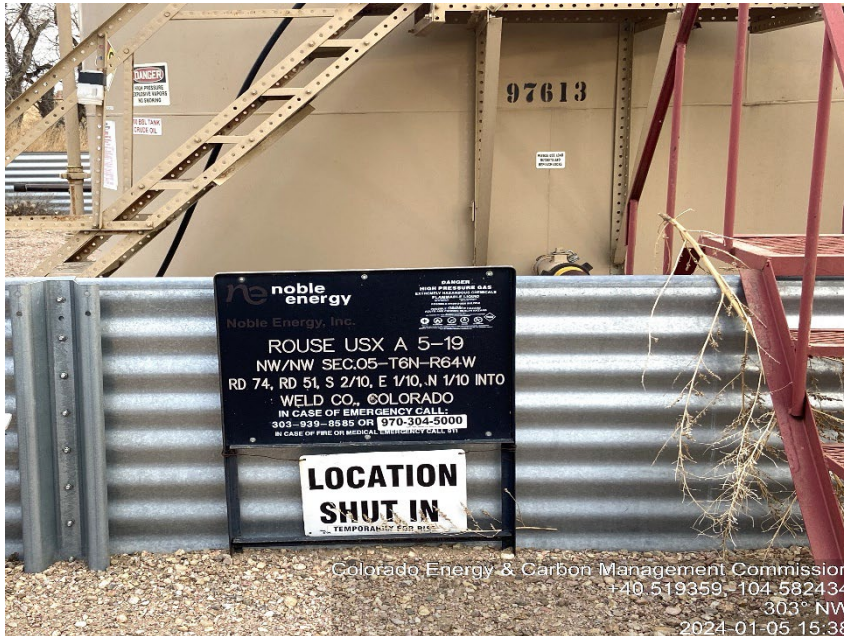
Photo #5

Battery sign
