Inspection Photos
Location Name: Champlin 86 Amoco B #2
Location ID: 318 253

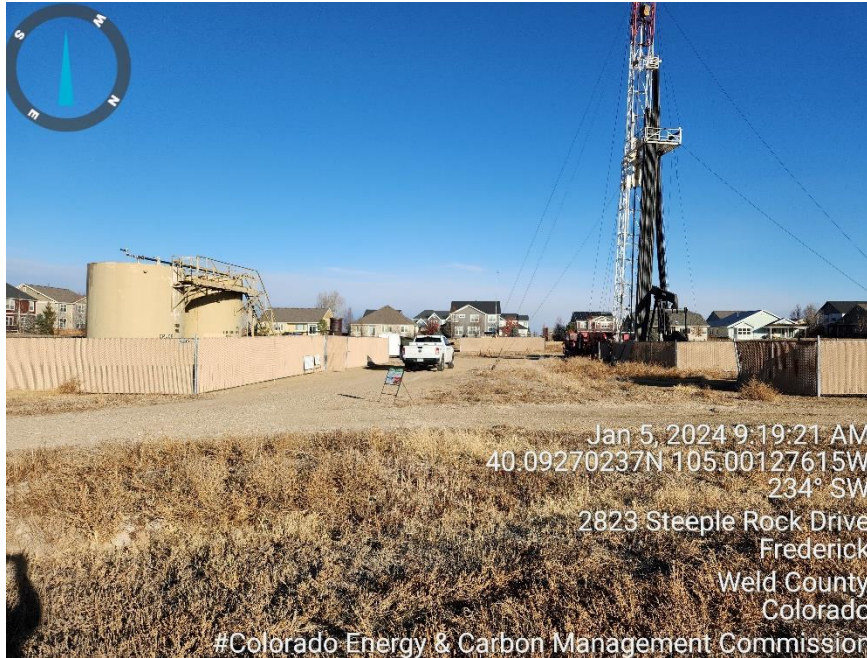
Photo 1 loc pic

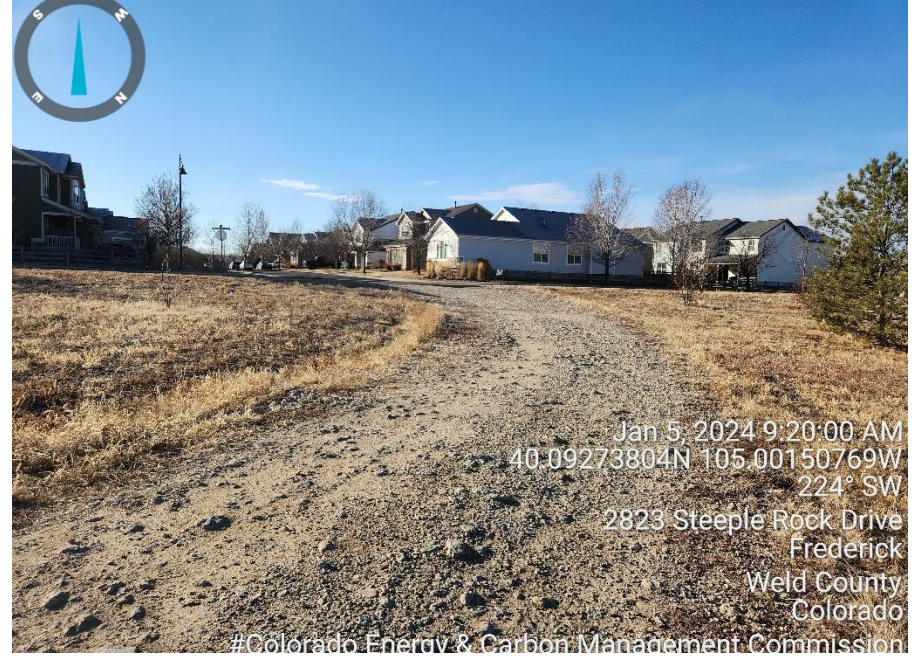
Photo 2 impacted tracking pad

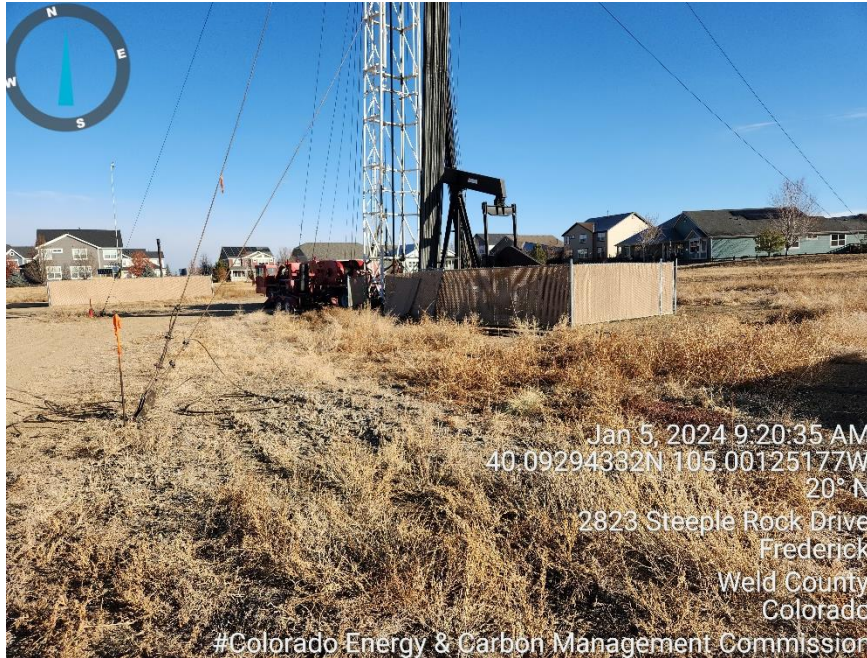
Photo 3 loc pic and dead weeds

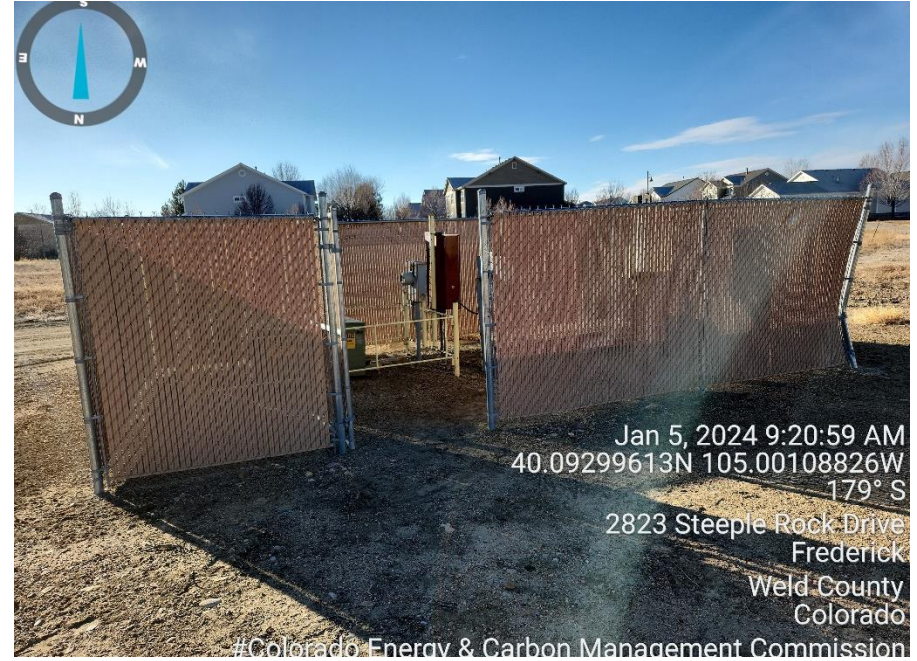
Photo 4 electric disconnect.

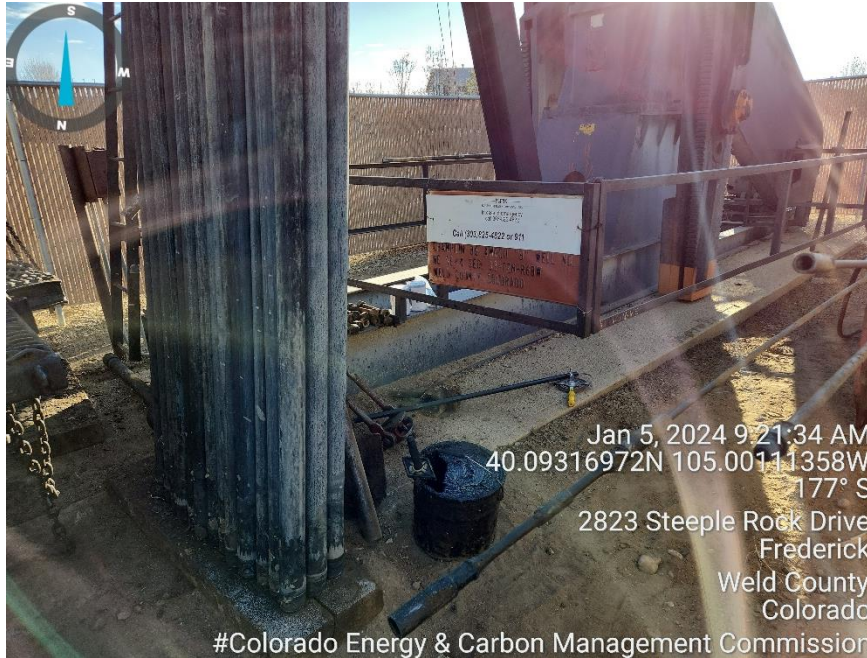
Photo 5 well head

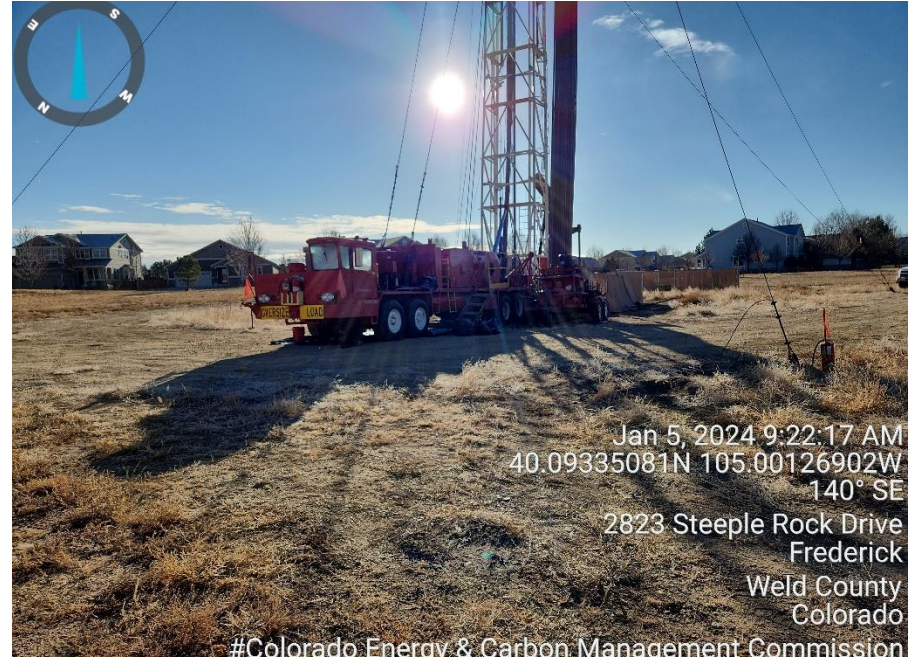
Photo 6 well head

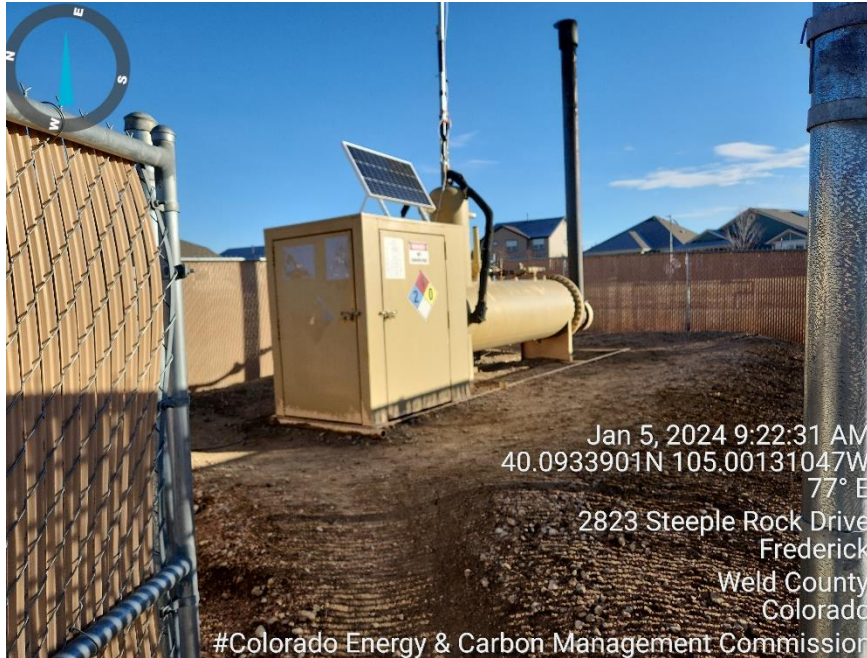
Photo 7 Hoz Sep

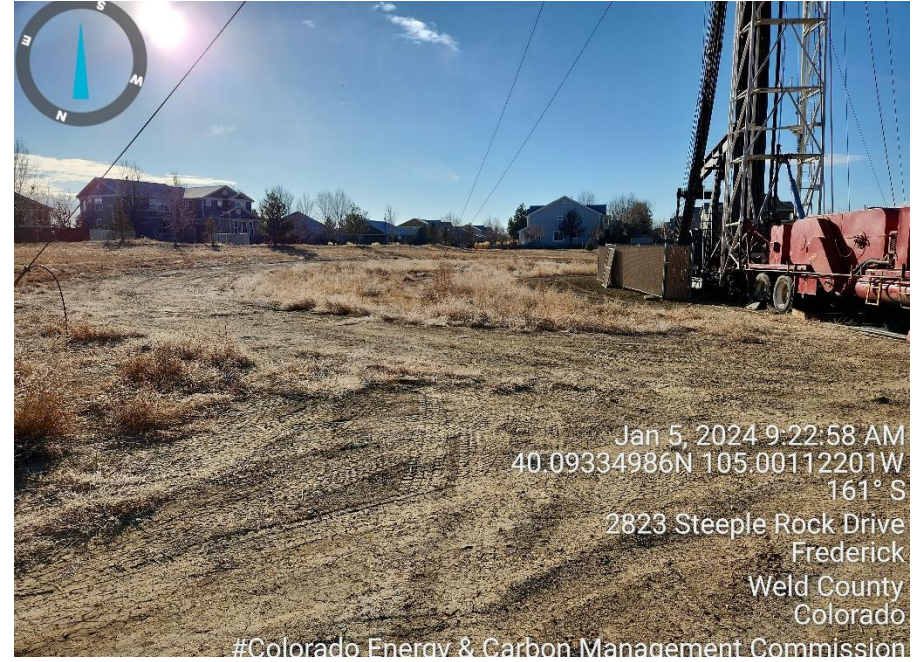
Photo 8 Dead weeds on location.

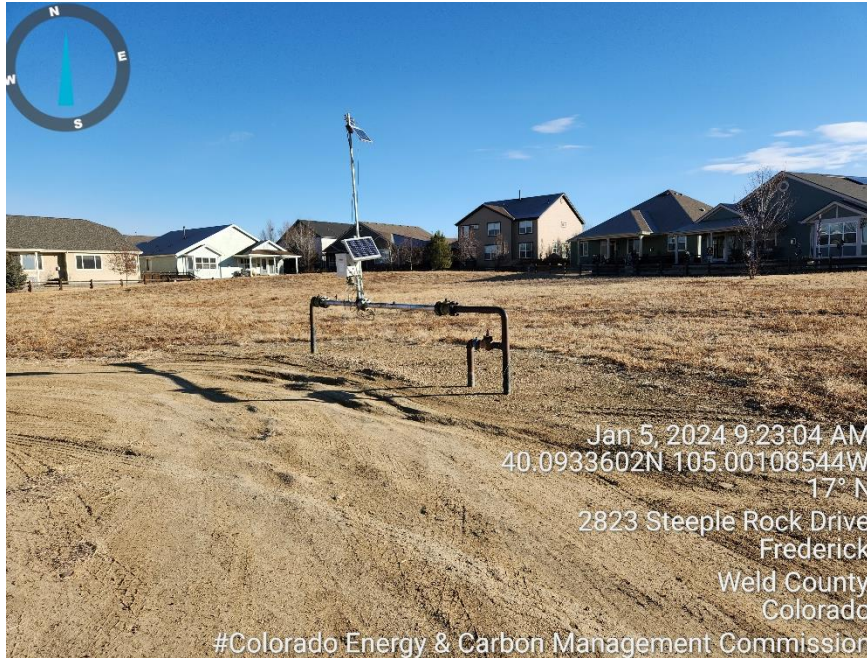
Photo 9 Meter run

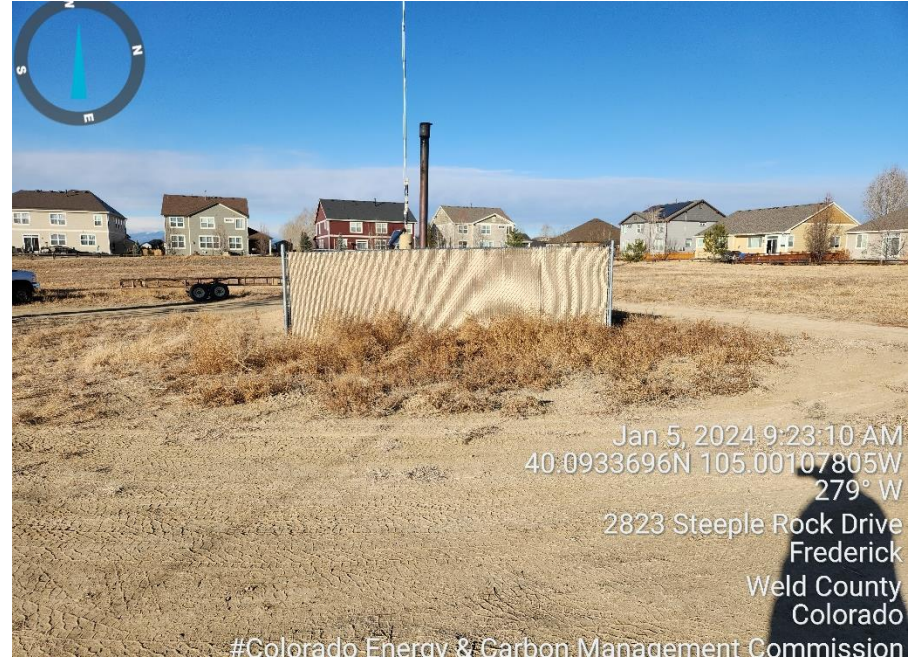
Photo 10 dead weeds on location

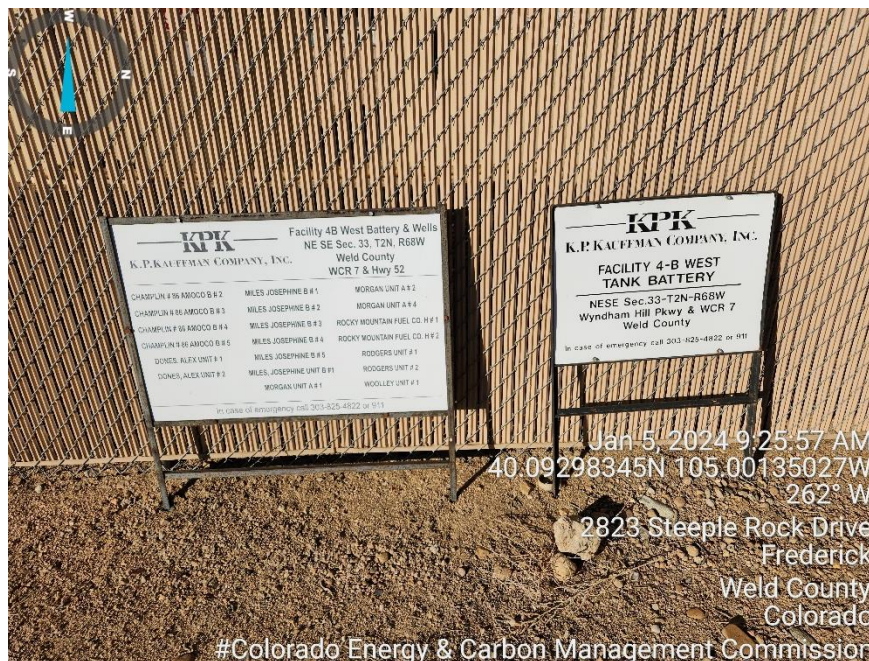
Photo 11 TNK BTRY sign

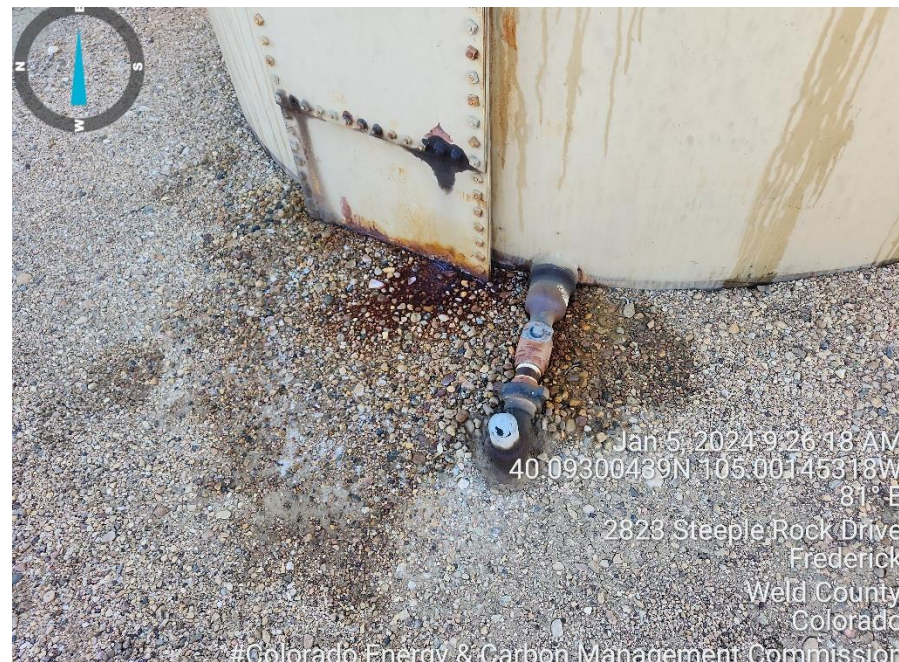
Photo 12 Crude oil tank stained soil and what appears to be mechanical issues with the 2 in piping and rusted bolts on inspection hatch.

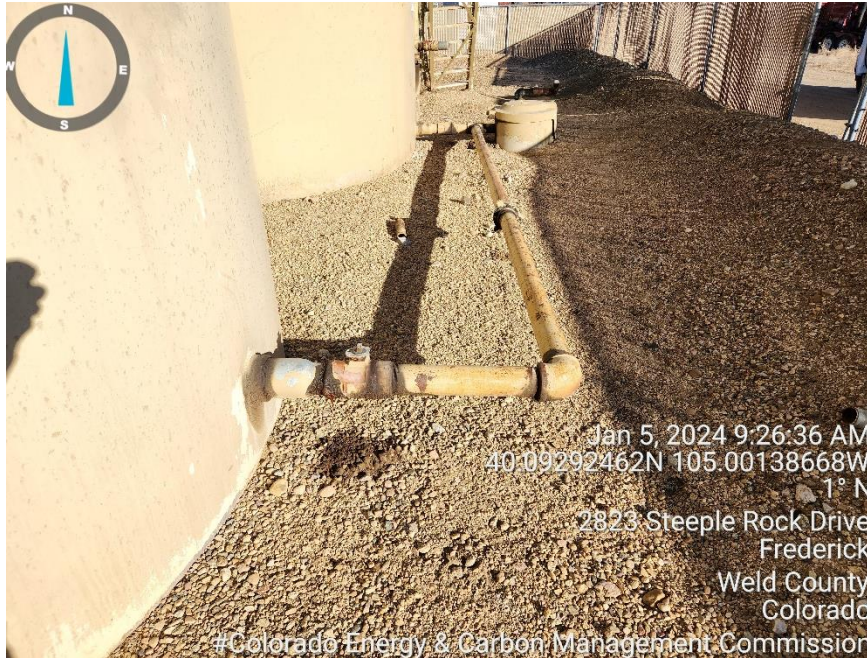
Photo13 stained soil under crude oil load out lines and what appears to be mechanical issue with 2 in piping

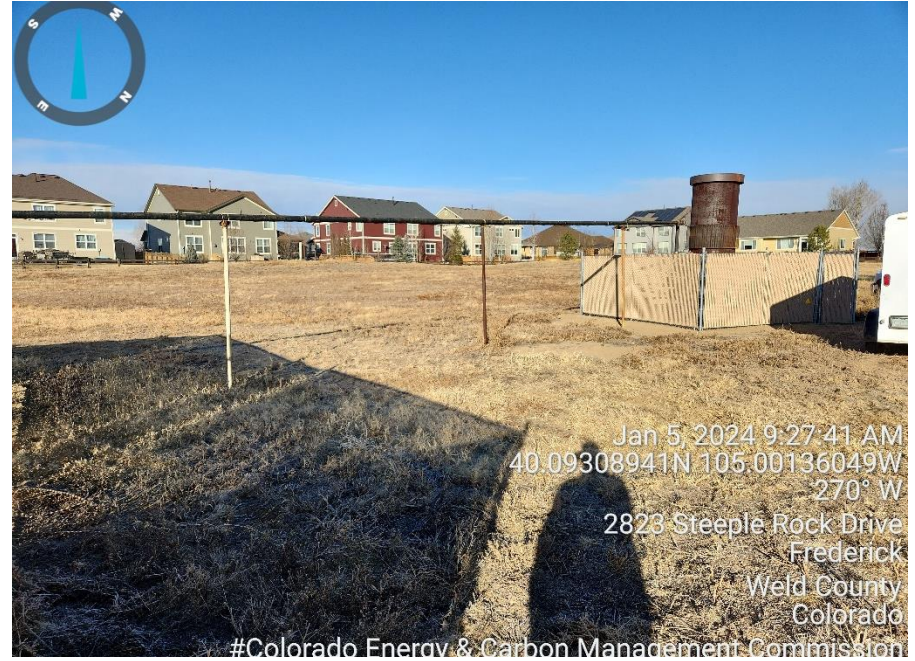
Photo 14 ECD
