Inspection Photos
Location Name: Champlin 367 Amoco #1
Location ID: 318431

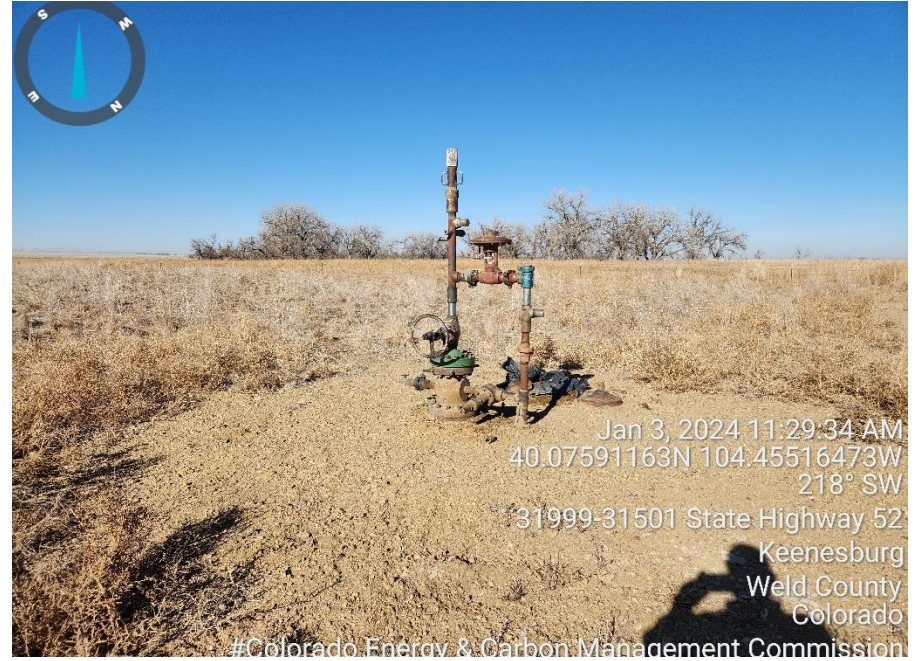
Photo 2 Well head. No sign DEAD WEEDS DEBRIS

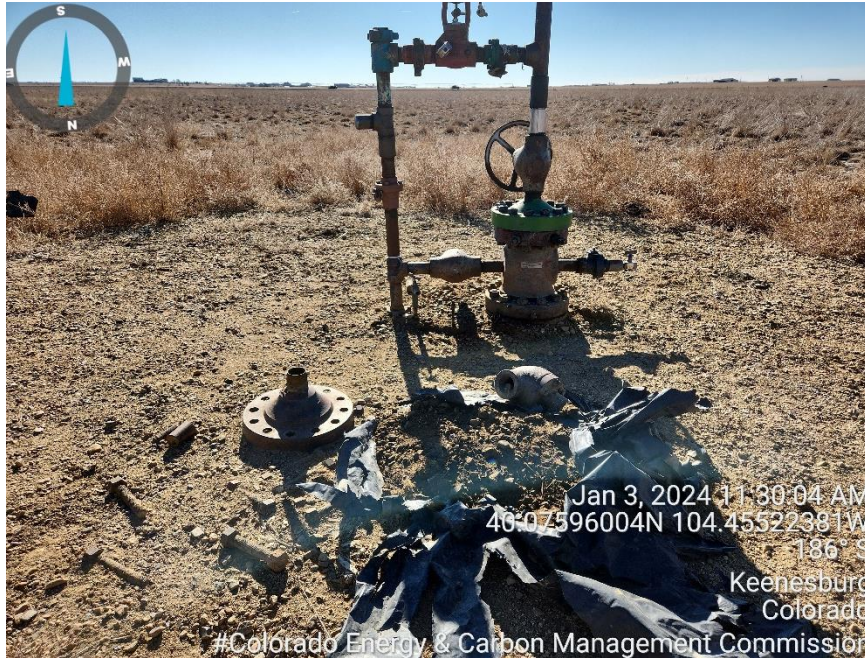
Photo 3 What appears to be contaminated soil and unused equipment

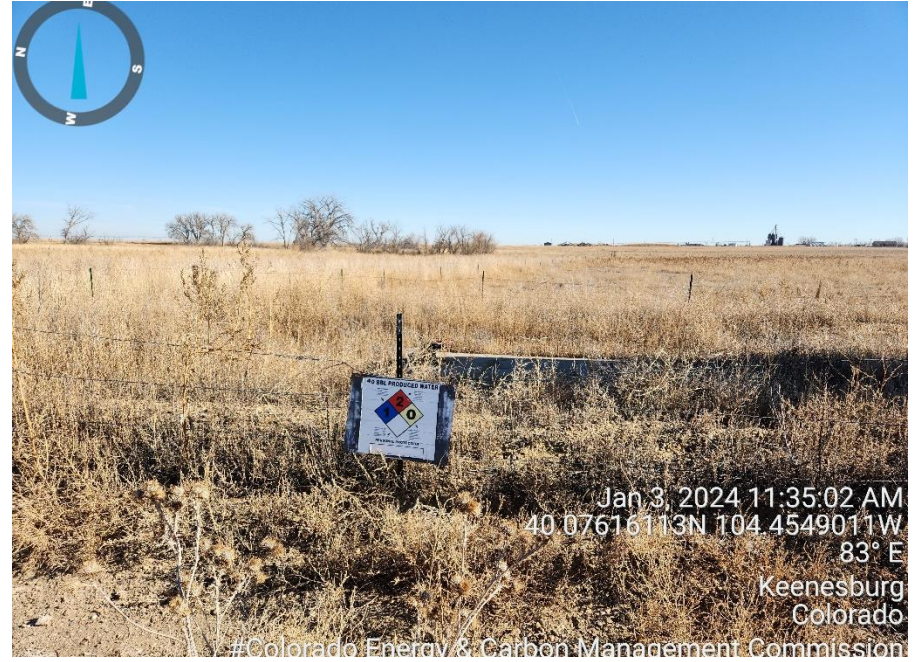
Photo 4 Produced water vault. DEBRIE

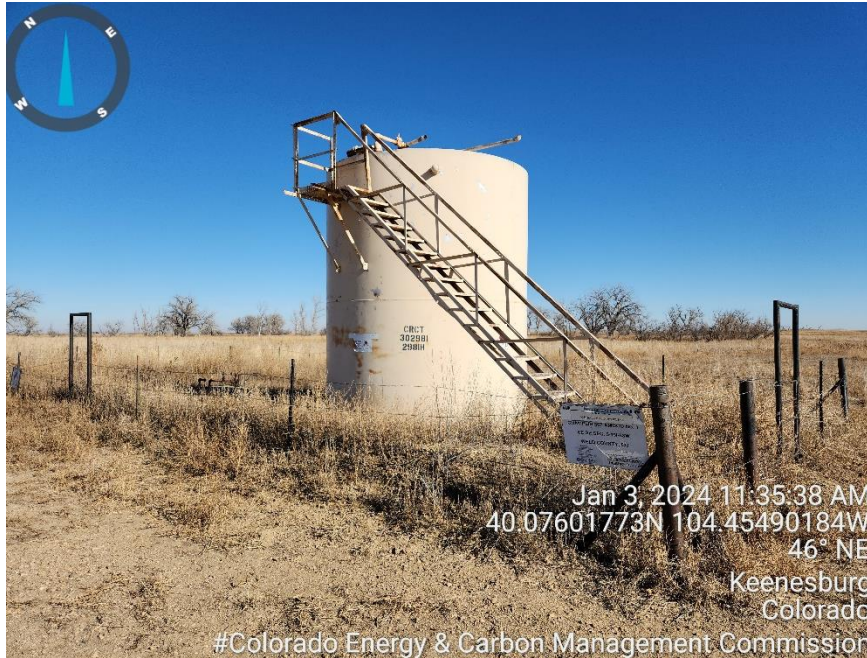
Photo 5 TNK BTRY Battery sign peeling need to be replaced along with NFPA placards DEAD WEEDS DEBRIS

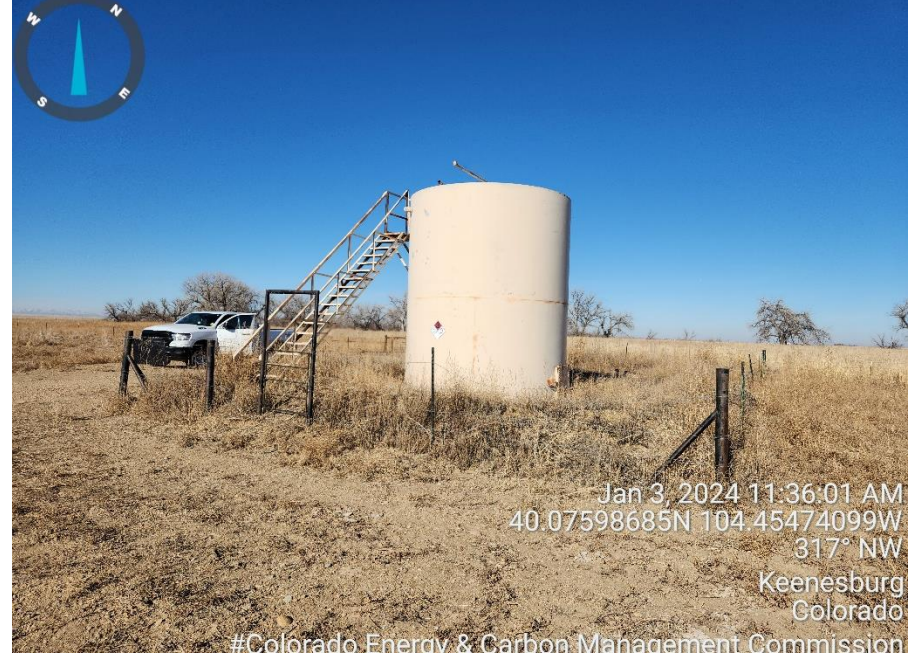
Photo 6 DEAD WEEDS DEBRIS

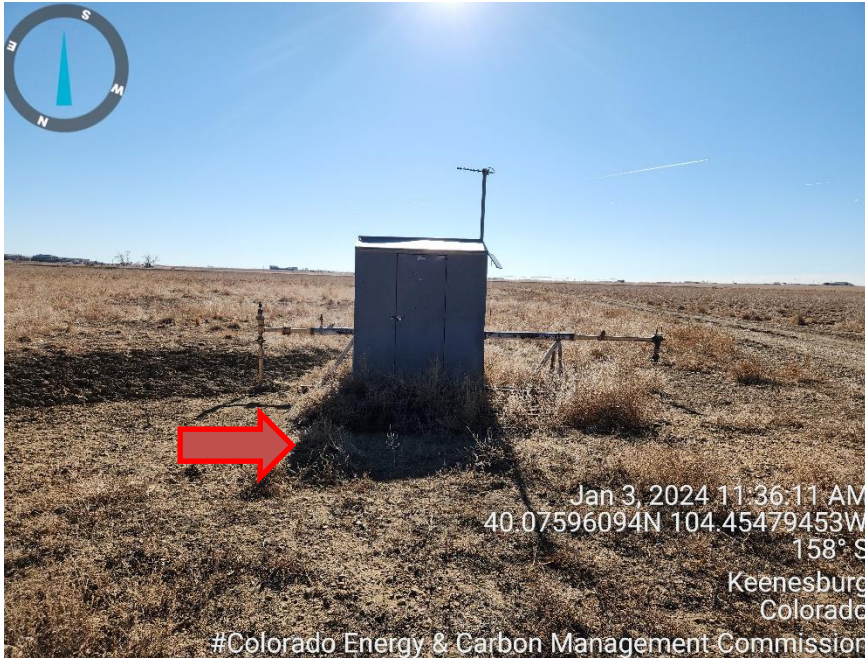
Photo 7 Meter house DEAD WEEDS DEBRIS. Unused equipment (cattle panels), Meter tube has been LOTO since 2020 and pined pulled house considered unused equipment.

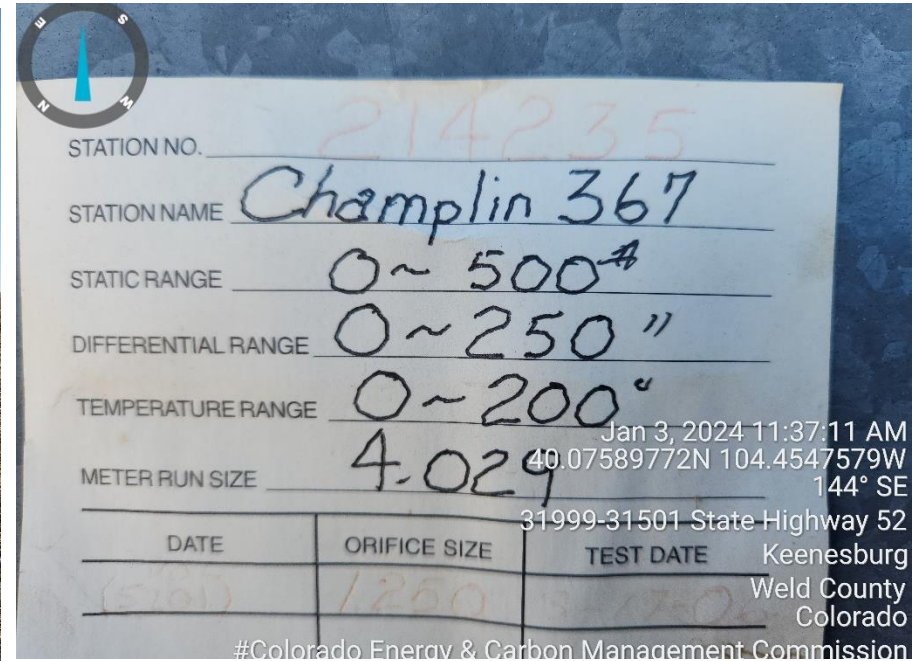
Photo 8 Meter calibration card has not been calibrated since 2006

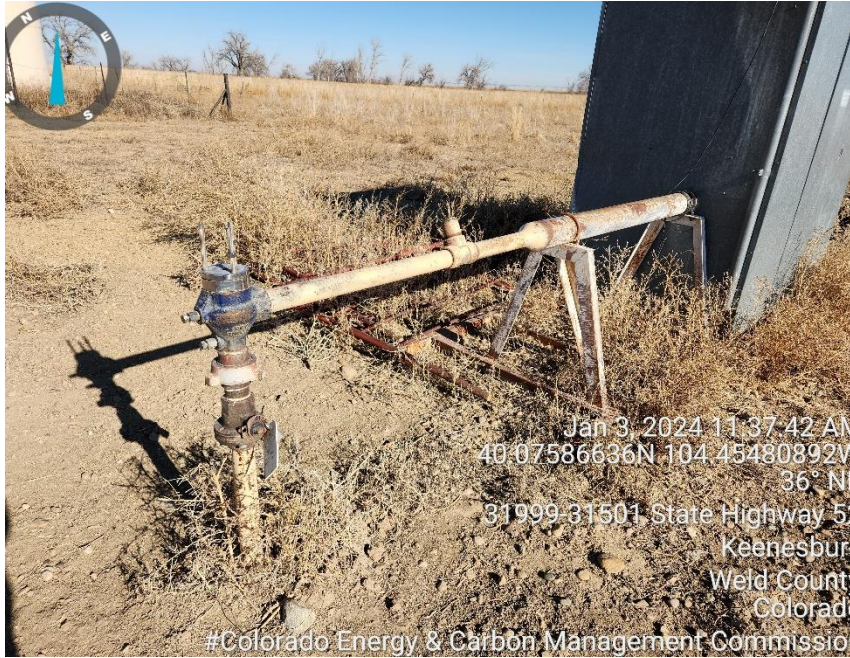
Photo 9 Meter tube LOTO and pined pulled.
